# Inspection Report

5135 Parker St  
Omaha NE 68104

**AmeriSpec Inspection Services**

<b>Date:</b> 5/8/2025	<b>Time:</b> 08:00:00 AM	<b>Report ID:</b> 42560
<b>Property:</b> 5135 Parker St Omaha NE 68104	<b>Customer:</b> Chris Holbeck	<b>Real Estate Professional:</b>

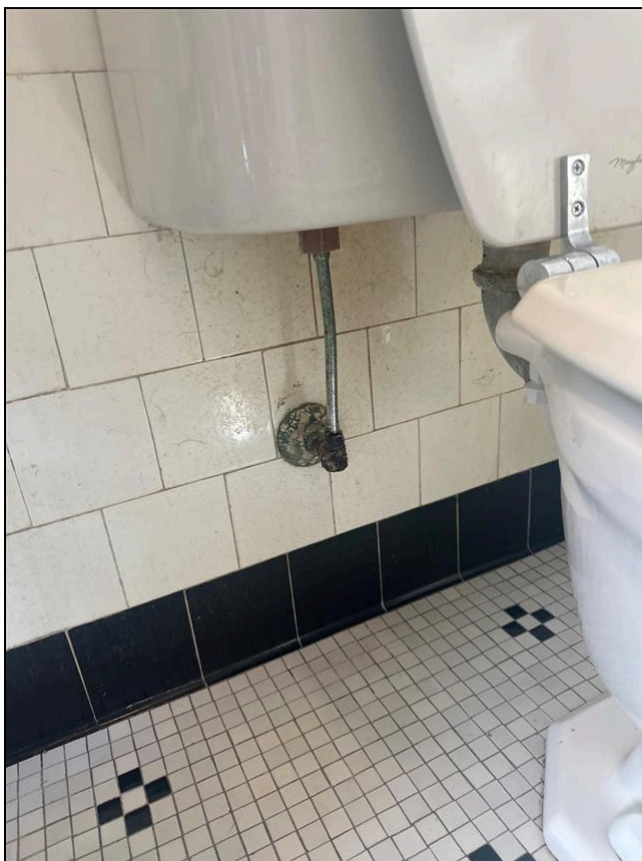
(2) No shut-off valve observed to the toilet in the hall bathroom. Shut off valves may not have been required when fixture was installed, recommend shut-off valve be installed as a plumbing up-grade.

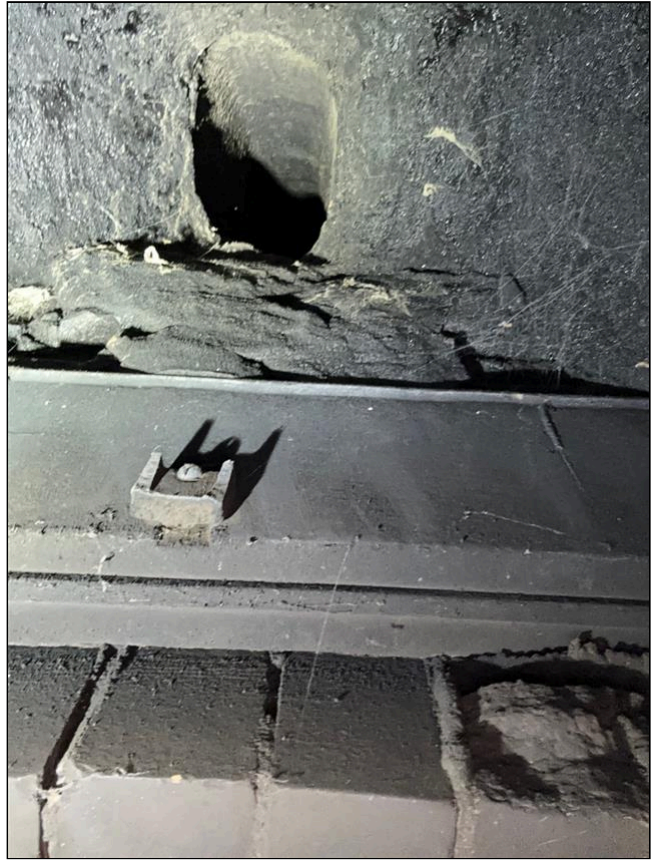
(1) Creosote build-up was observed in the fireplace located in the living room. Creosote is a naturally produced flammable by-product of combustion. Its presence is a limiting factor on a visual review. We suggest having cleaned and inspected by a fireplace and chimney specialist to assure safe operation prior to close.

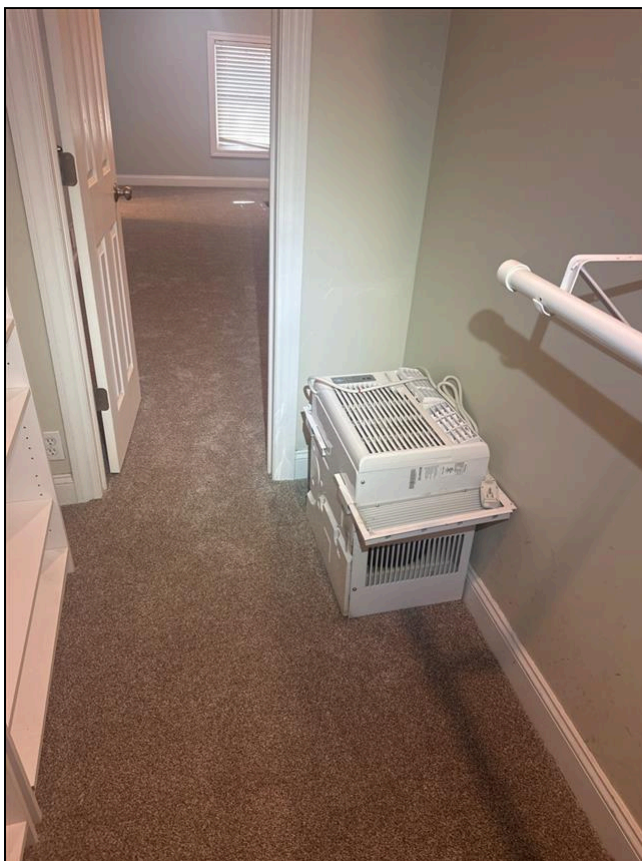
Possible temperature difference noticed at the upstairs attic room. If client has concerns, we suggest further review/repairs needed by a qualified HVAC professional.

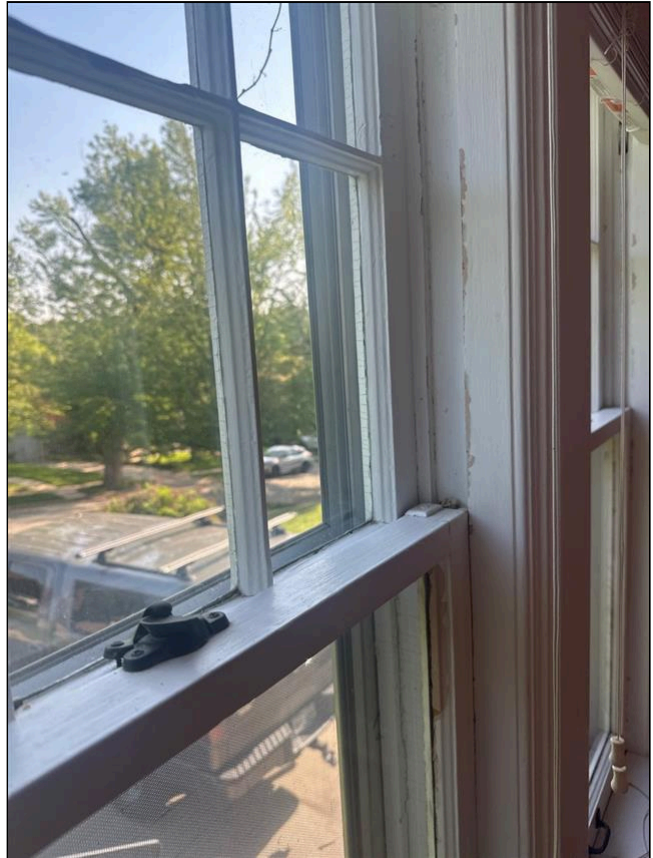
Multiple windows are missing components. We suggest repairs/replacements as needed for proper function.

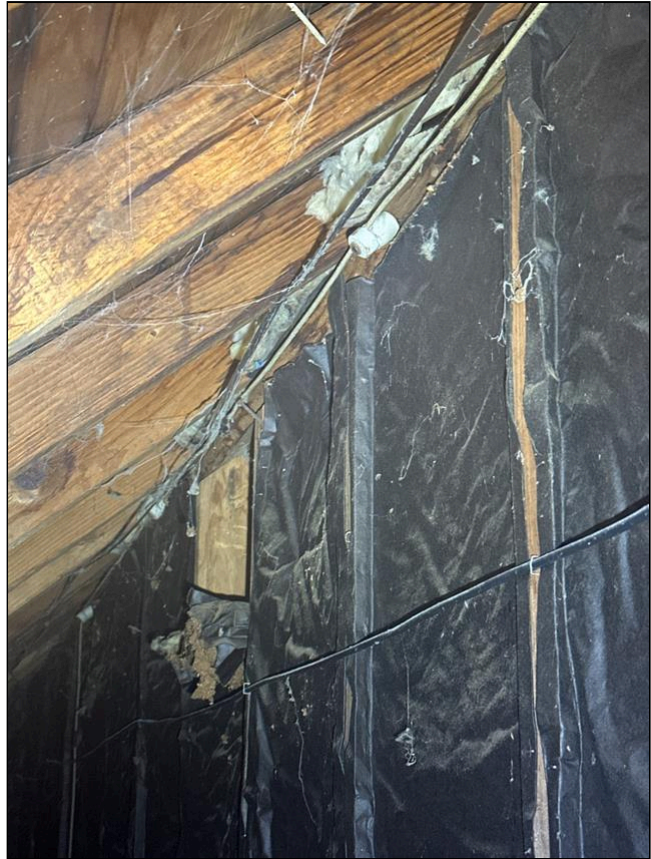
Knob and tube wiring found, knob and tube can exist in walls and insulation. We recommend further review/repairs needed by a qualified electrician for enhanced safety.
