# INSPECTION REPORT

For the Property at:  
**655 THE QUEENSWAY, 20 & 21**  
PETERBOROUGH, ON K9J 7M1

RE: Report No. 4569  
655 The Queensway, 20 & 21  
Peterborough, ON  
K9J 7M1

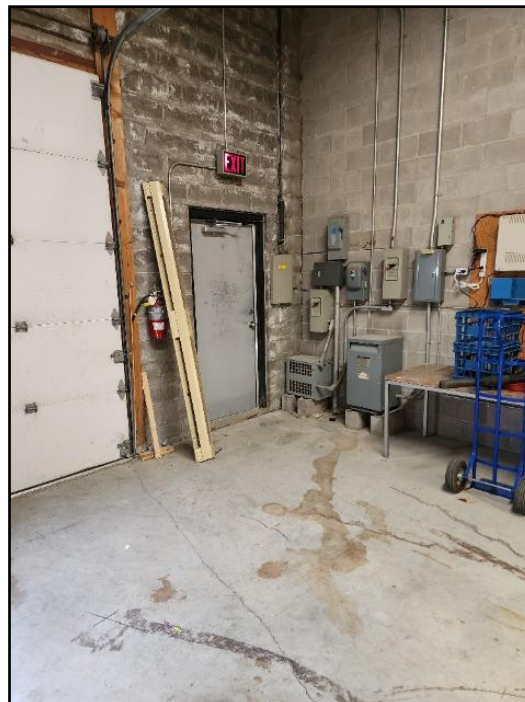
- 4. Condition:** • Prior repair

**Implication(s):** Possible weekend structure. Chance of structural movement

**Location:** Rear elevation

2. Prior repairs

**Task:** Monitor

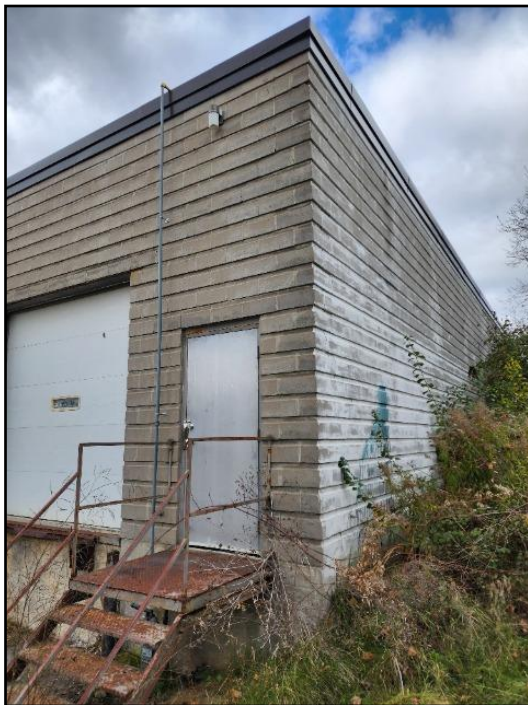
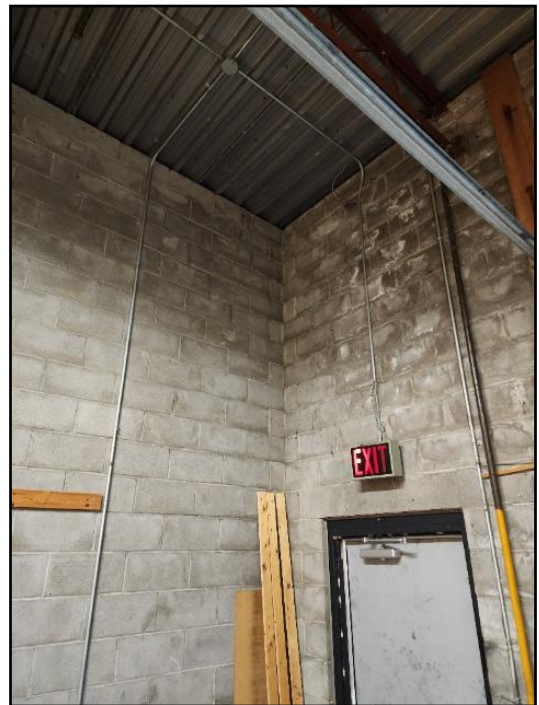
**5. Condition:** • Cracked

**Implication(s):** Weakened structure, material deterioration

**Location:** Rear left corner

3. Cracked

**Task:** Repair

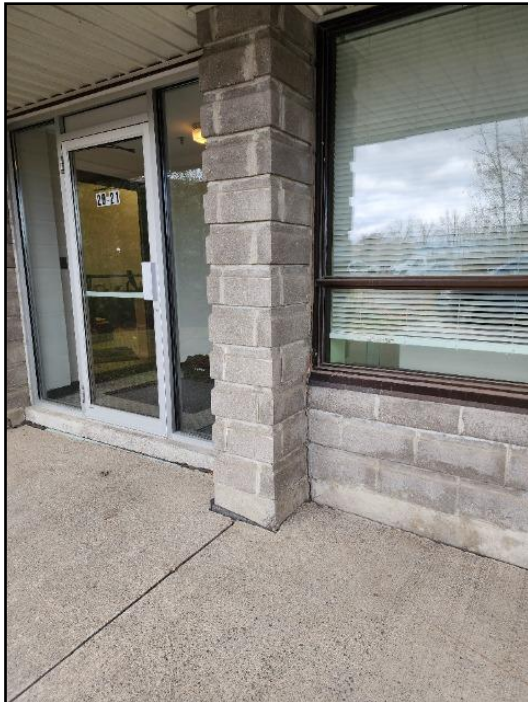
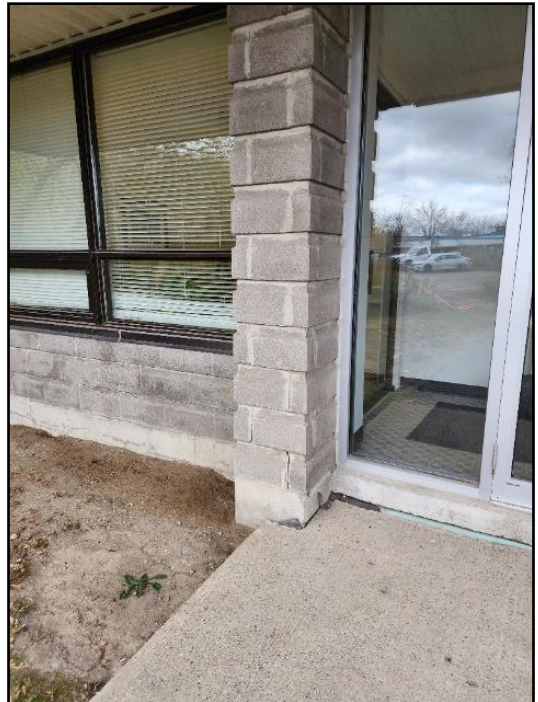
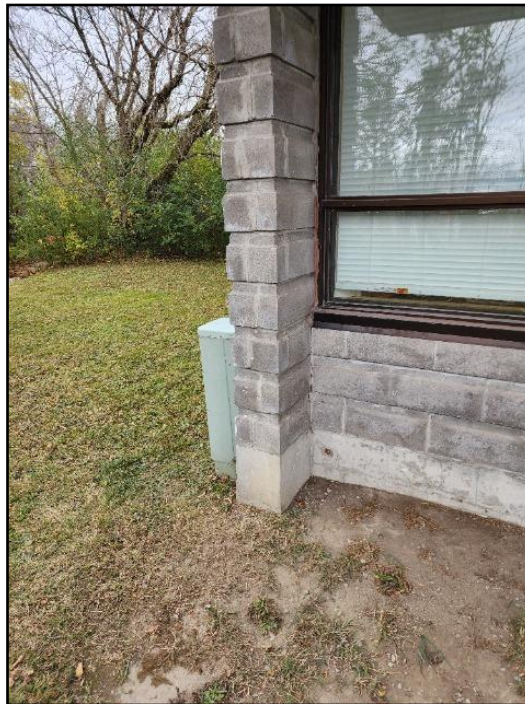
**6. Condition:** • Columns/piers settling or shifting

**Implication(s):** Weakened structure. Chance of structural movement

**Location:** Front elevation

5. Columns/piers settling or shifting

**Task:** Repair

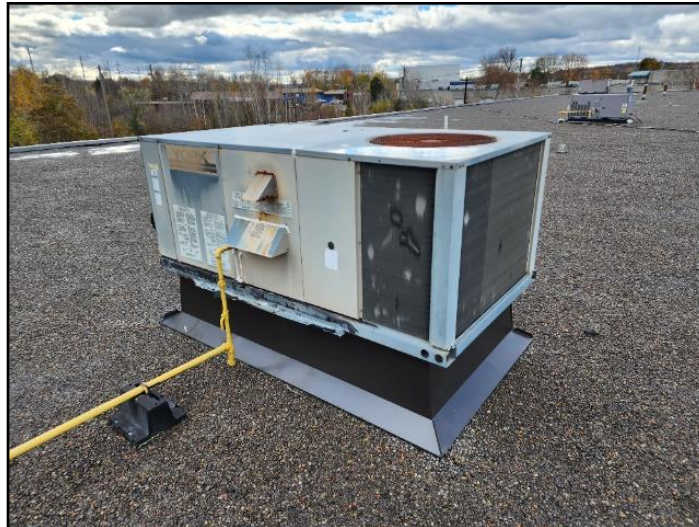
12. Forced air furnace with cooling unit

**Approximate age:** • 30 years

**Typical life expectancy:** • Furnace (conventional or mid-efficiency) 18 to 25 years

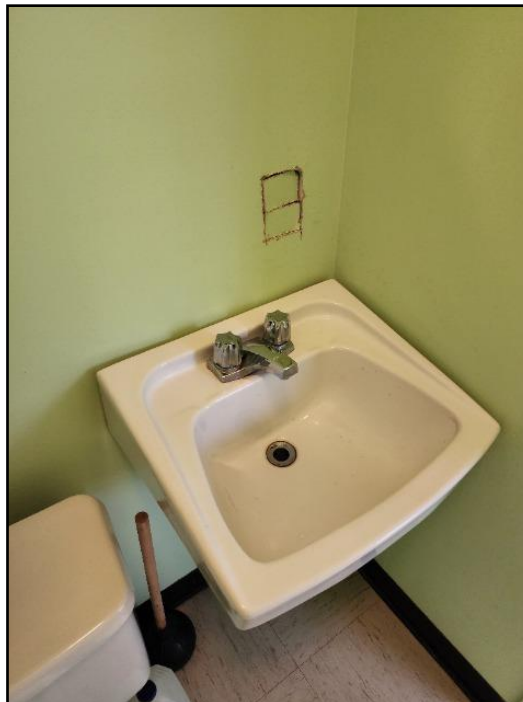
**10. Condition:** • Damaged/inoperative

**Implication(s):** System inoperative or difficult to operate

**Location:** Washroom

18. Damaged/inoperative

**Task:** Repair or replace

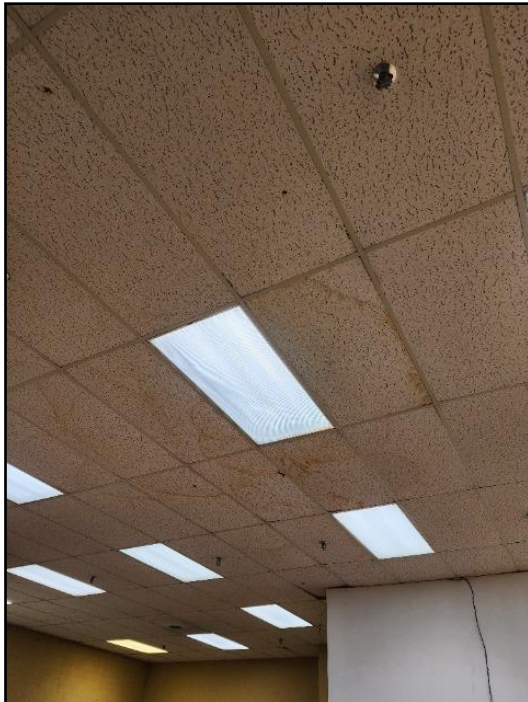
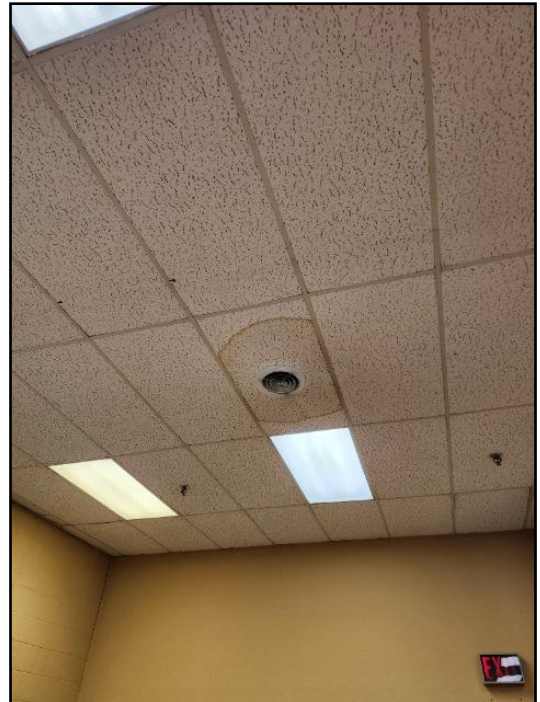
**11. Condition:** • Water stains

**Implication(s):** Chance of water damage to structure, finishes and contents

19. *Water stains*

**Task:** Repair or replace
