INSPECTION REPORT

For the Property at:
1598 COLLEGE PARK DRIVE
PETERBOROUGH, ON K9K 2G9

Prepared for: TEAM VANRAHAN
Inspection Date: Tuesday, June 17, 2025
Prepared by: David Sharman

RE: Report No. 5335
1598 College Park Drive
Peterborough, ON
K9K 2G9

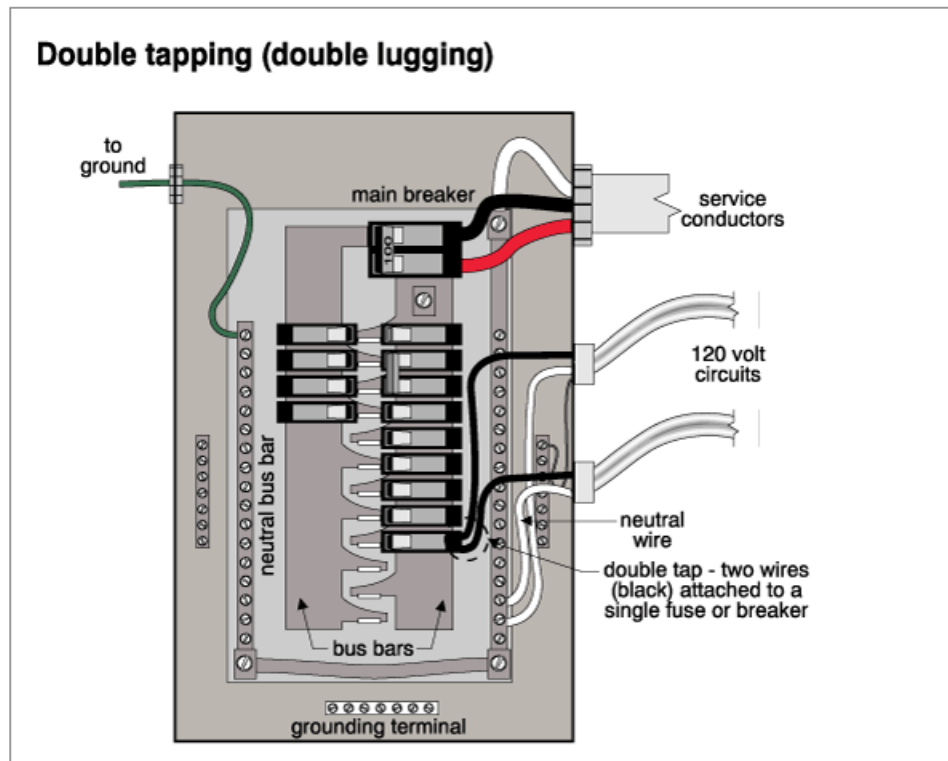
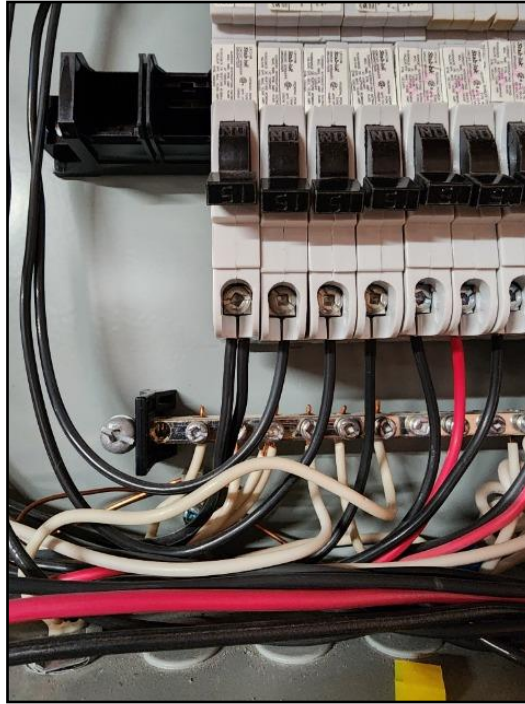
7. Double taps

4. Condition: • Double taps

Implication(s): Fire hazard

Location: Distribution panel

Task: Correct

Time: As soon as is practicable

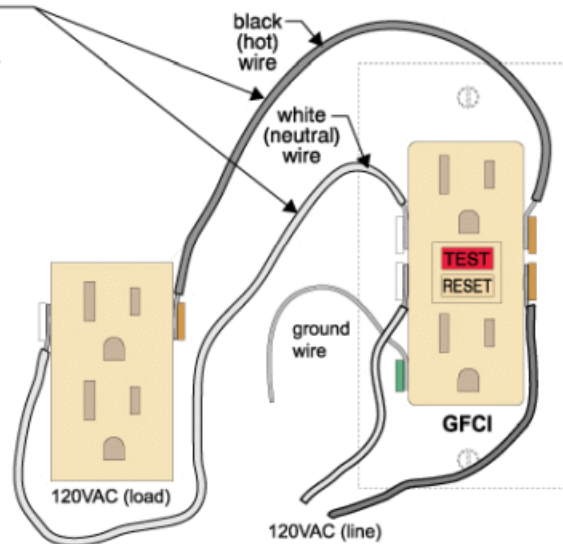
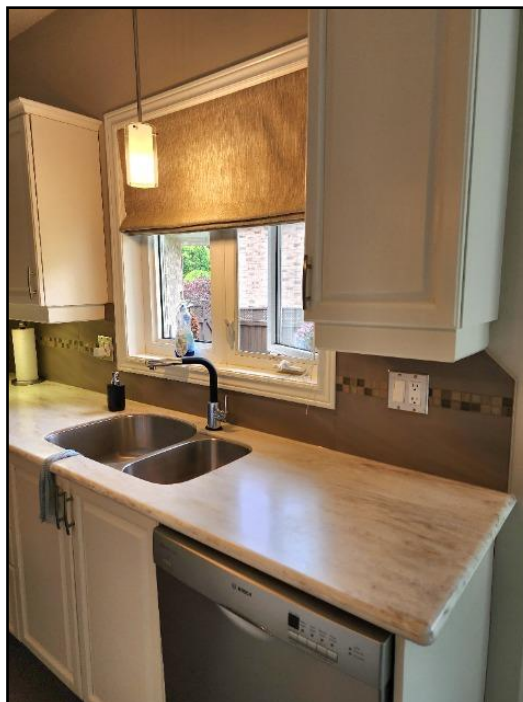
8. No GFCI/GFI (Ground Fault Circuit...

5. Condition: • No GFCI/GFI (Ground Fault Circuit Interrupter)

Although not a deficiency in a building of this age, safety may be improved by upgrading these receptacles.

Implication(s): Electric shock

Location: Kitchen

Task: Upgrade

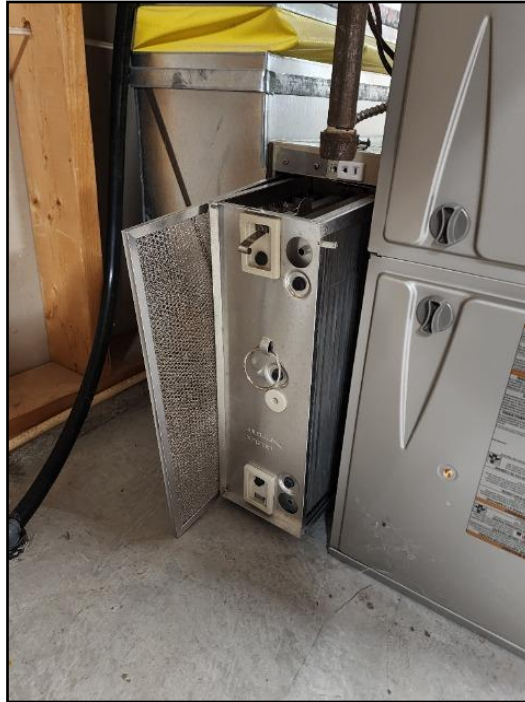
19. Clean cells/filters - regular maintenance

6. Condition: • Clean cells/filters - regular maintenance

Implication(s): Increased heating & maintenance costs, Reduced comfort

Location: Unit interior

Task: Clean - regular maintenance

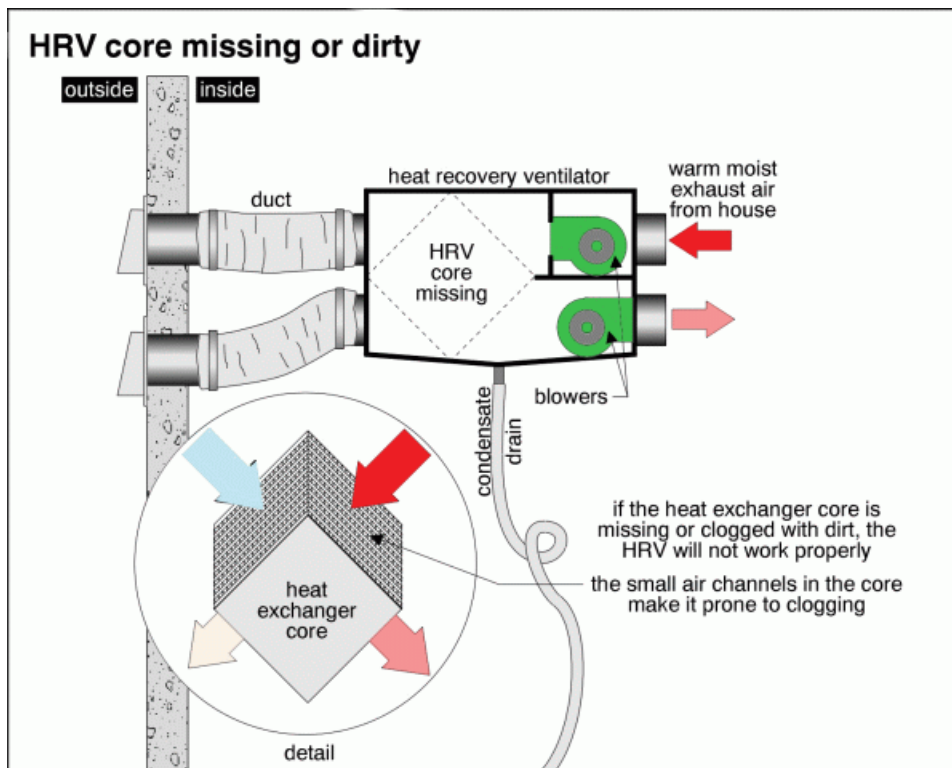
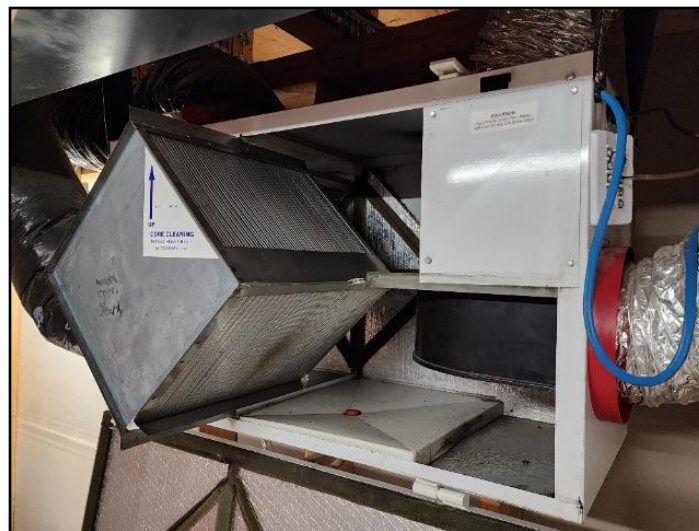
20. Clean core - regular maintenance

7. Condition: • Clean core - regular maintenance

Implication(s): Reduced operability & comfort

Location: Unit interior

Task: Clean - regular maintenance

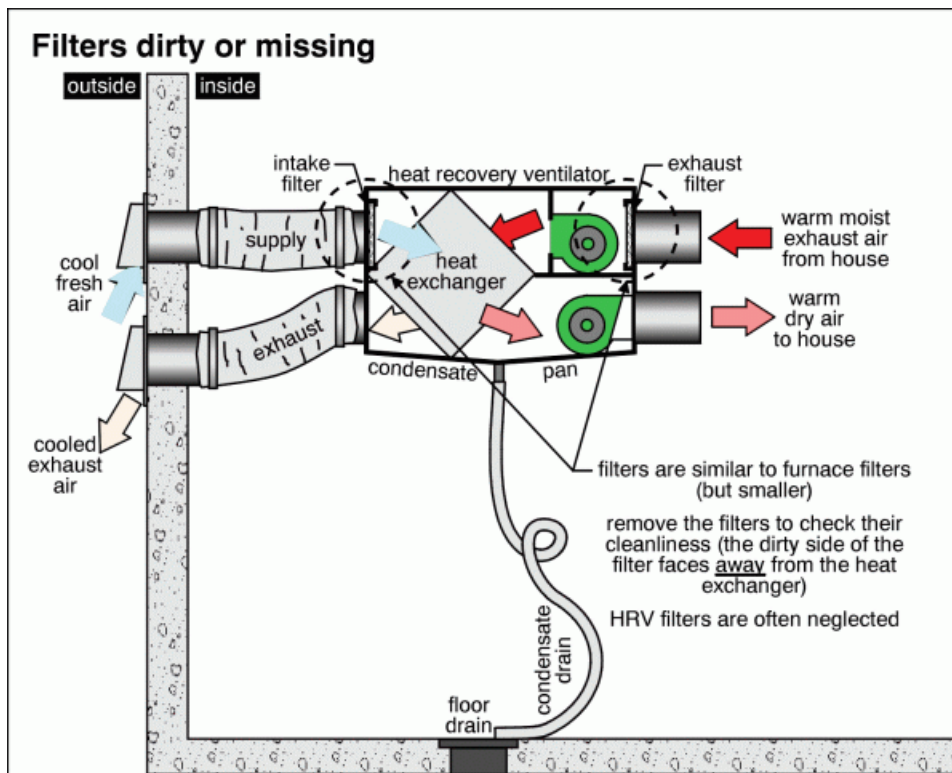
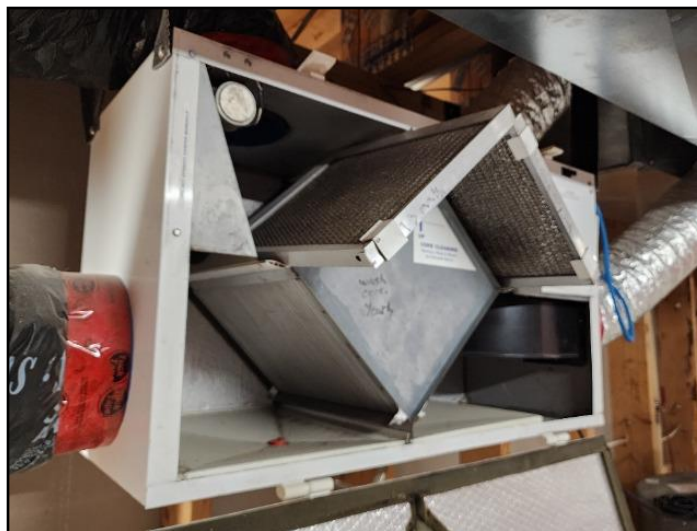
21. Clean filters - regular maintenance

8. Condition: • Clean filters - regular maintenance

Implication(s): Reduced operability & comfort

Location: Unit interior

Task: Clean - regular maintenance

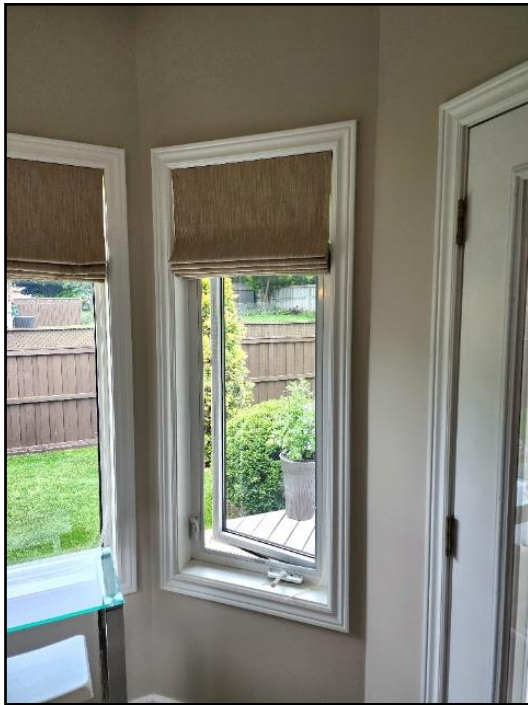
30. Inoperative/faulty

12. Condition: • Inoperative/faulty

Task: Repair or replace
