# INSPECTION REPORT

For the Property at:  
**1243 7TH LINE**  
SELWYN, ON

Prepared for: TEAM VANRAHAN  
Inspection Date: Thursday, August 28, 2025  
Prepared by: David Sharman

RE: Report No. 5423, v.2  
1243 7th Line  
Selwyn, ON

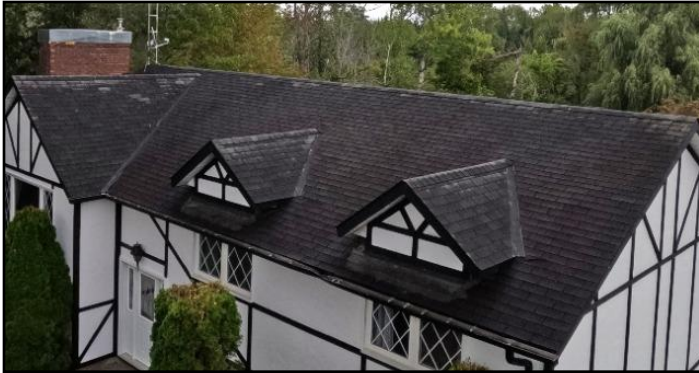
1. Asphalt shingles

**1. Condition:** • Aging

**Task:** Monitor

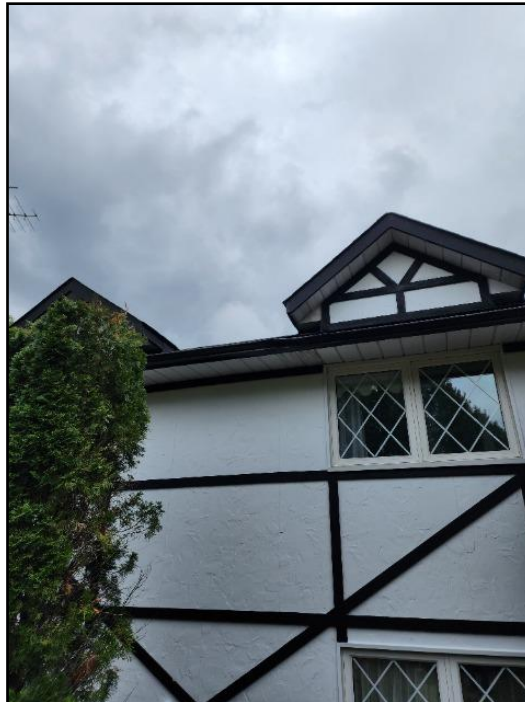
**2. Condition:** • Damage

**Implication(s):** Chance of water damage to structure, finishes and contents

4. Damage

**Task:** Repair or replace

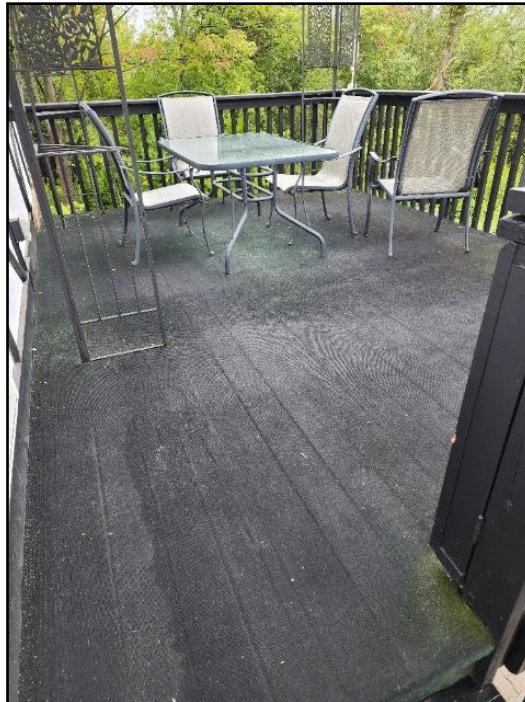
**3. Condition:** • Carpet

**Implication(s):** Shortened life expectancy of material | Material deterioration

5. Carpet

**Task:** Improve

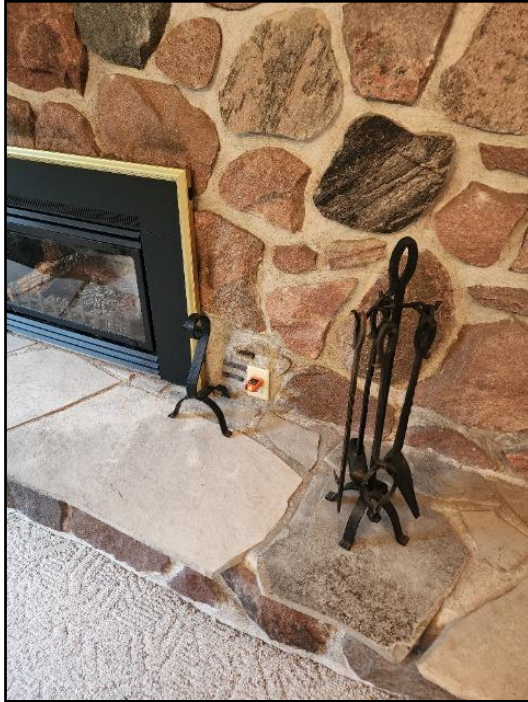
**5. Condition:** • Ungrounded

**Implication(s):** Electric shock

8. Ungrounded

**Task:** Repair

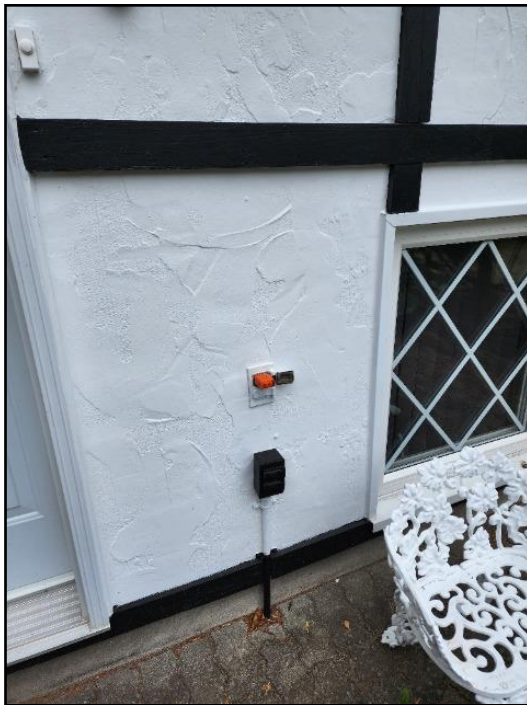
**6. Condition:** • No GFCI/GFI (Ground Fault Circuit Interrupter)

Although not a deficiency in a home of this age safety may be improved by upgrading these receptacles.

11. No GFCI/GFI (Ground Fault Circuit...

**Task:** Upgrade

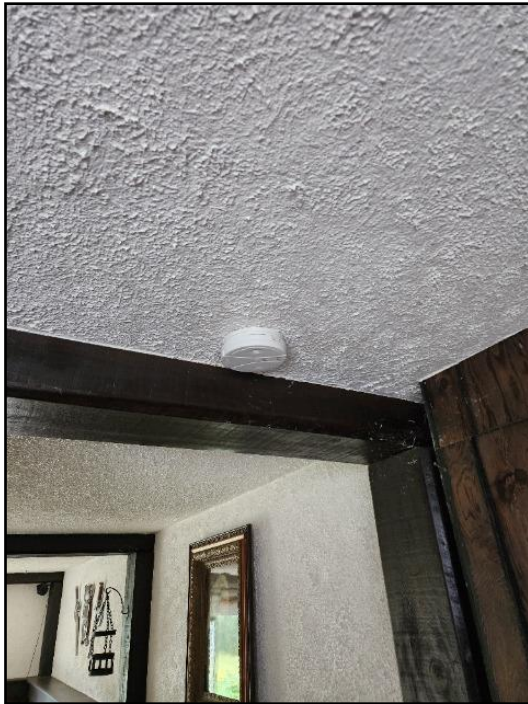
**7. Condition:** • More than 10 years old

**Implication(s):** Life safety hazard

15. More than 10 years old

**Task:** Replace

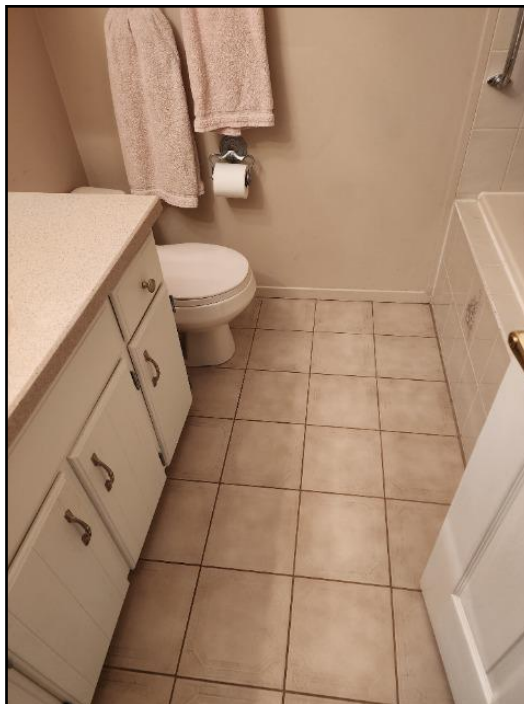
**9. Condition:** • Missing or too few heaters

20. Missing or too few heaters

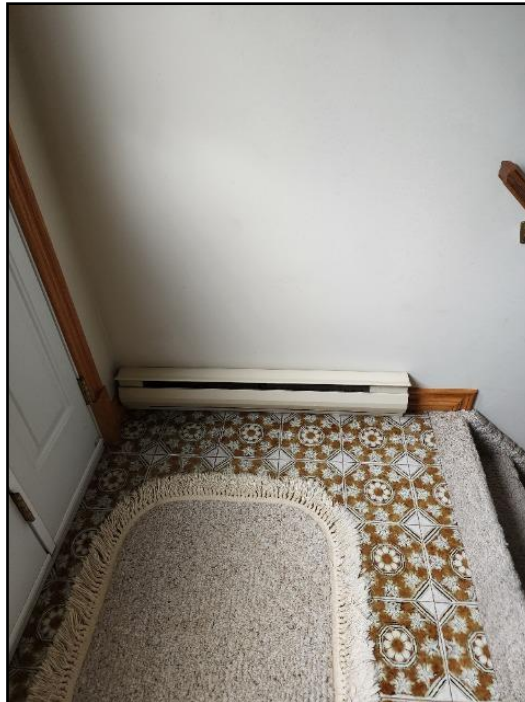
**10. Condition:** • Inoperative heaters

21. Inoperative heaters

**Task:** Repair or replace

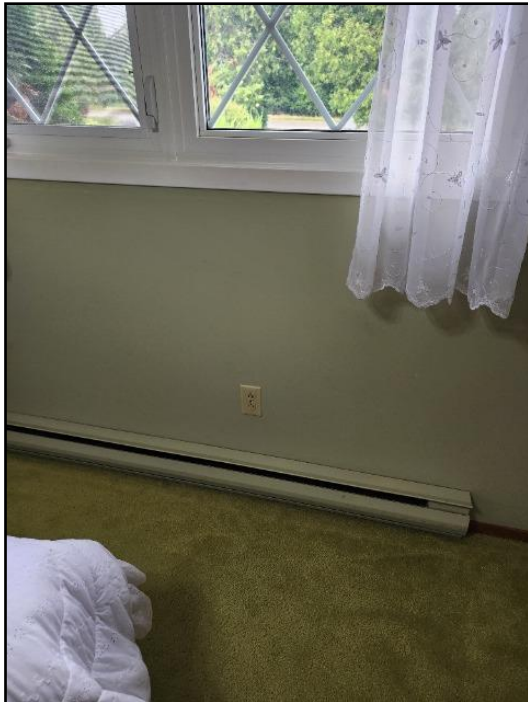
**11. Condition:** • Electrical receptacle above heater

**Implication(s):** Fire hazard

cords plugged into outlets above electric baseboard heaters could overheat if accidentally draped over the heater

22. Electrical receptacle above heater

outlets should be located at either end of the heater

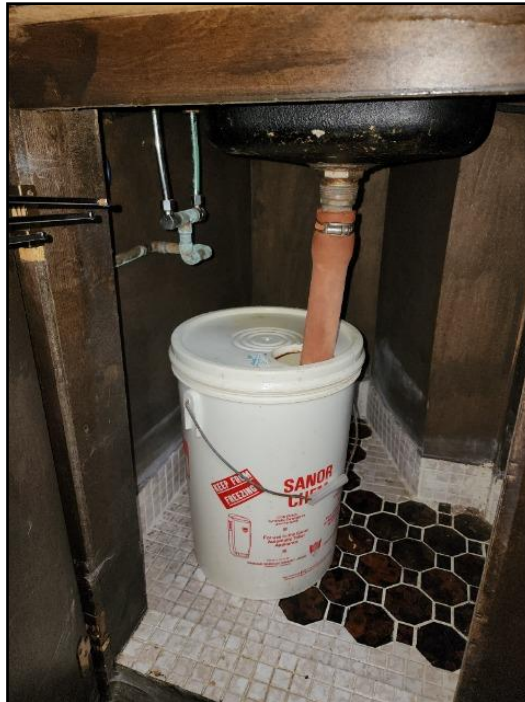
13. Condition: • Missing

Implication(s): Chance of water damage to structure, finishes and contents

33. Missing

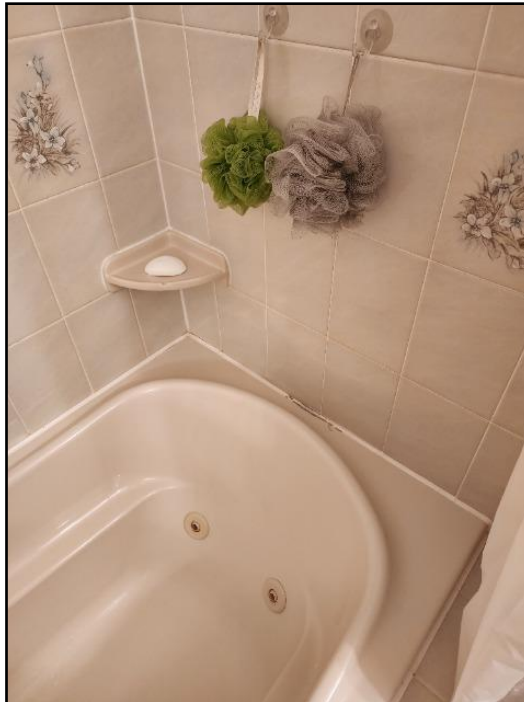
**14. Condition:** • Caulking loose, missing or deteriorated

**Implication(s):** Chance of water damage to structure, finishes and contents

**34.** *Caulking loose, missing or deteriorated*

**Task:** Repair or replace

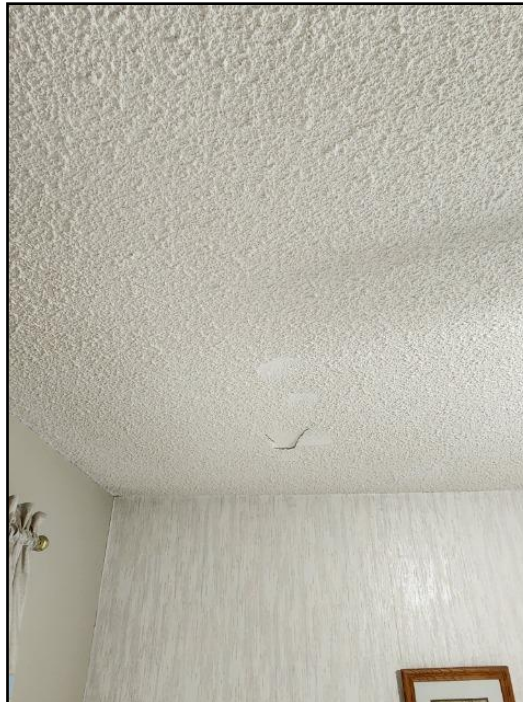
**15. Condition:** • Patched

35. Patched

Realtor Notes: Damage to ceiling has been patched up. See photo below.

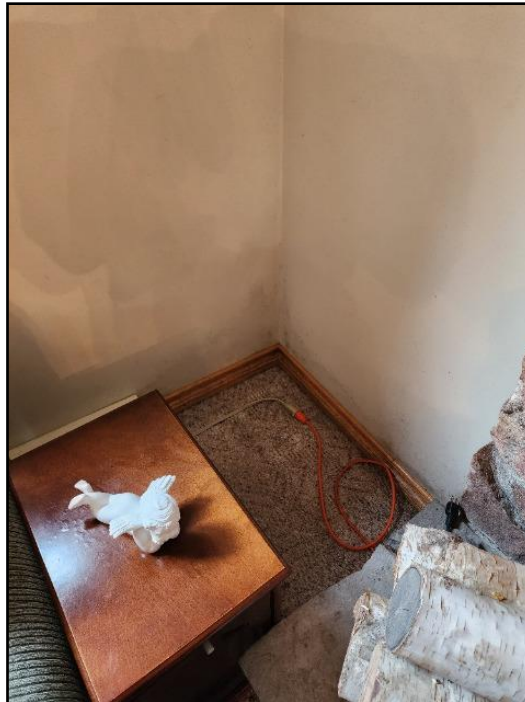
**16. Condition:** • Mold or mildew

**Implication(s):** Chance damage to structure, finishes and contents | Contaminants may enter building air

36. Mold or mildew

Realtor Notes: Mildew has been cleaned. See photos

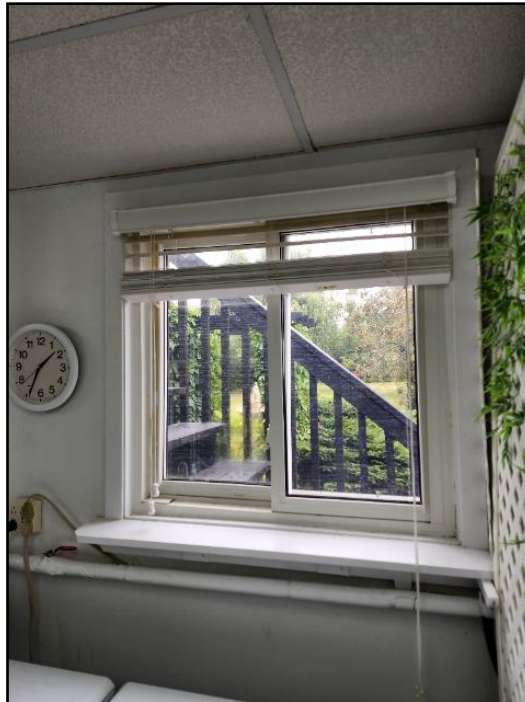
**17. Condition:** • Lost seal on double glazing

37. Lost seal on double glazing

**Task:** Repair or replace

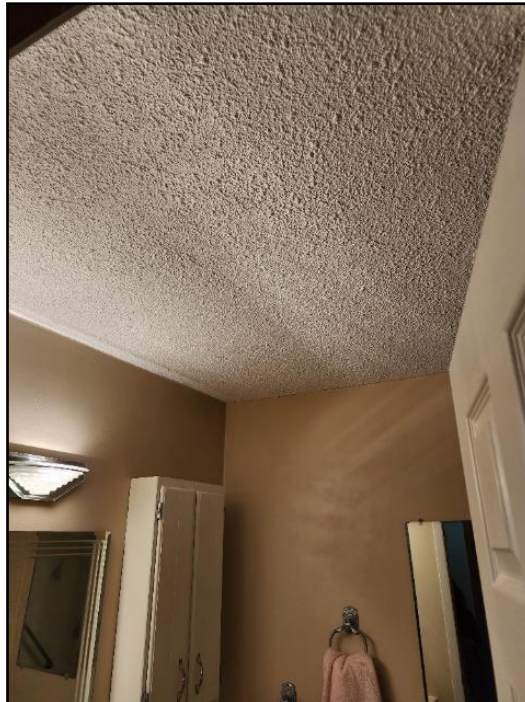
**18. Condition:** • Missing

**Implication(s):** Chance of condensation damage to finishes and/or structure

38. Missing
