INSPECTION REPORT

For the Property at:
1358 BOBOLINK COURT
PETERBOROUGH, ON K9K 2H9

Prepared for: TEAM VANRAHAN
Inspection Date: Monday, January 13, 2025
Prepared by: David Sharman

RE: Report No. 5122
1358 Bobolink Court
Peterborough, ON
K9K 2H9

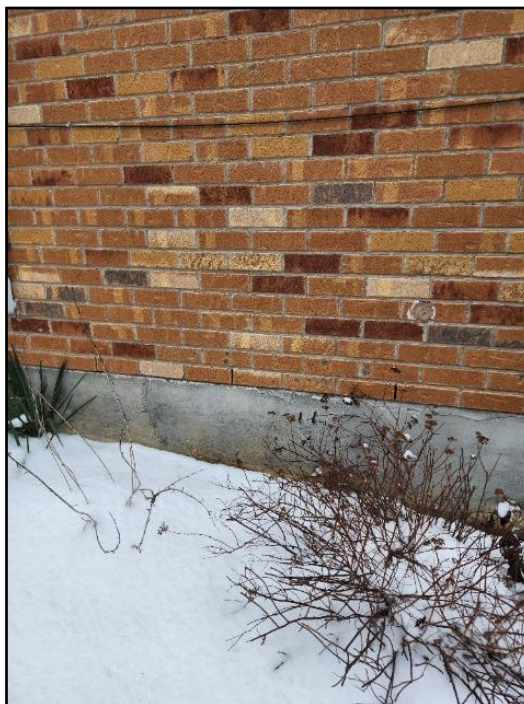
3. Condition: • Typical minor cracks
Implication(s): Material deterioration
Location: Right elevation
Task: Repair
Time: Discretionary
Cost: Minor

1. Typical minor cracks

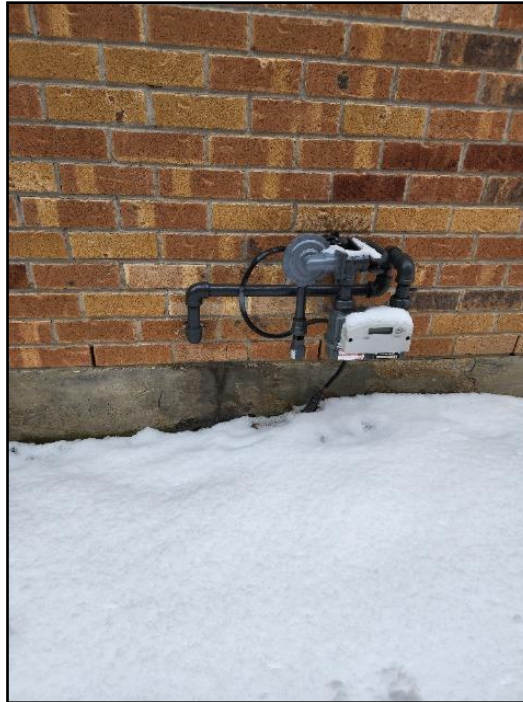
4. Condition: • Prior repairs

Implication(s): Possibility of a weakened structure

Location: Right elevation

2. Prior repairs

Task: Monitor

Time: Ongoing

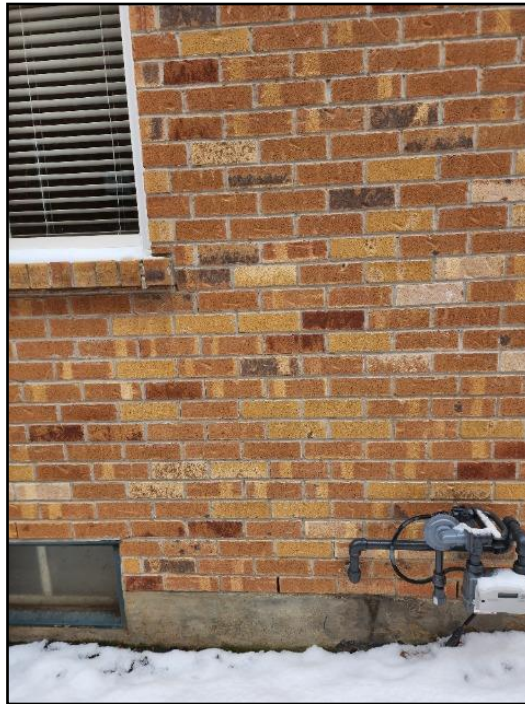
6. Condition: • Typical minor cracks

Implication(s): Chance of frost damage & material deterioration

Location: Left elevation

3. *Typical minor cracks*

Task: Repair

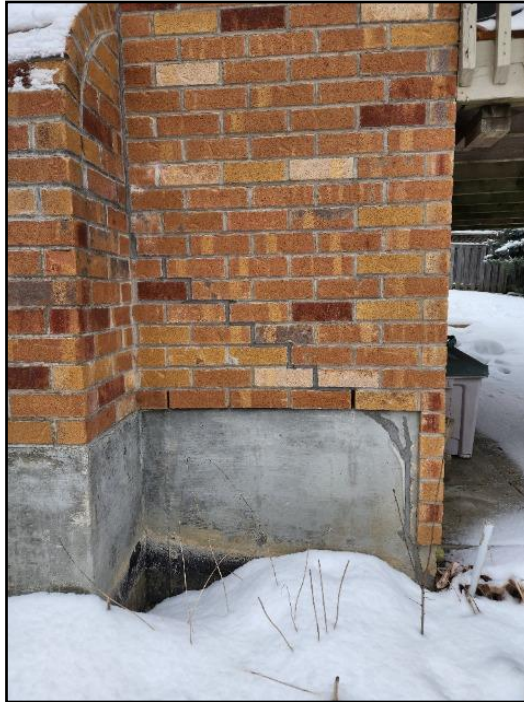
7. Condition: • Prior repairs

Implication(s): No implications exist for this condition

Location: Right elevation

4. *Prior repairs*

Task: Monitor

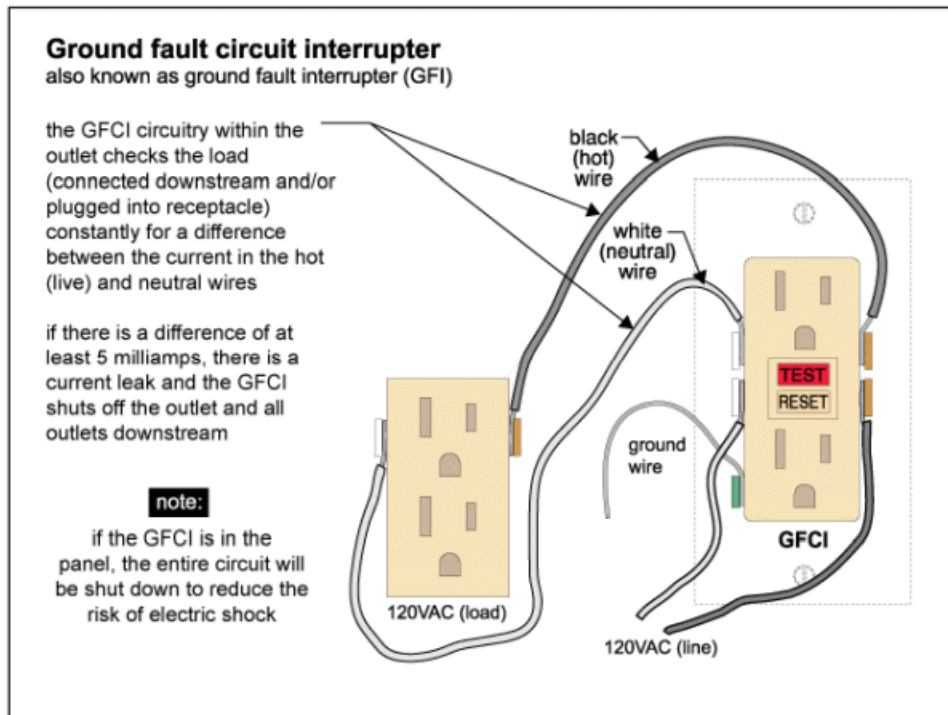
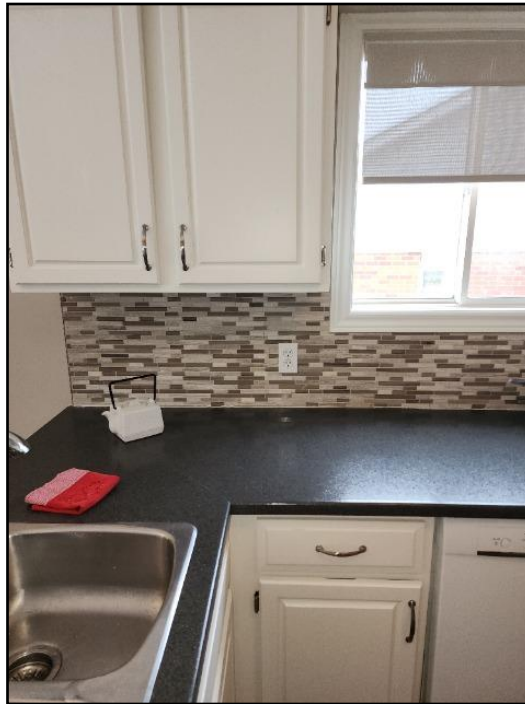
8. Condition: • No GFCI/GFI (Ground Fault Circuit Interrupter)

Although not a deficiency in a building of this age safety may be improved by upgrading this receptacle.

Implication(s): Electric shock

Location: Kitchen

7. No GFCI/GFI (Ground Fault Circuit...

Task: Upgrade

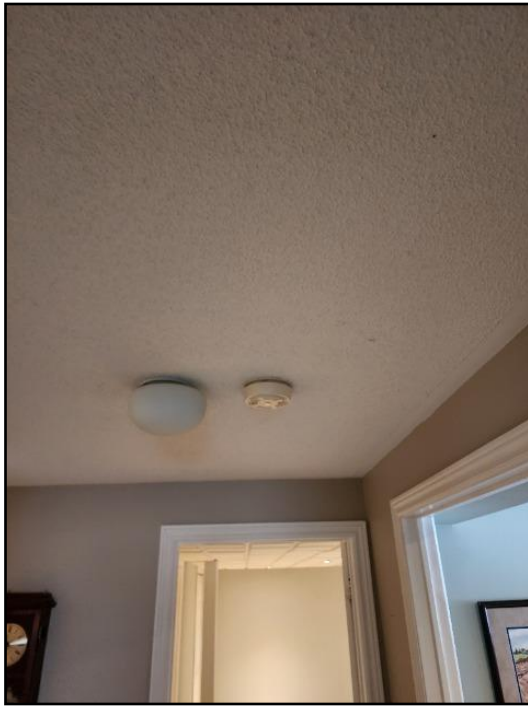
9. Condition: • More than 10 years old

Implication(s): Life safety hazard

Location: Throughout

8. More than 10 years old

Task: Replace

Time: Immediate

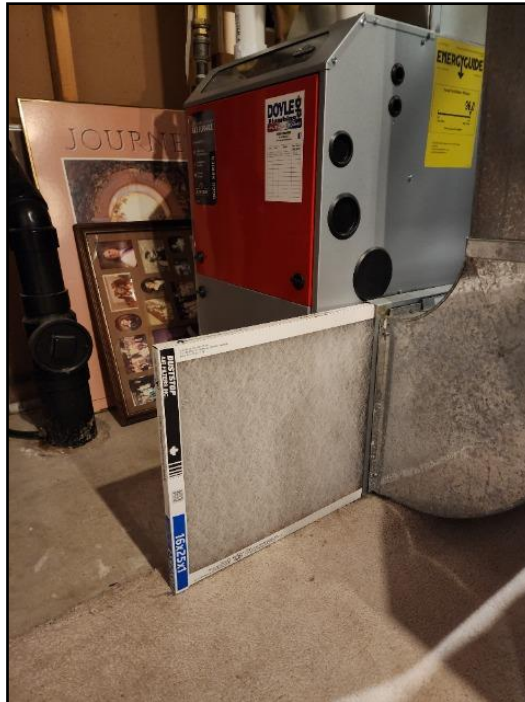
11. Condition: • Replace - regular maintenance

Implication(s): Increased heating & maintenance costs, Reduced comfort

Location: Cold air return

15. Replace - regular maintenance

Task: Replace - regular maintenance

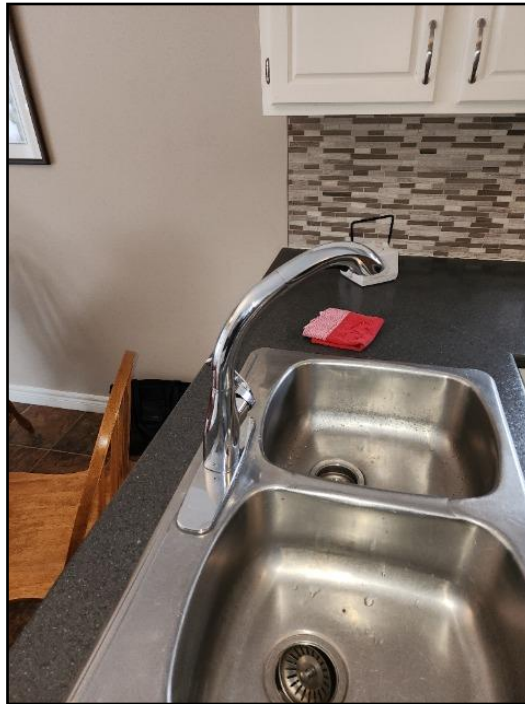
14. Condition: • Loose

Implication(s): Equipment failure. Water damage to Finishes, contents and structure

23. Loose

Task: Repair

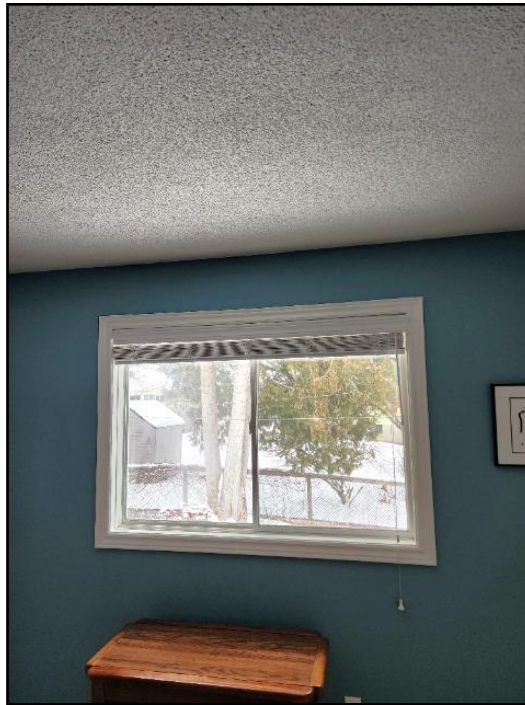
15. Condition: • Lost seal on double glazing

24. *Lost seal on double glazing*

Task: Repair or replace

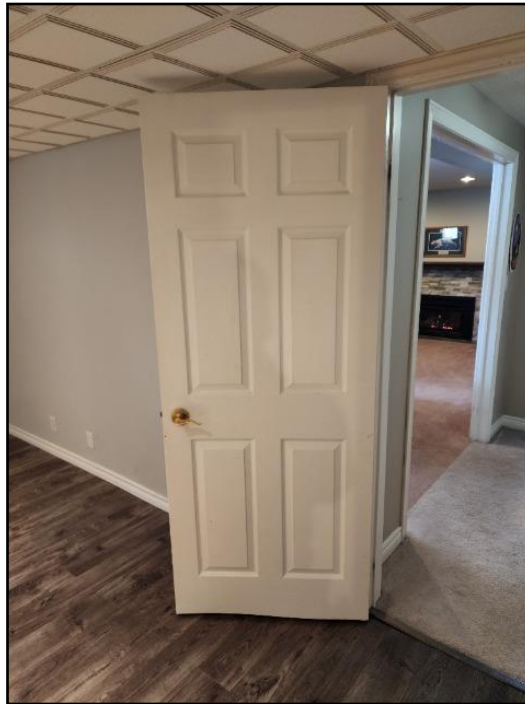
16. Condition: • Damage

25. *Damage*

Task: Repair or replace

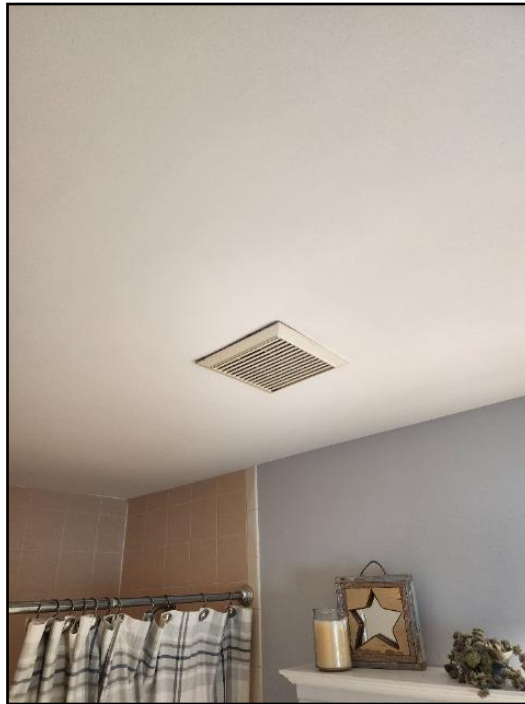
17. Condition: • Inoperative

Implication(s): Chance of condensation damage to finishes and/or structure

26. Inoperative

Task: Repair or replace

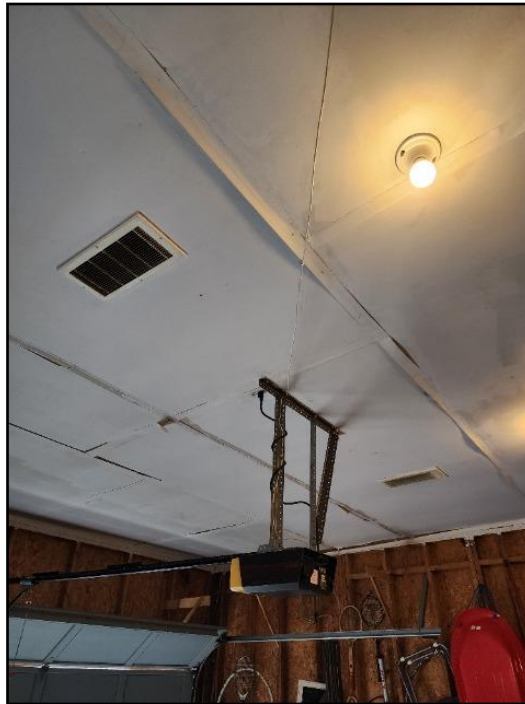
18. Condition: • Not gastight

Implication(s): Hazardous combustion products entering home

27. Not gastight

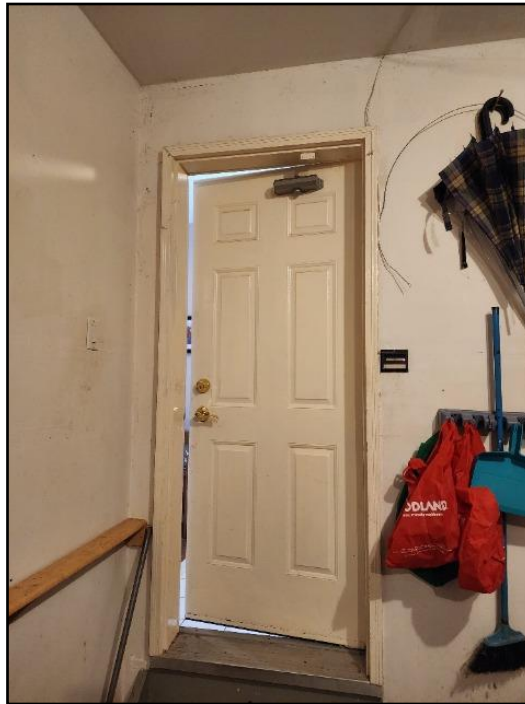
19. Condition: • Self closer missing, damaged or disconnected

Implication(s): Hazardous combustion products entering home

28. Self closer missing, damaged or disconnected

Task: Repair or replace

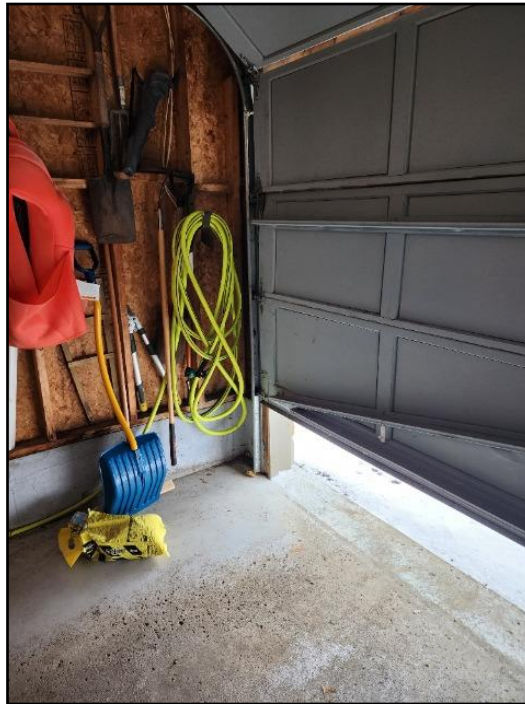
20. Condition: • Sensors missing/inoperative

29. *Sensors missing*
