Dubuqueland Home Inspection
18186 Williamsburg Ct. Durango IA, 52039
(563) 556-4663

Property Location
19148 91st., Maquoketa, IA

Date of Inspection
01/16/2025 09:49 AM GMT-06:00

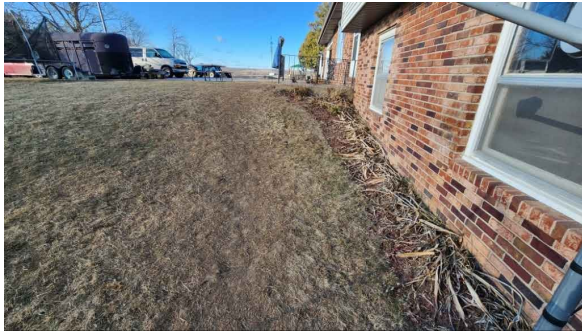
Recommend monitoring the south side for proper drainage away from the foundation.

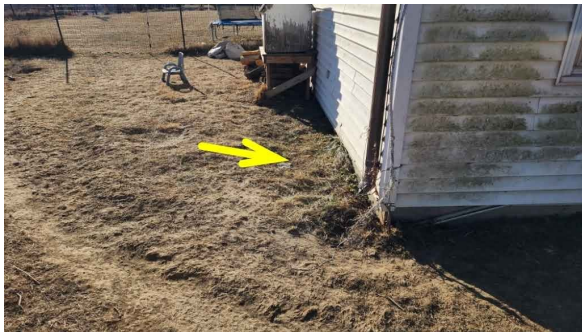
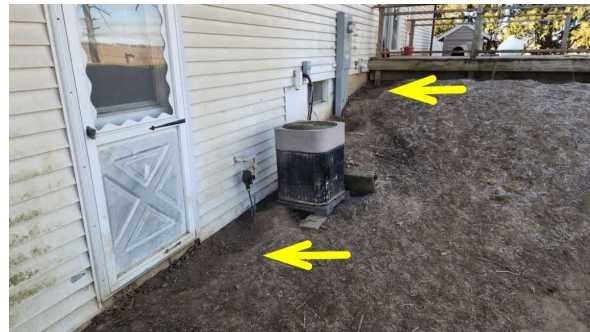
Some low spots, negative grade observed along north/east foundation walls. Recommend improving grade to maintain positive slope away from the foundation.

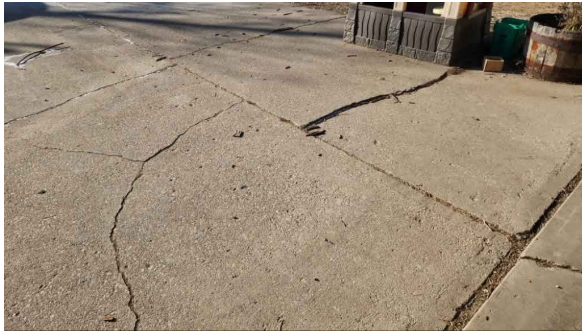
Driveway has settled, cracked along garage entrance.

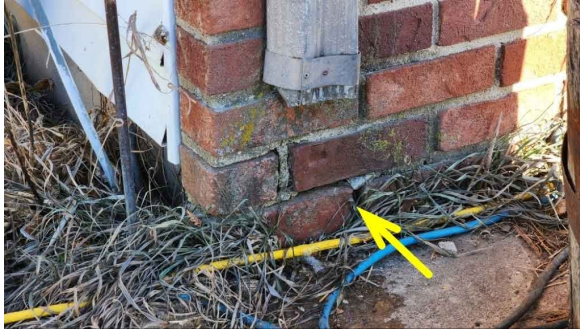
Some loose and missing mortar observed in southwest brick wall.
Recommend repair, tuck pointing.

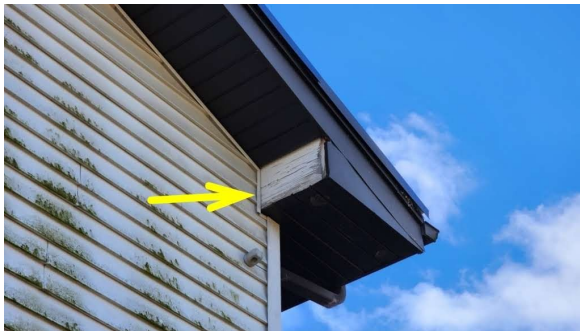
One piece of aluminum fascia was missing, north side.

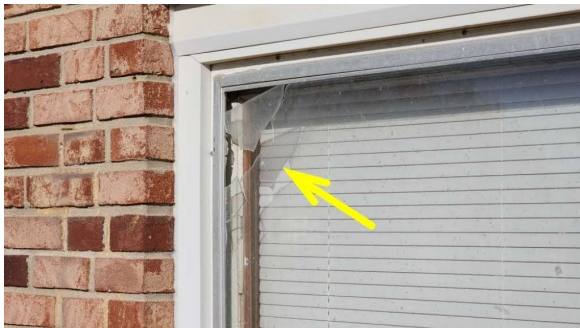
One southeast, one northeast basement storm window pane was cracked.

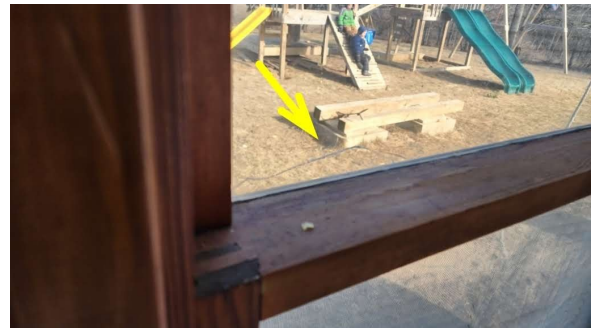
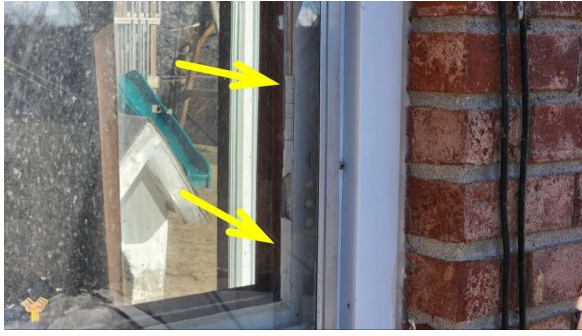
Loose and missing glazing, peeling paint observed throughout wood windows. Examples above.

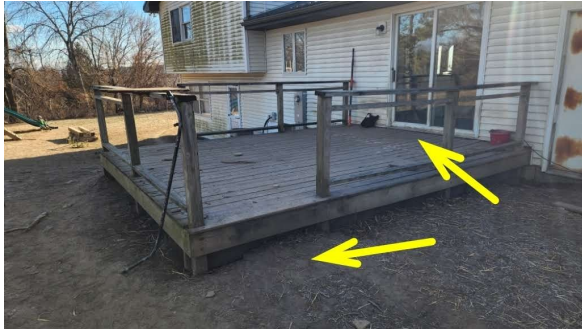
Deck guardrail spindles were spaced greater than 4 inches. West step was steep (rise greater than 7 inches).

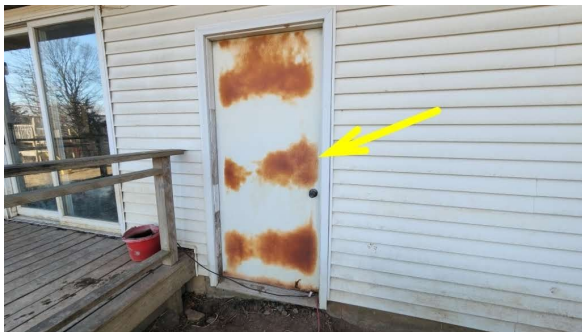
North garage walk door has rusted, deteriorated.

Door has been sealed and painted to preserve longevity.

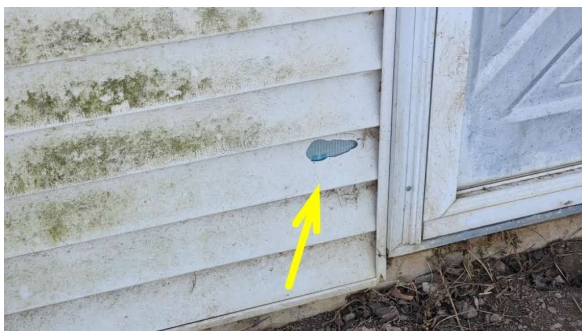
Northeast vinyl siding was damaged along the lower course.

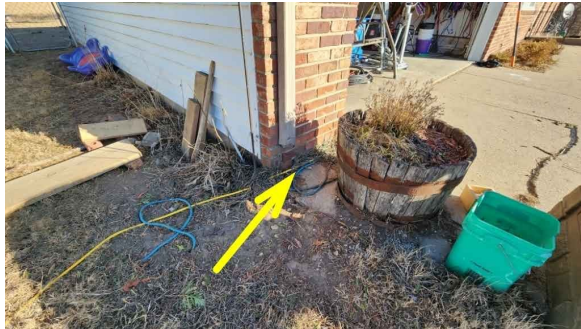
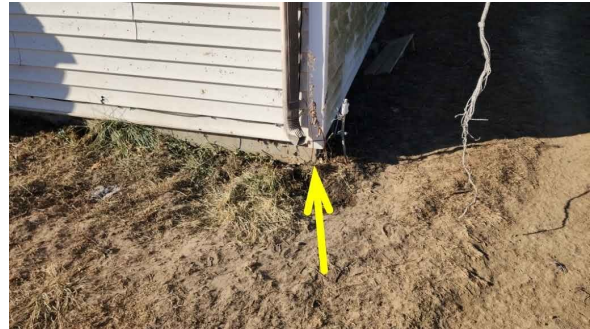
Recommend extending downspouts away from the foundation via downspout extension or drain tile

Downspout extenders will be re-added prior to close.

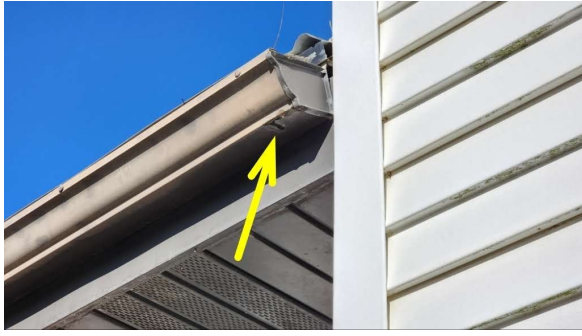
Gutter leak observed above front porch.
Recommend repair.

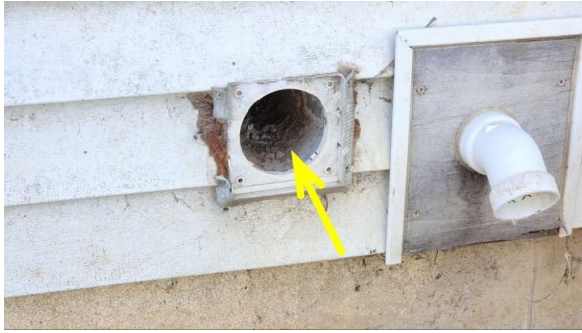
Dryer vent damper was missing.
Recommend installing.

Damper will be installed prior to close.

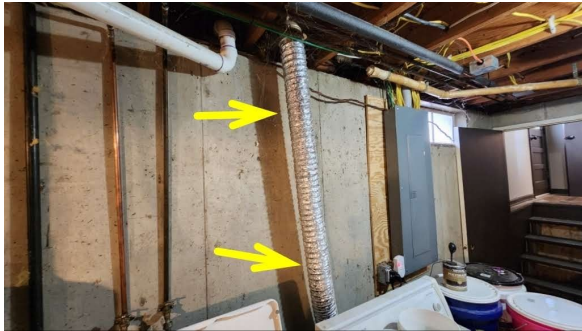
Recommend replacing flexible dryer vent with
rigid vent rated for gas dryers.

Rigid vent will be installed prior to close.

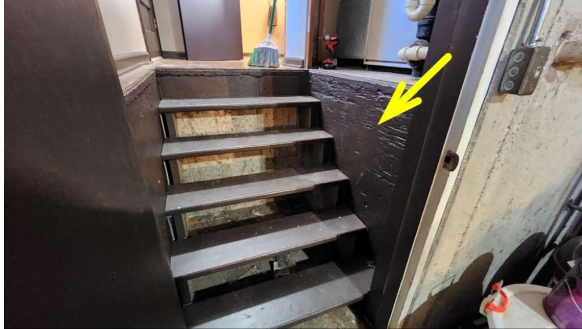
Recommend installing a handrail on steps to basement (all steps 3 or greater).

Railing will be installed prior to close.

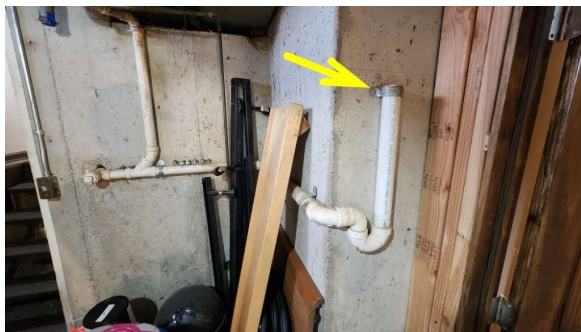
Recommend capping unused drain in north side of basement to prevent trap from drying out / sewer gasses from entering home.

Drain will be capped prior to close.

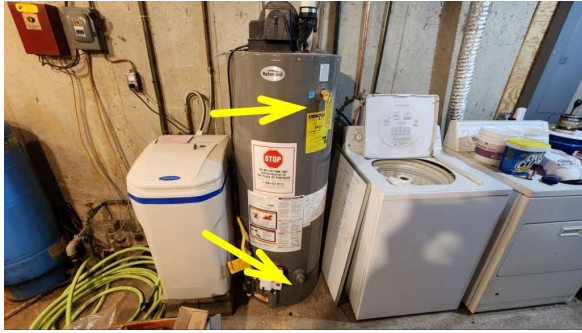
Pressure relief valve was extended.

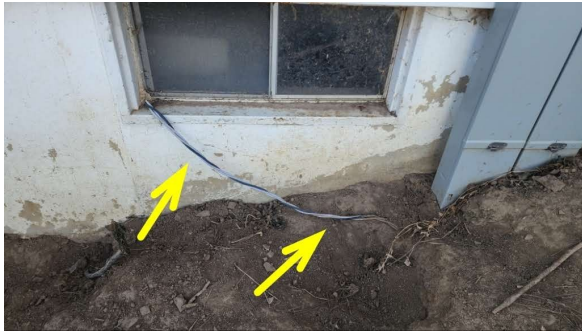
Exposed wiring observed along north side exterior wall (for well pump). Recommend conduit.

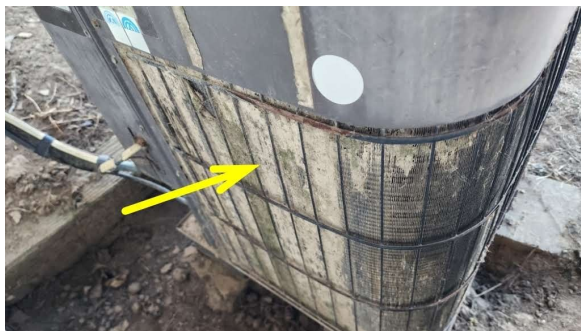
Recommend cleaning dirt and debris from AC condenser unit coils annually.

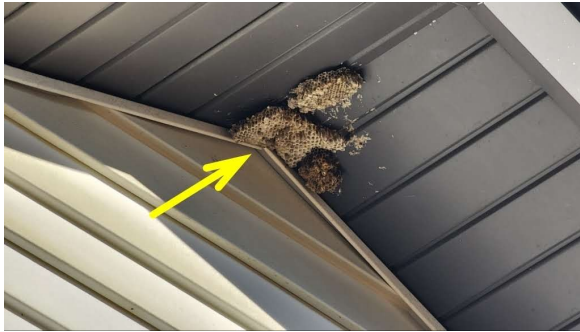
Recommend removing wasp nests from below soffits.

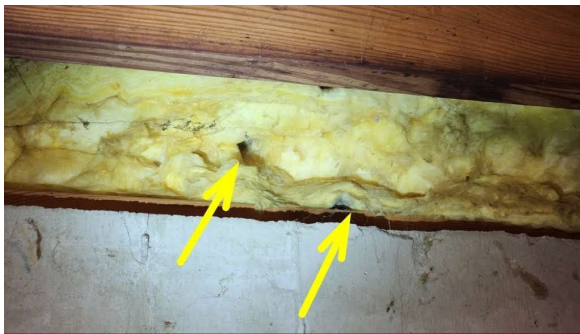
Signs of mouse tunneling observed through basement rim joist insulation. Recommend monitoring, pest control for rodents.
