# INSPECTION REPORT

For the Property at:  
**1087 BARNARDO AVENUE**  
PETERBOROUGH, ON K9H 5W9

Prepared for: TEAM VANRAHAN  
Inspection Date: Tuesday, July 29, 2025  
Prepared by: David Sharman

RE: Report No. 5391  
1087 Barnardo Avenue  
Peterborough, ON  
K9H 5W9

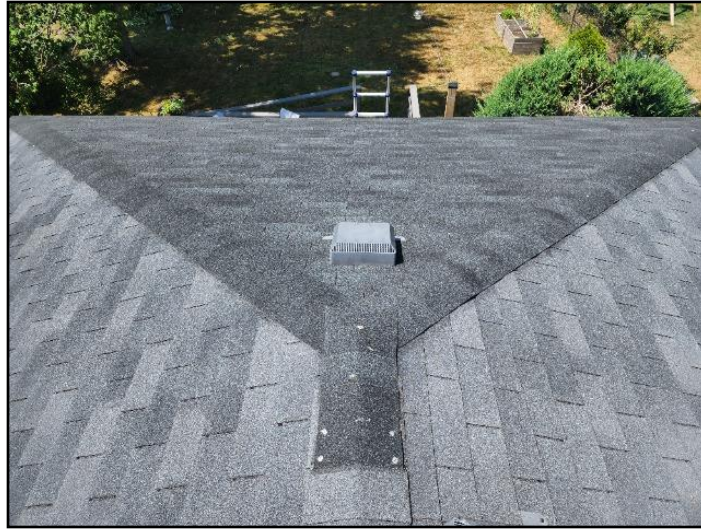
1. Condition: • Patched/repaired

Implication(s): Possible shortened life expectancy

Location: Rear elevation

3. Patched/repaired

Task: Monitor

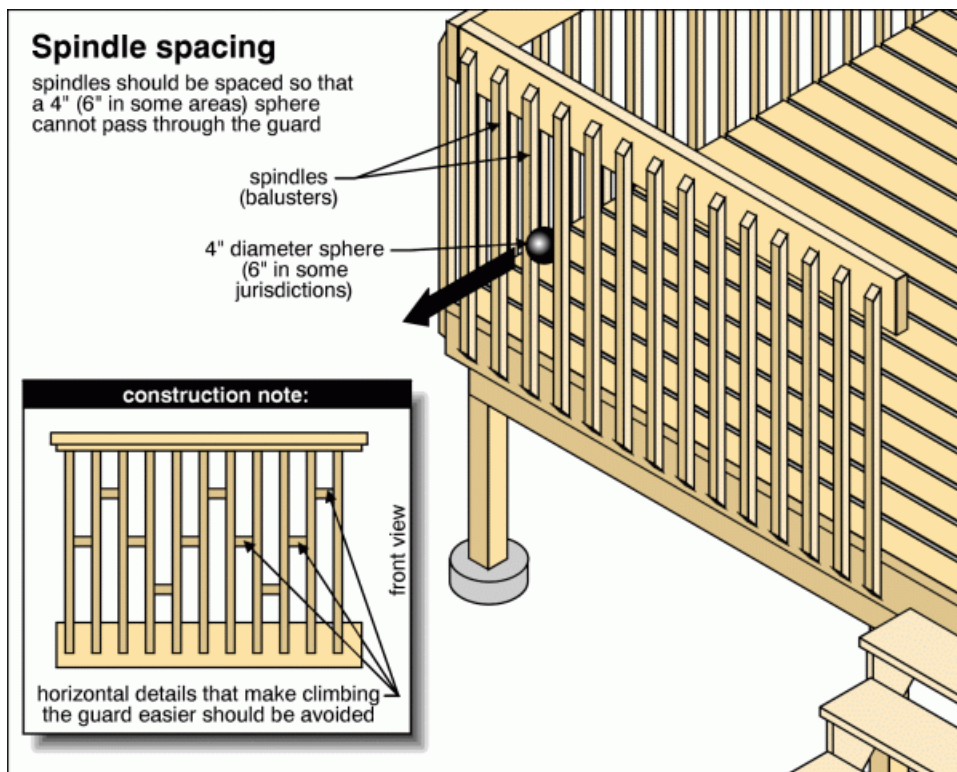
**2. Condition:** • Spindles, guards or barriers (balusters) climbable

All spindles must be vertical, unless, the raised building platform is less than 24 inches above grade, as not to facilitate climbing

**Implication(s):** Fall hazard

**Location:** Raised decking

**Task:** Improve

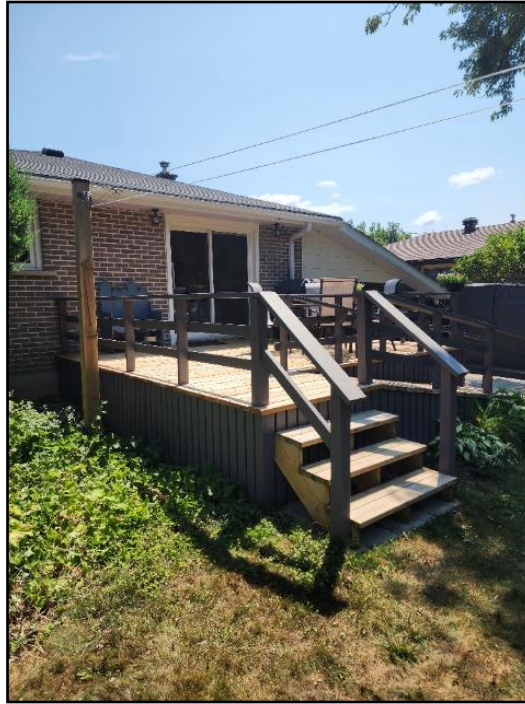
**3. Condition:** • Spindles (balusters) missing

**Implication(s):** Fall hazard

**Location:** Raised decking

4. Missing

**Task:** Provide

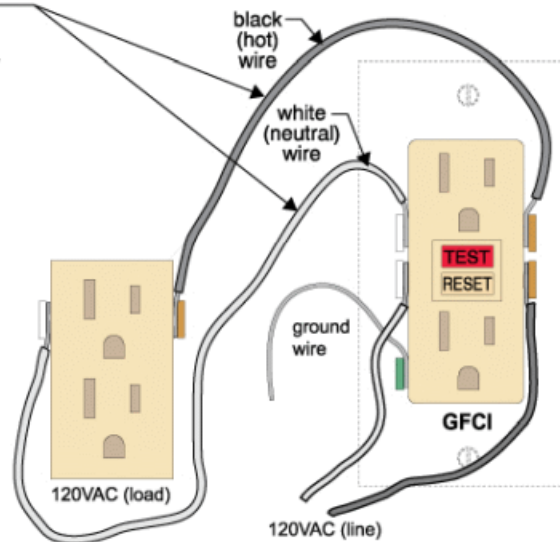
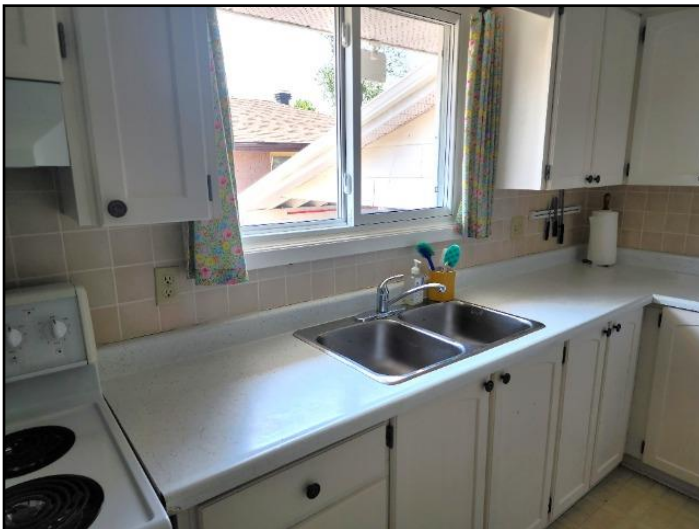
**5. Condition:** • No GFCI/GFI (Ground Fault Circuit Interrupter)

Although not a deficiency in a home of this age, safety may be improved by upgrading these receptacles

**Implication(s):** Electric shock

**Location:** Kitchen & exterior

7. No GFCI/GFI (Ground Fault Circuit...)

**Task:** Upgrade

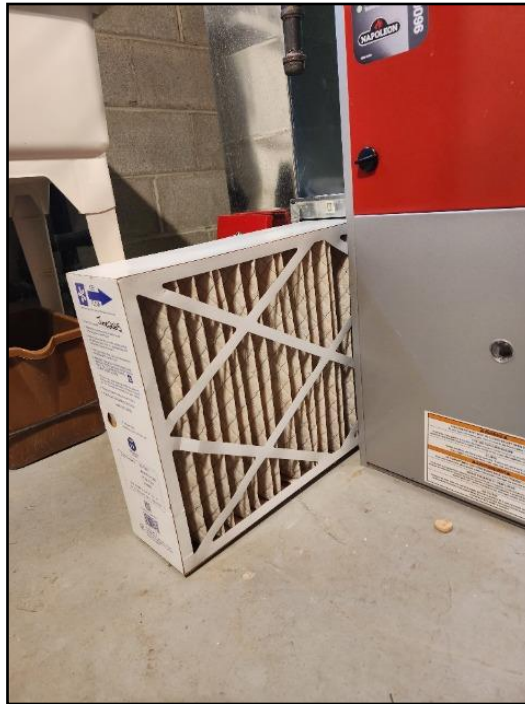
**6. Condition:** • Replace - regular maintenance

**Implication(s):** Increased heating & maintenance costs, Reduced comfort

**Location:** Cold air return

13. Replace - regular maintenance

**Task:** Replace - regular maintenance

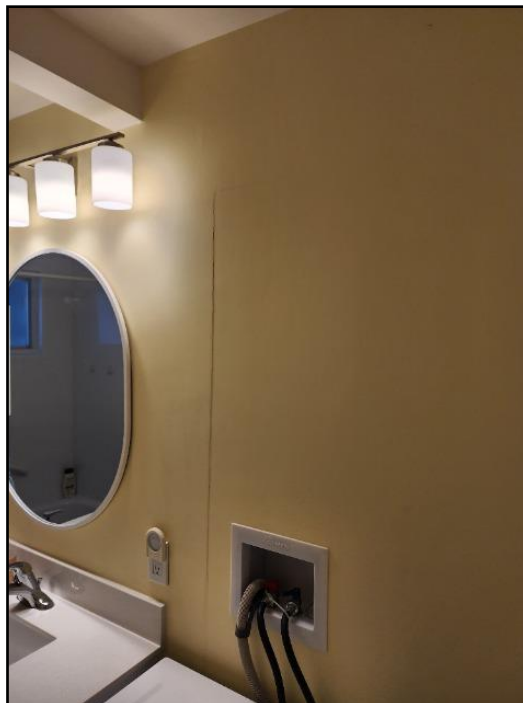
**10. Condition:** • Cracks

**Implication(s):** Material deterioration

**20. Cracks**

**Task:** Repair

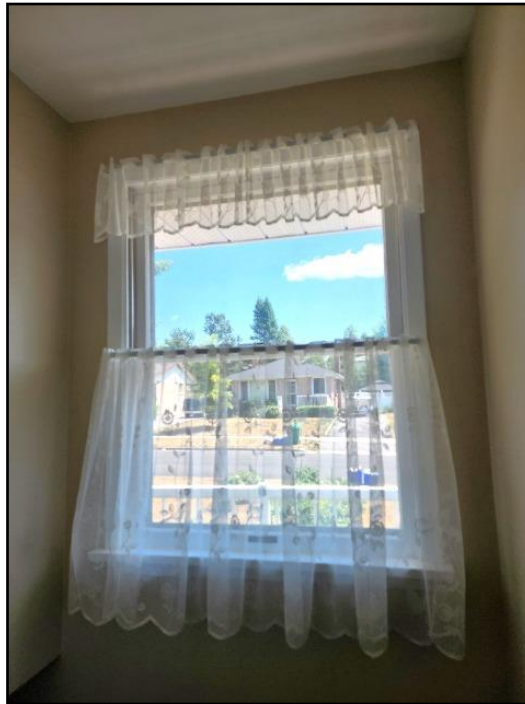
**11. Condition:** • Original lower quality units

21. *Original lower quality units*

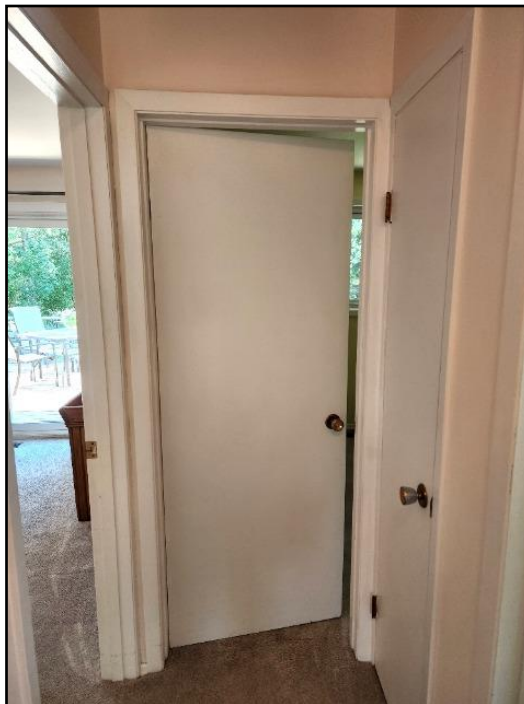
**12. Condition:** • Binds

22. *Binds*
