NORTHERN INSPECTIONS

FOUNDATION INSPECTION REPORT

1165

Gesto Side Rd.

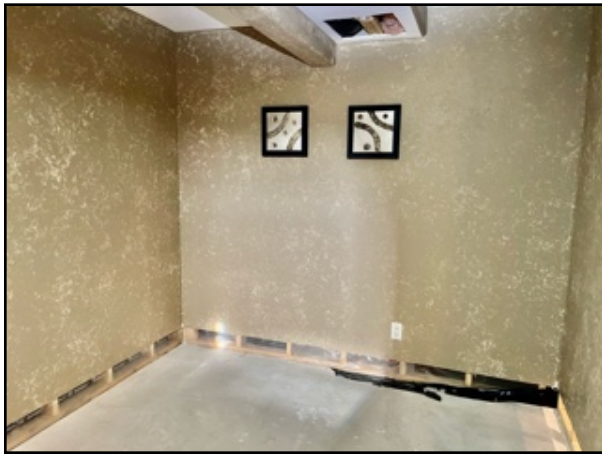
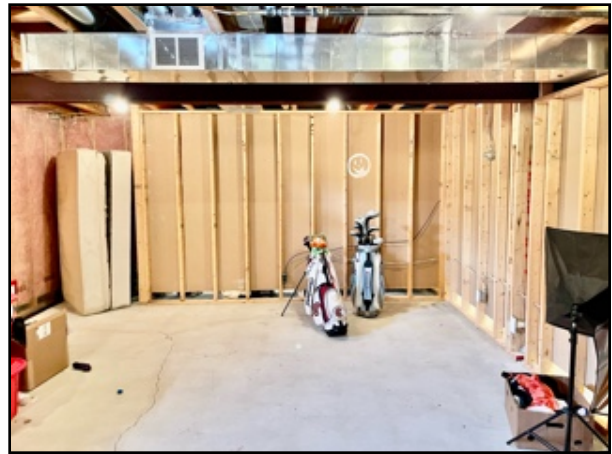
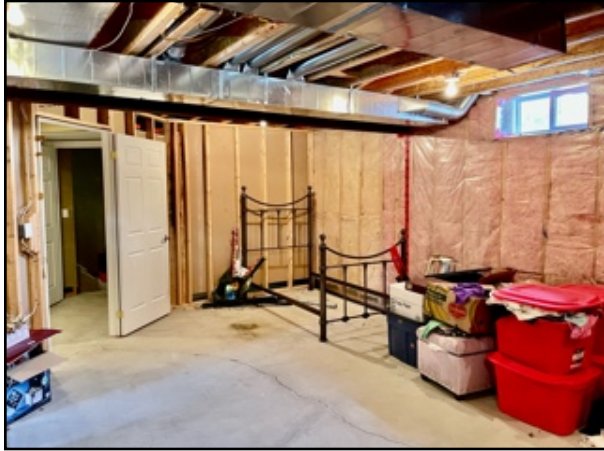
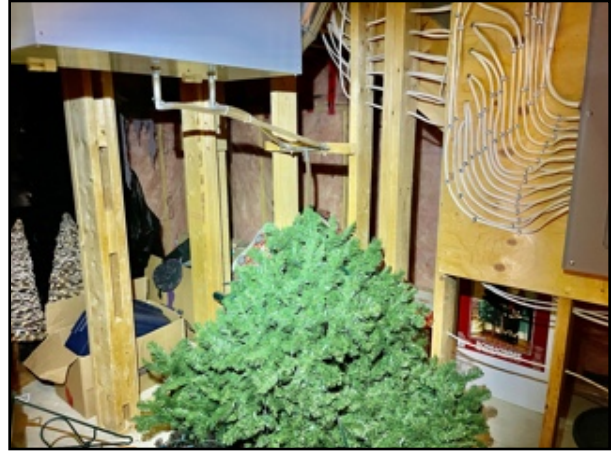
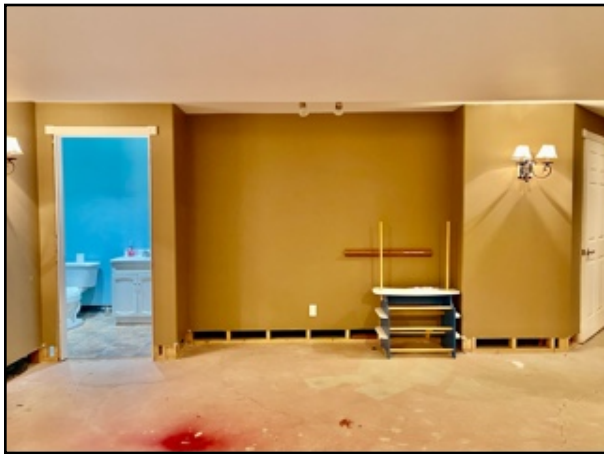
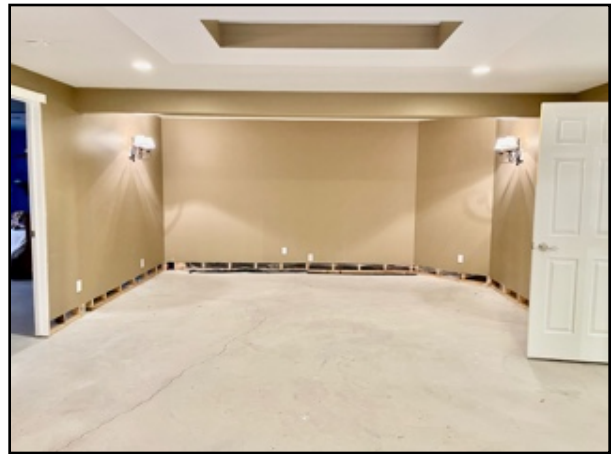
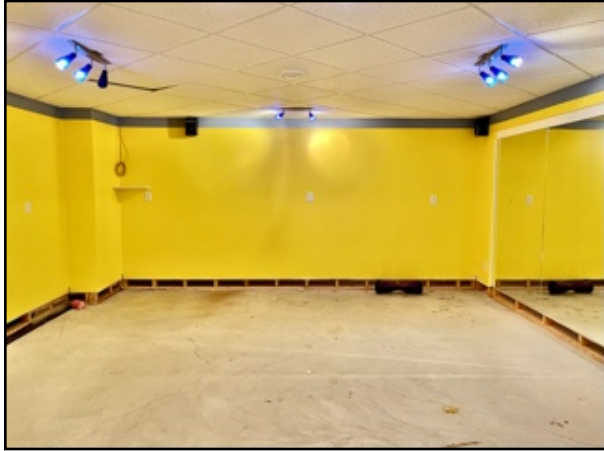
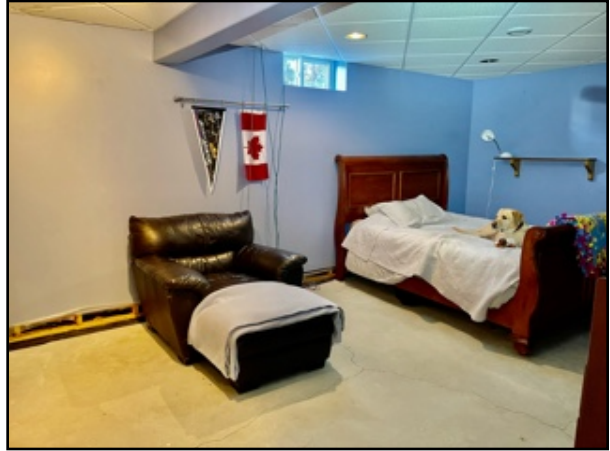
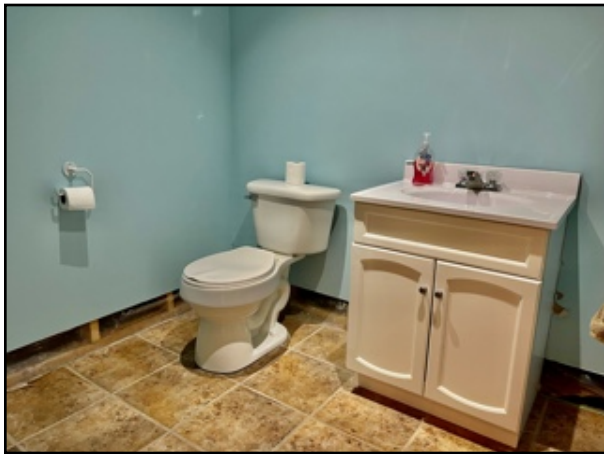
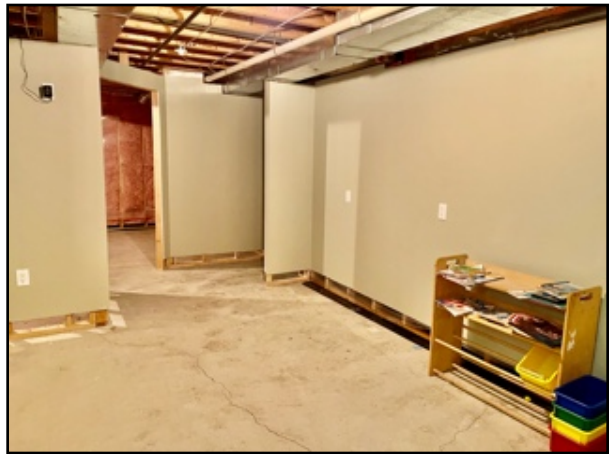
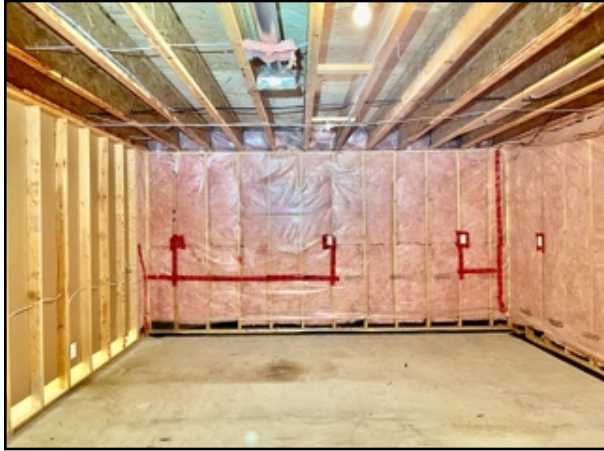
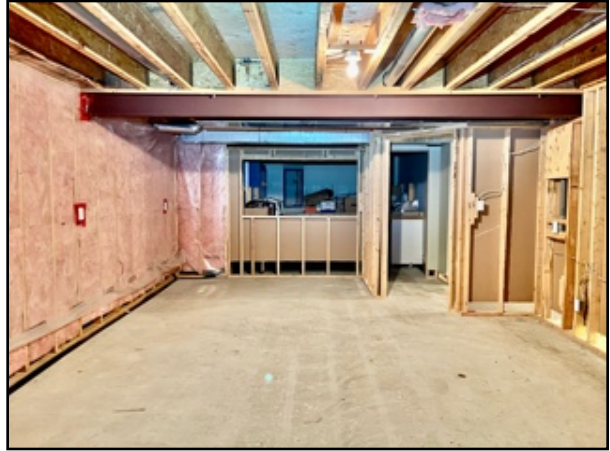
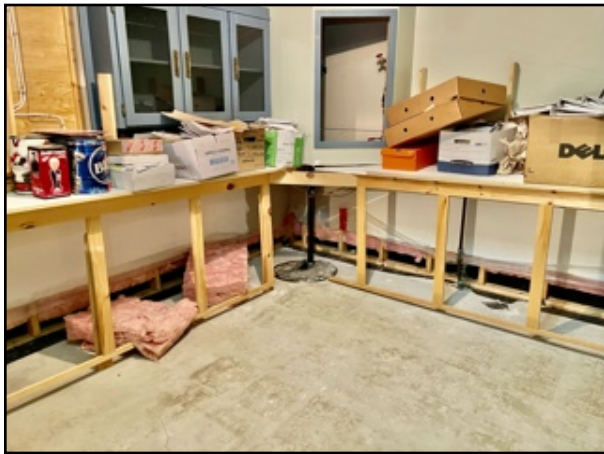
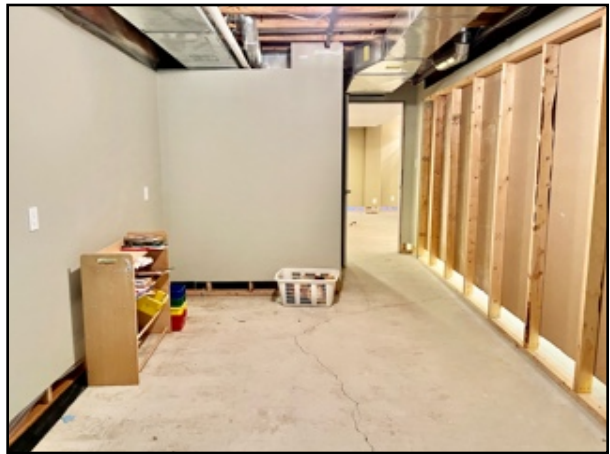
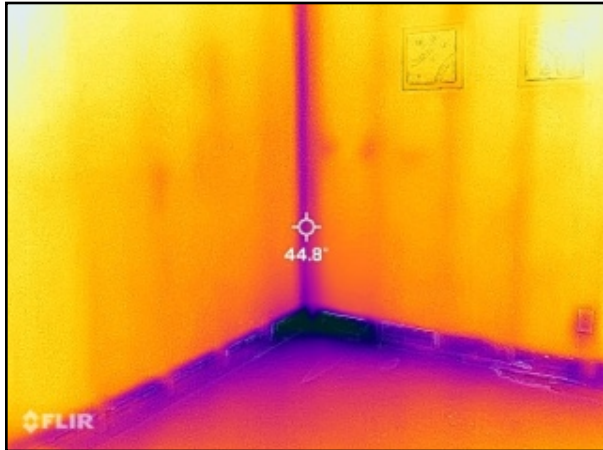
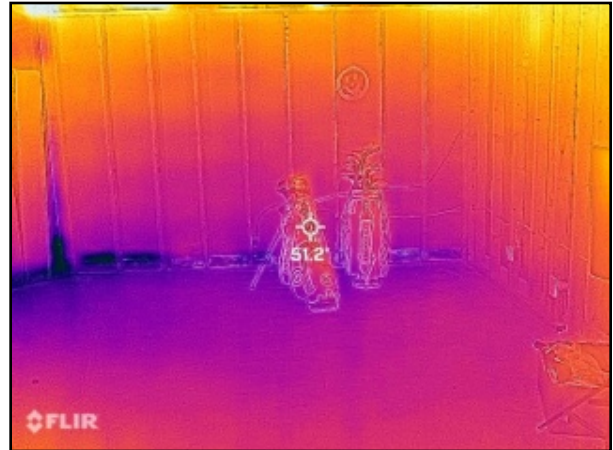
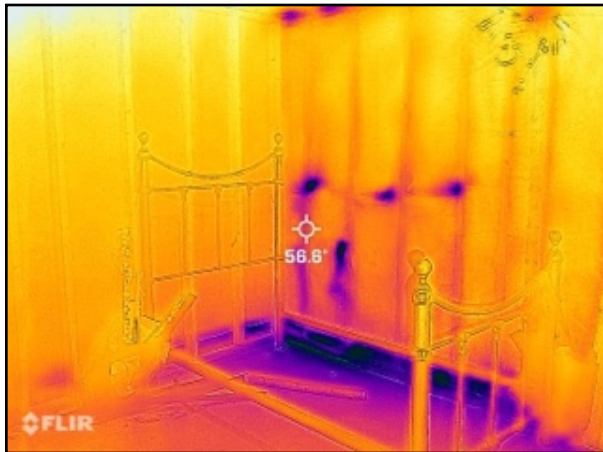
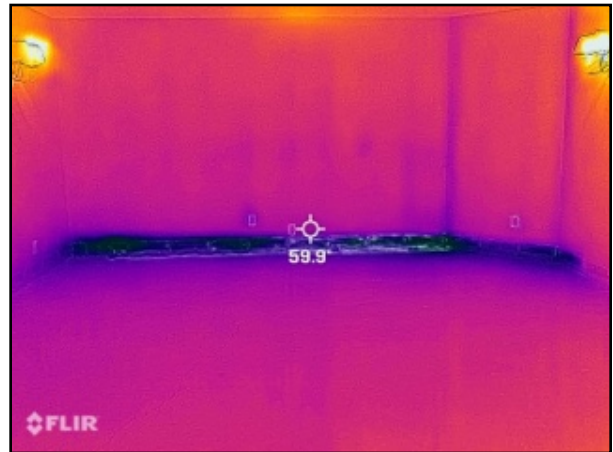
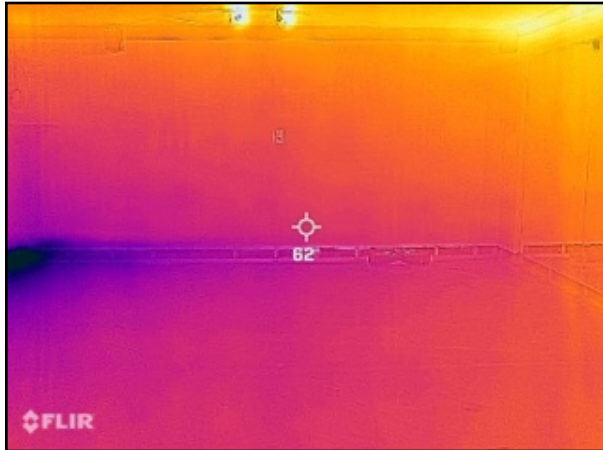
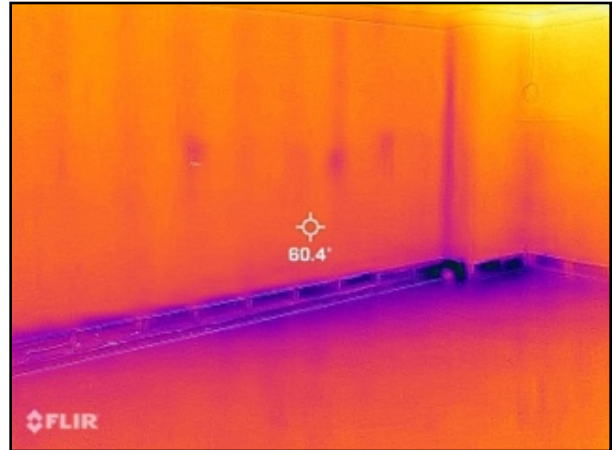
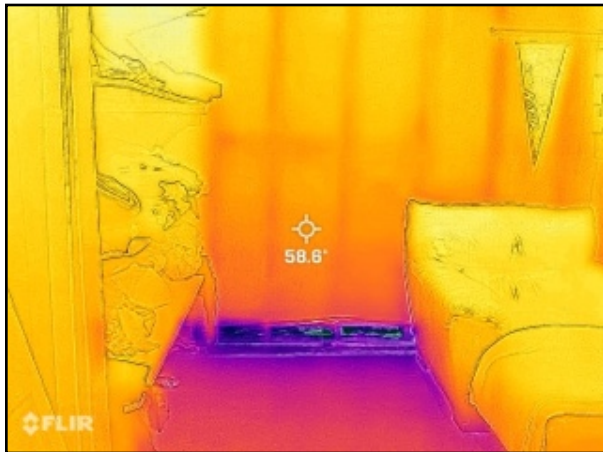
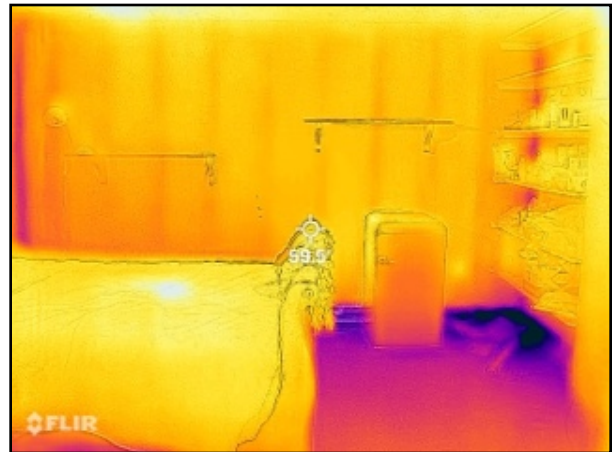
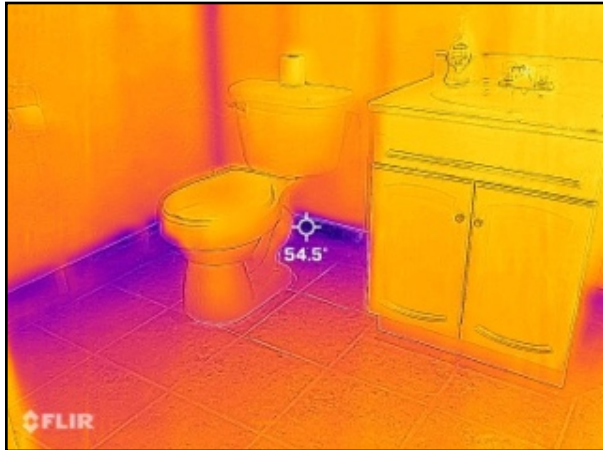
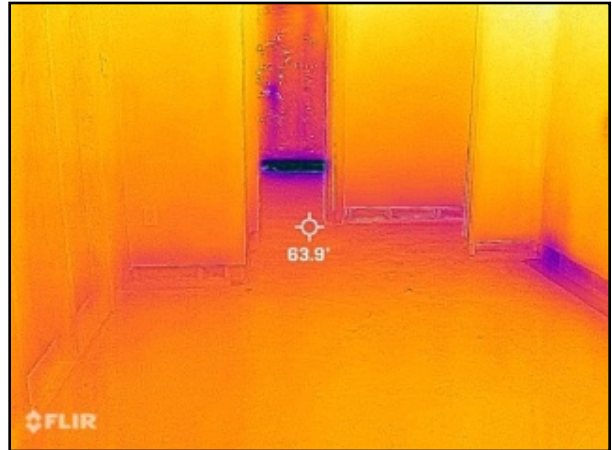
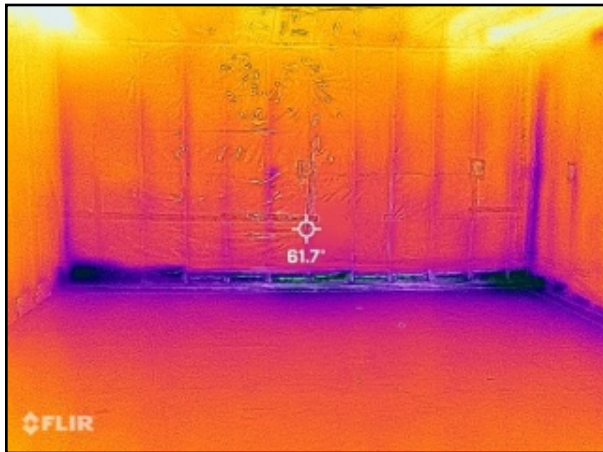
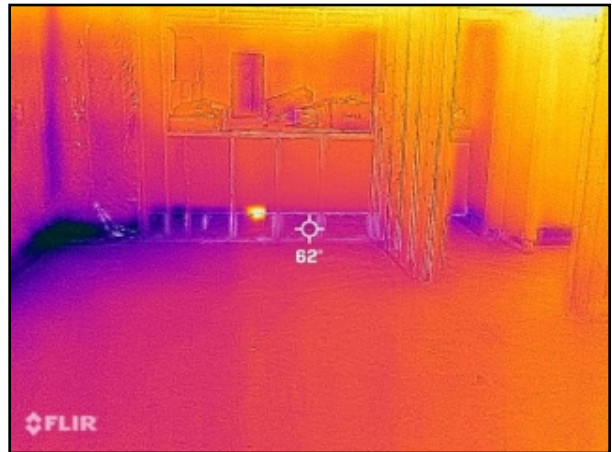
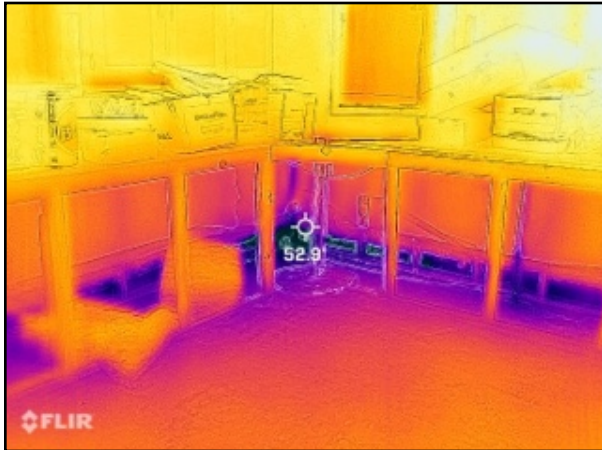
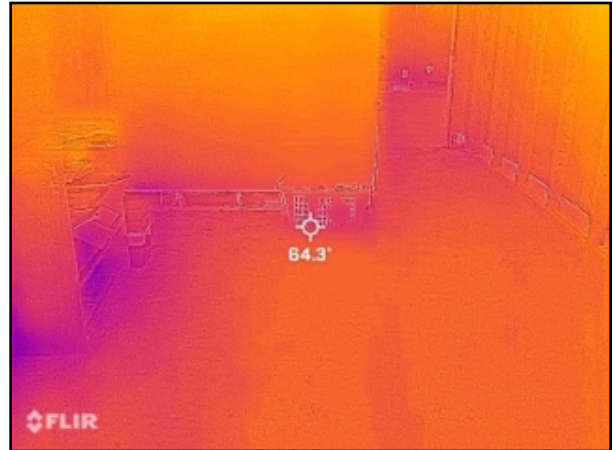
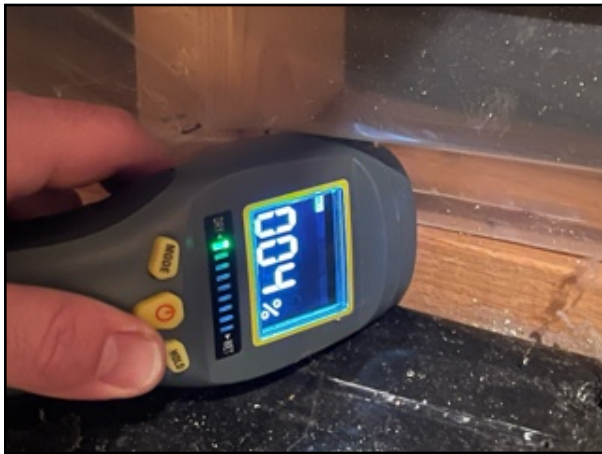
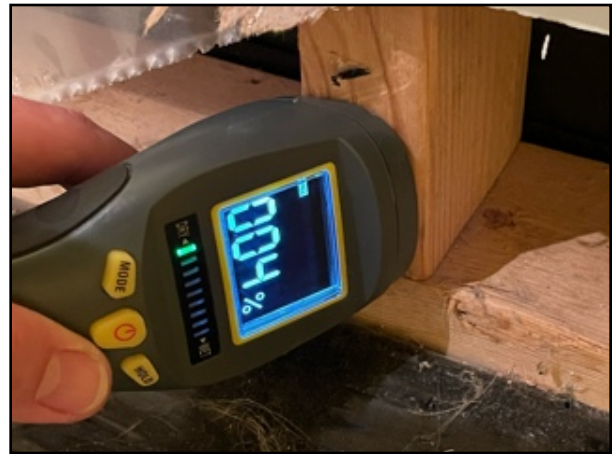
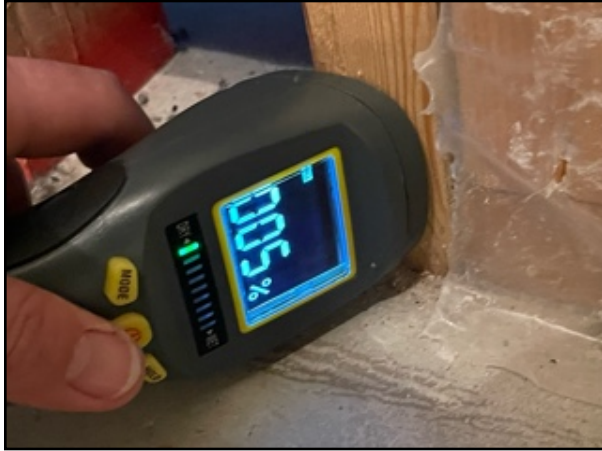
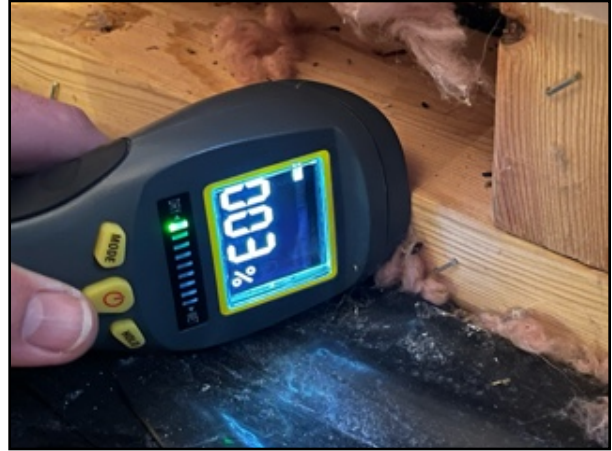
Access limited. The Thermal Imaging camera showed no visual signs of active moisture or heavy draft along the finished accessible portions of the exterior walls at the time of the inspection. No evidence of active or prior microbial growth or staining. Typical minimal air leaks and natural air movement at the base of the walls and corners found with less than a 10 degree F difference in temperature. Moisture readings taken did not exceed 5% in the finished areas when tested. No deficiencies in these areas were noted.

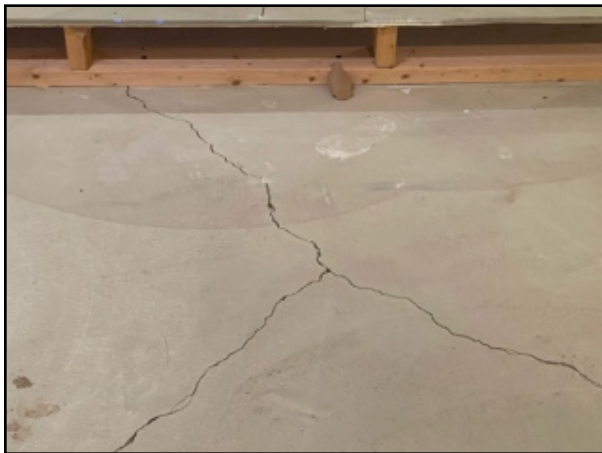
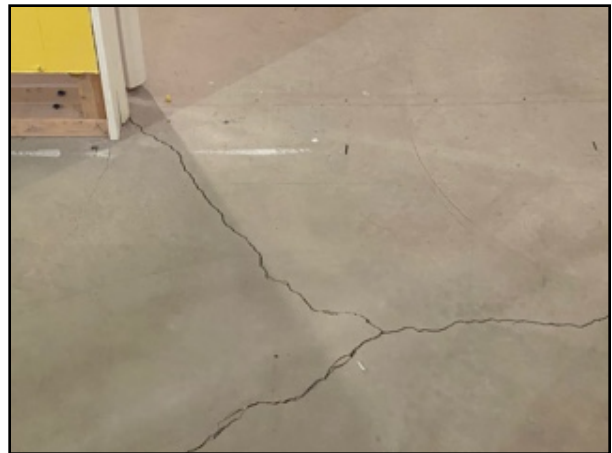
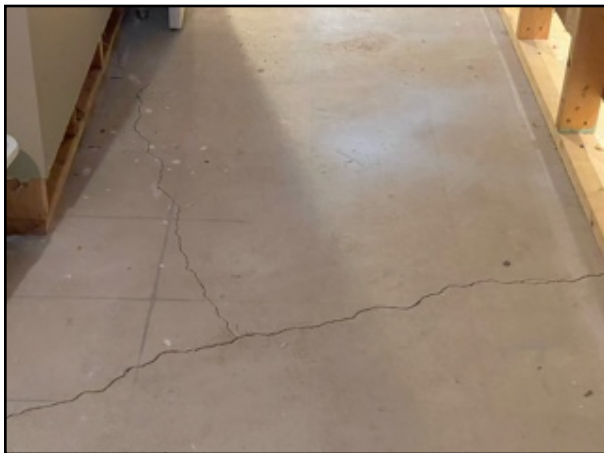
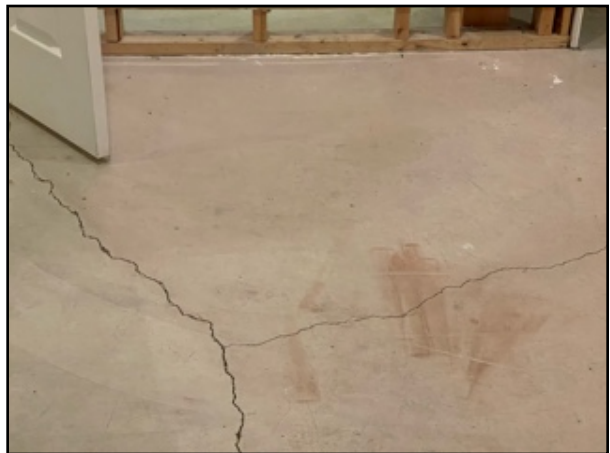
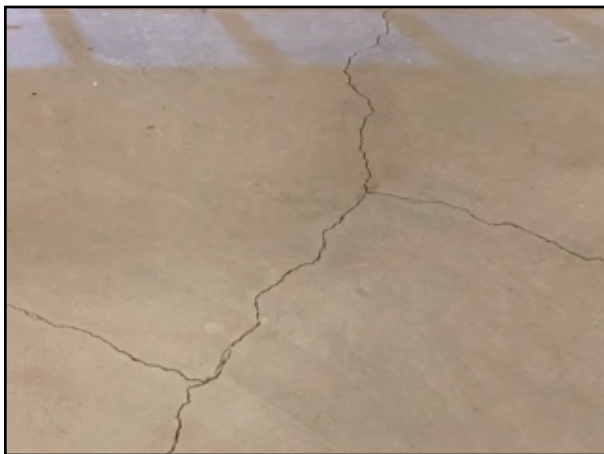
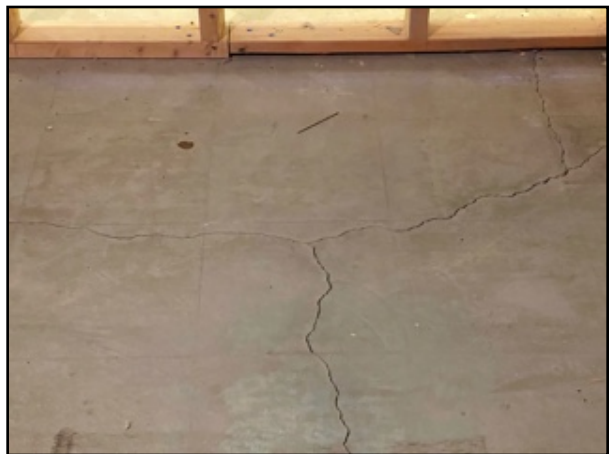
Shrinkage cracks noted in the basement floor. This is typically found. As concrete cures, the water in the mixture evaporates causing the concrete to lose volume (shrink). If the surface of the slab has already begun to dry before this, shallow hairline cracks will form. Because the basement floor is independent of any structural components, this would be considered to be a cosmetic issue and not a defect in the floor.

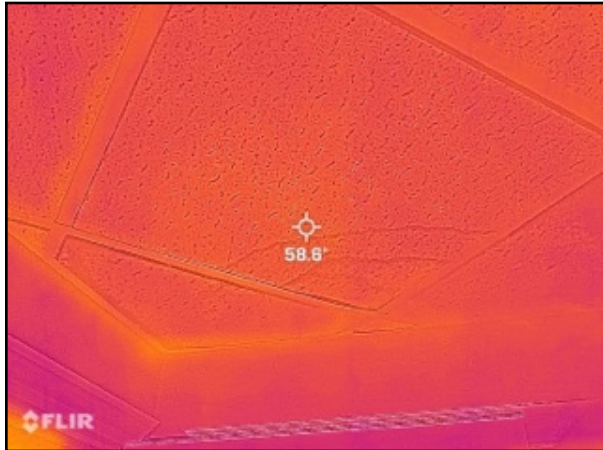
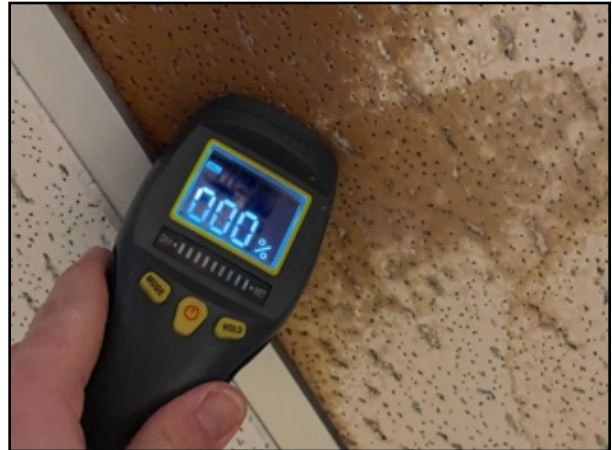
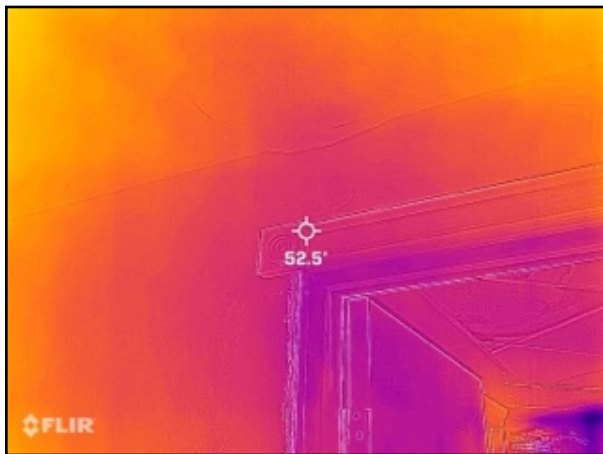
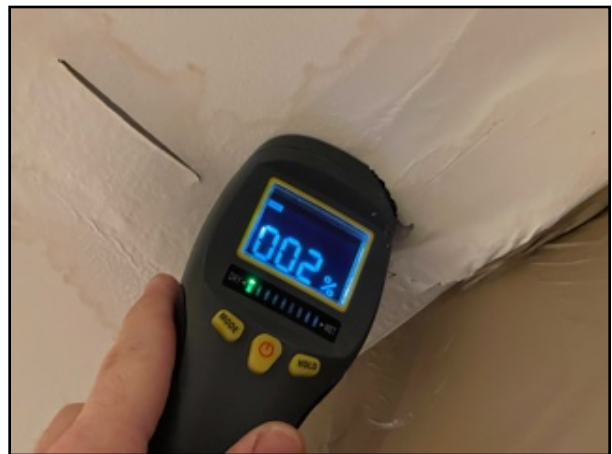
Water stains noted at the bedroom ceiling (prior leak at kitchen sink faucet). No active moisture when inspected.
