# **Cornerstone Inspection**

## **Property Inspection Report**

**3880 Santa Domingo Rd, Arroyo Grande, CA 93420**  
**Inspection prepared for: Kent and Sue Zammit**  
**Real Estate Agent: Jennifer Mandulay Poelking - Blair Properties**

**Date of Inspection: 3/10/2025 Time: 1:30 PM**  
**Age of Home: 2000 Size: 2708**  
**Weather: Clear**  
**Order ID: 11841**

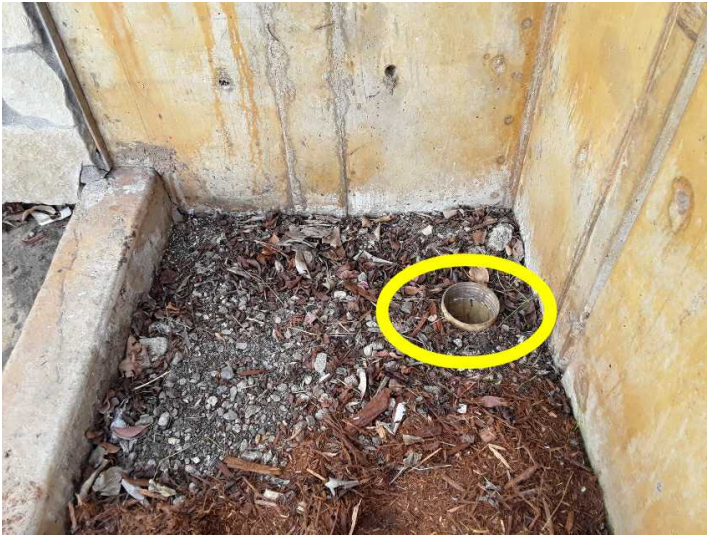
2.8. There are missing or broken area drain covers. This could have allowed leaves and other debris to enter the drain lines and contribute to blockages. Therefore, it would be prudent to have the lines flushed through to the street or to their termination point before the broken covers are replaced.

There are missing or broken area drain covers. This could have allowed leaves and other debris to enter the drain lines and contribute to blockages. Therefore, it would be prudent to have the lines flushed through to the street or to their termination point before the broken covers are replaced.

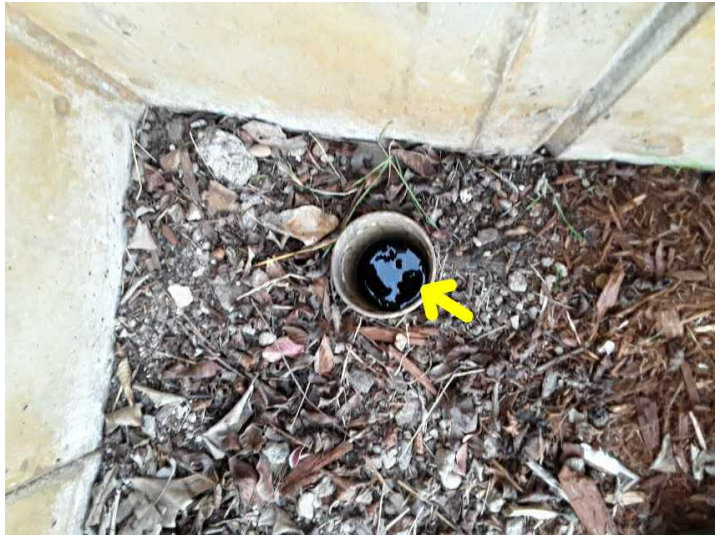
2.7. There is standing water or debris visible within the area drains, which could be indicative of at least a partial blockage. The tendrils of roots may have invaded the drains, but silt also tends to become trapped within the drain pipes and hardens during the summer months to the consistency of wet concrete and creates an impediment that commonly leads to a full blockage. Therefore, we recommend that the lines be flushed through to the street or to their termination point.

There is standing water or debris visible within the area drains, which could be indicative of at least a partial blockage. The tendrils of roots may have invaded the drains, but silt also tends to become trapped within the drain pipes and hardens during the summer months to the consistency of wet concrete and creates an impediment that commonly leads to a full blockage. Therefore, we recommend that the lines be flushed through to the street or to their termination point.

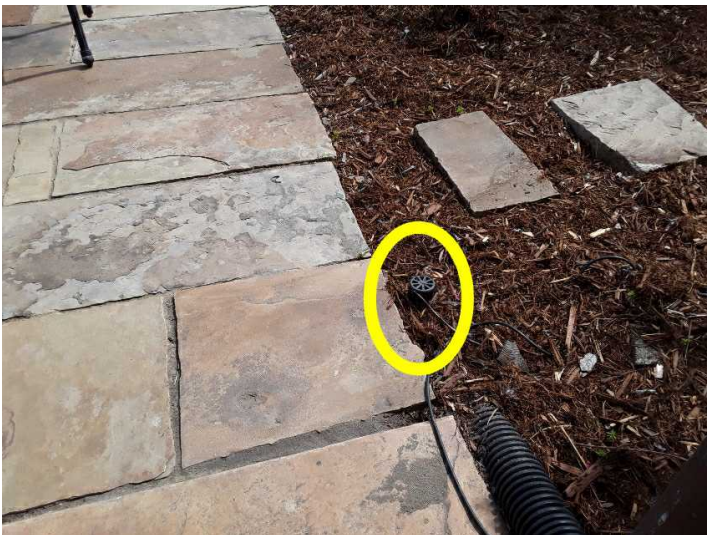
There are area drains in planter beds or yards that will be subject to contamination by dirt and debris, and these drains should be periodically monitored and cleaned.

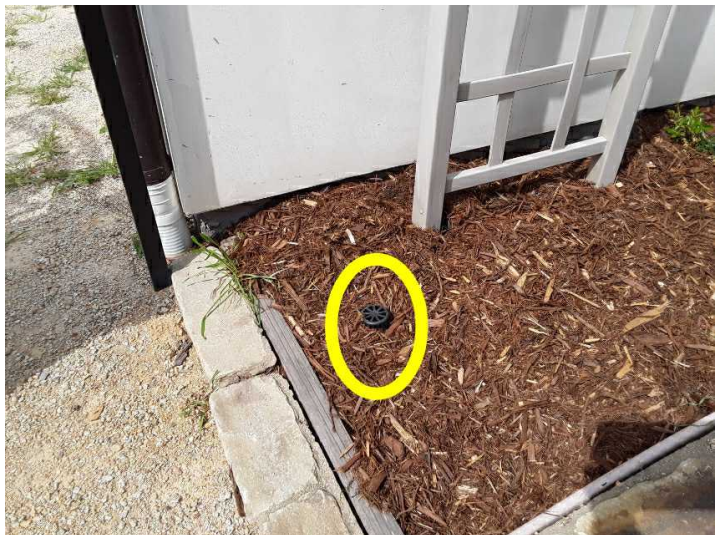
There are area drains in planter beds or yards that will be subject to contamination by dirt and debris, and these drains should be periodically monitored and cleaned.

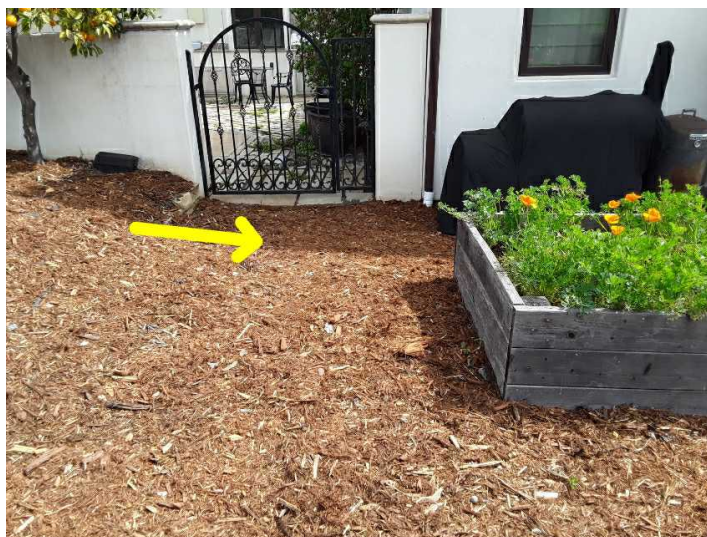
2.3. There are areas at the rear where water will be directed toward the house instead of away from it, as is recommended. This not only allows for the possibility of moisture intrusion but also for differential settling.

There are areas at the rear where water will be directed toward the house instead of away from it, as is recommended. This not only allows for the possibility of moisture intrusion but also for differential settling.

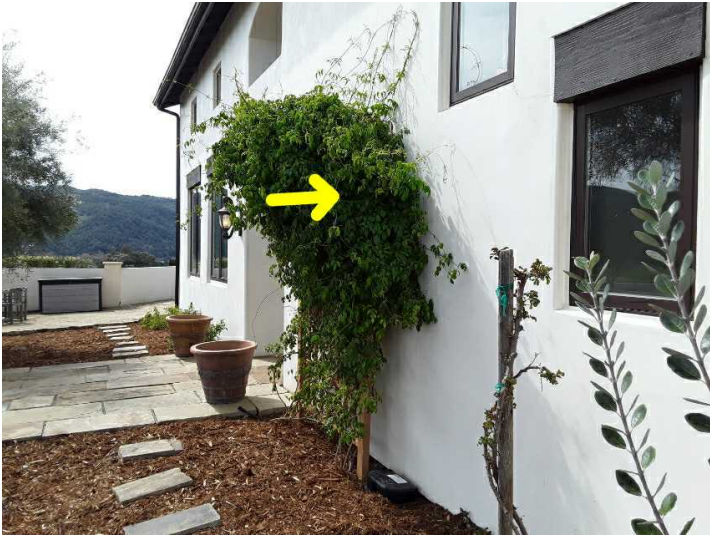
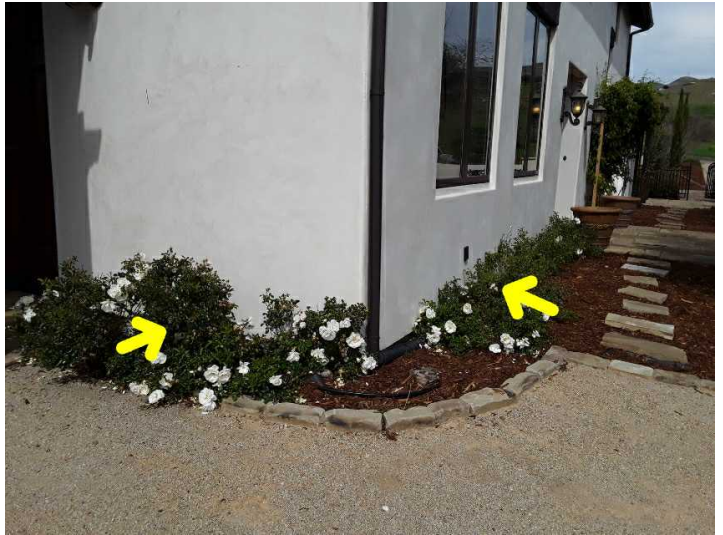
3.2. Vines, shrubs or bushes are growing on the house walls and although they are attractive they can introduce pests and rodents and accelerate deterioration. Therefore, you may wish to consider having them removed or cut back to 12 inches (30 cm) away from the home.

Vines, shrubs or bushes are growing on the house walls and although they are attractive they can introduce pests and rodents and accelerate deterioration. Therefore, you may wish to consider having them removed or cut back to 12 inches (30 cm) away from the home.

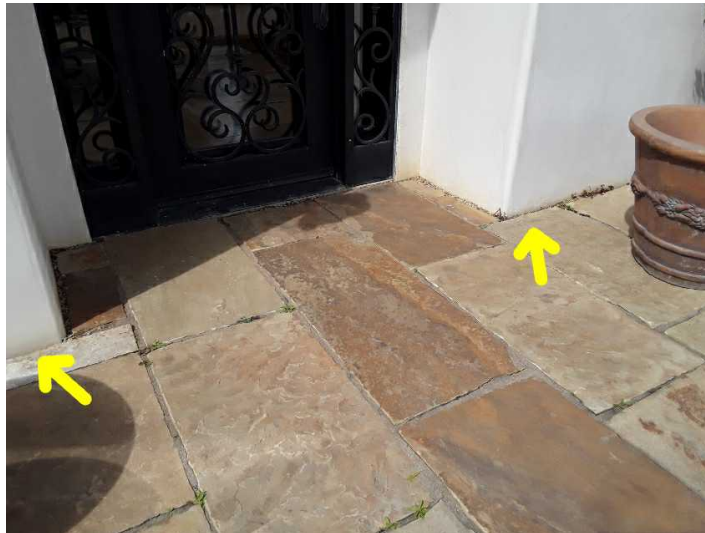
3.5. Portions of the weep-screed have been covered. Weep-screed not only allows the house walls to move independently of the foundation and prevents the plate-line cracks that are commonly seen at the base of many stucco walls but allows any moisture that penetrates the stucco to drain. Therefore, the interior and exterior plaster in this area should be monitored to ensure that no moisture damage results.

Portions of the weep-screed have been covered. Weep-screed not only allows the house walls to move independently of the foundation and prevents the plate-line cracks that are commonly seen at the base of many stucco walls but allows any moisture that penetrates the stucco to drain. Therefore, the interior and exterior plaster in this area should be monitored to ensure that no moisture damage results.

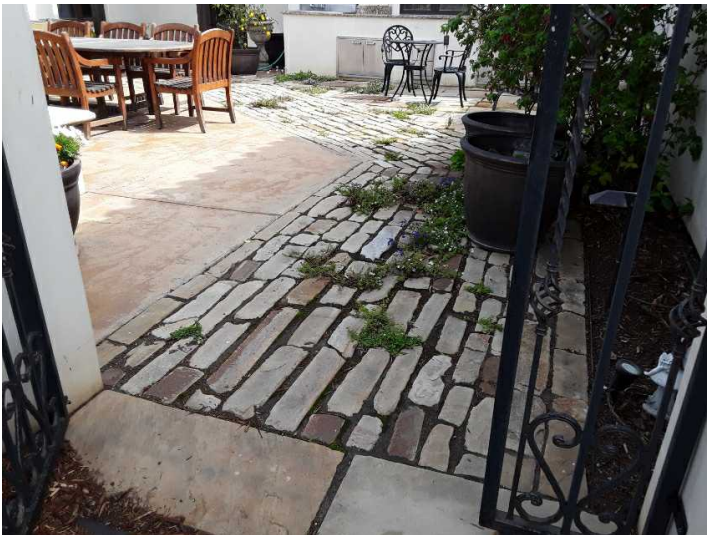
4.4. The paver patio or walkway has one or more offsets that may prove to be trip-hazards. This may be by design or due to unsuitable soil below the pavers.

The paver patio or walkway has one or more offsets that may prove to be trip-hazards. This may be by design or due to unsuitable soil below the pavers.

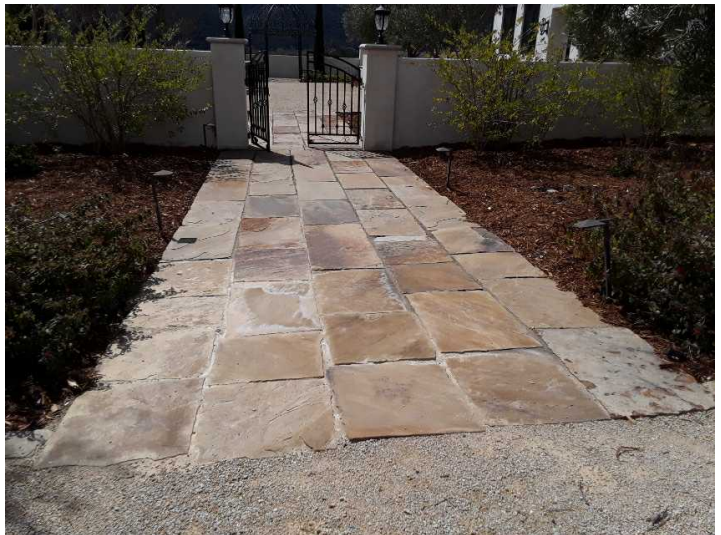
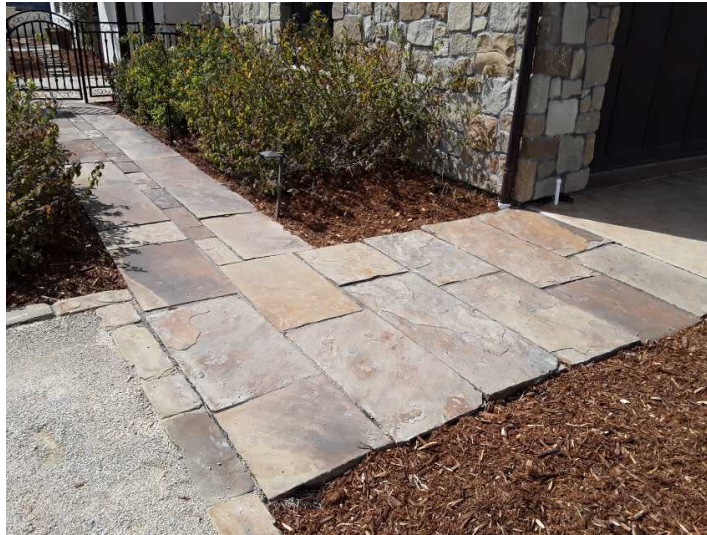
4.5. The natural stone patio or walkway has one or more offsets that may prove to be trip-hazards. This may be by design or due to unsuitable soil below the stone.

The natural stone patio or walkway has one or more offsets that may prove to be trip-hazards. This may be by design or due to unsuitable soil below the stone.

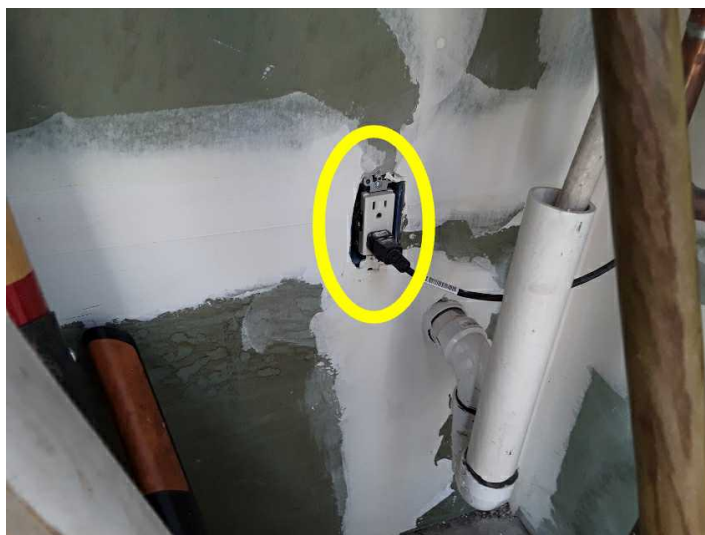
6.2. Some of the exterior electrical outlets do not have a weather rated cover or the cover is damaged and should be serviced.

Some of the exterior electrical outlets do not have a weather rated cover or the cover is damaged and should be serviced.

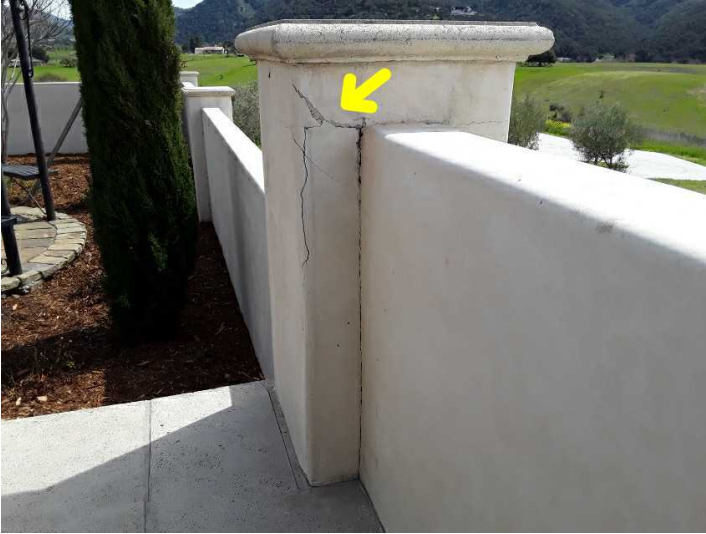
9.1. There are typical cracks in the stucco covering the yard walls which you should view for yourself. Such cracks are common, and are generally not structural.

There are typical cracks in the stucco covering the yard walls which you should view for yourself. Such cracks are common, and are generally not structural.

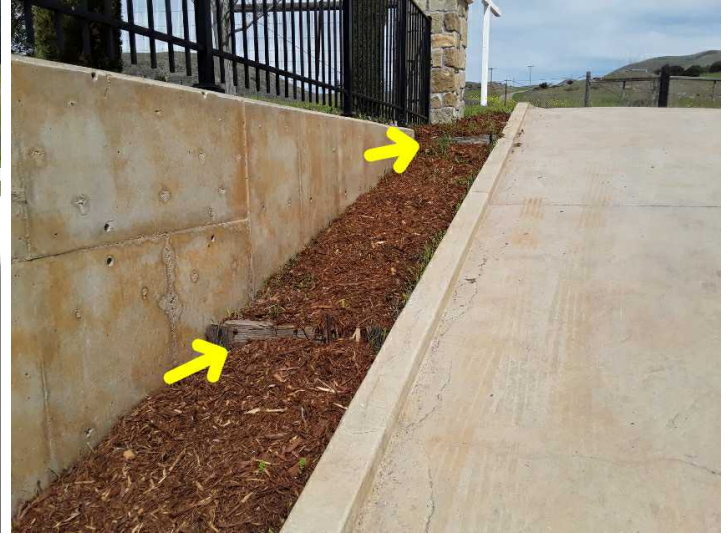
9.2. The wooden planks terracing the slope have no structural value, and are intended to inhibit surface soil movement. They should be periodically monitored for damage and stability.

The wooden planks terracing the slope have no structural value, and are intended to inhibit surface soil movement. They should be periodically monitored for damage and stability.

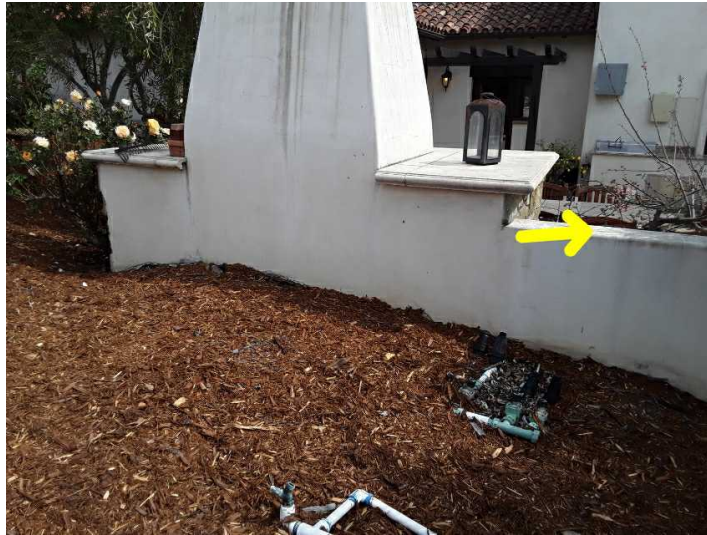
One or more guardrails do not conform to common safety standards. Common safety standards require them to be a minimum of 42 inches high when the standing surface is 30 inches or more above grade. Also, guardrail pickets should be no more than 4 inches apart for child safety.

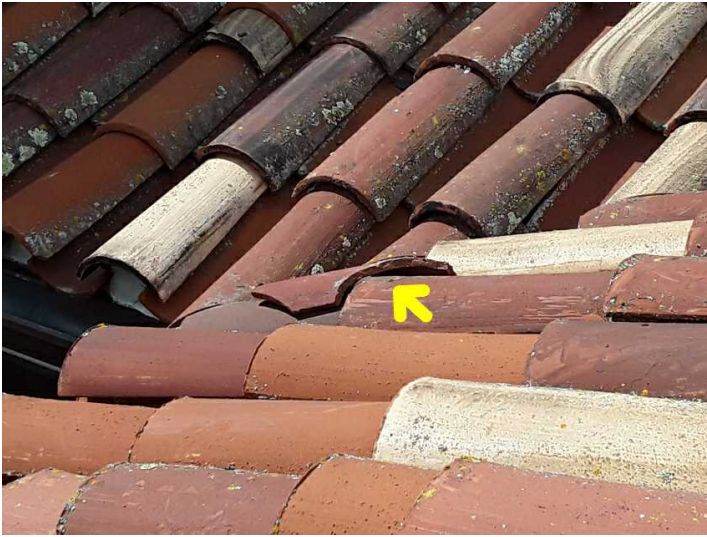
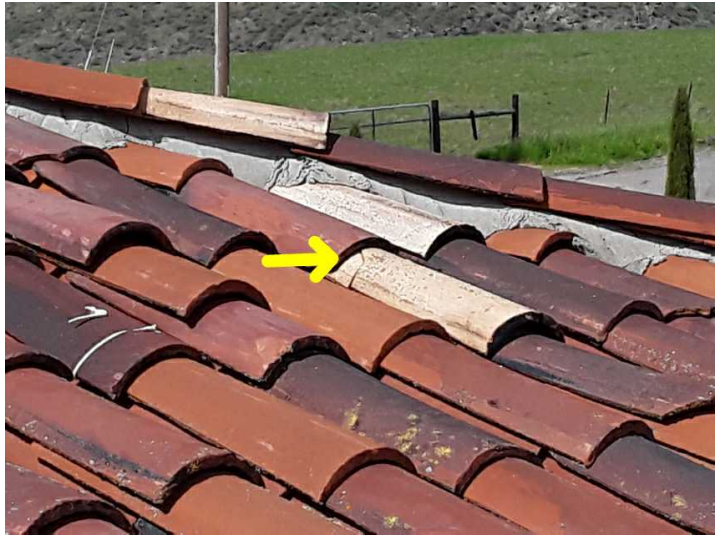
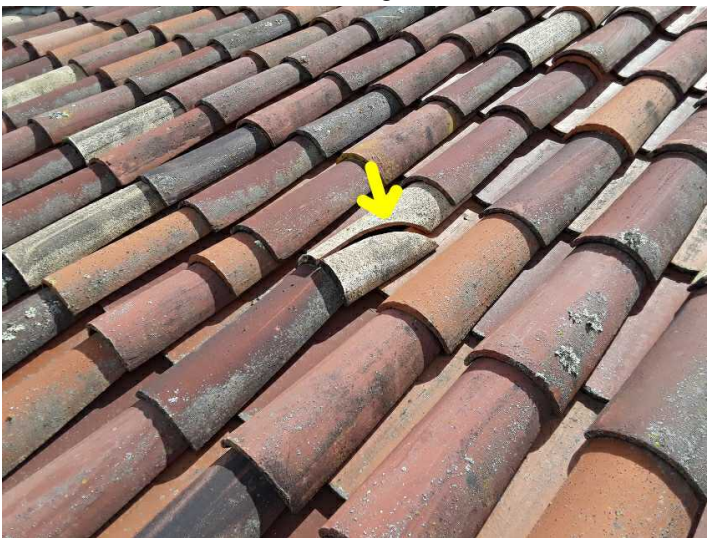
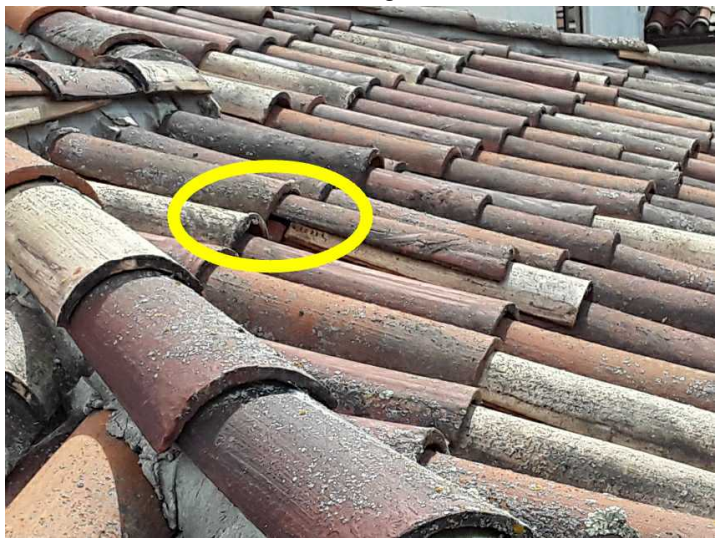
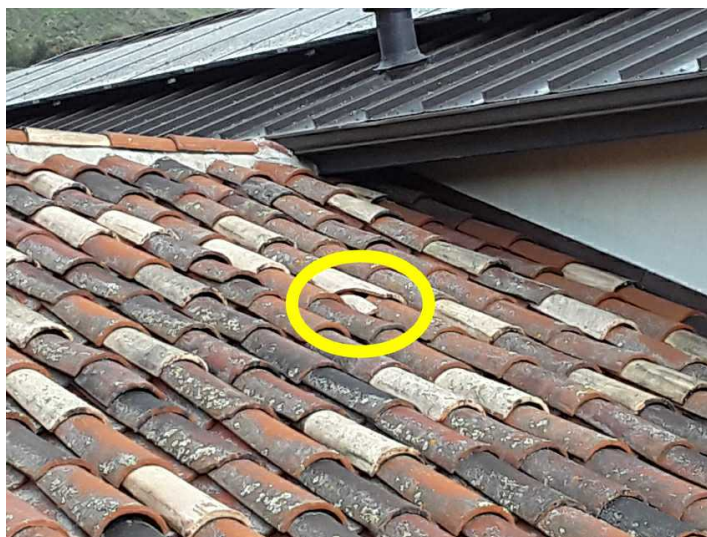
There are cracked or broken tiles that should be serviced by a licensed roofing contractor.

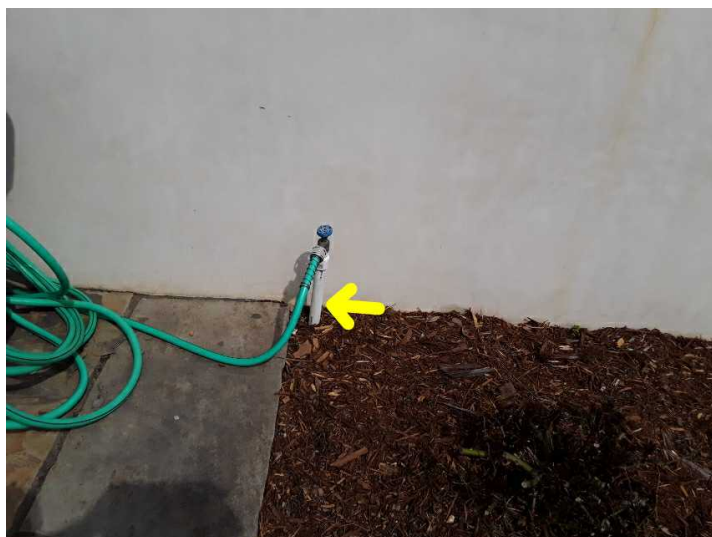
A PVC hose bib pipe should be braced with a metal stake to reduce the possibility of leaks.

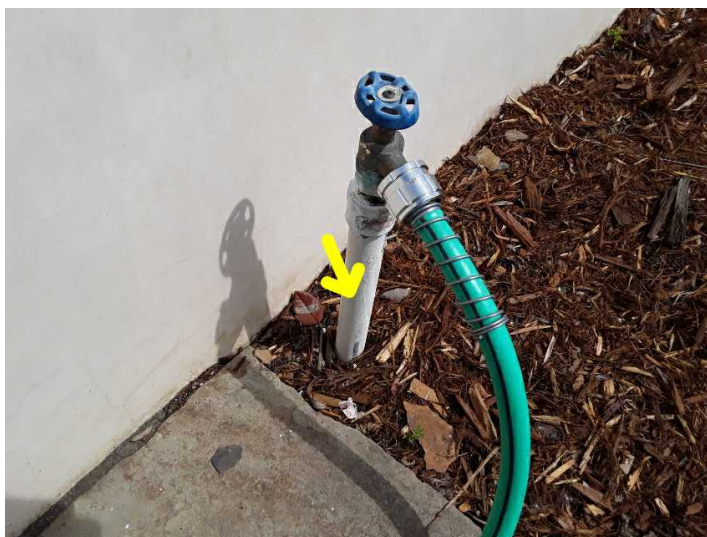
We have observed exposed PVC pipes on the exterior, which may become brittle when exposed to the sun's ultraviolet light. These pipes can become subject to breaking or leaking. We recommend painting the PVC pipes to block the UV rays and protect the pipe.

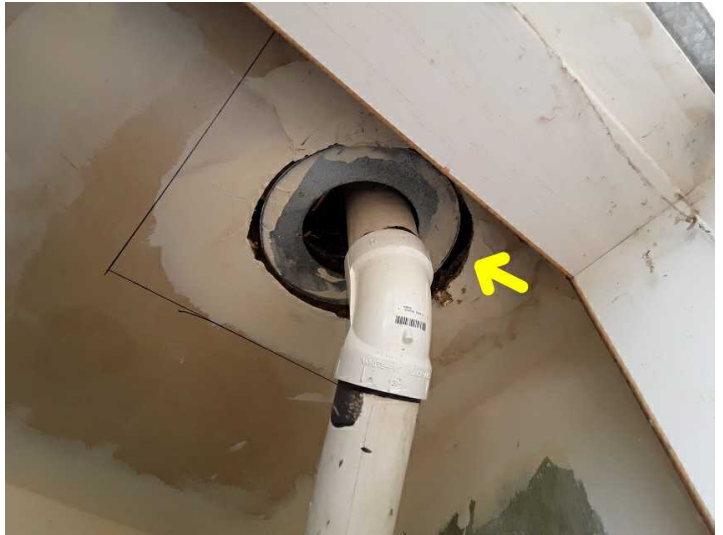
A transition spacer is improperly sized where the vent pipe enters the attic or wall cavity, which should be serviced.

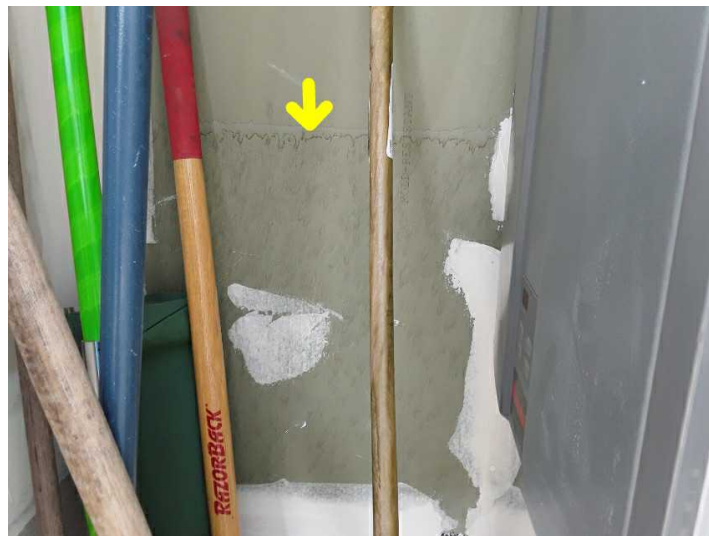
There is a moisture stain on the wall or ceiling that should be explained or explored further.

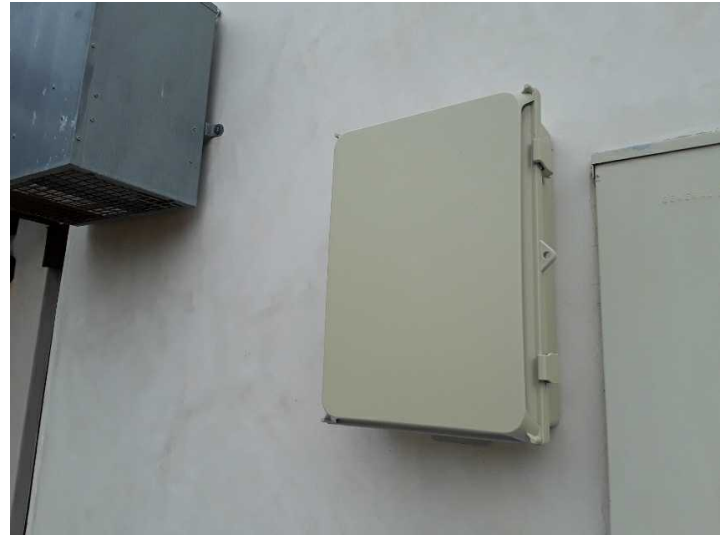
A photovoltaic solar system has been installed, which we do not have the expertise to evaluate. We recommend the sellers provide information regarding its installation, operation, and maintenance history. You may also wish to have it evaluated by a qualified specialist.

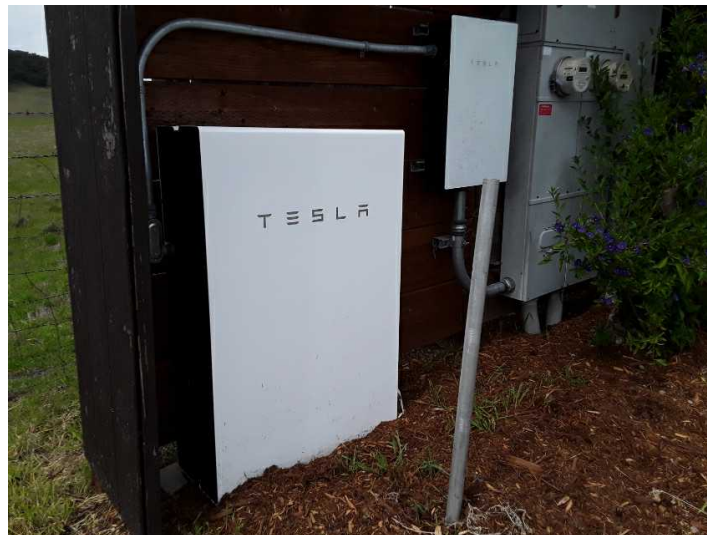
A battery backup or power bank system has been installed, which we do not have the expertise to evaluate. We recommend the sellers provide information regarding its installation, operation, and maintenance history. You may also wish to have it evaluated by a qualified specialist.

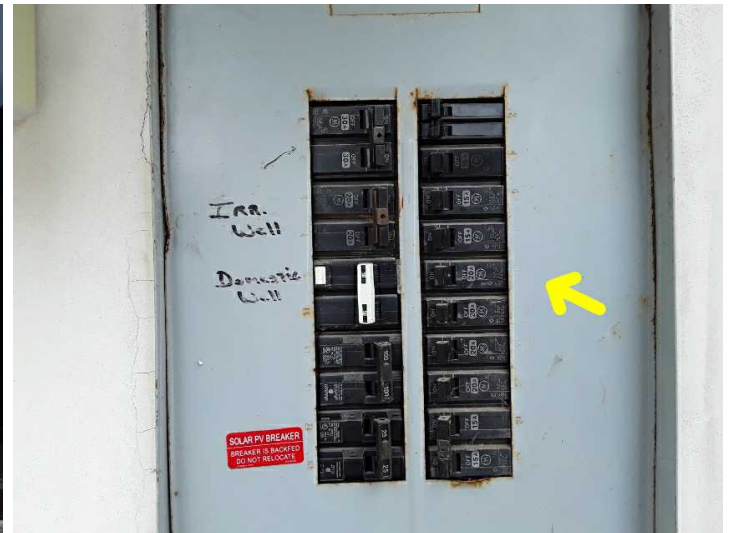
Various circuits within the sub-panel are not labeled, and this condition should be serviced by a qualified electrical contractor so that the appropriate load calculations and breaker sizes can be determined.

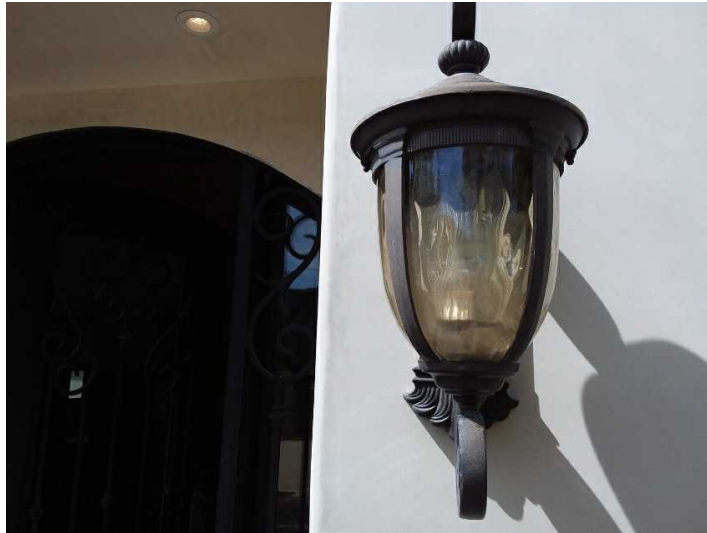
An exterior wall light did not respond and should be serviced.

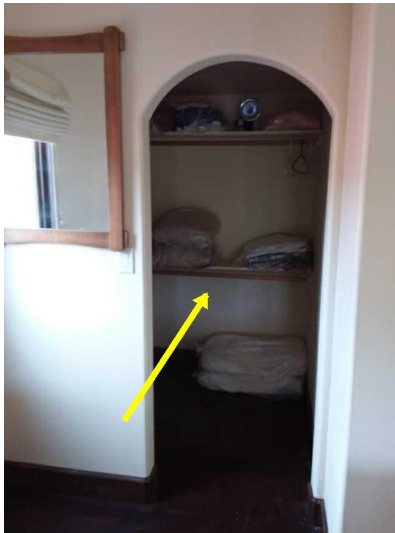
The closet door is missing which you may wish to have installed.

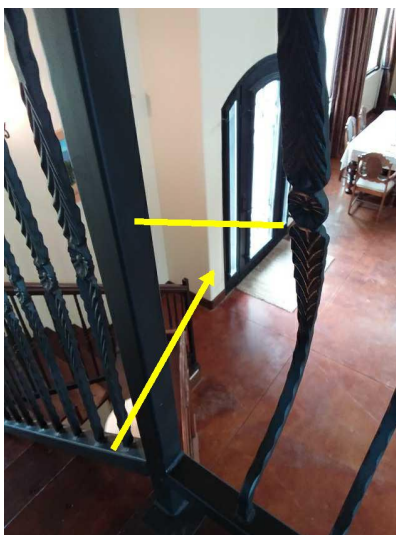
The balusters in the corners of the stair or guardrails are more than four-inches apart and are not child safe. Therefore, you may wish to add a protective barrier.

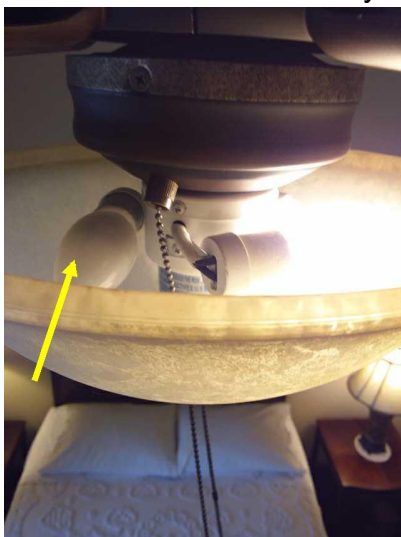
A ceiling light bulb in the bedroom does not respond, and should be serviced.

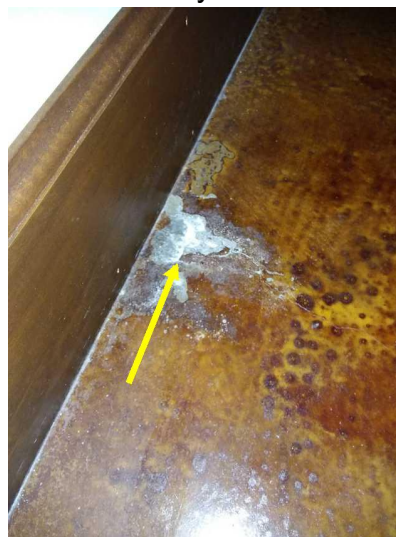
The floor is worn or cosmetically damaged, which you should view for yourself.

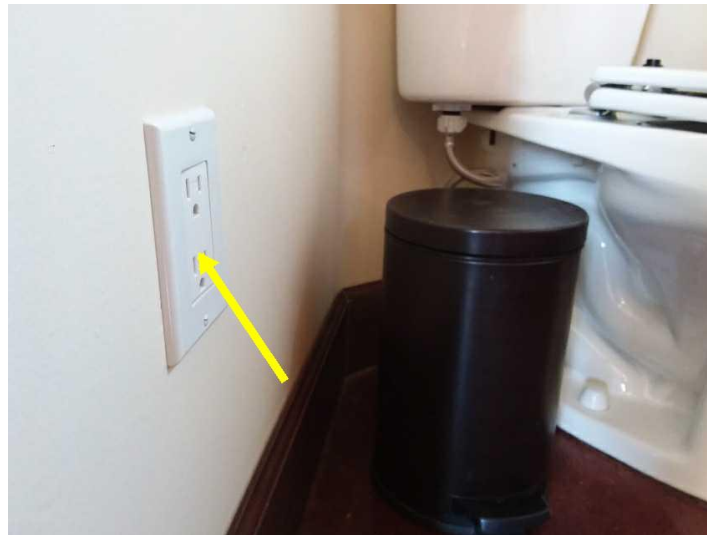
The toilet room outlet is functional, but should be upgraded to have ground-fault protection.

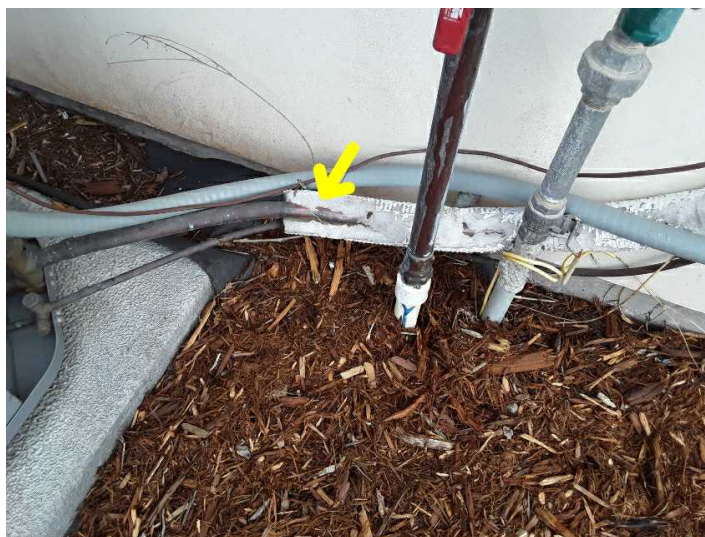
Insulation is missing from the refrigerant lines at the evaporator coil, which will allow condensation to form and drip, and should be installed.

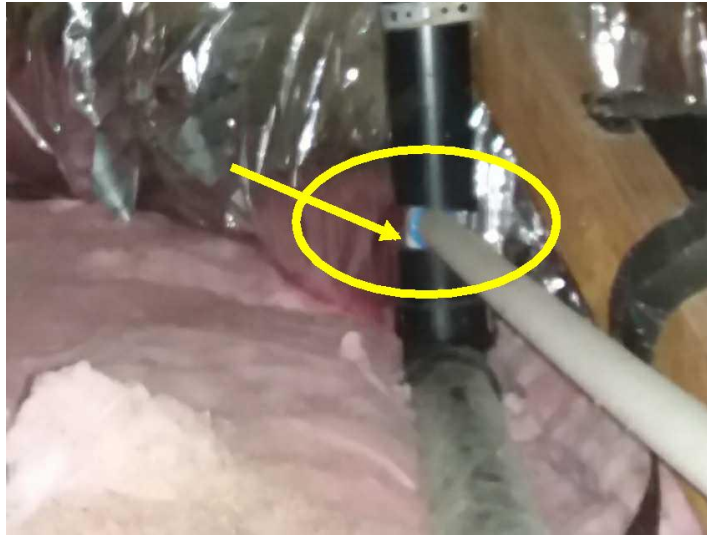
There is a drainpipe vent that is cut or separated inside the attic which should be evaluated and serviced by a licensed specialist.

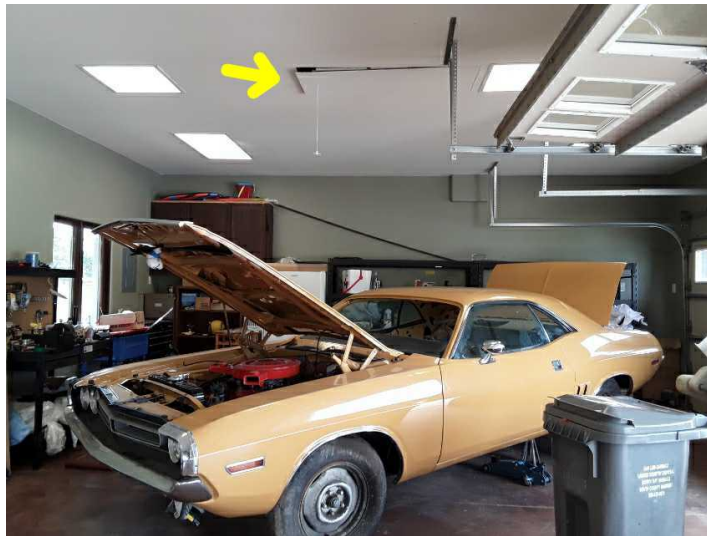
2.1. We were unable to access the attic due to personal contents within the hatch area. We recommend that the access area be cleared and the attic be inspected. Contact Cornerstone Inspection for this additional inspection.

We were unable to access the attic due to personal contents within the hatch area. We recommend that the access area be cleared and the attic be inspected. Contact Cornerstone Inspection for this additional inspection.

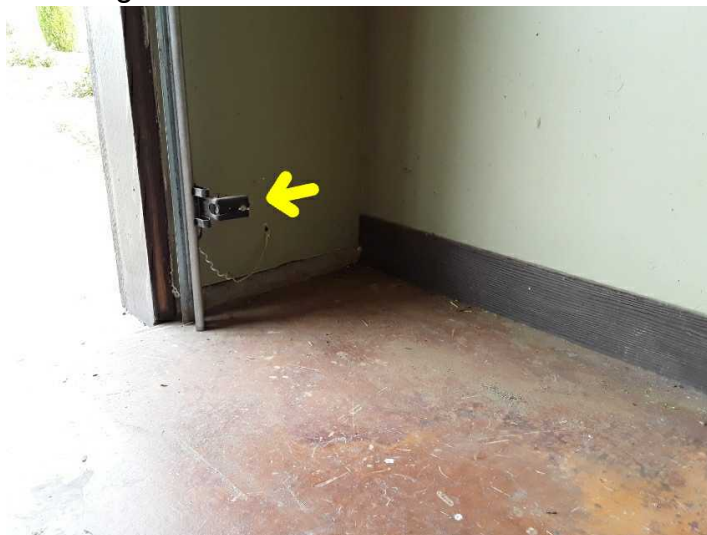
The infrared auto-reversing sensor mechanisms are functional but located higher than the recommended six inches above grade.
