INSPECTION REPORT

For the Property at:
225 PATRICIA CRESCENT
PETERBOROUGH, ON K9J 6X3

Prepared for: TEAM VANRAHAN
Inspection Date: Thursday, November 2, 2023
Prepared by: David Sharman

RE: Report No. 4566
225 Patricia Crescent
Peterborough, ON
K9J 6X3

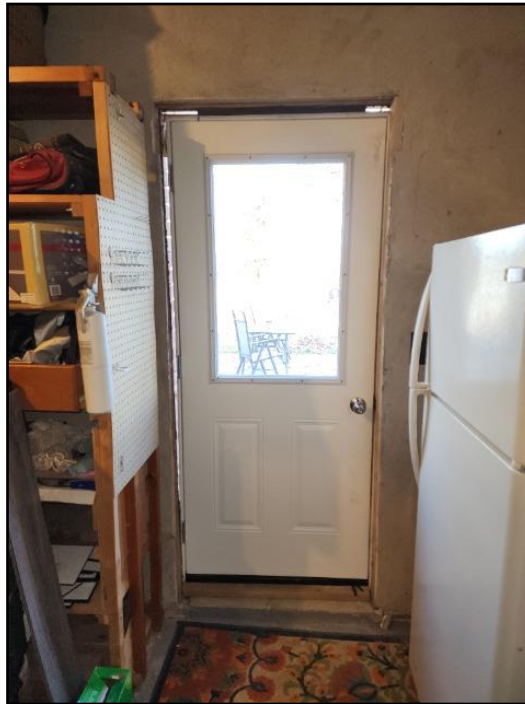
3. Condition: • Exterior caulk/sealant missing

Implication(s): Chance of water damage to finishes and structure

Location: Garage

3. Exterior caulk/sealant missing

Task: Provide

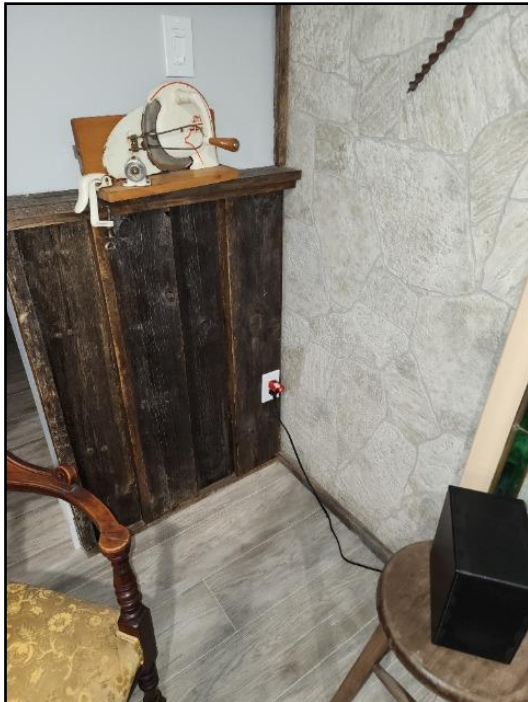
5. Condition: • Ungrounded

Implication(s): Electric shock

Location: Basement family room

9. Ungrounded

Task: Repair

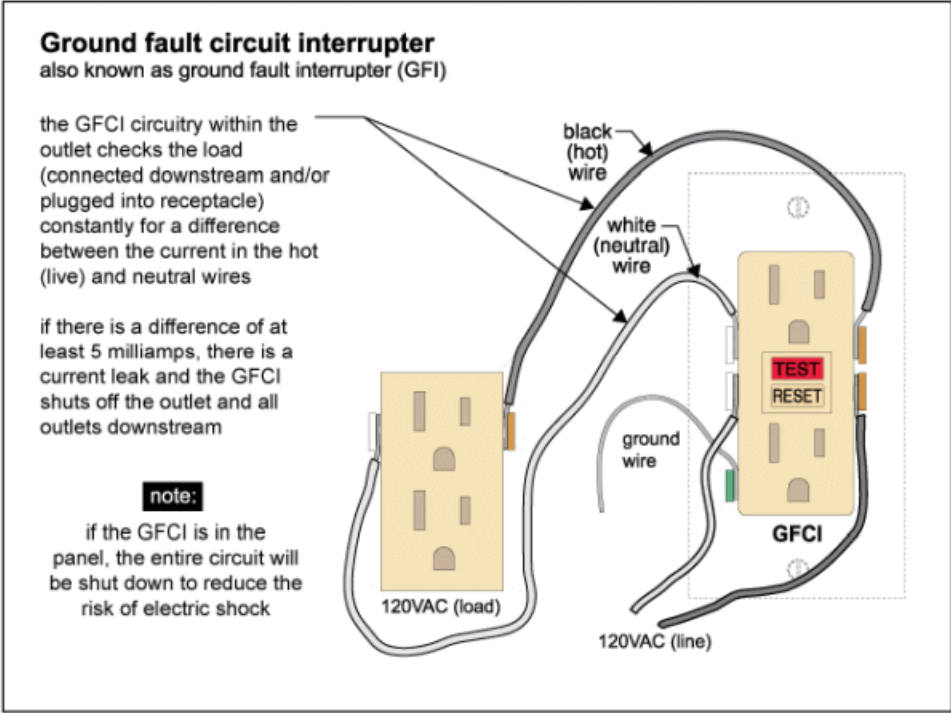
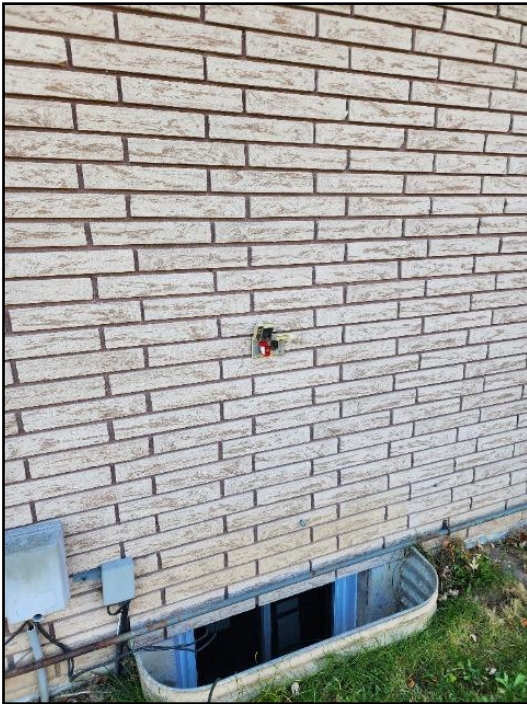
6. Condition: • No GFCI/GFI (Ground Fault Circuit Interrupter)

Although not a deficiency in a home of this age, safety may be improved by upgrading this receptacle

Implication(s): Electric shock

Location: Exterior wall

11. No GFCI/GFI (Ground Fault Circuit...

Task: Upgrade

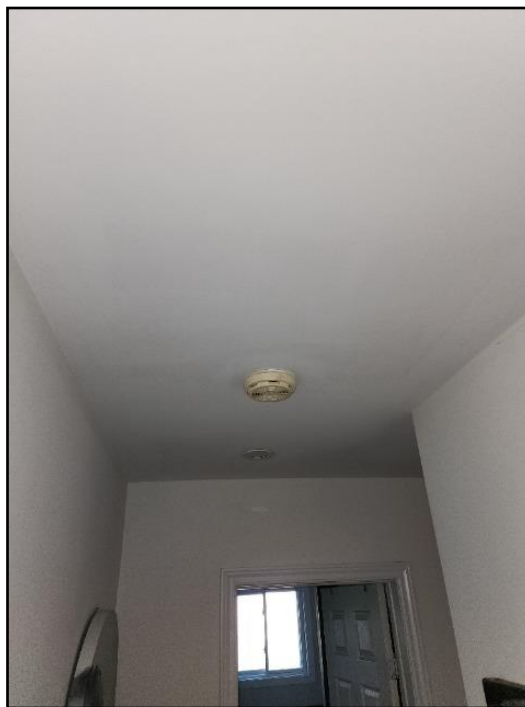
8. Condition: • More than 10 years old

Implication(s): Life safety hazard

Location: First floor

12. More than 10 years old

Task: Replace

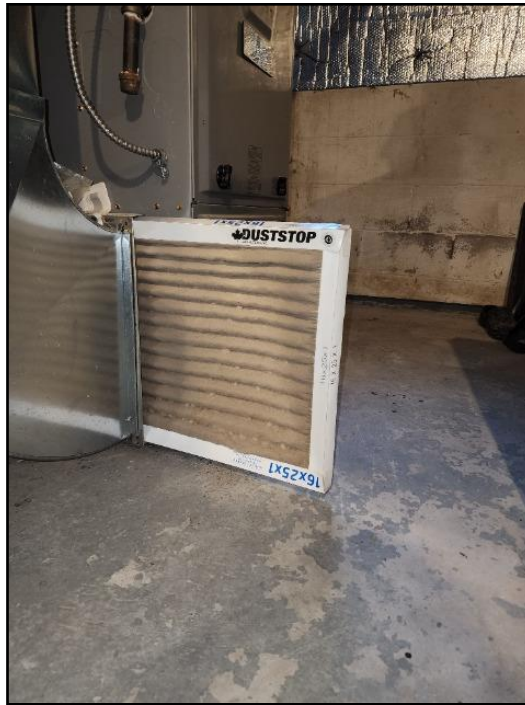
10. Condition: • Replace - regular maintenance

Implication(s): Increased heating & maintenance costs, Reduced comfort

Location: Cold air return

21. Replace - regular maintenance

Task: Replace

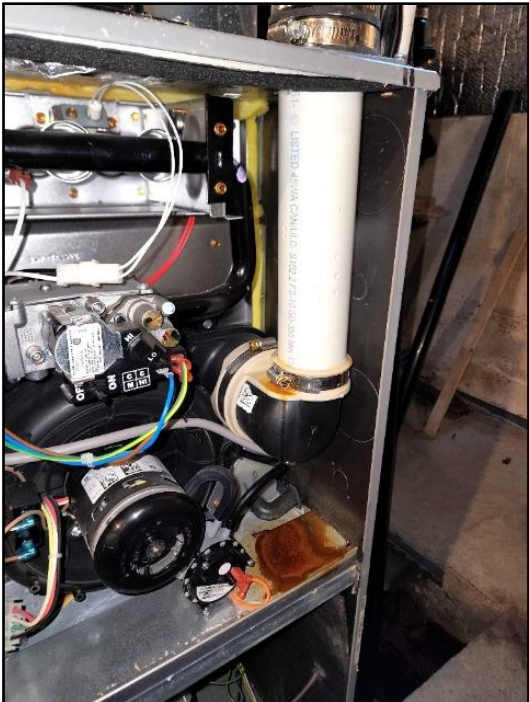
11. Condition: • Condensate problems/leak

Implication(s): Chance of water damage to contents, finishes and/or structure | Reduced system life expectancy

Location: Unit interior

22. Condensate problems/leak

Task: Repair

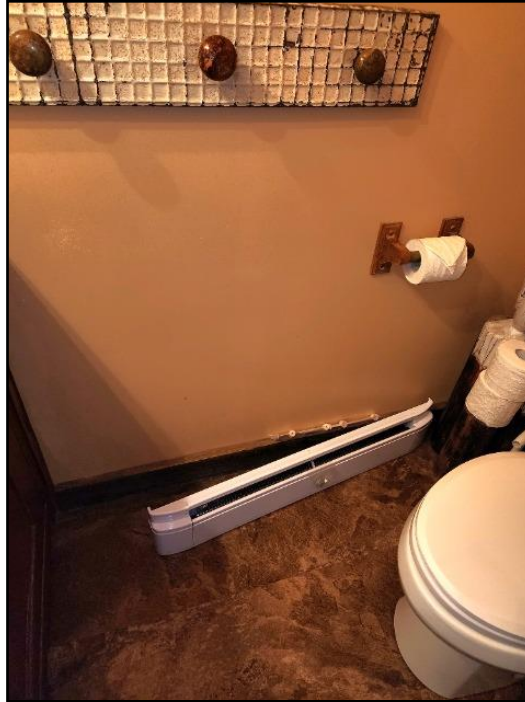
12. Condition: • Inoperative heaters

Implication(s): No heat for building

Location: First floor washroom

23. Inoperative heaters

Task: Provide

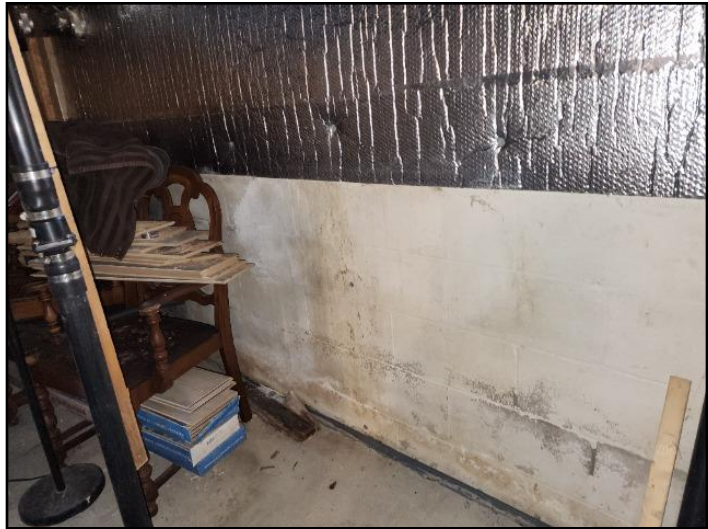
16. Condition: • Efflorescence

Implication(s): Chance of water damage to structure, finishes and contents

32. Efflorescence

Task: Monitor

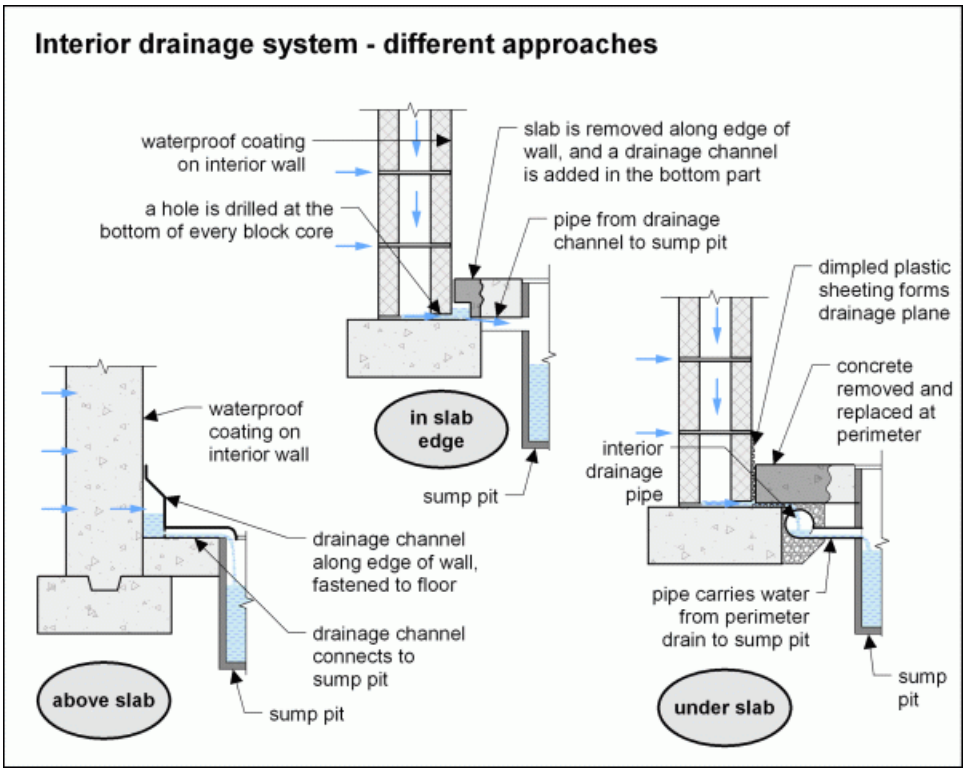
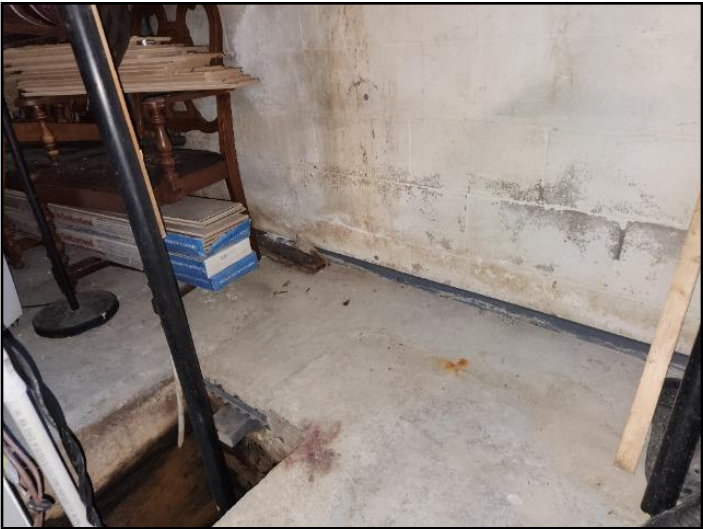
- 17. Condition:** • Drainage membrane & sump pump
- Implication(s):** Chance of water damage to structure, finishes and contents
- Location:** Rear elevation
- Task:** Monitor
- Time:** Ongoing

33. Drainage membrane & sump pump

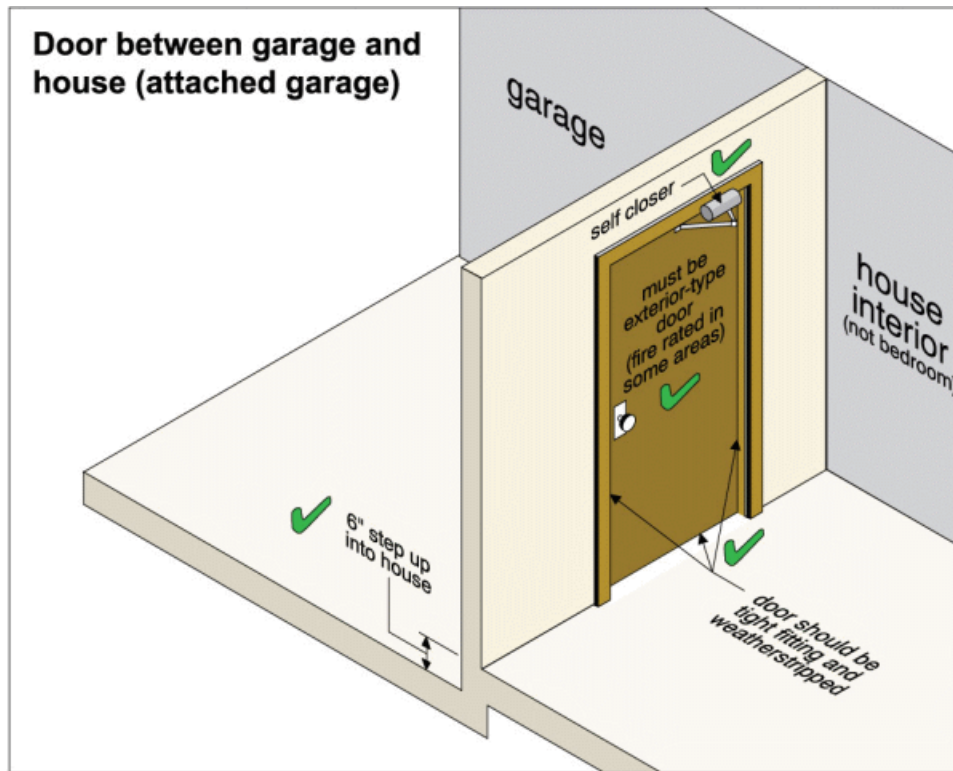
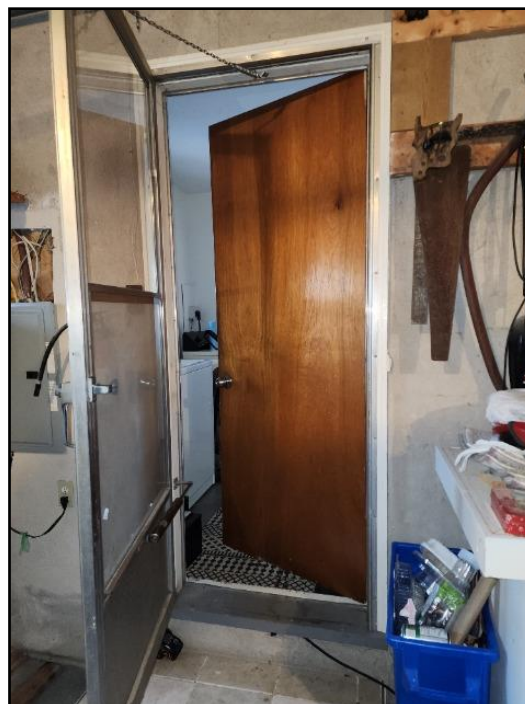
18. Condition: • Self closer missing, damaged or disconnected

Implication(s): Hazardous combustion products entering home

34. Self closer missing, damaged or disconnected
