# INSPECTION REPORT

For the Property at:  
**1307 MONAGHAN ROAD**  
PETERBOROUGH, ON K9J 5L9

Prepared for: TEAM VANRAHAN  
Inspection Date: Saturday, September 30, 2023  
Prepared by: David Sharman

RE: Report No. 4516  
1307 Monaghan Road  
Peterborough, ON  
K9J 5L9

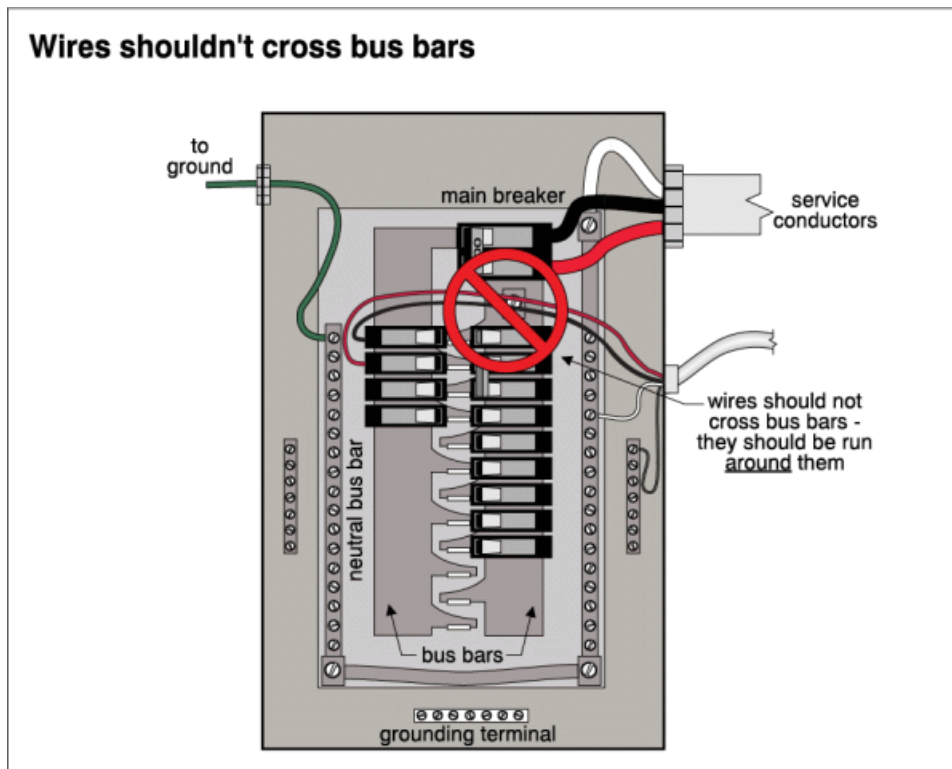
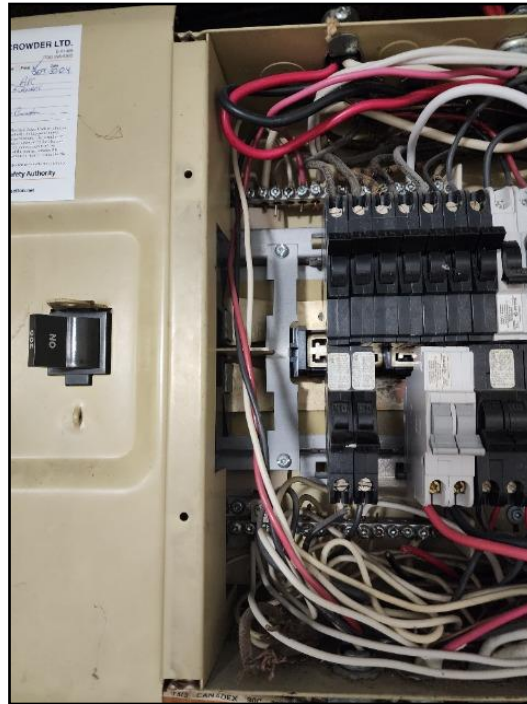
**5. Condition:** • Wire crossing bus connections

**Implication(s):** Electric shock | Fire hazard

5. Wire crossing bus connections

**Task:** Improve

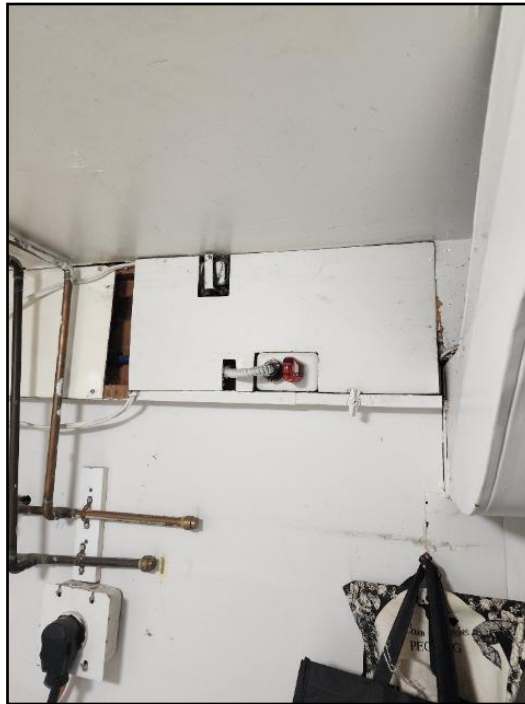
**6. Condition:** • Inoperative

**Implication(s):** Equipment inoperative

**Location:** Laundry area

6. Inoperative

**Task:** Repair or replace

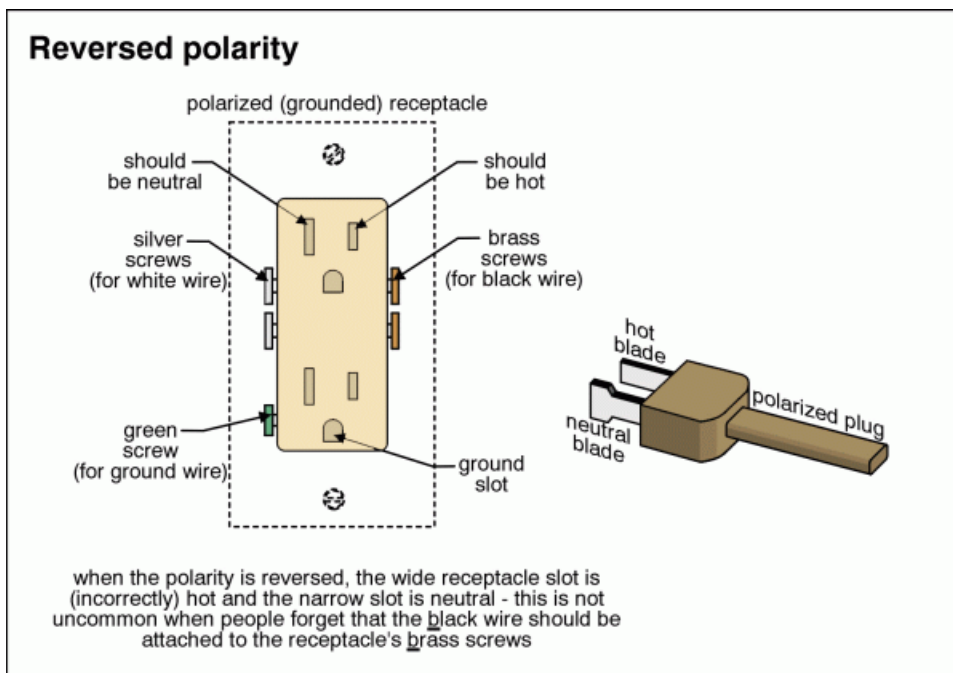
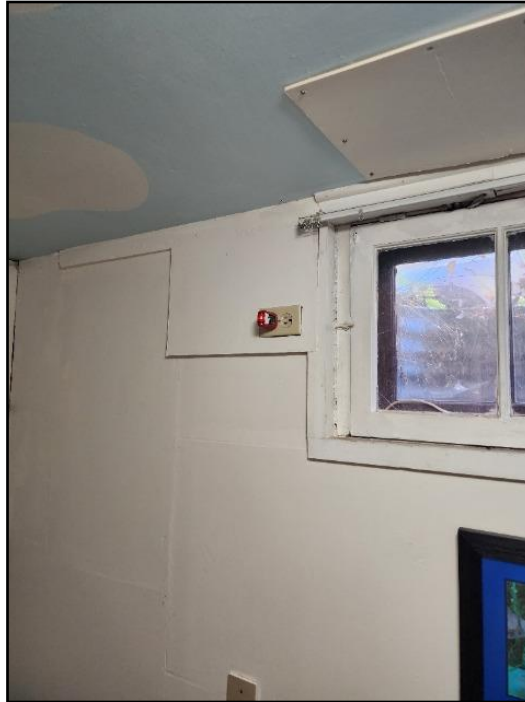
7. Condition: • Reversed polarity

Implication(s): Electric shock

Location: Basement

7. Reversed polarity

Task: Correct

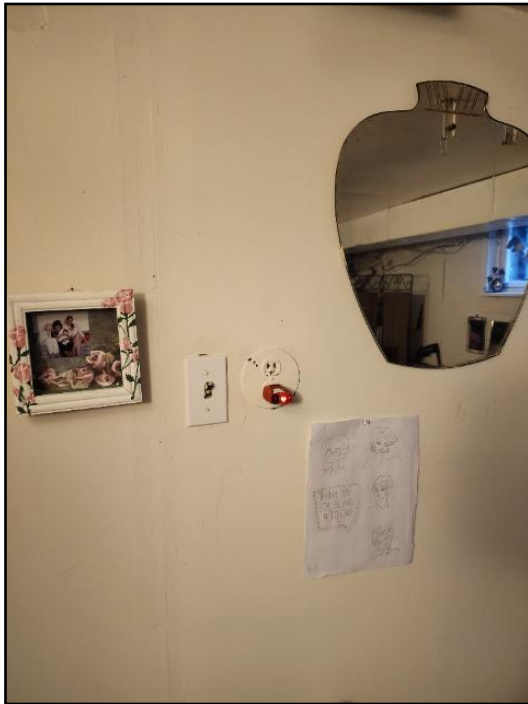
**8. Condition:** • Ungrounded

**Implication(s):** Electric shock

**Location:** Various locations

8. Ungrounded

**Task:** Upgrade

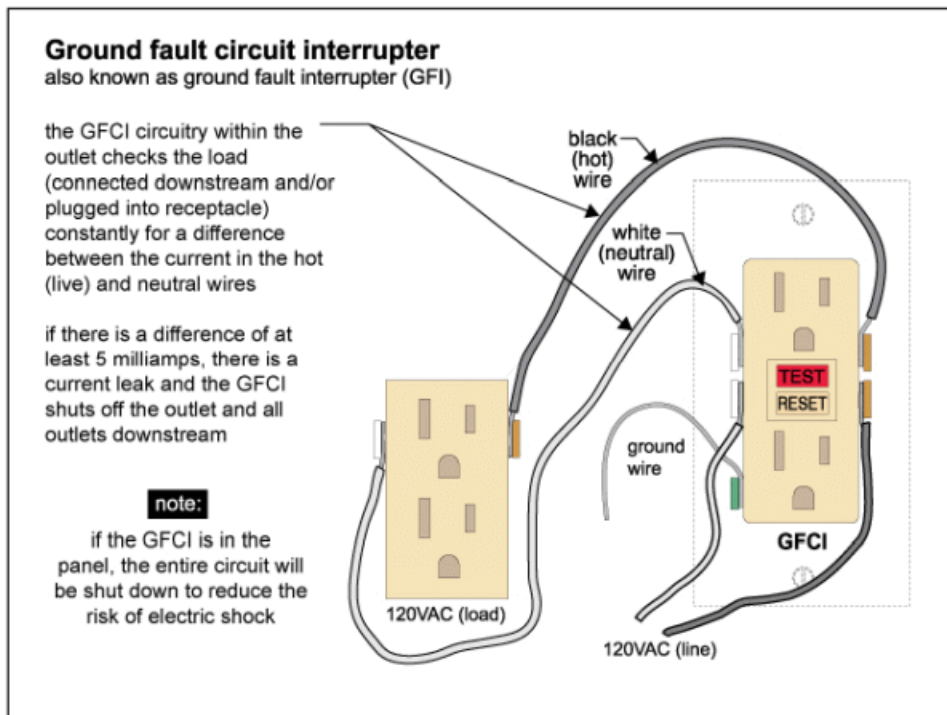
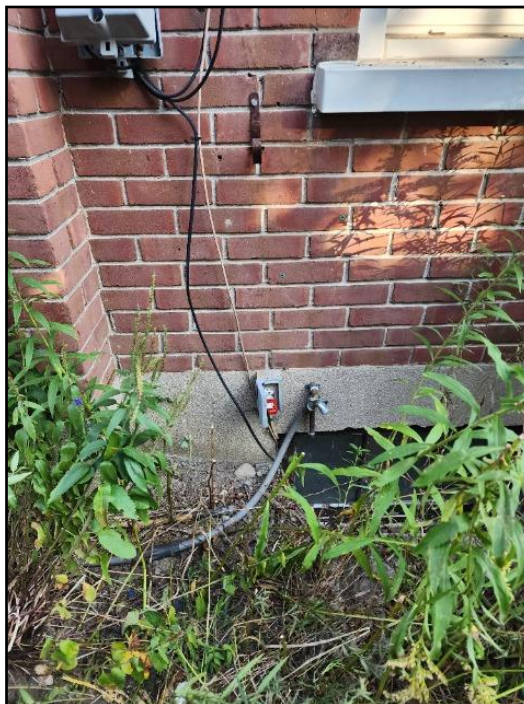
**9. Condition:** • No GFCI/GFI (Ground Fault Circuit Interrupter)

Although not a deficiency in a building of this age, safety may be improved by upgrading this receptacle

**Implication(s):** Electric shock

**Location:** Exterior wall

19. No GFCI/GFI (Ground Fault Circuit...)

**Task:** Upgrade

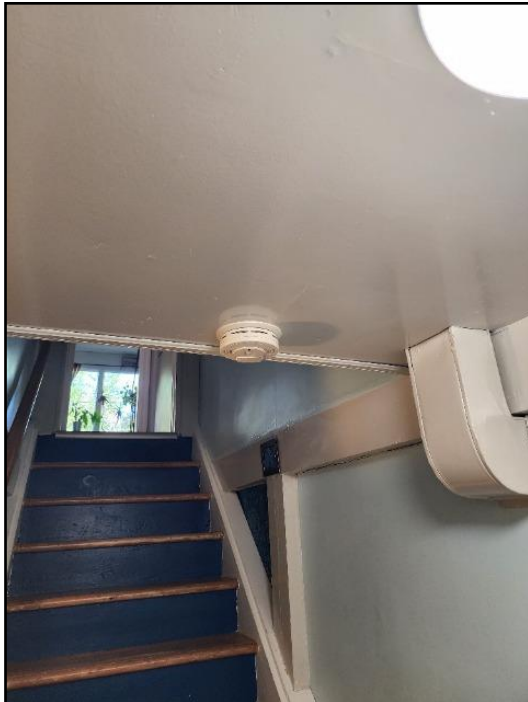
**10. Condition:** • More than 10 years old

**Implication(s):** Life safety hazard

20. *More than 10 years old*

**Task:** Replace

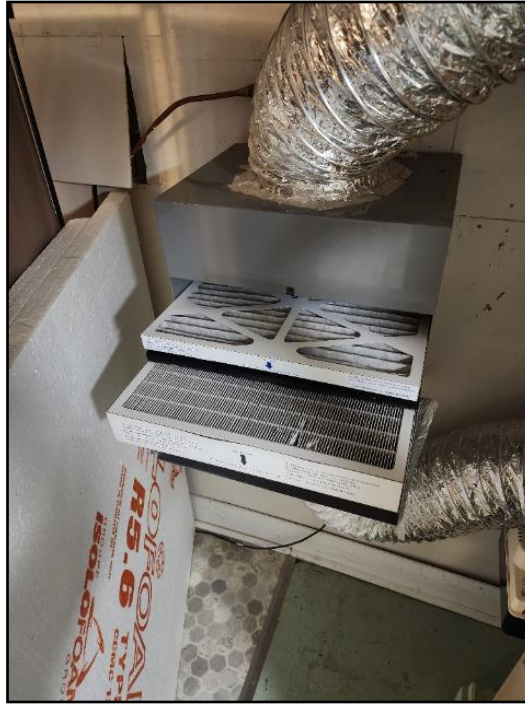
**12. Condition:** • Replace - regular maintenance

30. Replace - regular maintenance

**Task:** Replace

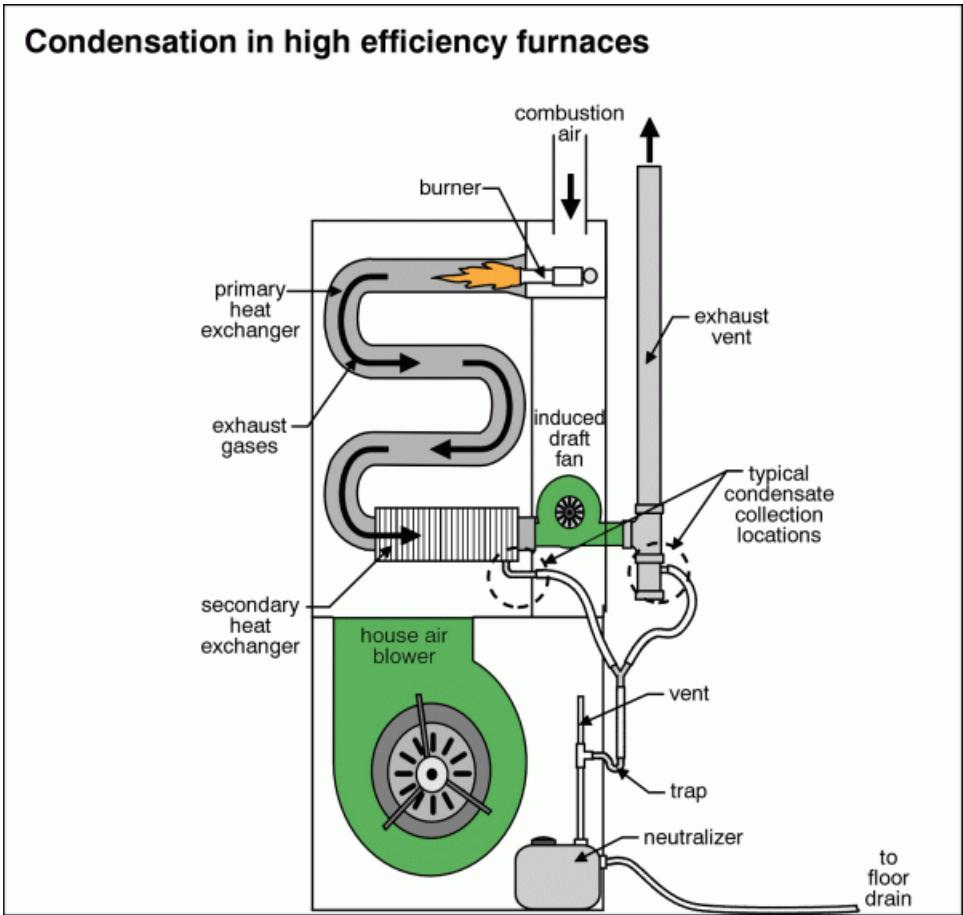
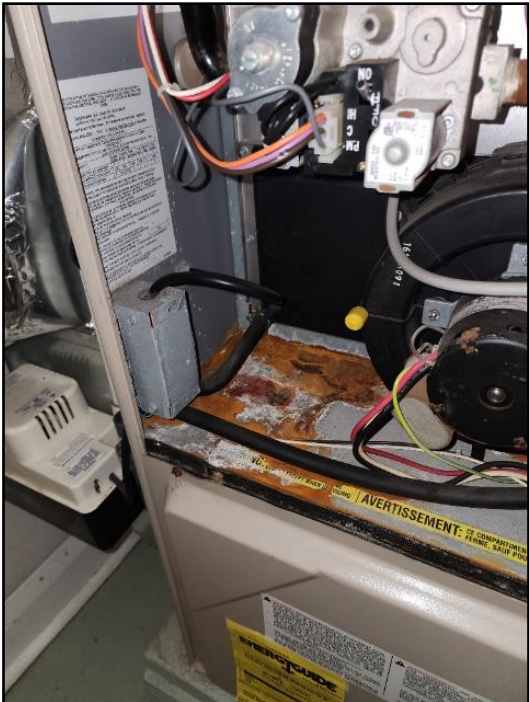
**13. Condition:** • Condensate problems/leak

**Implication(s):** Chance of water damage to contents, finishes and/or structure | Reduced system life expectancy

31. Condensate problems/leak

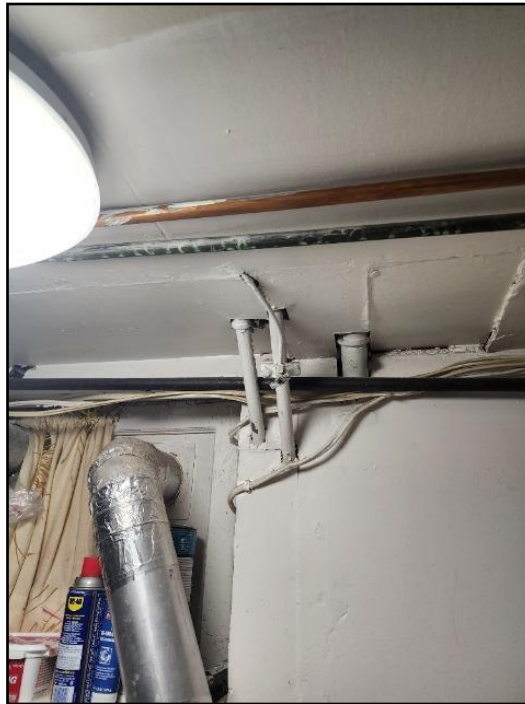
**16. Condition:** • Galvanized steel

39. Galvanized steel

**Task:** Monitor

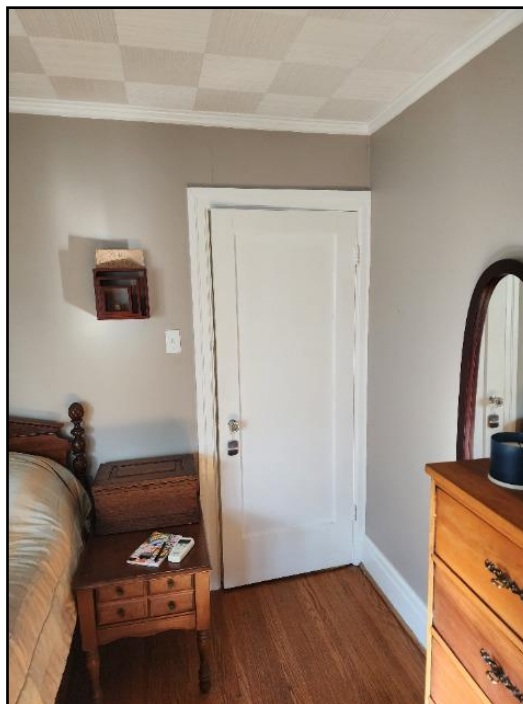
**19. Condition:** • Binds

40. Binds

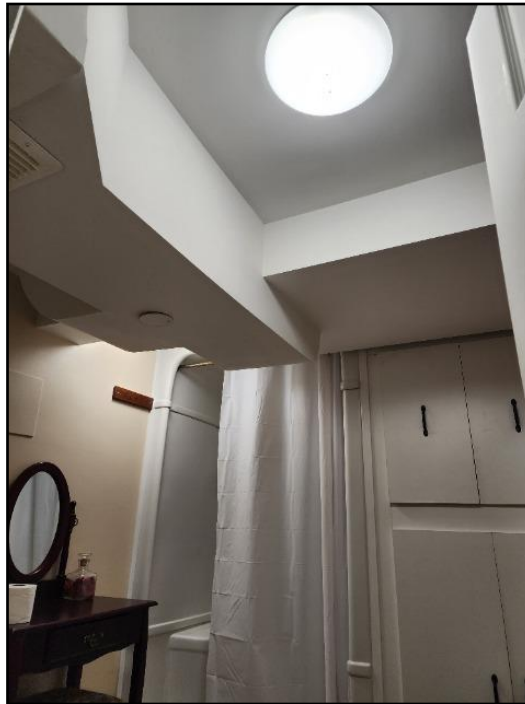
**20. Condition:** • Missing

**Implication(s):** Chance of condensation damage to finishes and/or structure

41. *Missing*
