HOME INSPECTION REI 7-6

20808 Silverbell Ln
Pflugerville, TX 78660

PROPERTY INSPECTION REPORT FORM

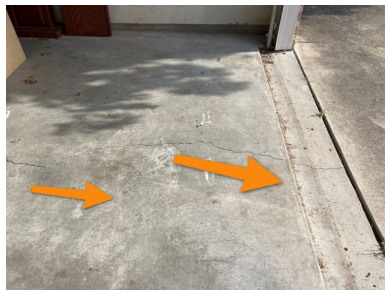
1: Foundation/flatwork Cracks - Minor

Minor cracking was noted at the foundation and surrounding flatwork. This is common as concrete ages and shrinkage surface cracks are normal. Recommend monitoring for more serious shifting/displacement (hydration cracks)

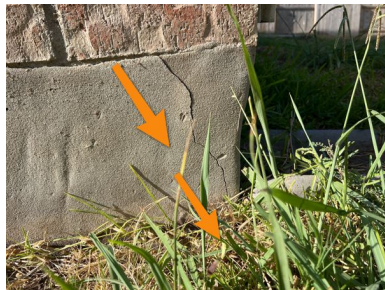
Right

2: Corner/Wedge Crack

Corner or Wedge crack - several corners of the foundation. This is a common condition to observe with slab on grade foundations. These cracks develop as a result of the expansion of the brick/stone veneer when it is warmed by the sun. – Recommend sealing with an approved material to prevent further / future moisture penetration. NOTE: Cracks that extend into the ground, should have the soil removed and be properly patched and sealed to prevent this from being a means for wood destroying insects to enter the house unnoticed.

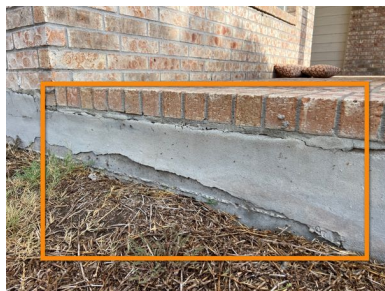
Left/other locations

3: Underpinning

Concrete mortar/underpinning chipped/cracked at various locations.

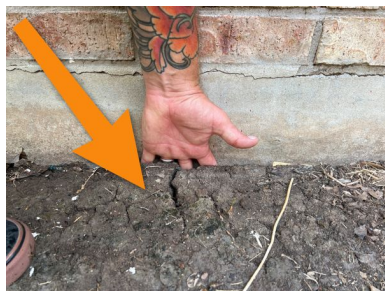
Right side

4: Soil Shrinkage

Soil shrinkage observed at slab perimeter in several locations. Recommend proper routine foundation watering to prevent foundation issues.

**Owners Notes:
Watering and condition improving.**

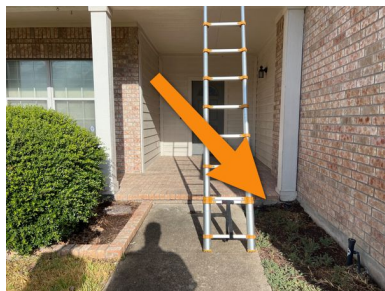
Elevated soil/front entry

Elevated soil or flower beds observed at the foundation/slab perimeter. Soil above the slab line is conducive for wood destroying insect activity and may allow for moisture penetration at the walls. Top soil and plant bedding should be at least 4" below brick line or bottom of siding & sloped away from the foundation.

Owners Notes: Soil has been pulled back.

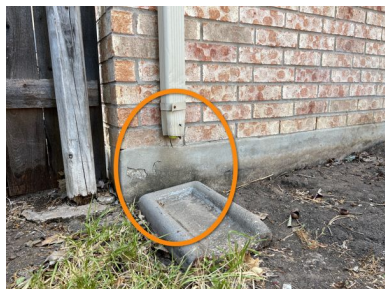
Rear Right

2: Elbow is missing

The elbow is missing from one or more gutter downspouts. An elbow and/or extension should be installed to help divert drainage away from the foundation.

Owners Notes: Replaced

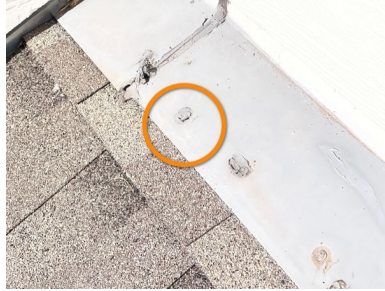
Flashing/Several Locations

Nail/screw heads are exposed and missing roofing sealant. – Make sure flashing at various plumbing vent stacks, exhaust vents, Wall and or chimney flashing and roofing fasteners on the ridge caps are sealed. Roofing sealant can protect against moisture intrusion. Water running down the roof can seep in around the nails/screws into the roof decking, attic and or interior space causing damage. NOTE: Do not use a (Silicon) based caulk. Use only a roofing sealant/mastic.

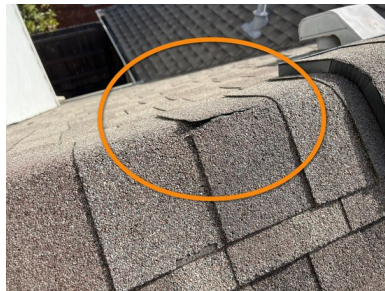
Above garage

2: Torn/Missing shingles

Torn/damaged/missing shingle/s observed at time of inspection. Repair is advised.

Owners Notes: Roofing sealant applied.

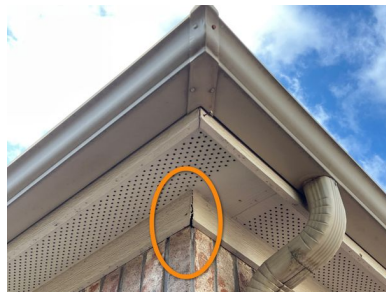
Frieze/ Rear Right

1: Open/exposed fascia board corners

Corner of Fascia boards are exposed - recommend sealing/caulking - various locations

Owners Notes: Sealed and painted

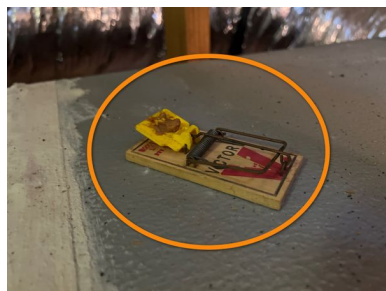
Baited traps/attic

Rodent tunnels and/or droppings were observed in the attic at one or more locations. Recommend getting on routine pest control

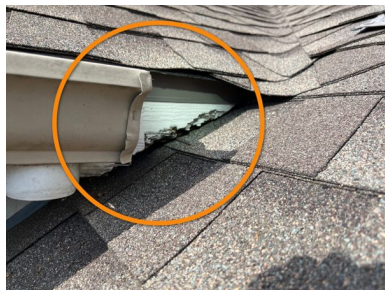
Front Right

3: Deteriorated Fascia/Soffits

Fascia/soffit boards are damaged/deteriorated at various locations. Recommend sealing/caulking and/or replacing.

Owners Notes: sealed and painted.

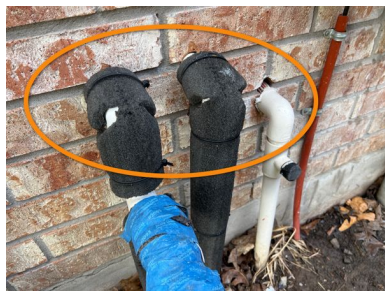
Right/several other locations

Routine Maintenance - The deteriorated caulk joints between the exterior cladding/veneer and ALL wall penetrations need to be properly sealed such as utility connections, downspouts, hose bibs, lighting fixtures, receptacles, etc with an exterior grade elastomeric sealant (caulking) to prevent wind driven rain/moisture from entering behind the exterior veneers, doors, windows and other wall penetrations.

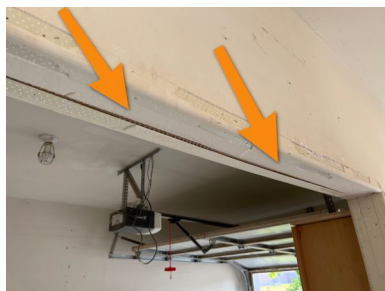
Garage/several locations

2: Sheetrock Common Cracks

Wallboard/sheetrock has cracks at seam(s) in various locations. In most cases this occurs from normal settling/shifting of the structure and/or thermal expansion. Caulk and paint where needed (Homeowner Maintenance items)

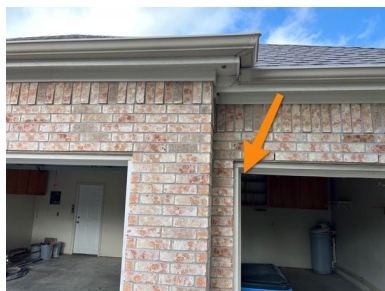
Front

3: Exterior Walls Common Mortar/cracks

Brick/stone mortar is cracked at various locations. In most cases this occurs due to normal settling/shifting of the structure and/or thermal expansion. Point up mortar where needed to prevent moisture penetration.

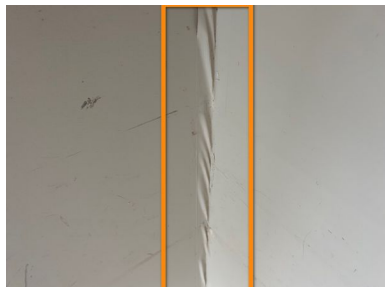
Garage

One or more pulled tape joints were observed on the interior walls. This is commonly due to structural movement as the home settles. Touch up where needed.

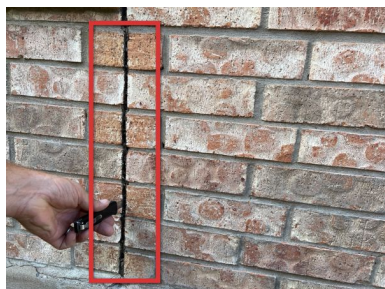
Right Exterior

5: Open Expansion Joints

Expansion joints have cracks and voids in caulk/sealant. Recommend caulking and sealing to prevent moisture and/or pest intrusion.

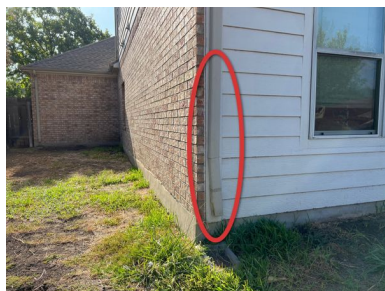
Rear Right trim

6: Press wood siding deterioration

Exterior press wood siding and trim boards are deteriorated at one or more locations. Exterior siding and trim that has deteriorated from water penetration or weathering should be repaired or replaced as necessary.

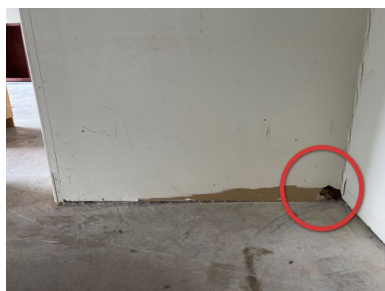
Garage

7: Minor damage and/or holes observed in drywall/sheetrock

Minor damage and/or holes observed in drywall/sheetrock at one or more locations. Repair as desired.

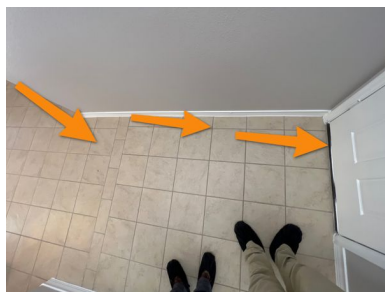
Front entry

1: Grout separations/Loose tile

Separated grout and/or loose tile observed at one or more locations. Repair as needed.

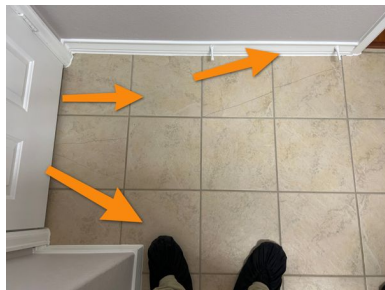
Laundry

2: Cracked/chipped tile

There are one or more cracked/chipped floor tiles. This can result from cracks in the foundation slab, improper tile installation, or physical damage exerted on the tiles. Replace as needed.

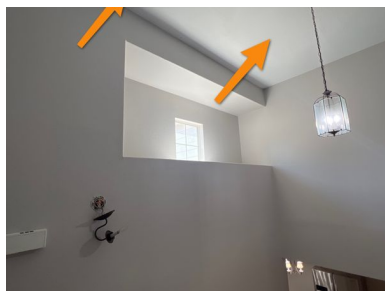
Above Staircase Landing

There are nails backing out of the ceilings at one or more locations. This is a common occurrence usually related to expansion and contraction of the building materials.

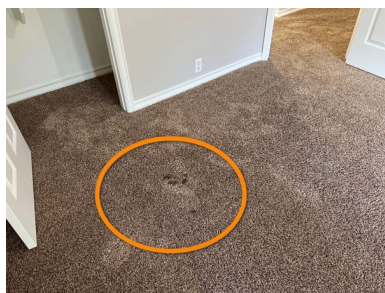
Front Right Bedroom

4: Carpet damaged/loose/stained

The carpet floor covering appears to be noticeably worn, stained and/or loose in one or more areas

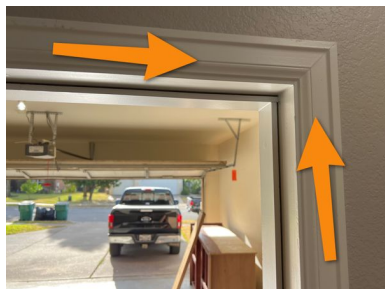
Garage entry

1: Damaged/Missing Weather Stripping

The weatherstripping on the door bottom or sides appeared to be either missing, damaged and in need of replacement

Owners Notes: weatherstripping installed

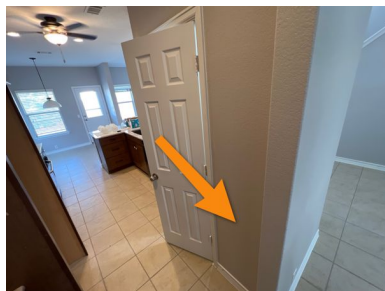
Pantry

2: Missing door stops

Door stop is missing or non-functional at one or more locations. This prevents sheetrock and possible door damage when properly installed.

Owners Notes: new doorstops installed

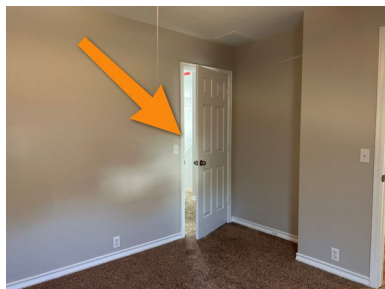
Rear Right Bedroom

Some doors were observed to be sticking, not closing properly, out-of-level (ghosting), or missing and/or non-functional hardware.

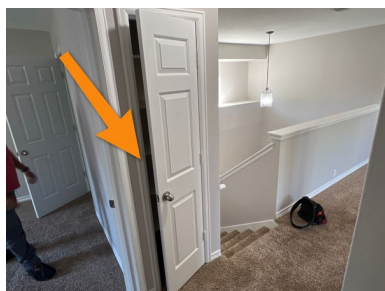
2nd Floor Linen

One or more doors do not latch when closed and minor adjustment is needed.

Owners Notes: corrected

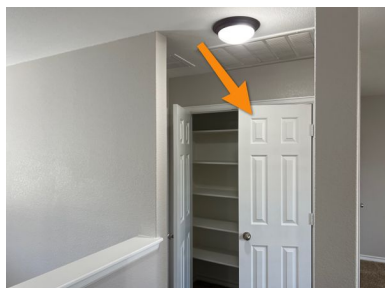
2nd Floor Living Room

Ball latch out of adjustment/missing and does not latch/close properly when the door is shut.

Owners Notes: corrected

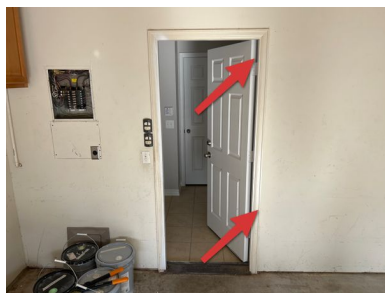
Garage entry

Self closing hinges at garage door have not been properly set/installed - These are recommended anytime garages have gas fired appliances or store any type of harmful liquids that could potentially spill and cause inhalation hazards. Cars also pose a threat due to the emissions of CO2 they emit through their engine exhaust.

OWNERS NOTE: Spring is engaged.

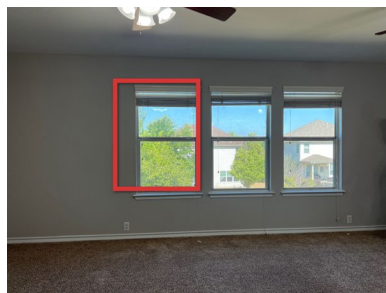
2nd Floor Living Room

One or more of the thermal pane windows were observed to have lost their seals or have metallic deglazing. This has resulted in condensation or a fog like film to develop between the panes of glass. The thermal pane windows are no longer functional as designed when the seal is lost and replacement may be necessary. NOTE: This does not materially affect the performance of the windows.

Owners Notes: not observed.

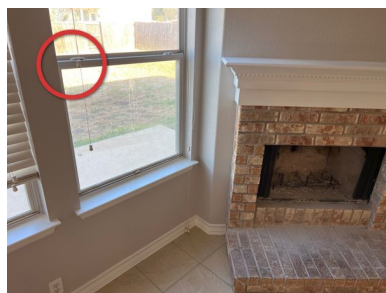
Living Room

3: Broken/Latch

Window latches and/or locks were either damaged, inoperable or missing at one or more locations.

Owners Notes: latch replaced

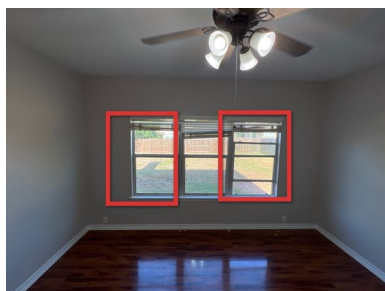
Master bedroom

4: Window Spring damaged

One or more windows had broken and/or inoperable sash springs (balances).

Owners Notes: sash repaired.

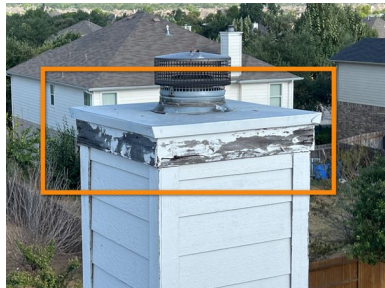
Damaged trim

1: Damaged Trim

Chimney trim boards are exposed to the weather due to the paint deteriorating and trim joints not caulked. Recommend repainting/caulk/repair.

Owners Notes: painted

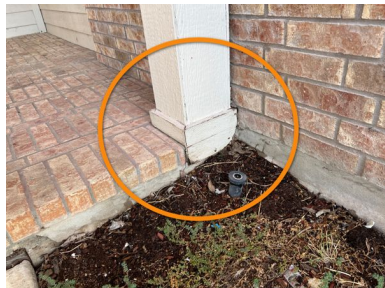
Wood rot/front column

Column has moisture damaged wood at the bottom. Caulk/paint to protect from outside elements.

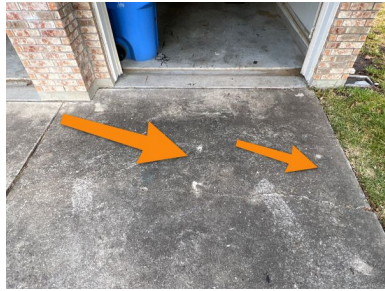
Driveway

1: Cracked/damaged driveway/flatwork sections

Driveway/sidewalk is cracked and damaged with uneven sections - Possible trip hazard caution

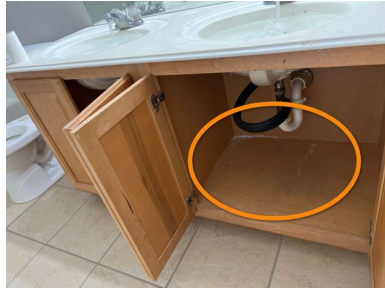
2nd Floor Bathroom/dry

2: Moisture in Cabinets

Cabinets are damaged inside/outside due to moisture at one or more locations - Dry at time of inspection

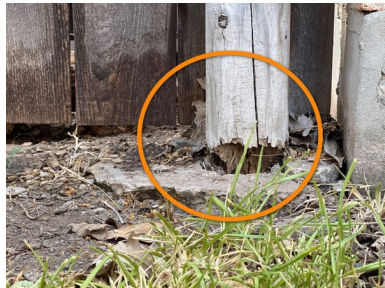
Rotted post/right side, other locations

3: Damaged fence posts/pickets

One or more wood posts/pickets were missing and/or damaged from either weed eaters, wood rot and/or wood destroying insects.

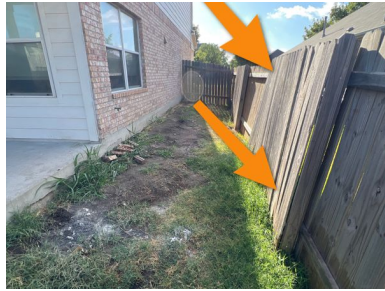
Left/other locations

4: General repairs/maintenance needed at the fence and/ or hardware, multiple locations

Wood rot/damaged and leaning fence sections observed

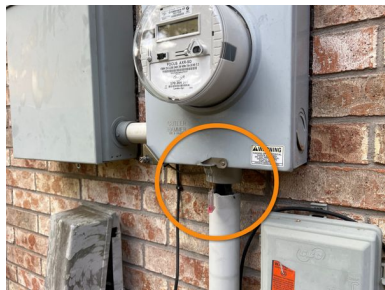
Main Panel

The service entrance conductor conduit is separated from the meter box. The conduit should be secured to the meter box to ensure the conductors are properly protected.

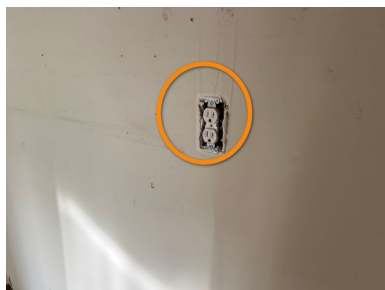
Garage

1: Damaged/missing cover plates

Cover plates for outlets and light switches are damaged/loose and/or missing. Replace as needed.

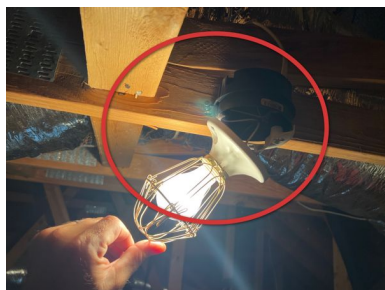
Attic light

One or more light fixtures were damaged at time of inspection.

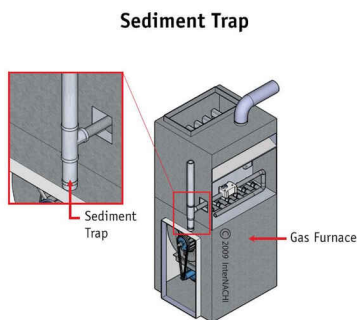
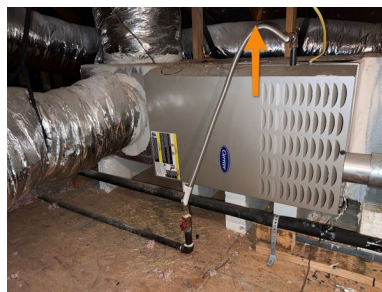
The gas supply line was not equipped with a required sediment trap just before the appliance connector. This condition does not meet current mechanical standards and should be corrected.

Gas line/missing sediment trap

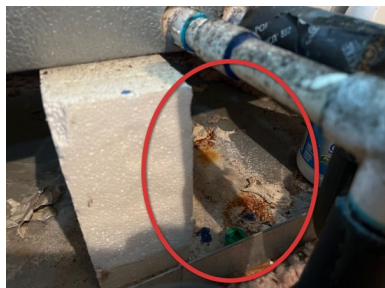
Rust in drain pan

There is rust and/or water in the evaporator coil emergency condensate drain pan. This may indicate that the primary drain is clogged or that the system is under performing. Further evaluation and/or repair by a licensed HVAC technician is advised.

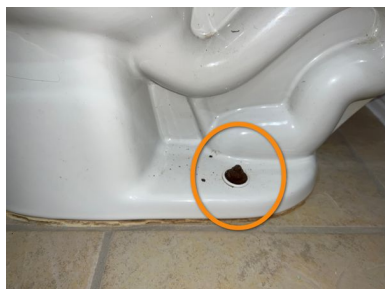
2nd Floor Bathroom/other locations

One or more toilet tank bolts are rusted. The bolts should be monitored for leaks and replaced as required.

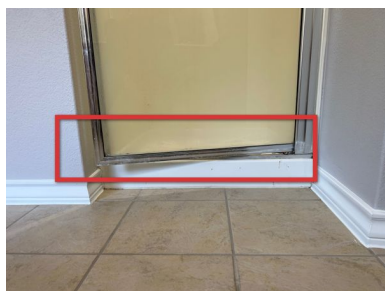
Master shower

Shower door seal/sweep is damaged/missing/ corrosion present at one or more locations.

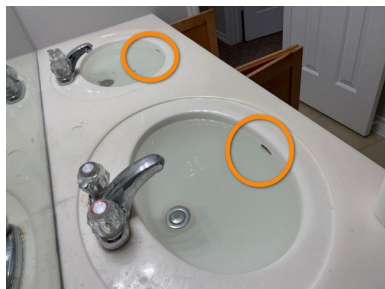
2nd Floor Bathroom

When tested overflows did not drain properly - recommend further evaluation and or cleaning

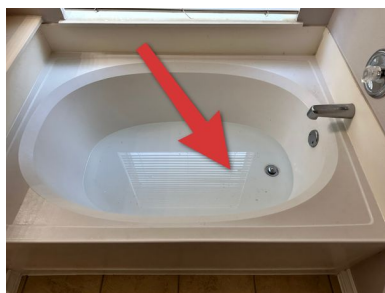
Master tub

One or more sinks/tubs/showers drained slowly when tested. This may indicate a blockage or a more extensive problem. Further evaluation and/or repair by a licensed plumber is advised.

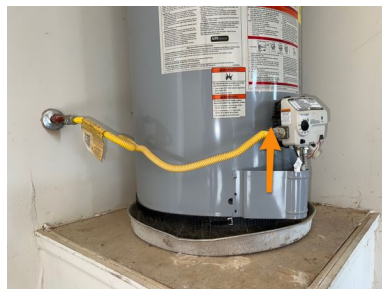
The sediment trap in the gas supply pipe to the water heater is not installed. Most manufacturers of gas-fired equipment such as a gas-fired heating system require a sediment trap (or dirt leg). The sediment trap protects the appliance from debris in the gas - such as dirt, soil, pipe chips, pipe joint tapes and compounds, and construction site debris that may enter the pipe during installation or repair. Sediment traps are designed to cause the gas flow to change direction 90 degrees at the sediment collection point. The change in direction causes the contaminants to drop out of the gas flow. The sediment trap utilizes a tee fitting. The nipple and cap must not be located in the branch opening of a tee fitting, because this does not allow the change in direction. Contaminants can pass right through the fitting and not drop out.

Missing sediment trap

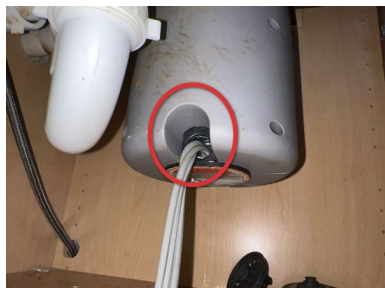
The conductors feeding the food waste disposer are not properly protected from the food waste disposer housing. A bushing with a clamp should be installed to help prevent the housing cutting into the conductor casing.

Missing connector

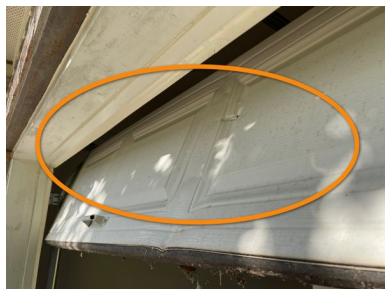
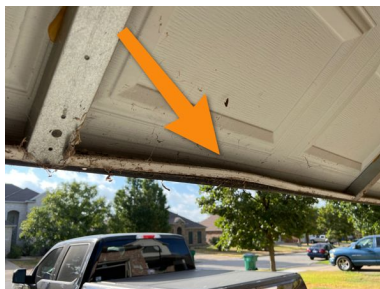
Damaged panels/both doors

Dents were observed in the overhead garage door at time of inspection. Large dents may affect operation of the garage door opener or increase stress of the associated hardware.

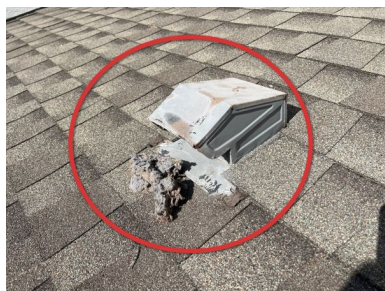
Rooftop/front

Lint accumulation was observed in the dryer vent cover. This may indicate the vent and/or cover need to be cleaned. Lint accumulations can obstruct air flow and reduce dryer performance. Additionally, dryer vent obstructions are a fire hazard. It is recommend the vent be cleaned to ensure proper performance.
