INSPECTION REPORT

For the Property at:
147 GREENHILL DRIVE
PETERBOROUGH, ON K9J 6E2

Prepared for: TEAM VANRAHAN
Inspection Date: Monday, July 15, 2024
Prepared by: David Sharman

RE: Report No. 4893
147 Greenhill Drive
Peterborough, ON
K9J 6E2

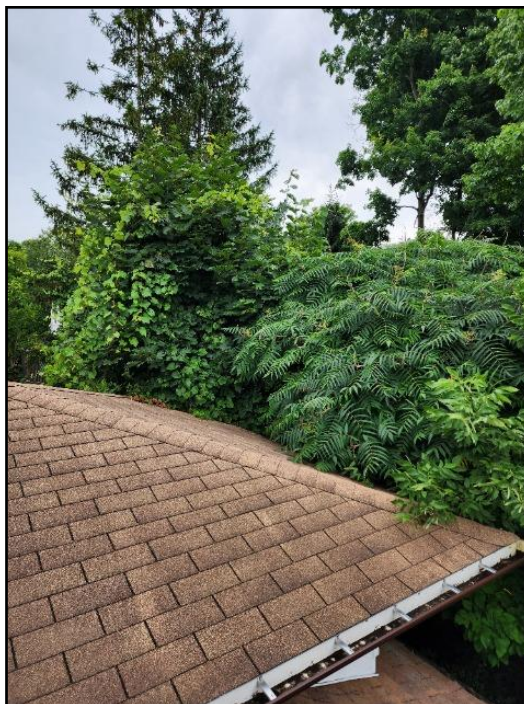
1. Condition: • Tree branches touching roof

Implication(s): Shortened life expectancy of material

Location: Rear right corner

4. Tree branches touching roof

Task: Improve

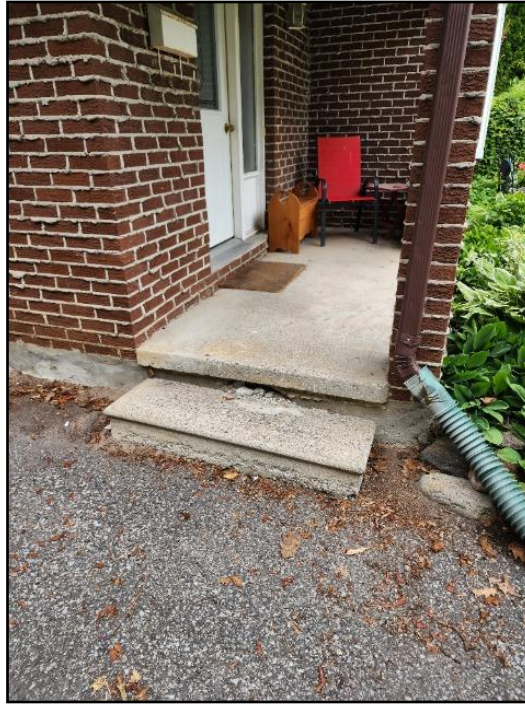
2. Condition: • Masonry or concrete spalling

Implication(s): Chance of damage to structure | Material deterioration | Trip or fall hazard

Location: Porch

5. *Concrete spalling*

Task: Repair

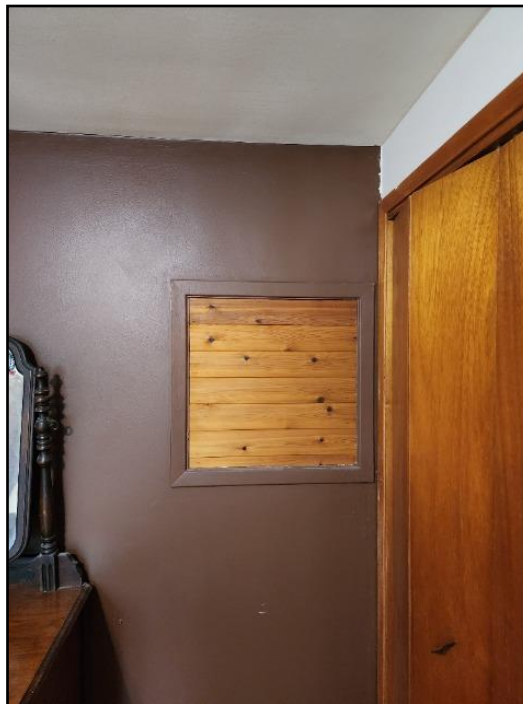
Lower attic

6. No access

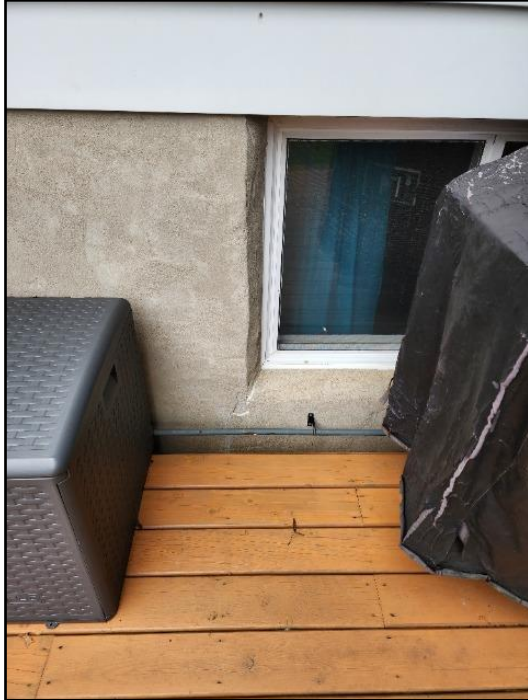
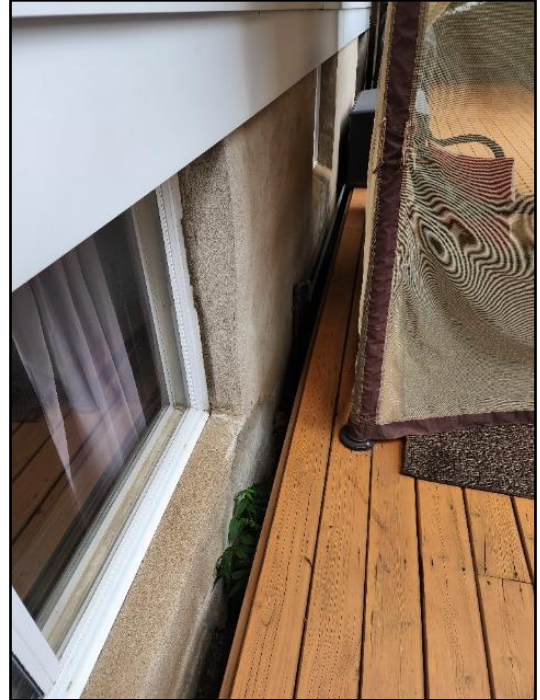
3. Condition: • Prior repairs

Implication(s): Weakened structure

Location: Rear elevation

7. Prior repairs

Task: Monitor

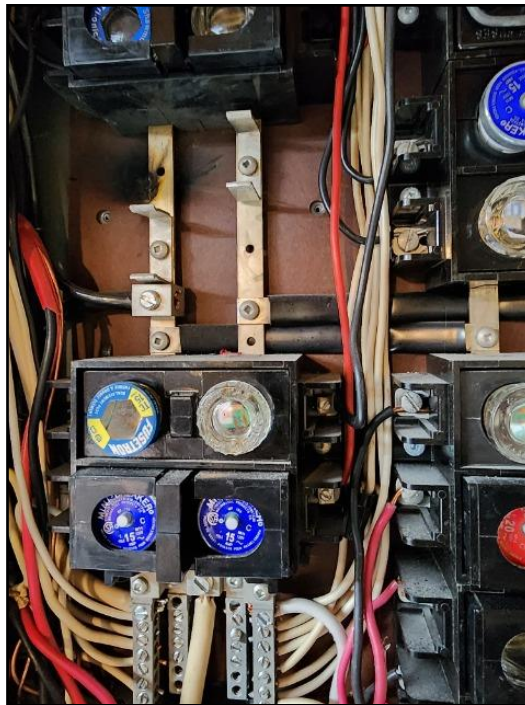
- 5. Condition:** • Fuses too big
- 30 Amp fuses on a 12 gauge branch circuit
- Implication(s):** Equipment overheating | Fire hazard
- Location:** Distribution panel
- Task:** Correct

16. Fuses too big

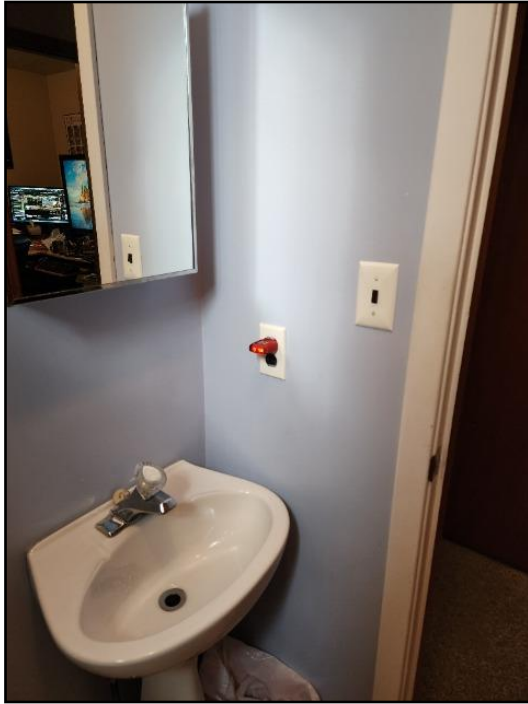
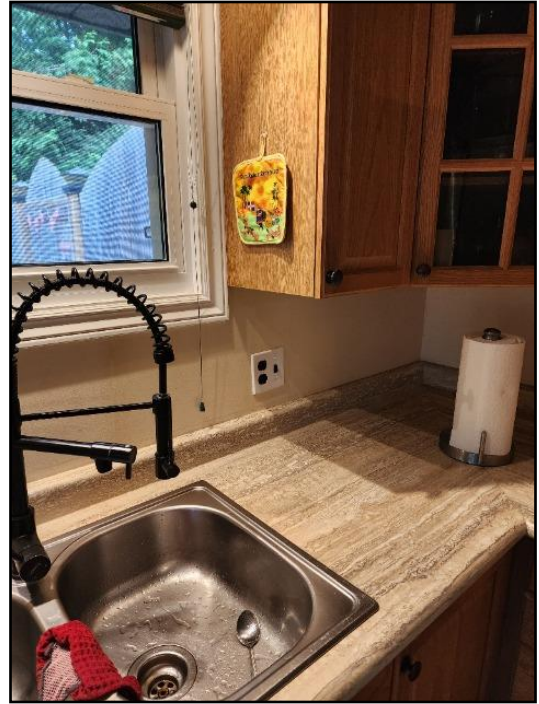
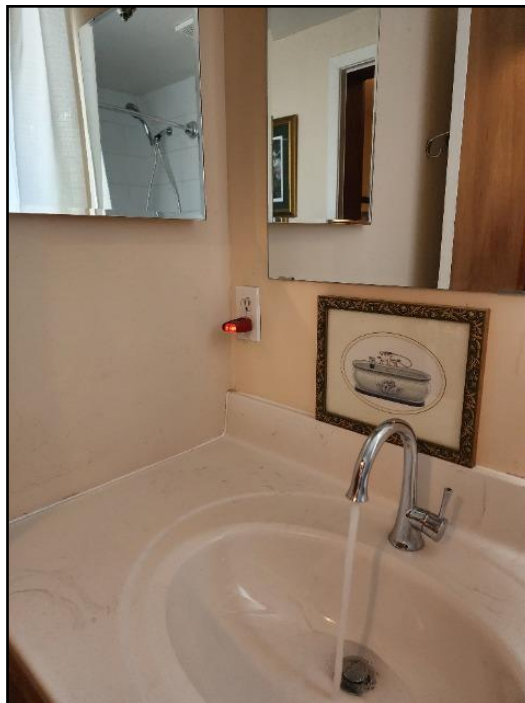
6. **Condition:** • No GFCI/GFI (Ground Fault Circuit Interrupter)

Although not a deficiency in a home of this age safety may be improved by upgrading these receptacles.

Implication(s): Electric shock

17. No GFCI/GFI (Ground Fault Circuit...

Task: Upgrade

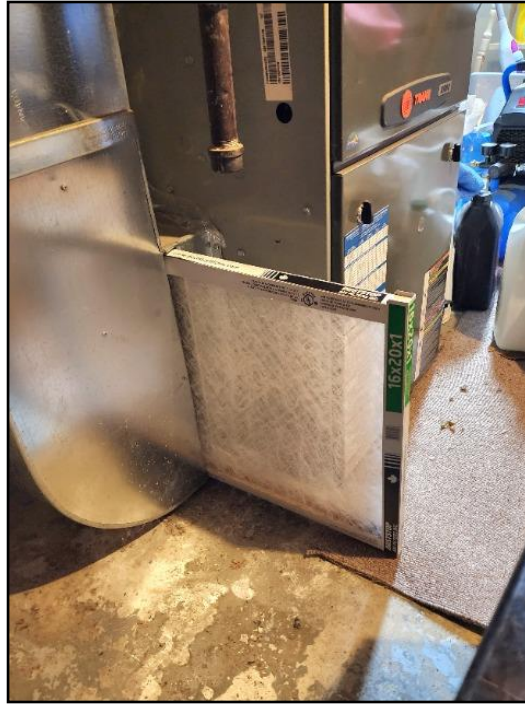
10. Condition: • Replace - regular maintenance

25. Replace - regular maintenance

Task: Replace - regular maintenance

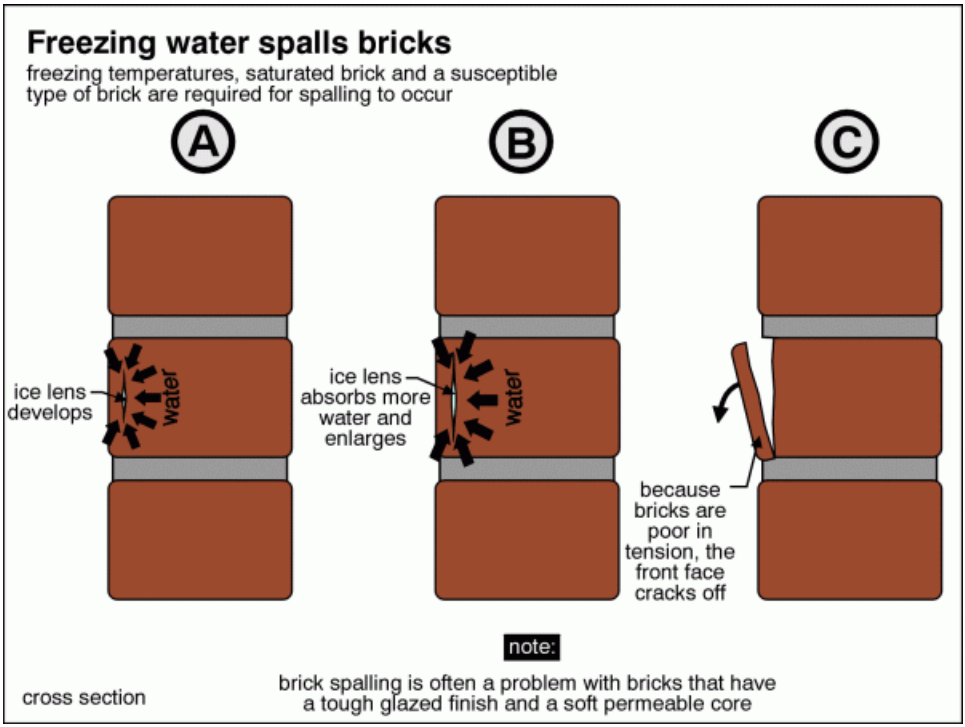
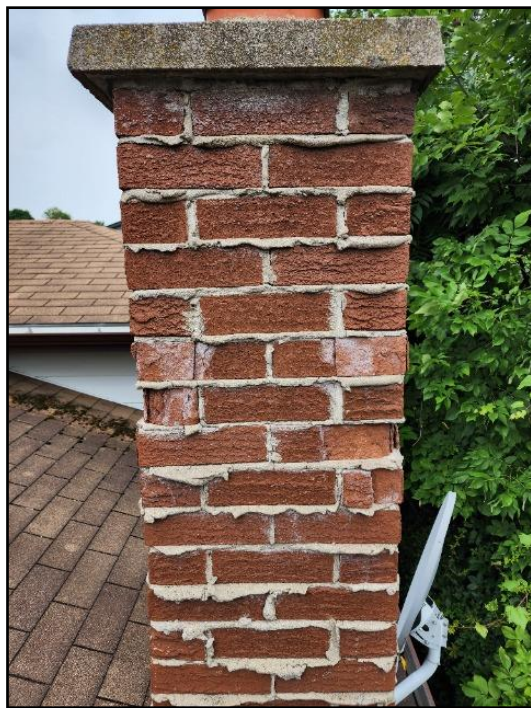
11. Condition: • Spalling

Implication(s): Material deterioration

26. Spalling

Task: Repair

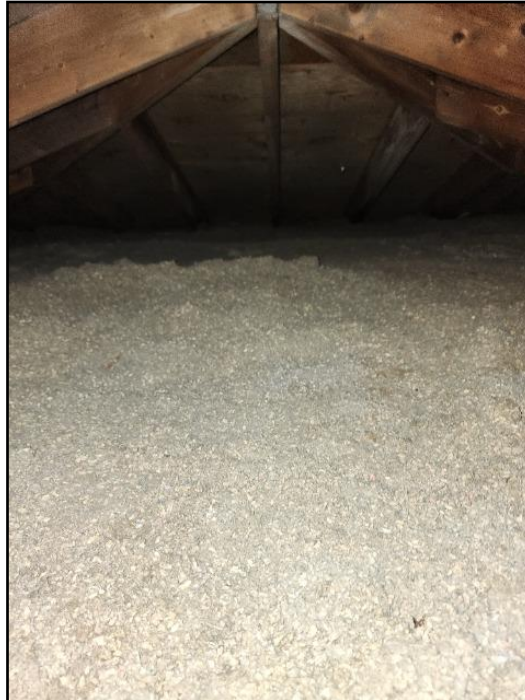
28. *Amount less than current standards*

13. Condition: • Amount less than current standards

Although being below current standards is not a deficiency, the home may benefit from an increased level of insulation.

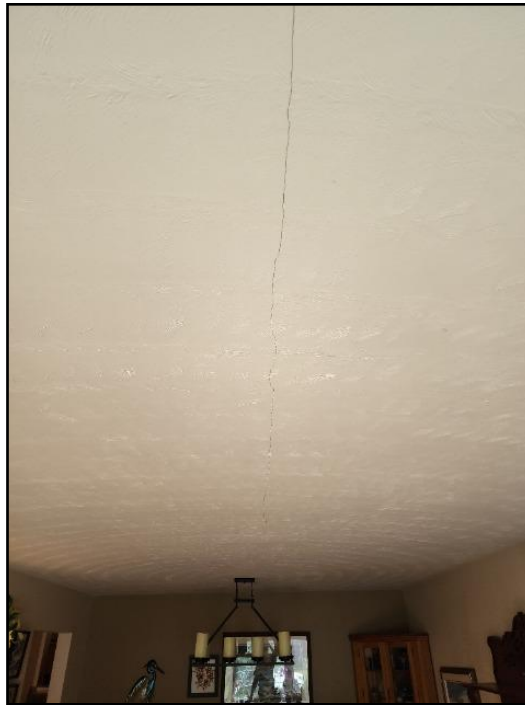
15. Condition: • Minor cracking

Implication(s): No implications exist for this condition

35. *Minor cracking*

Task: Repair

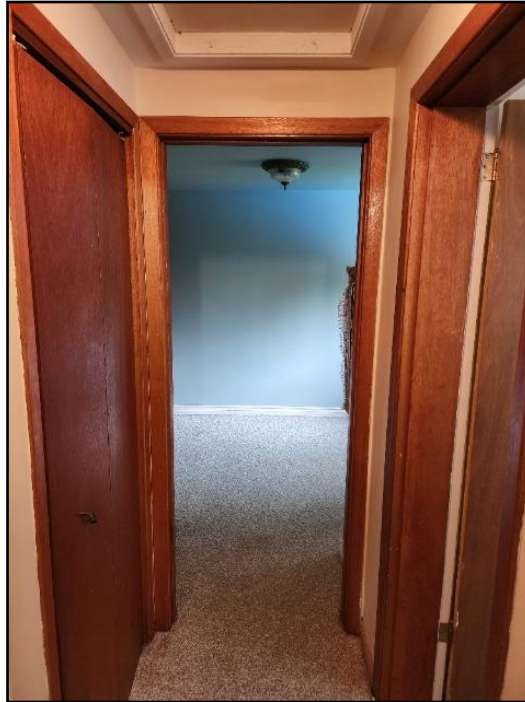
17. Condition: • Missing

Implication(s): No implications exist for this condition

36. Missing

Task: Replace

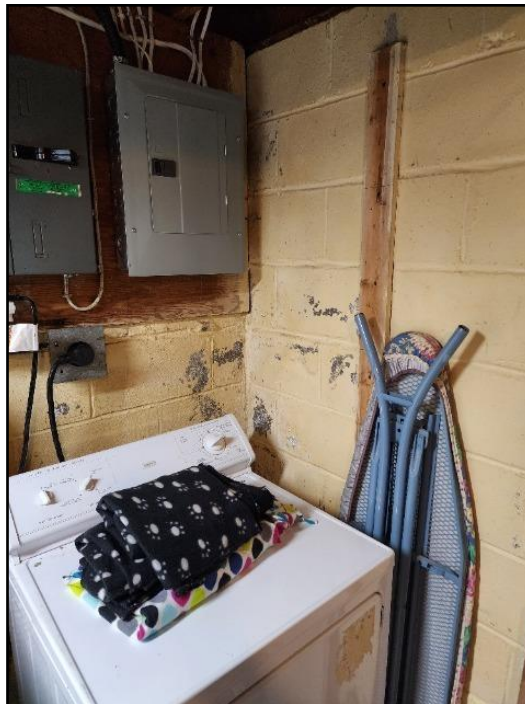
18. Condition: • Efflorescence

Implication(s): Chance of water damage to structure, finishes and contents

37. Efflorescence

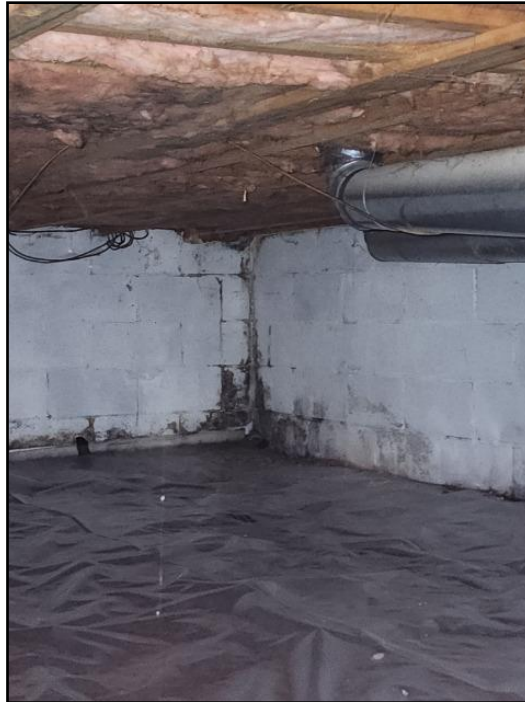
19. Condition: • Mildew

Implication(s): Chance of water damage to structure, finishes and contents | Contaminants may enter building air

38. Mildew
