Your Inspection Report

281 A Glory Road
Bancroft, ON K0L 1C0

INSPECTION DATE:
Wednesday, June 18, 2025

RE: Report No. 2340
281 A Glory Road
Bancroft, ON
K0L 1C0

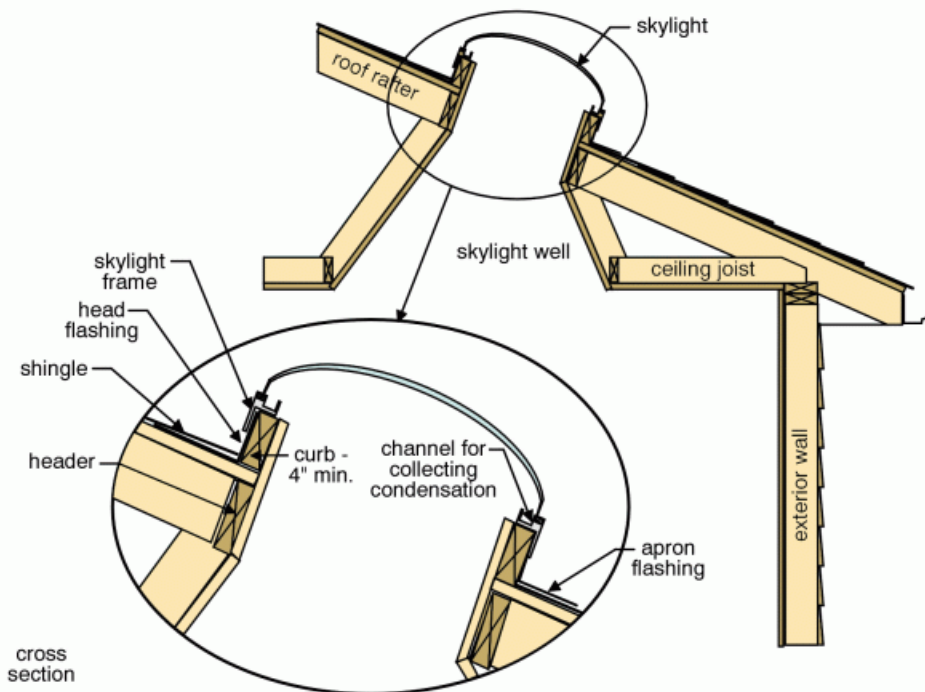
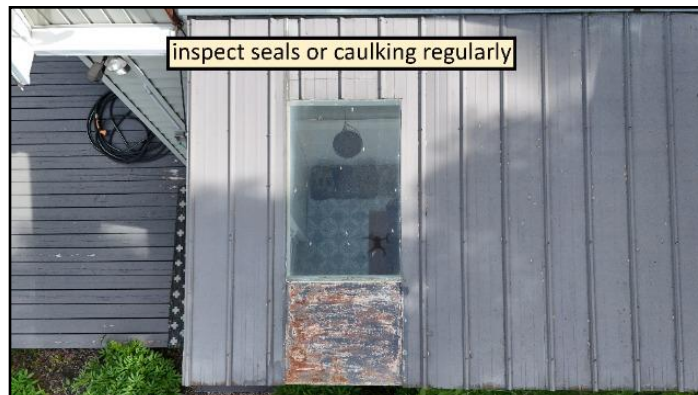
2. **Condition:** • [Curb - low, missing](#)

This skylight or roof window should be checked regularly and re-caulked as required.

Implication(s): Chance of water damage to structure, finishes and contents

Location: Front Roof

17. Curb - low, missing

Task: Inspect annually

Time: Regular maintenance

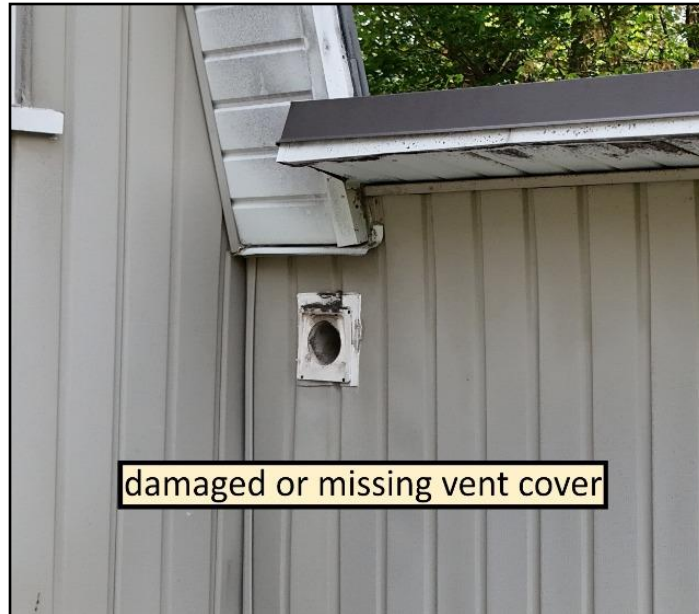
3. Condition: • Vent cover missing or damaged.

Location: Front Second Floor Exterior Wall

38. Vent cover missing or damaged.

Task: Replace

Time: Immediate

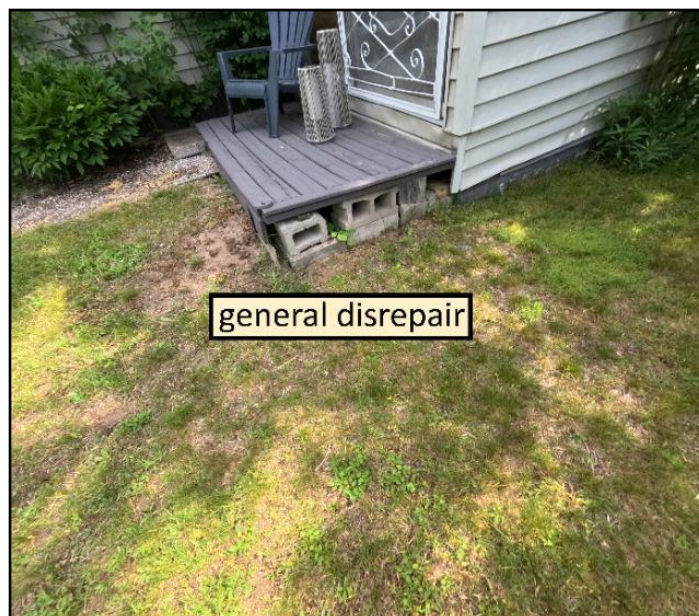
4. **Condition:** • Disrepair

Implication(s): Weakened structure

Location: Front Porch

39. Disrepair

Task: Repair or replace

Time: Less than 1 year

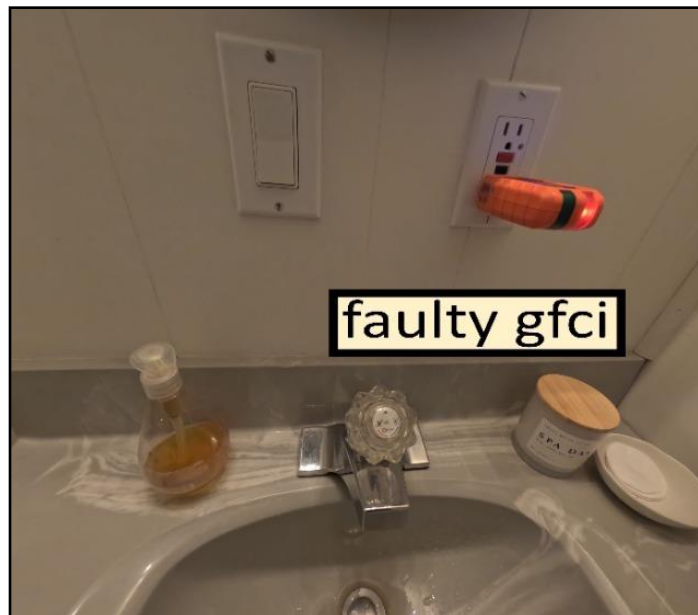
6. Condition: • [Test faulty on GFCI/GFI \(Ground Fault Circuit Interrupter\)](#)

Implication(s): Electric shock

Location: First Floor Bathroom

50. Test faulty on GFCI/GFI (Ground Fault...

Task: Replace

Time: Immediate

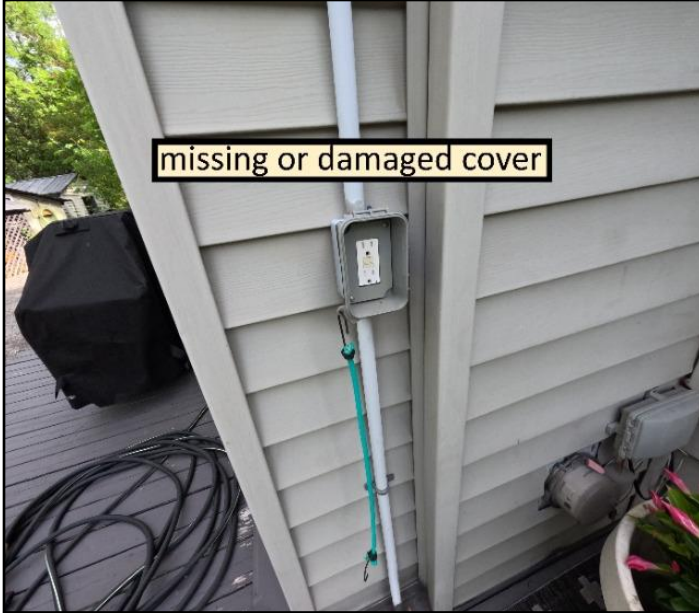
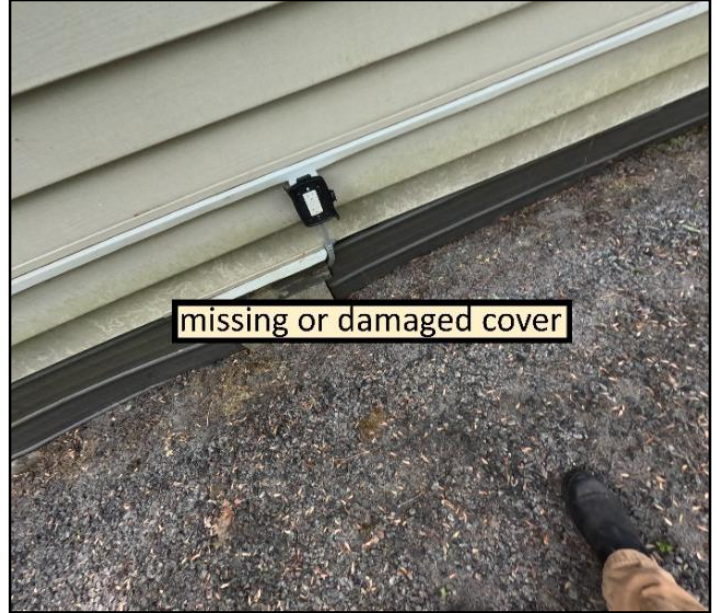
7. Condition: • [Missing](#)

Implication(s): Electric shock

Location: Exterior Wall

51. Missing

52. Missing

Task: Replace

Time: Immediate

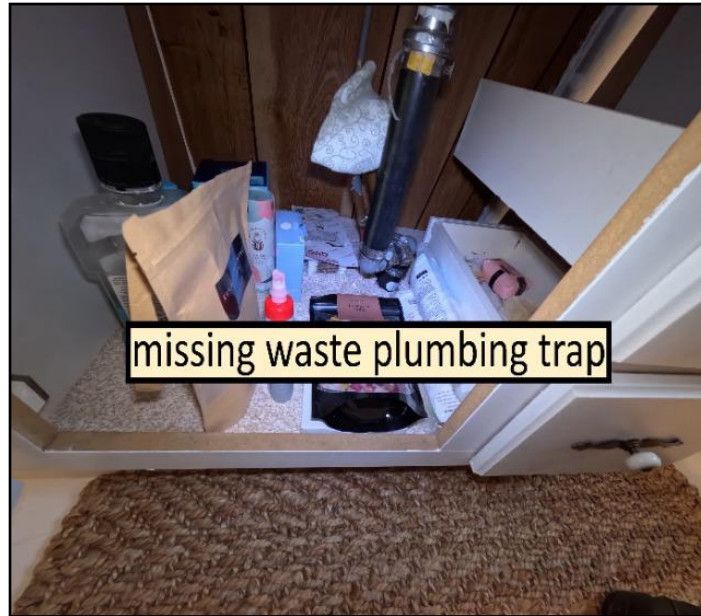
11. Condition: • [Not visible](#)

Implication(s): Difficult access

Location: Second Floor Bathroom

64. *Not visible*

Task: Further evaluation
