Crossroads Engineers PC

Summary & Conclusions

On May 11, 2024 Garth Haslem of CEI performed a structural inspection on the property at 167 Goltz Ave in Salt Lake City UT. According to an online source, this is a 2 bed, 1 bathroom single family home with 1050 square feet of living space. This value may not include the basement. The home was built in 1919, and is presently for sale.

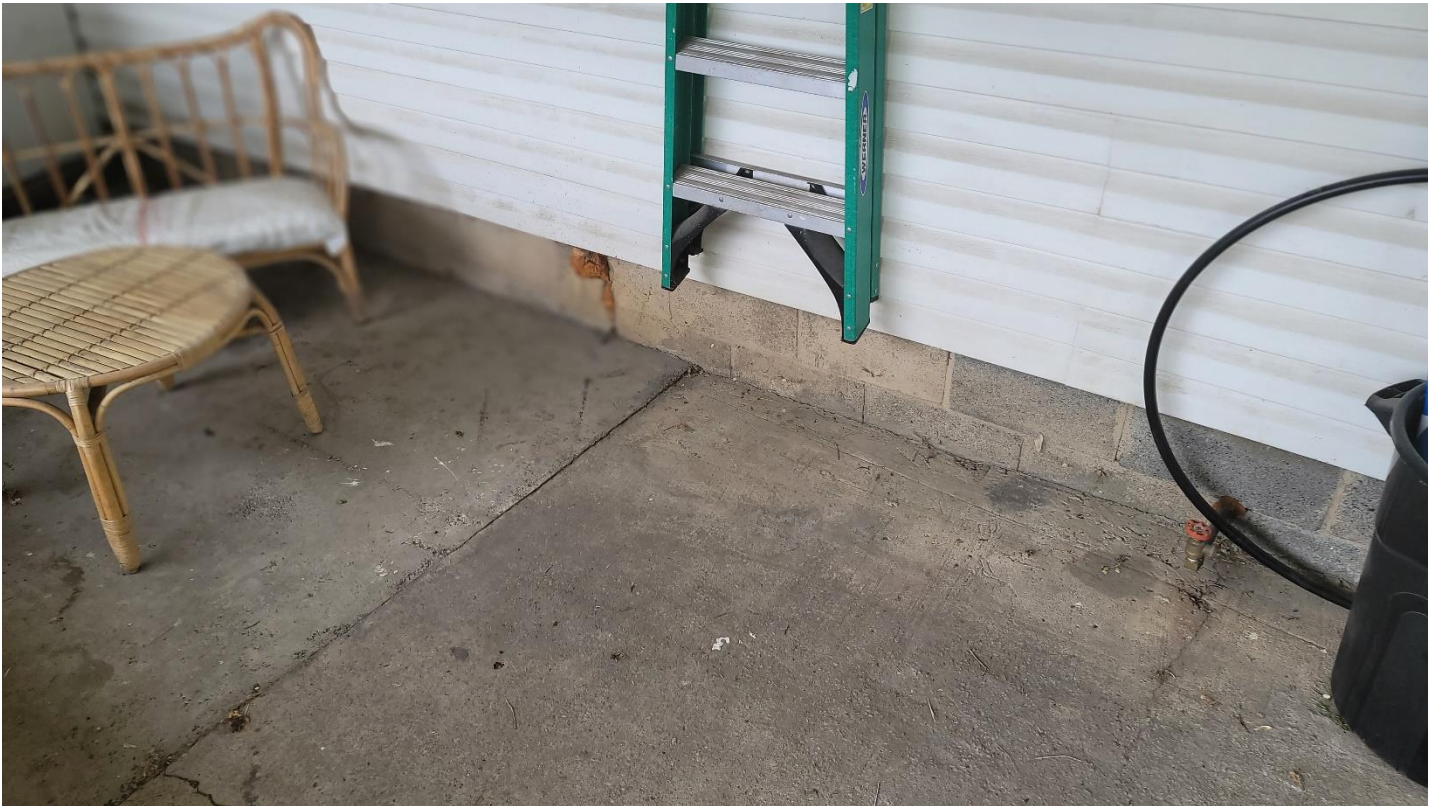
The addition on the back side uses a block foundation

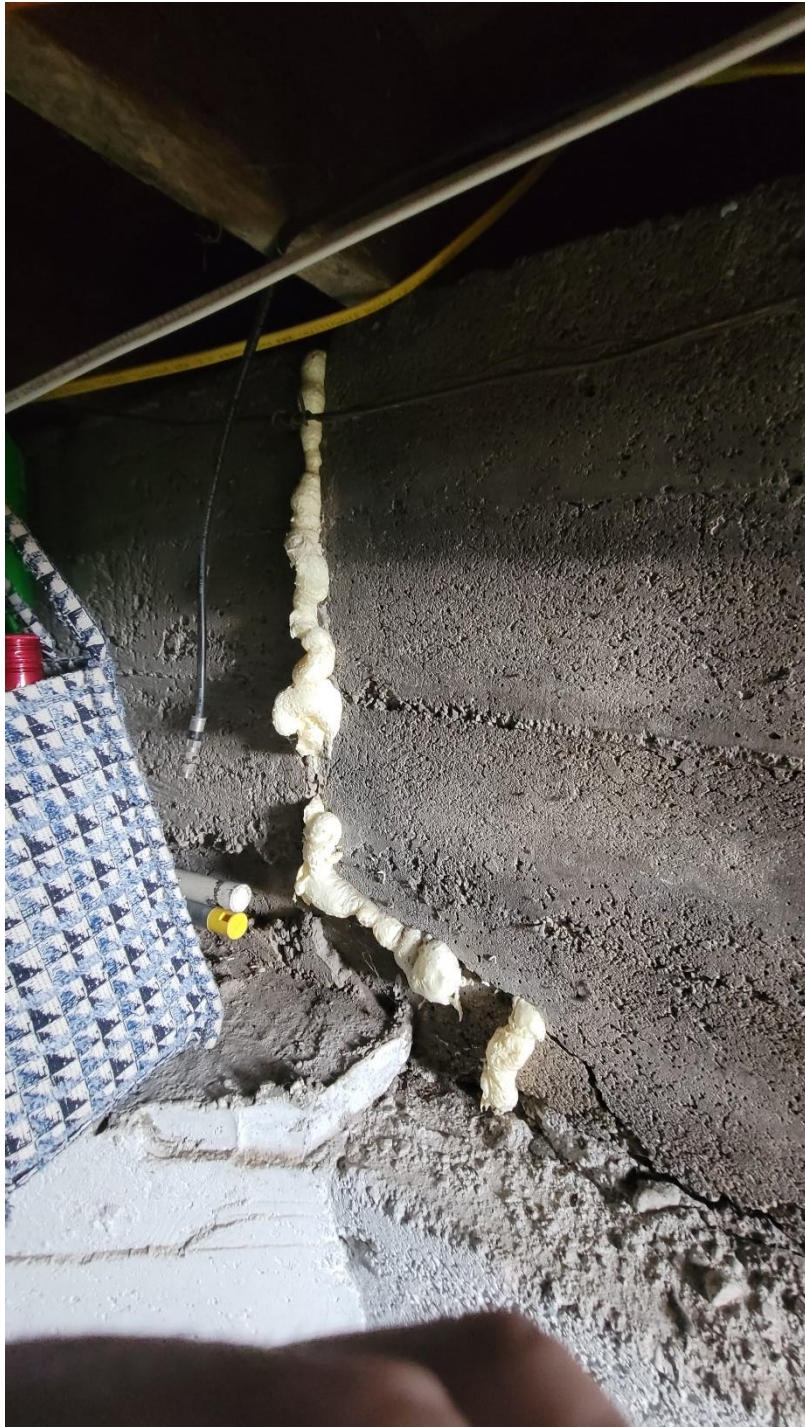
At question is a crack located near the southeast corner of the home in the foundation. This crack has been filled in with expanding foam – a move that made the problem look much worse. The foam does nothing from a structural point of view, but does help to prevent insects, pests and cold air from entering the home at that location.

The crack is partly covered by the foam insulation, but the width and location of the crack does not appear to be remarkable, especially given the age of the structure. This home is over 100 years old, and as such this kind of wear is predictable.

The separation is related to drainage conditions over the years, where the roof drainage caused muddy conditions at the southeast corner. This mud then allowed the foundation to settle and rotate, resulting in the conditions found at this location. This in itself is fairly typical for homes of this age – in fact this foundation appears to be in better condition than most of its vintage. Given the single story nature of the structure and the apparent framing, as well as the presence of a concrete footing, the engineer believes that this home is above average for homes of this age. To be clear, the home does not meet current building standards, but it is unrealistic to expect such a condition. Reasonable steps can be taken to assure the long-term future of this structure.

The cracking and expanding foam on the southeast corner

The engineer does not recommend structural piers. Instead, the recommendation is for a healthy drainage system. Drainage is about capturing, controlling and routing water well away from the structure. This includes managing the roof drainage, the surface water near the home and the sprinkler water near the foundation. This task should be done all around the home and is a condition that nearly every home should improve on. If that step is taken, the engineer expects that the home will continue to serve adequately for decades to come.

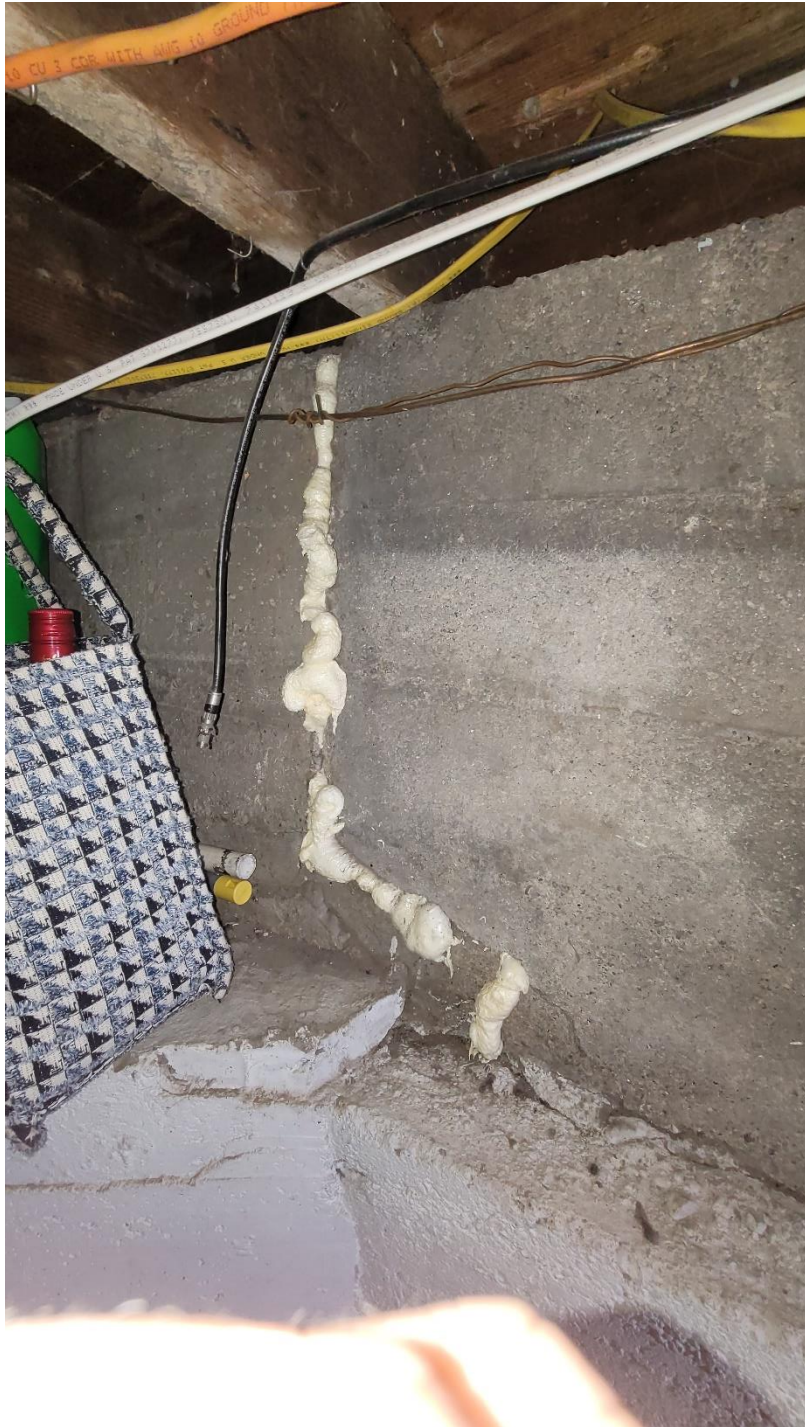
Another shot of the cracking

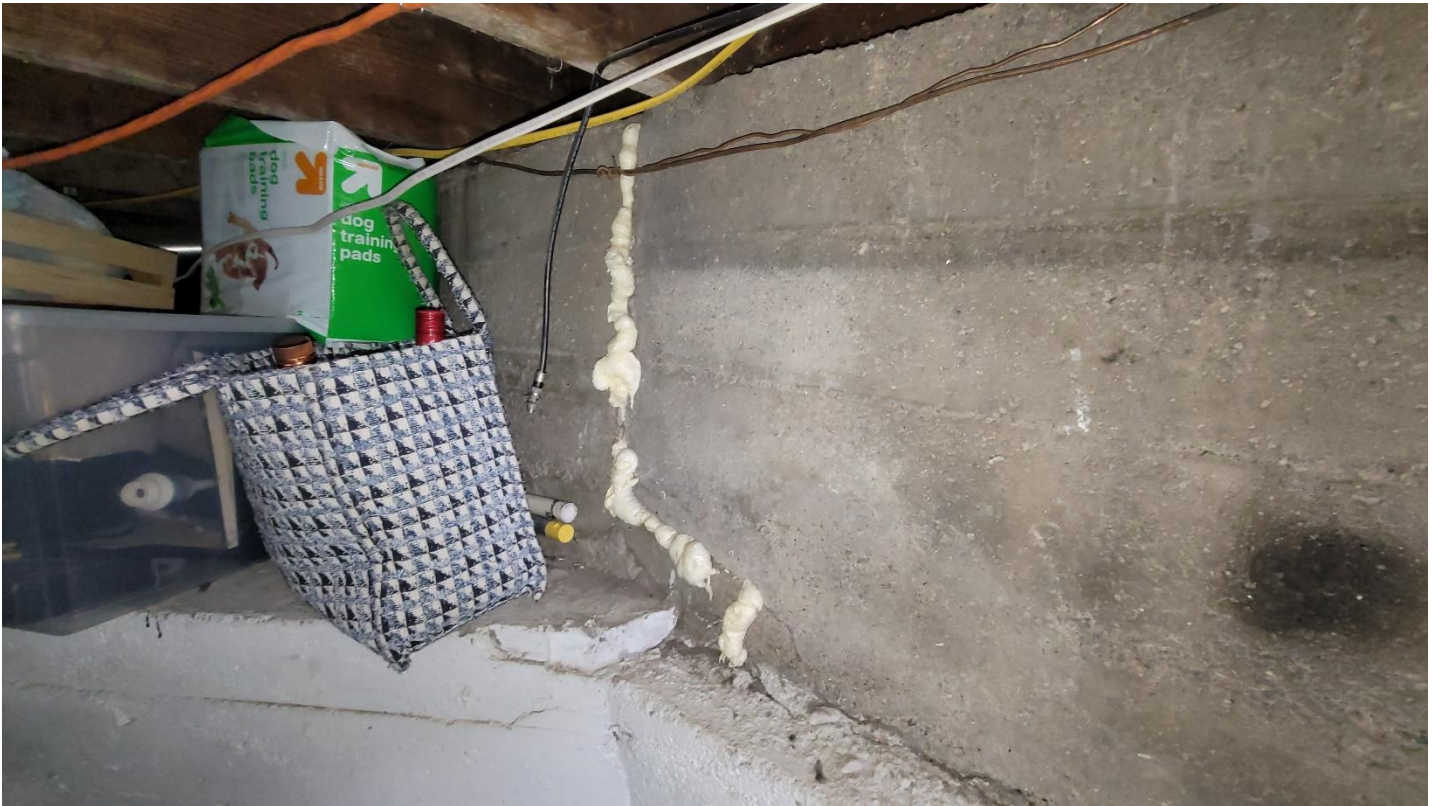
A view of the wall from further back
