INSPECTION REPORT

For the Property at:
14 ROBINSON STREET
CODRINGTON, ON K0K 1R0

Prepared for: TEAM VANRAHAN
Inspection Date: Wednesday, August 30, 2023
Prepared by: David Sharman

RE: Report No. 4470
14 Robinson Street
Codrington, ON
K0K 1R0

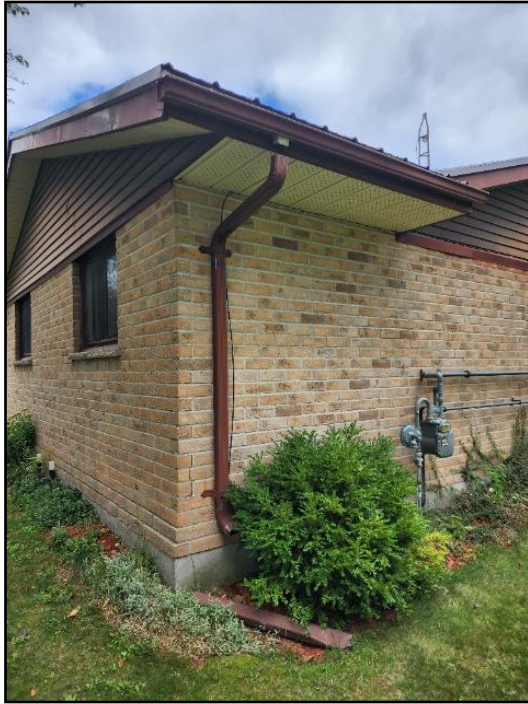
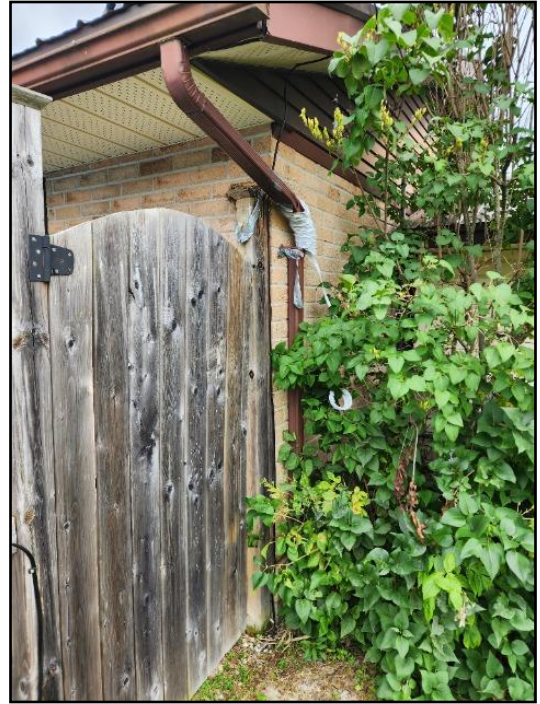
2. Condition: • Connections loose

Implication(s): Leakage

Location: Various locations

4. *Connections loose*

Task: Repair

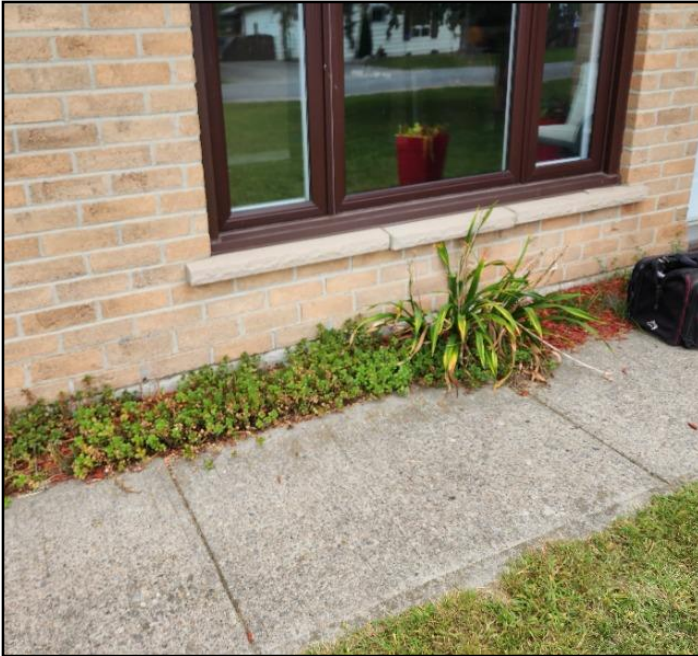
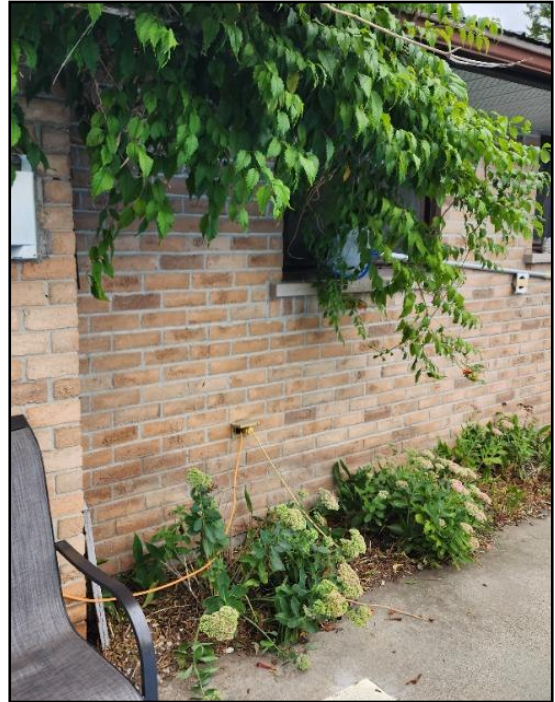
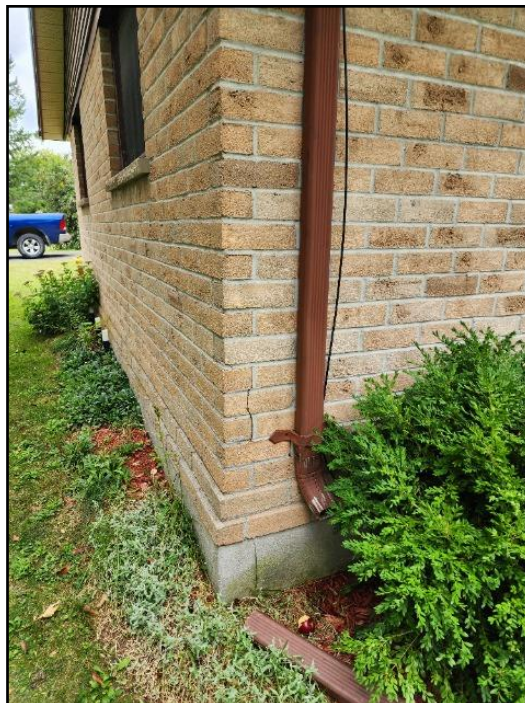
4. Condition: • Typical minor cracks

Implication(s): Chance of frost damage & material deterioration

Location: Various locations

6. Typical minor cracks

Task: Repair

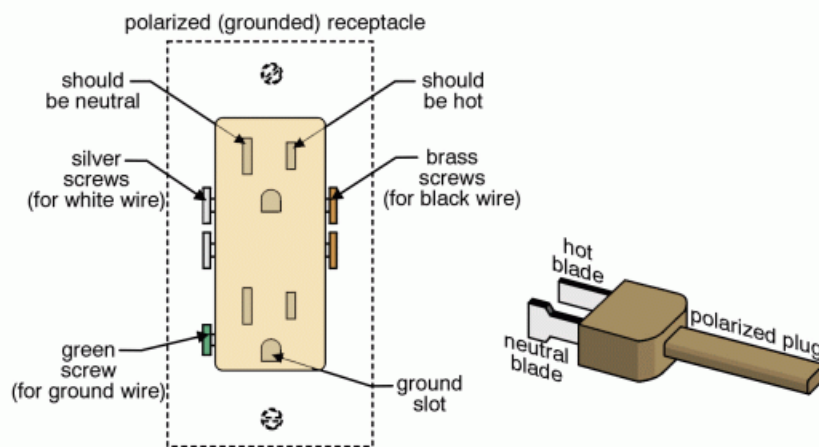
Reversed polarity

when the polarity is reversed, the wide receptacle slot is (incorrectly) hot and the narrow slot is neutral - this is not uncommon when people forget that the black wire should be attached to the receptacle's brass screws

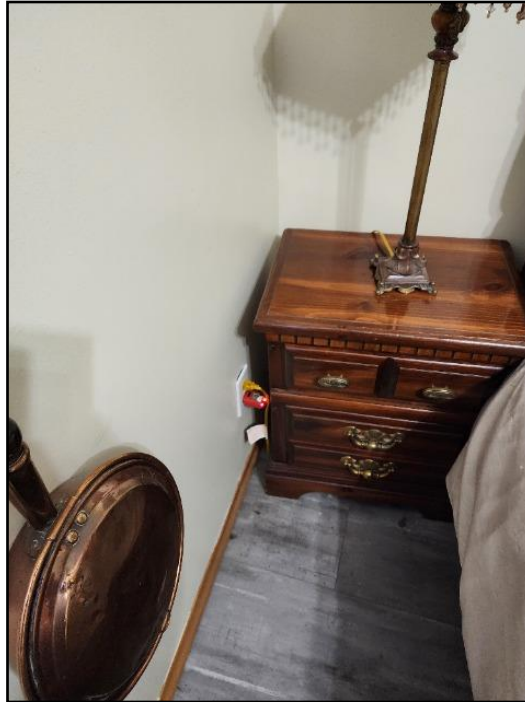
5. Condition: • Reversed polarity

Implication(s): Electric shock

Location: Bedroom

11. *Reversed polarity*

Task: Correct

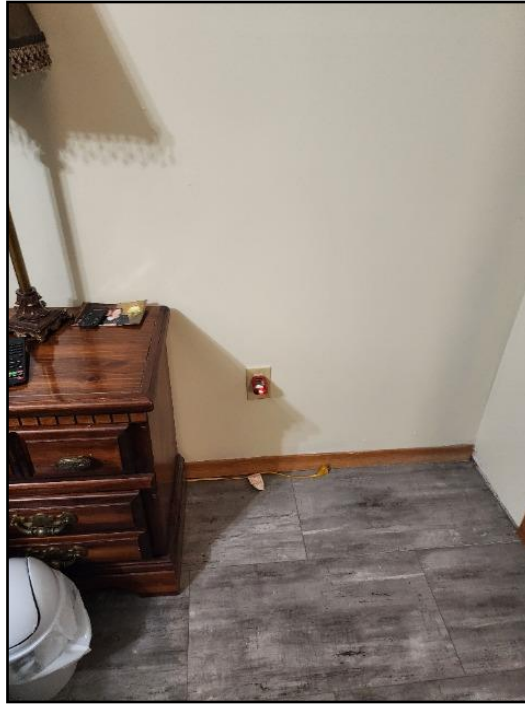
6. Condition: • Ungrounded

Implication(s): Electric shock

Location: Bedroom

12. Ungrounded

Task: Repair

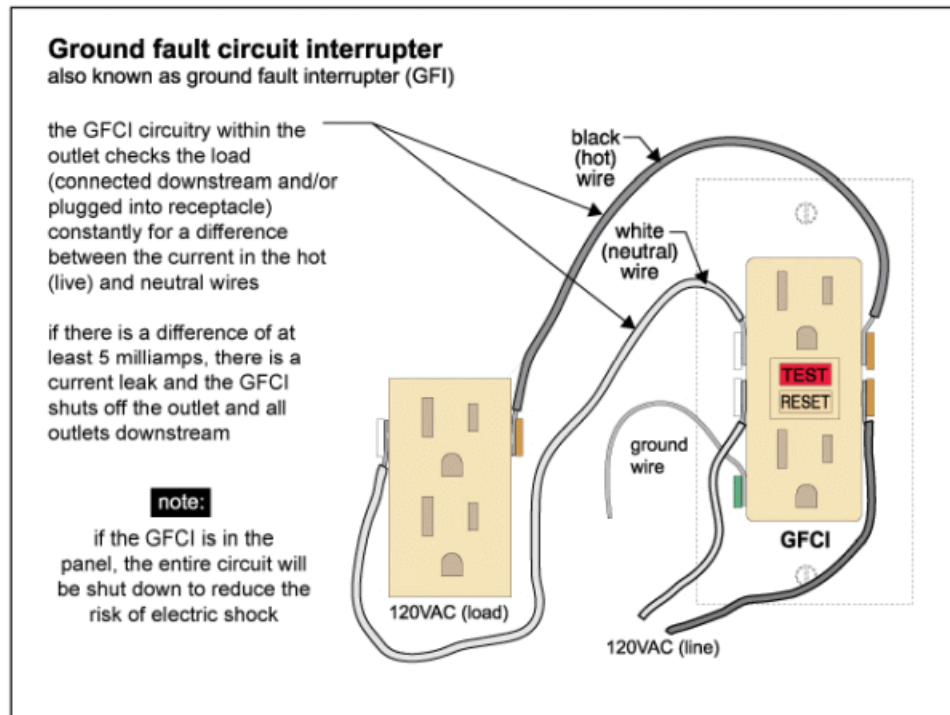
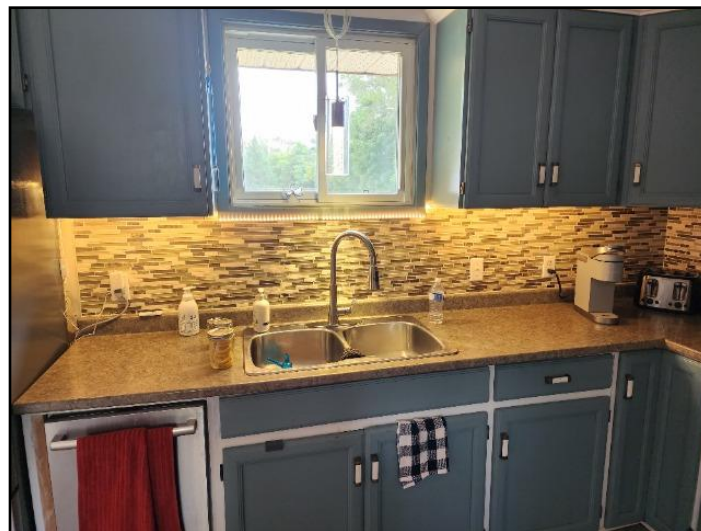
7. Condition: • No GFCI/GFI (Ground Fault Circuit Interrupter)

Although not a deficiency in a home of this age, safety may be improved by upgrading these receptacles

Implication(s): Electric shock

Location: Kitchen

13. No GFCI/GFI (Ground Fault Circuit...

Task: Upgrade

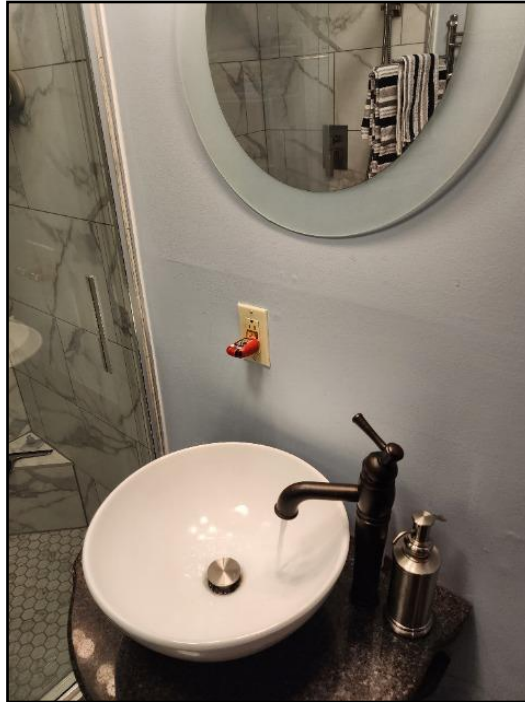
8. Condition: • Test faulty on GFCI/GFI (Ground Fault Circuit Interrupter)

Implication(s): Safety hazard

Location: Ensuite bathroom

14. Test faulty on GFCI/GFI (Ground Fault...

Task: Replace

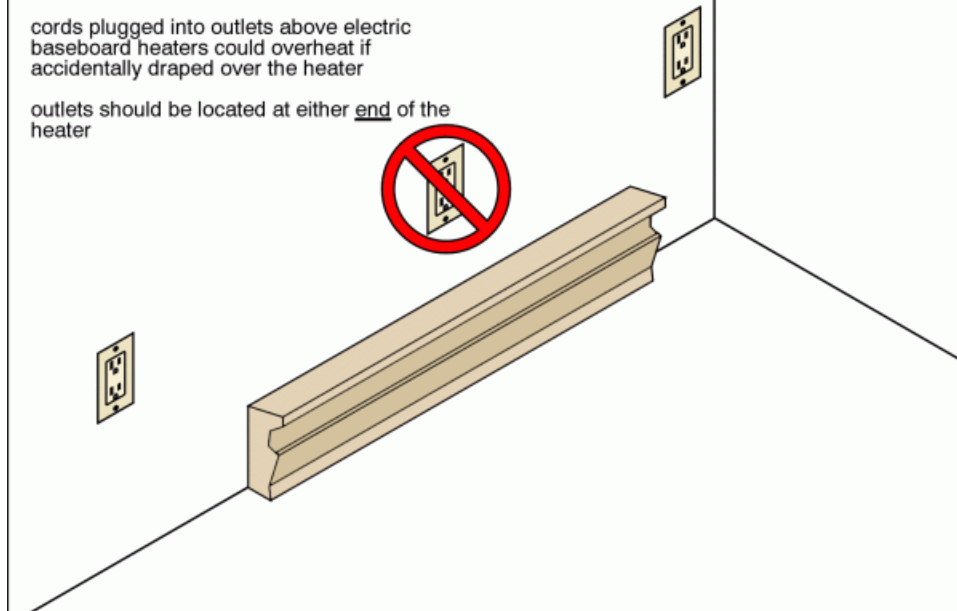
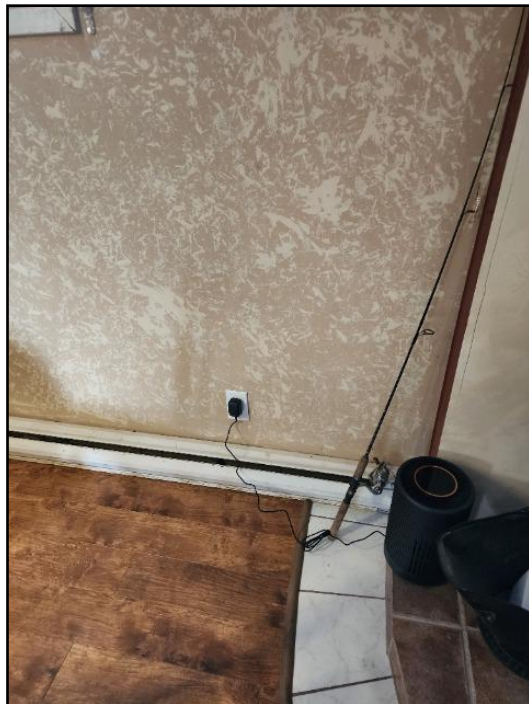
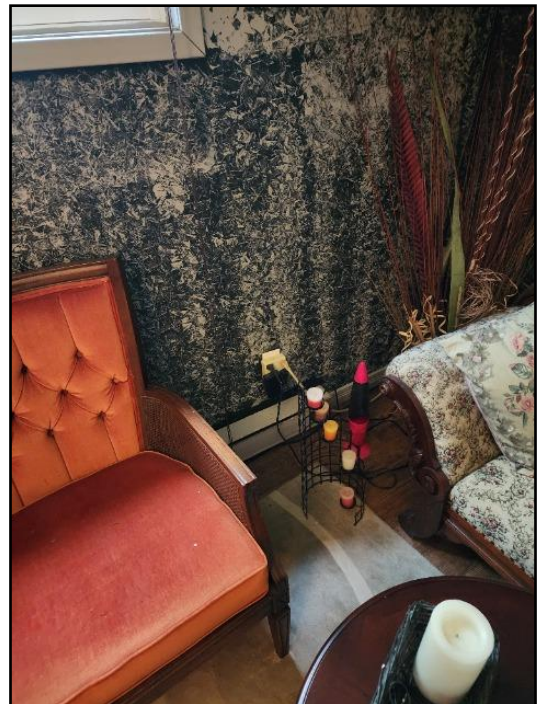
9. Condition: • Electrical receptacle above heater

Implication(s): Fire hazard

Location: Various locations

Outlets should not be above electric baseboard heaters

cords plugged into outlets above electric baseboard heaters could overheat if accidentally draped over the heater

18. Electrical receptacle above heater

Task: Improve

outlets should be located at either end of the heater

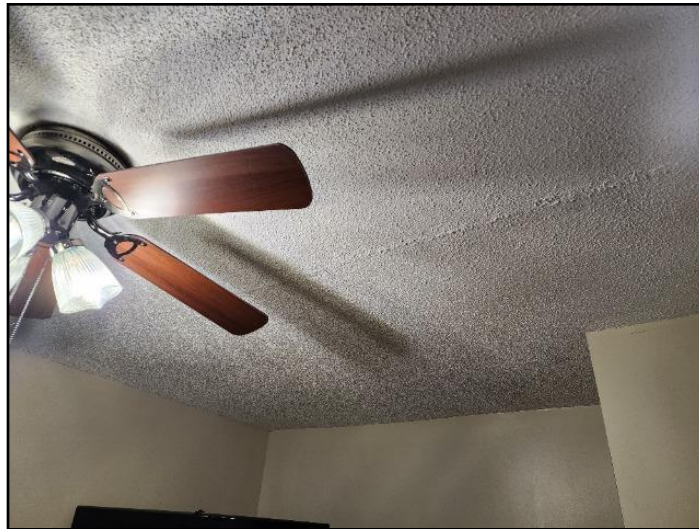
13. Condition: • Cracks

Implication(s): Damage or physical injury due to falling materials

27. Cracks

Task: Repair

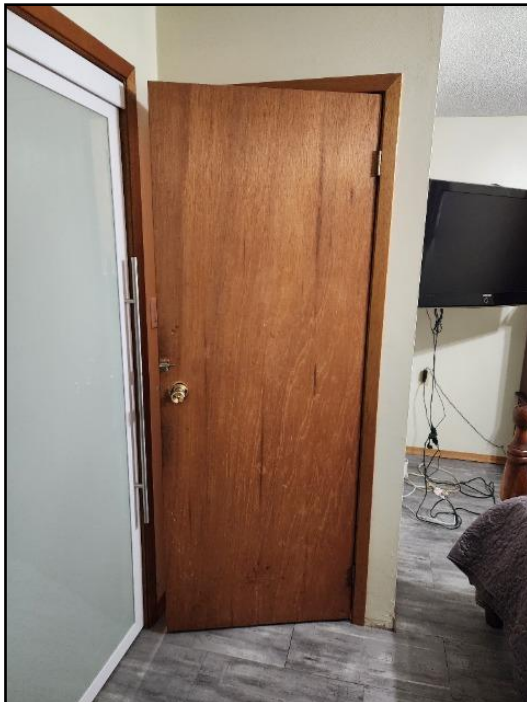
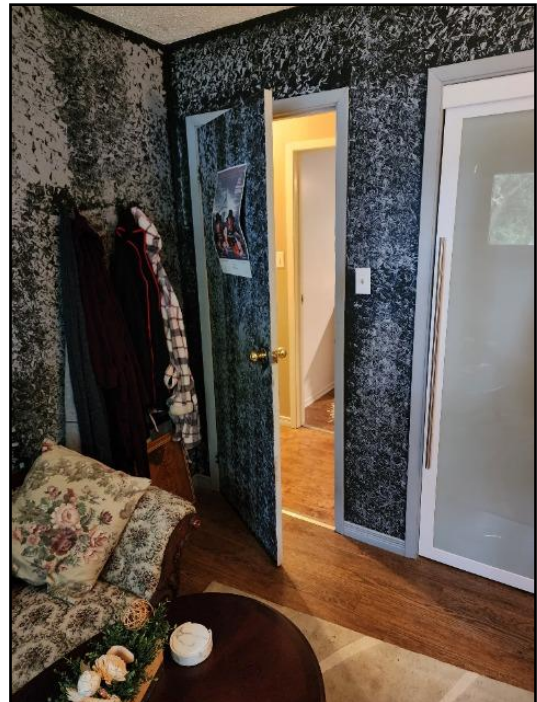
14. Condition: • Binds

28. Binds
