England Home Inspections LLC  
102 Benoir Trail  
Madison,, AL 35756

**\* Seller Pre-Listing Professional Inspection Report**

**5025 7 Pine Circle  
Huntsville, Alabama 35816**

**For your convenience this is the Summary section of an annotated report of a professional pre-listing inspection performed by the seller on March 21, 2024. A full copy of the 16 page report is available upon request. Each of the 17 items listed on this report has been marked "DONE" or AS-IS. AS-IS = the seller is not planning to address this item. All items except #s 10 and 13 have been DONE. #10 and #13 are AS-IS.**

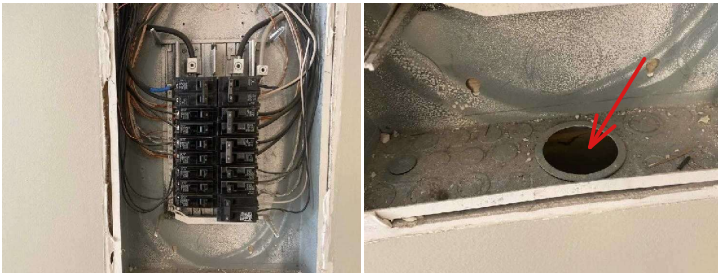
2. Interior Hall Electric Panel Electric Panel Notes Needs Evaluation and Repair - One romex connector was missing at the bottom of the interior of the breaker panel. A romex connector is the bushing in the breaker panel wiring hole. Recommend evaluation and repairs by a licensed electrician.

**DONE**

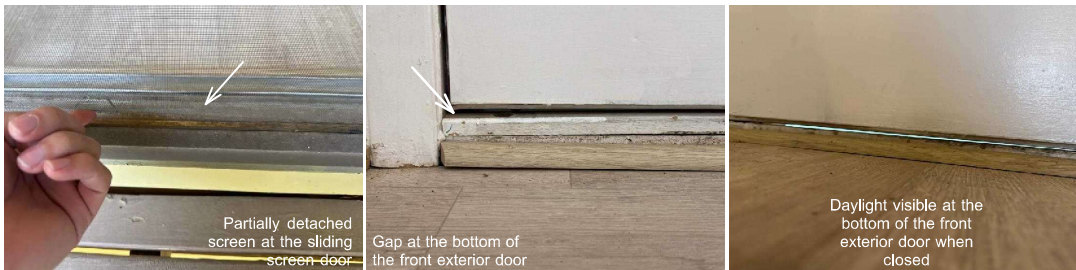
3. Interior Living Space Exterior Doors Needs Repairs - The exterior sliding glass door did not latch and closed properly during the inspection. Recommend evaluation and repairs. **DONE**
  - The screen was partially detached for the sliding screen door near the bottom. Recommend evaluation and repairs. **DONE**
  - There was no doorstop installed for the back exterior door at time of inspection. Recommend evaluation and repairs. **DONE**
  - Daylight was visible at the bottom of the front exterior door when closed. Recommend evaluation and repairs. **DONE**
  - There was no doorstop installed for the front exterior door at time of inspection. Recommend evaluation and repairs. **DONE**
  - Sections of damage were noted at the exterior molding for the front entry door. Recommend evaluation and repairs. **DONE**

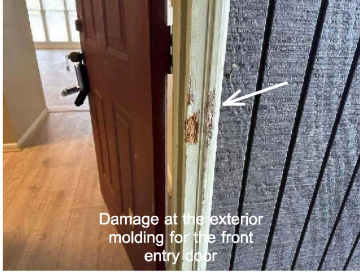
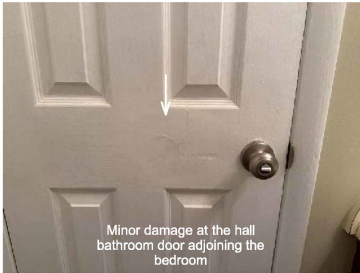
4. Interior Living Space Interior Doors Recommend Repairs - The hall bathroom door would not latch properly to the strike plate at time of inspection. Recommend evaluation and repairs.

- - A section of minor damage was noted at the hall bathroom door adjoining the bedroom.

**DONE**

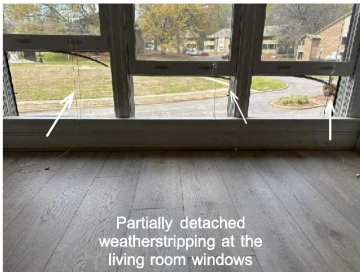
5. Interior Living Space Windows Wood double hung - The bottom weatherstripping was partially detached at the three living room windows. See picture. Recommend evaluation and repairs.

**DONE**

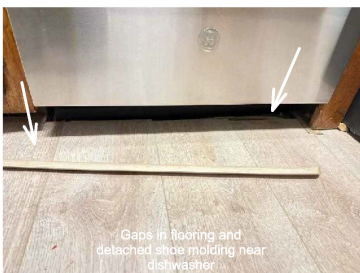
6. Interior Living Space Floors Recommend Repairs - Gaps were noted in the flooring near the dishwasher kickplate. Additionally, the shoe molding adjoining the dishwasher and kitchen sink was detached. Repairs would be cosmetic.

**DONE**

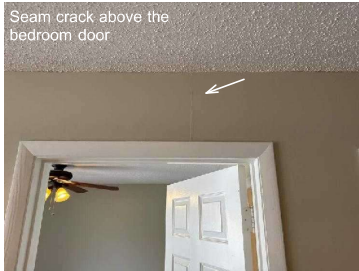
7. Interior Living Space Walls Drywall - A seam crack was noted at the living room area above the bedroom door at time of inspection. Repairs would be cosmetic.

**DONE**

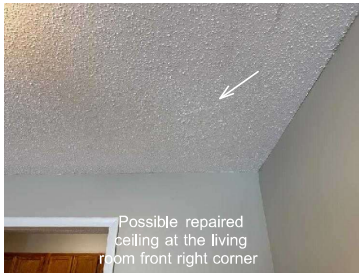
8. Interior Living Space Ceilings Drywall - A section of possible repaired drywall was noted at the front right corner of the living room. Recommend monitoring. Repairs would be cosmetic.

**DONE**

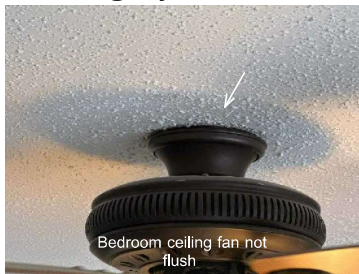
10. Interior Living Space Ceiling Fans Recommend Repairs - The bedroom ceiling fan escutcheon was not flush to the ceiling drywall at time of inspection. Recommend evaluation and repairs.

**AS IS**

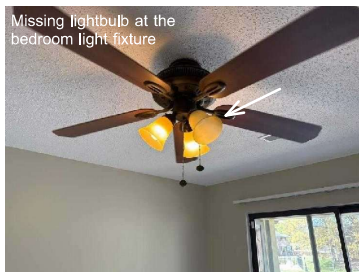
11. Interior Living Space Interior Lighting Needs Repairs - One of the lightbulbs was missing at the bedroom light fixture. Recommend evaluation and repairs.

**DONE**

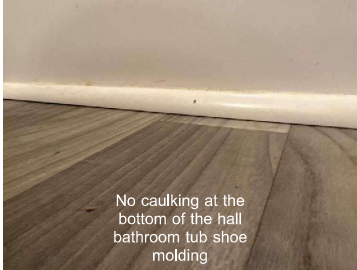
12. Hall Bathroom Bathtub Tub/Shower Combo - No caulking was installed at the bottom of the hall bathroom tub shoe molding at time of inspection. This area is typically caulked to prevent possible deterioration/damage from spillage. Caulking this area would be considered a recommended upgrade.

**DONE**

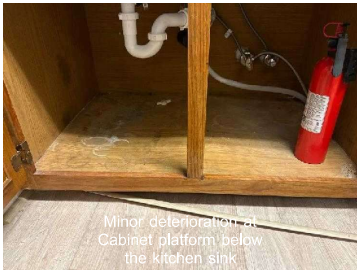
14. Main Floor Kitchen Sink Recommend Repairs - Water pressure was significantly lower when running cold water at the kitchen sink faucet. Recommend evaluation and repairs. **DONE**
15. Main Floor Kitchen Cabinets: Wood - Areas of minor deterioration were noted at the kitchen cabinet platform directly below the kitchen sink. Recommend monitoring. Recommend evaluation and possible repairs.

**DONE**

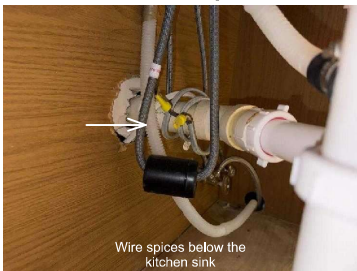
16. Main Floor Kitchen Electrical Needs Repairs - Electric wire splices were noted in the cabinets below the kitchen sink. These electric wire splices were wrapped around the PVC drain line. Electric wire splices are required to be installed within junction box with a cover to prevent accidental exposure to electricity. These wires are likely functional from the switch to the left of the kitchen sink for potential food disposal installation. Recommend evaluation and repairs.

**DONE**
