INSPECTION REPORT

For the Property at:
1497 ASPHODEL 6TH LINE
HASTINGS, ON K0L 1Y0

Prepared for: TEAM VANRAHAN
Inspection Date: Saturday, June 10, 2023
Prepared by: David Sharman

RE: Report No. 4355
1497 Asphodel 6th Line
Hastings, ON
K0L 1Y0

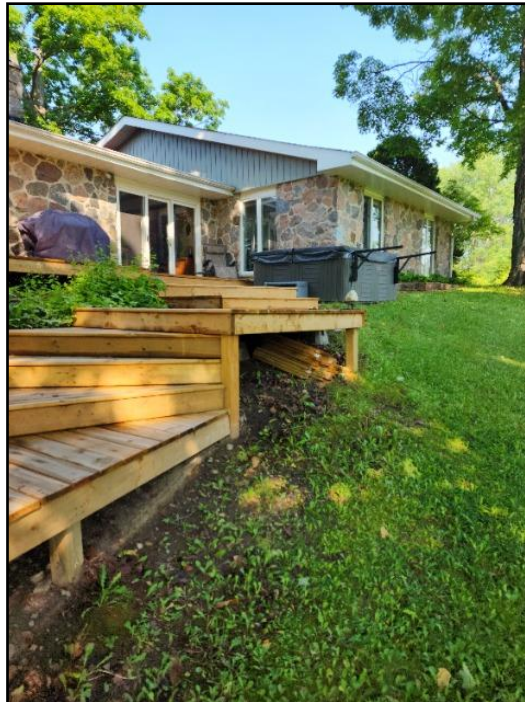
2. Condition: • Missing

Implication(s): Fall hazard

Location: Rear decking

3. Missing

Task: Provide

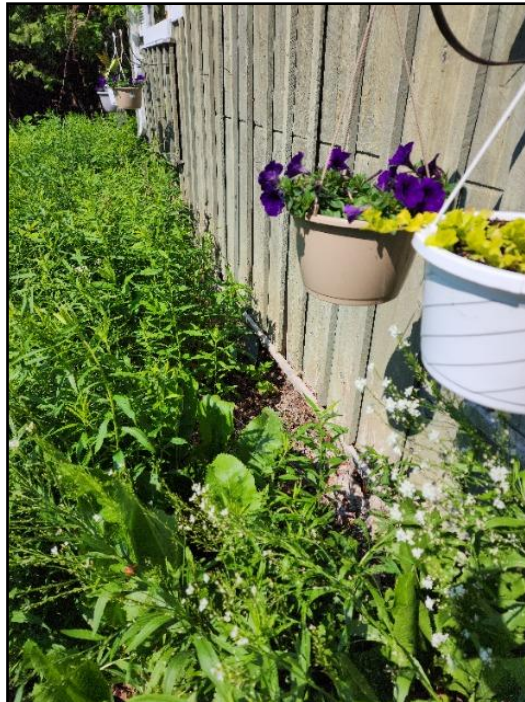
3. Condition: • Extensive rot

Implication(s): Chance of damage to structure

Location: Left elevation

4. Extensive rot

Task: Repair

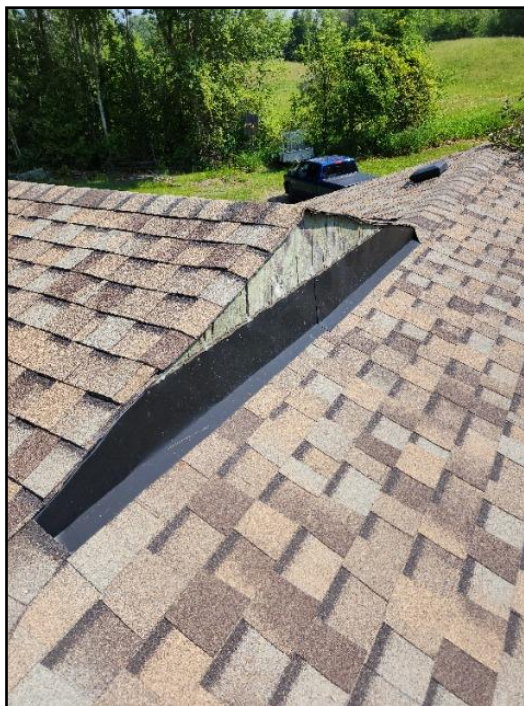
4. Condition: • Roof flashings open at the top

Implication(s): Chance of water damage to structure, finishes and contents

Location: Left elevation

5. Roof flashings open at the top

Task: Repair

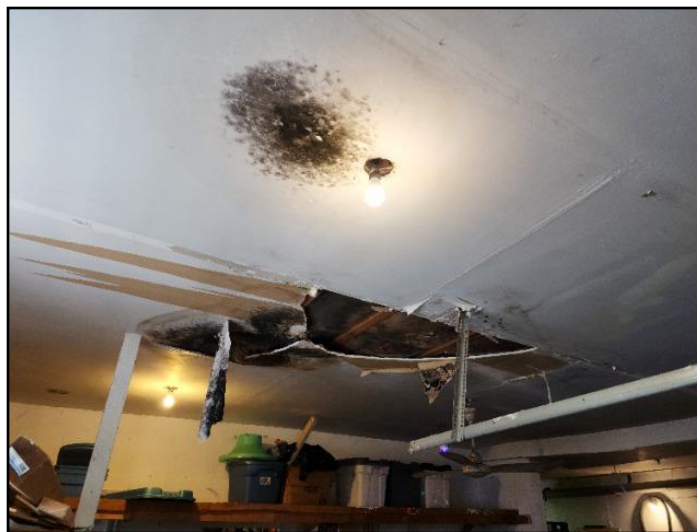
5. **Condition:** • Water damage

Implication(s): Chance of water damage to structure, finishes and contents

Location: Left elevation

6. Water damage

Task: Repair

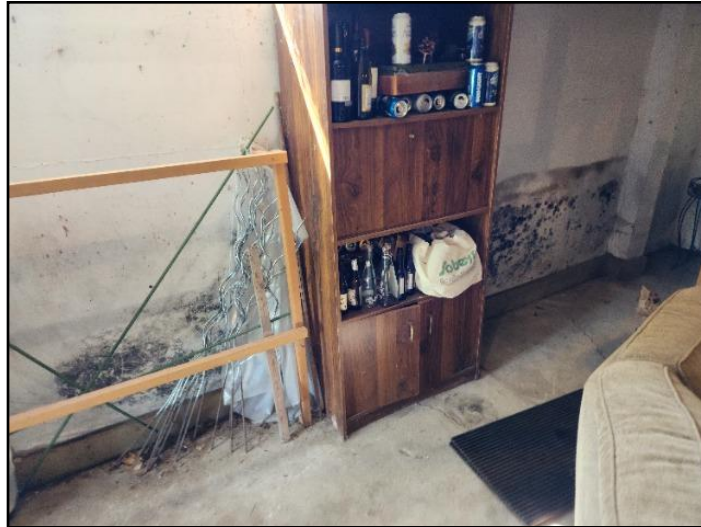
6. **Condition:** • Mold

Implication(s): Contaminants may enter building air. Chance damage to structure, finishes and contents

Location: Left elevation

7. Mold

Task: Remove

Realtor Note: Mold has been professional cleaned and removed effective August 2nd, 2023

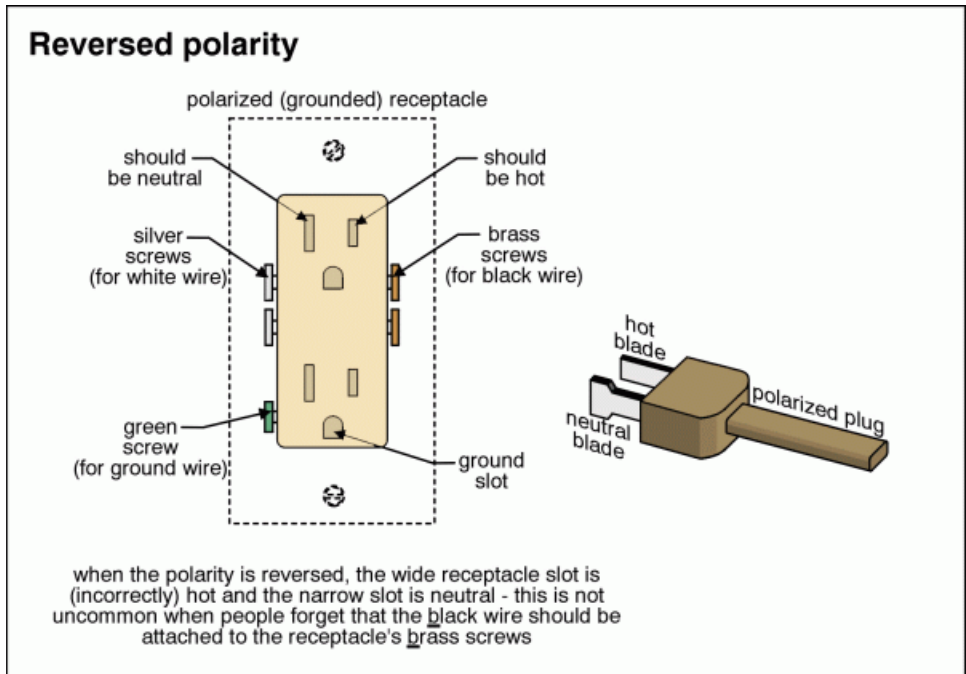
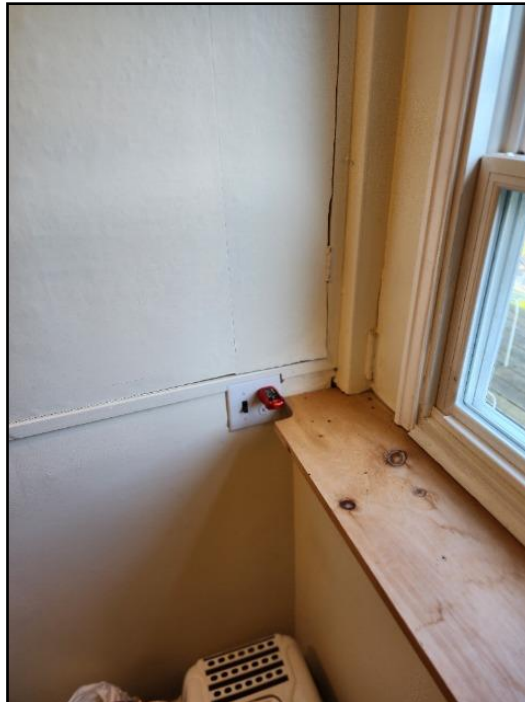
8. Condition: • Reversed polarity

Implication(s): Electric shock

Location: Utility room

11. *Reversed polarity*

Task: Correct

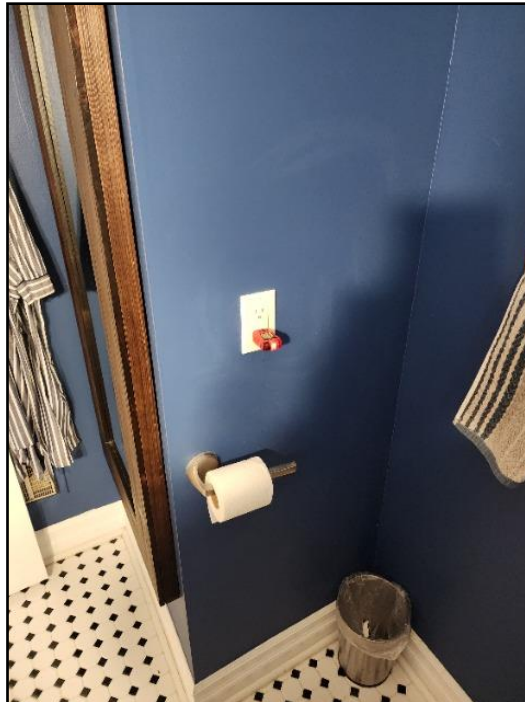
9. Condition: • Ungrounded

Implication(s): Electric shock

Location: Ensuite bathroom

12. Ungrounded

Task: Repair

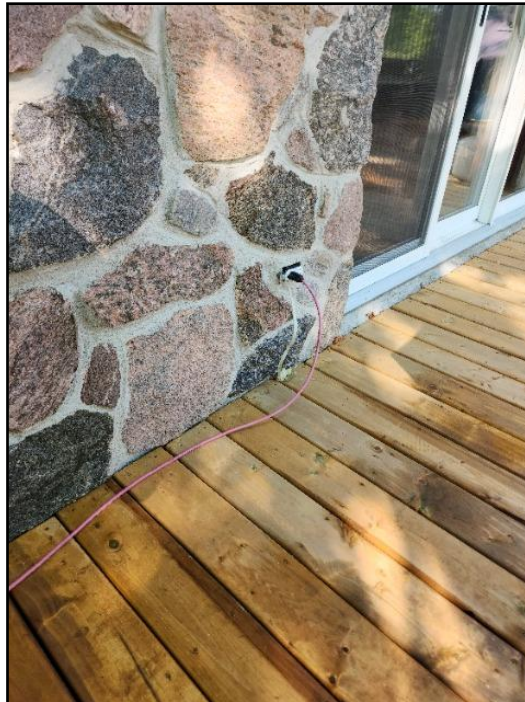
- 10. Condition:** • Not suitable for outdoor (exterior) use
- Implication(s):** Shock hazard or interruption of electrical service
- Location:** Rear elevation
- Task:** Replace
- Time:** As soon as is practicable
- Cost:** Minor

13. Not suitable for outdoor (exterior) use

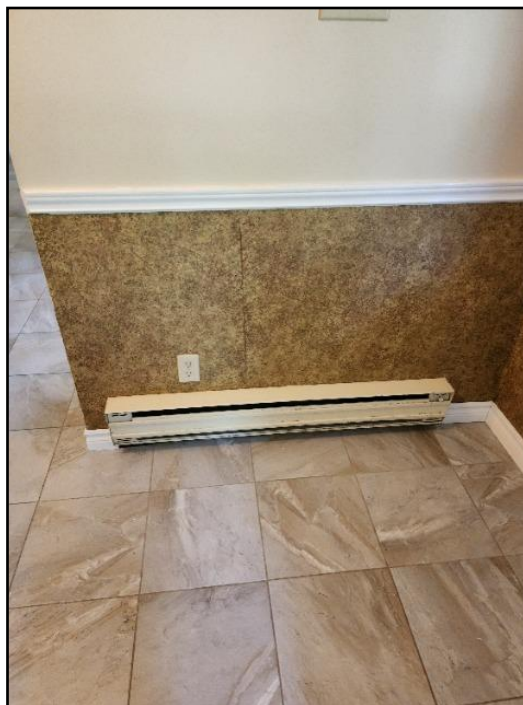
11. Condition: • Electrical receptacle above heater

Implication(s): Fire hazard

Location: Hall

17. *Electrical receptacle above heater*

Task: Improve

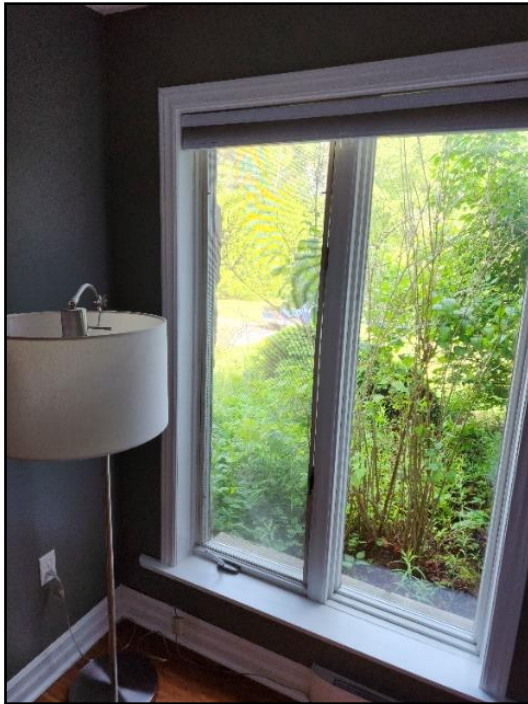
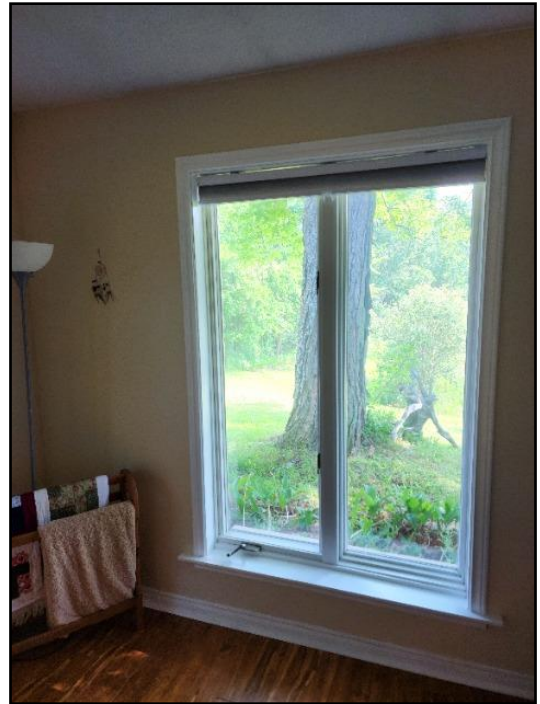
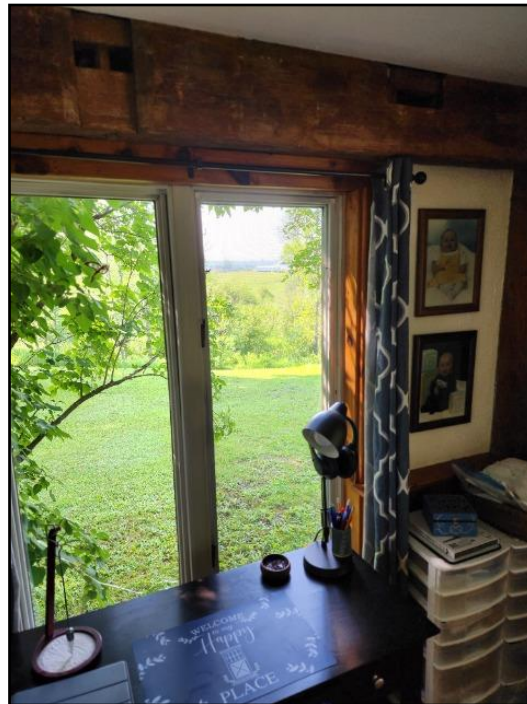
14. Condition: • Inoperative

Implication(s): System inoperative or difficult to operate | Reduced comfort | Restricted emergency exits

Location: Various locations

25. Inoperative

Task: Repair

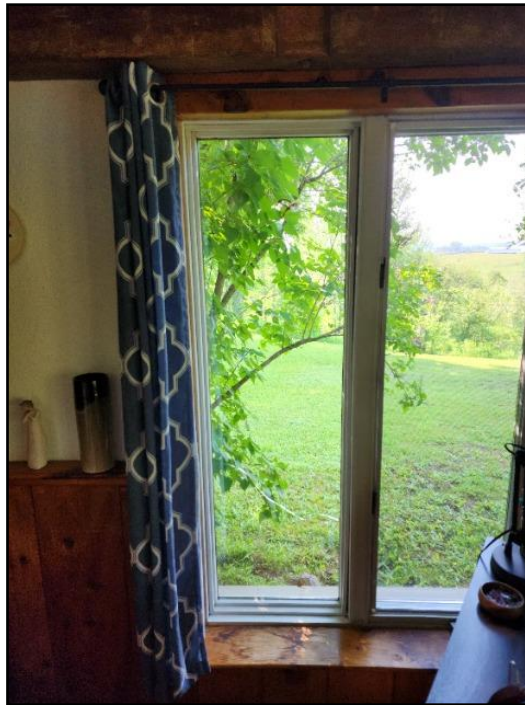
15. Condition: • Cracked

28. *Cracked*

Task: Replace

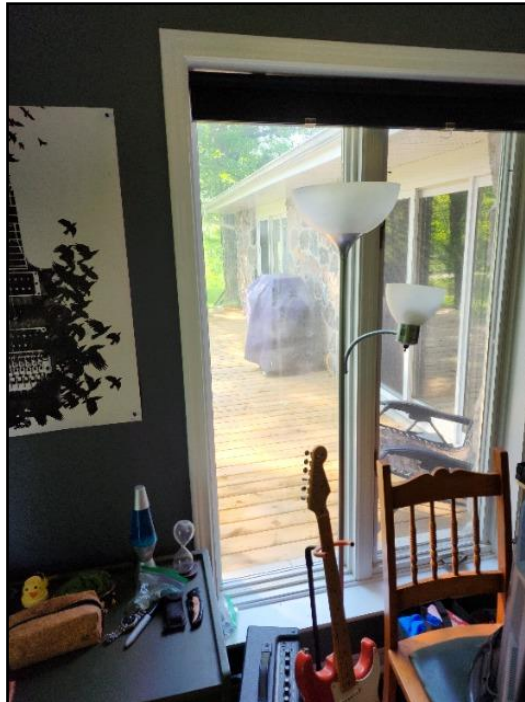
16. Condition: • Lost seal on double glazing

29. Lost seal on double glazing

Task: Repair or replace
