# *Hanna Home Inspection*

## Home Inspection Report

764 Parent, Windsor, ON

Inspection prepared for: Al Teshuba  
Date of Inspection: 6/7/2024

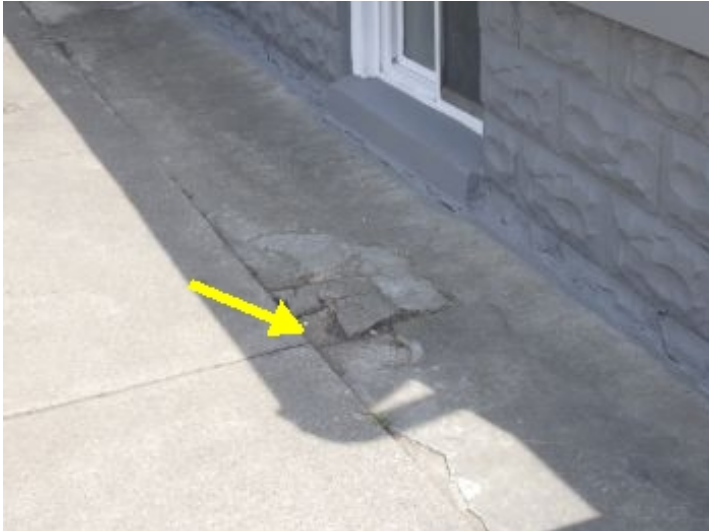
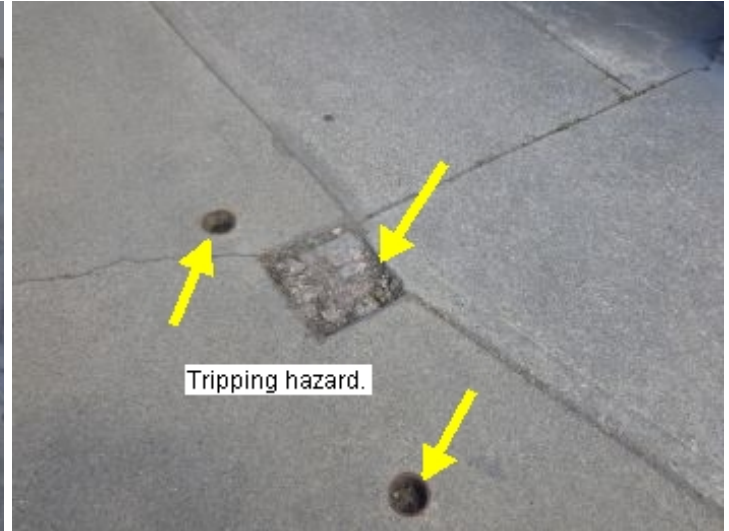
### 1. Driveway Condition

- Common cracks and patching noted.
- Settlement and common cracking noted.
- **Driveway is pitched towards the structure, which may result in basement seepage.**

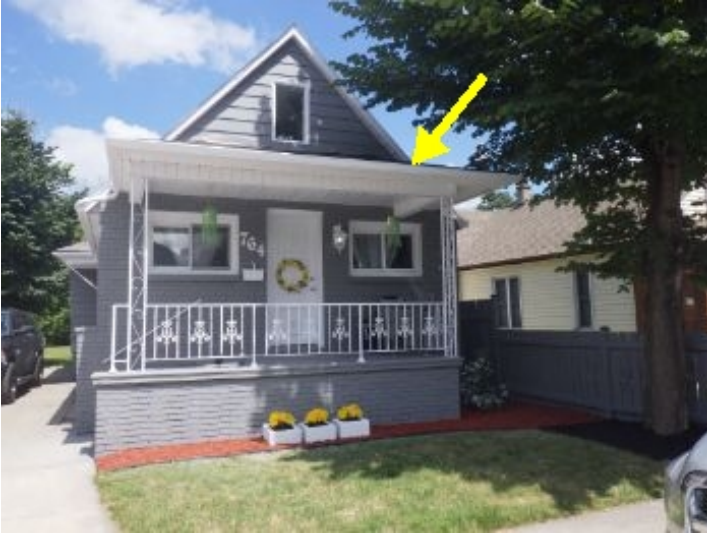
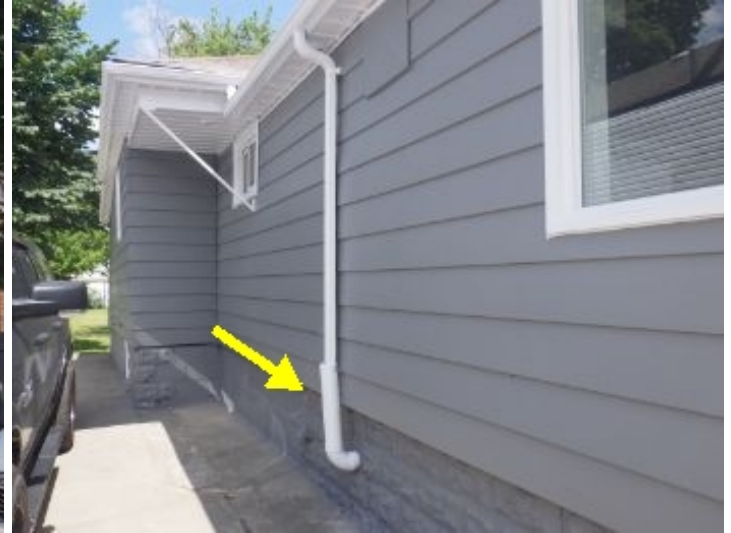
### 6. Gutter Condition

- Suggest cleaning gutters now, and as a normal part maintenance.
- Suggest gutters be cleaned out as a part of a normal maintenance routine to ensure proper drainage.
- Drains to underground drain piping which was not tested.
- **The city of Windsor has implemented a "mandatory" downspout disconnection program. The objective of this program is to reduce the amount of water sent to the storm sewer system. It may require that downspouts be disconnected from the existing underground piping. The cost will be the responsibility of the homeowner, if required. Buyer is advised to consult with the City of Windsor to determine if this property will be subject to this program, as the inspector is unable and unqualified to make such a determination.**

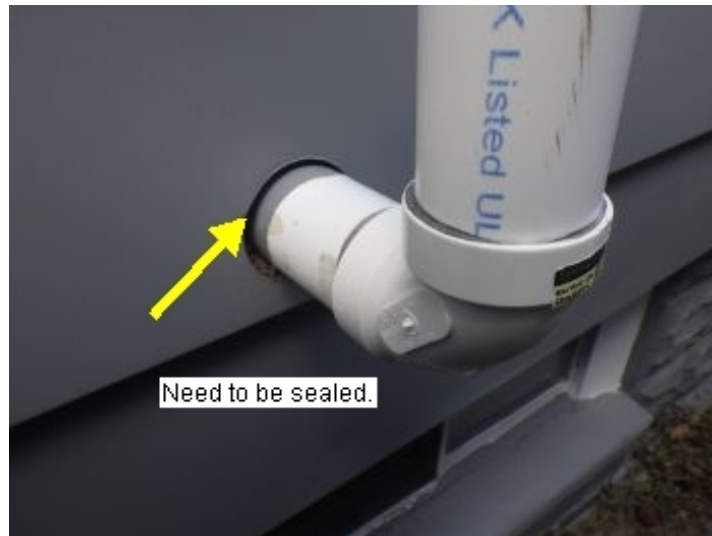
### 10. General Exterior Comments

- Suggest trimming back vegetation for proper clearance and ventilation.
- An effective water management program is required for all homes. This includes maintenance of all wooden components, caulking of all openings and ongoing vigilance of water handling systems, roof and flashing. Buyer is advised that while there may not be evidence of water intrusion into structure at time of inspection, NO STATEMENT referring to future performance can be made due to changing weather and structure conditions.
- Exhaust pipe through the exterior wall need to be sealed to prevent water and insect entering the house.

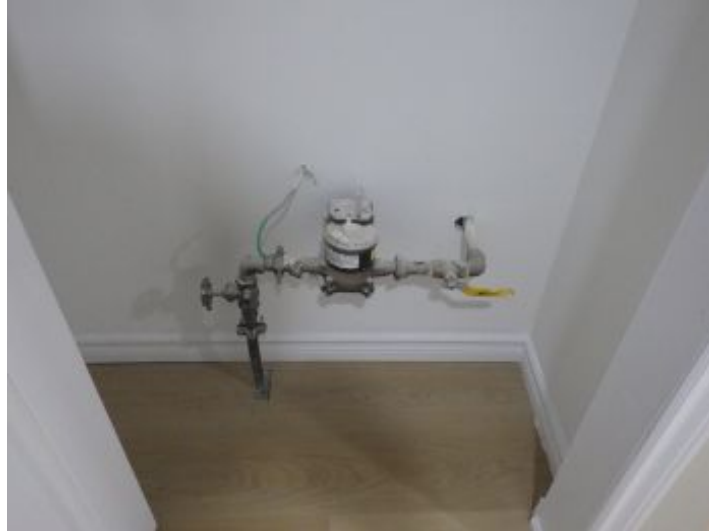
### 1. Main Shutoff Location

- Since main shutoff valves are operated infrequently, it is not unusual for them to become frozen over time. They often leak or break when operated after a period of inactivity. For this reason main shutoff valves are not tested during a home inspection. We suggest caution when operating shutoffs that have not been turned for a long period of time. All shutoff valves and angle stops should be turned regularly to ensure free movement in case of emergency.
- Ground wire in place. Compliant 3/4" copper supply line.
- Basement closet.

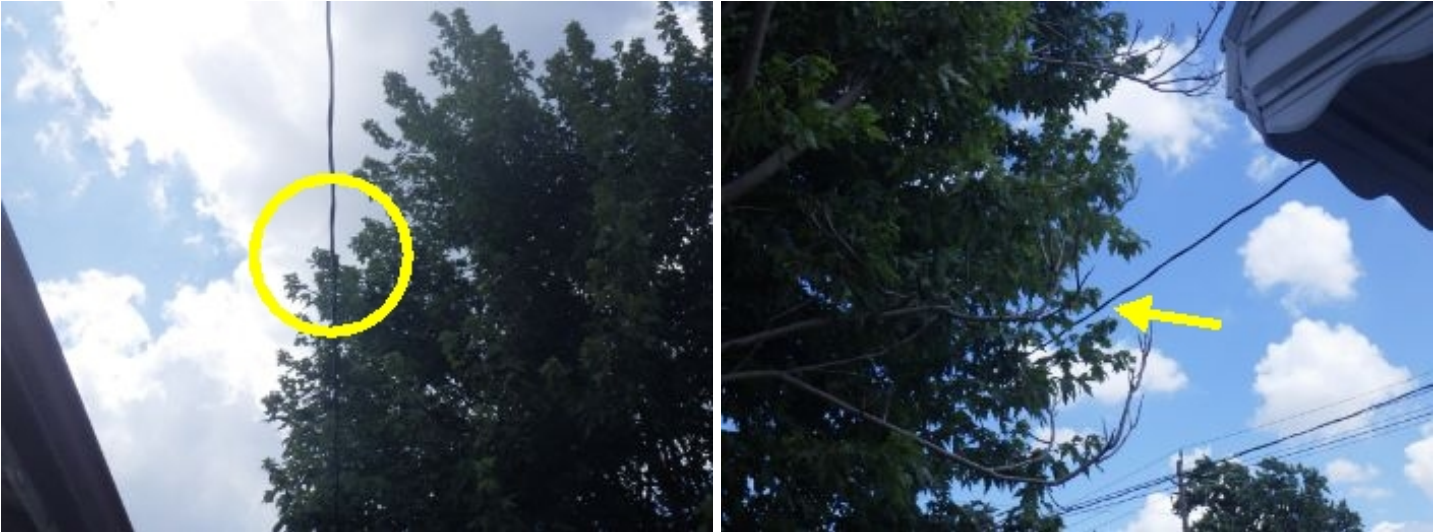
### 1. Main Service Drop Condition

- Wires are touching trees, recommend review by the local utility company for repair as necessary.

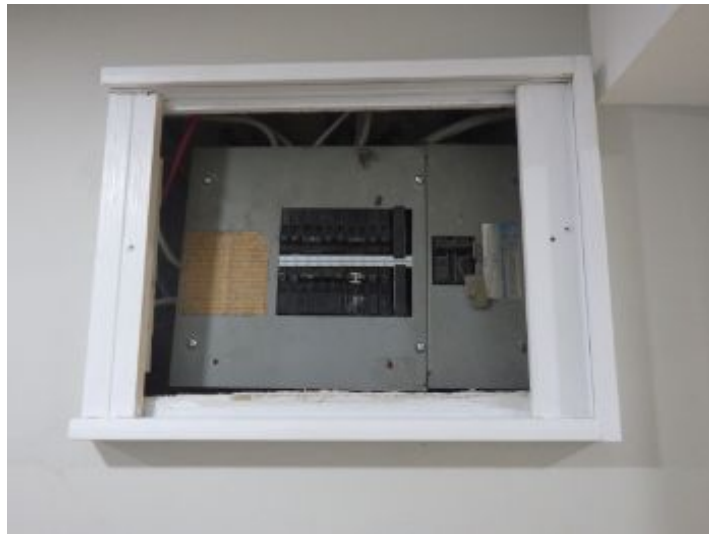
### 2. Electrical panel Condition

- Overload protection provided by breakers.
- The main service is approximately 100 amps, 240 volts.
- Overload protection provided by breakers.
- No open positions observed, box is full.

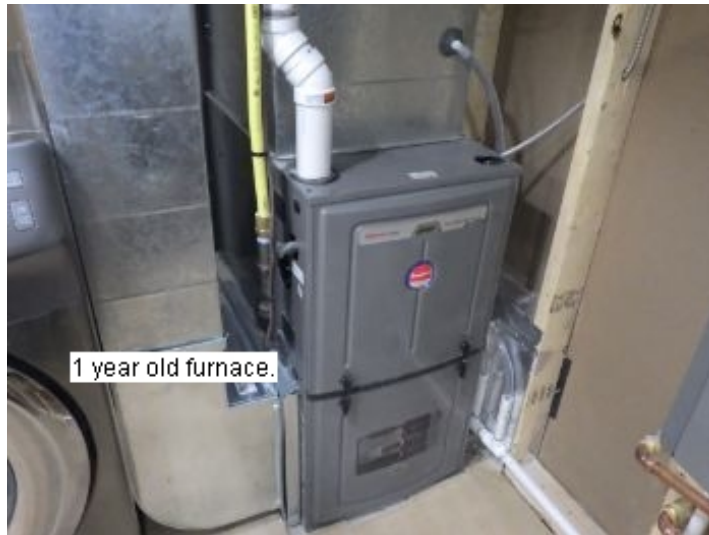
### 2. Heating Comments

- Relatively new high efficiency furnace in place.
- This was a very limited inspection as inspector is neither qualified nor authorized to carry out a technically exhaustive inspection of heating system. Buyer is advised to have this system serviced annually to ensure safe and efficient operation.

Carbon monoxide detectors are mandatory in most municipalities and should be installed in furnace area and bedroom area at minimum.

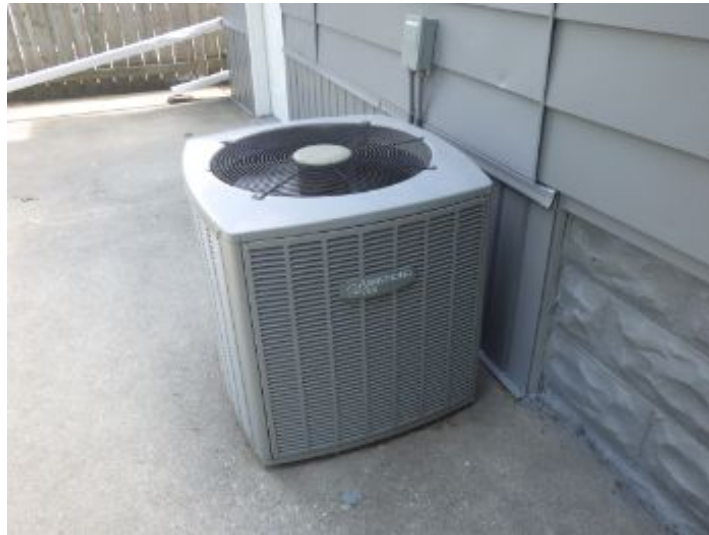
### 1. Air Conditioning Comments

- Air conditioning operating during inspection and appeared to be performing satisfactorily. Buyer is advised to verify satisfactory operation prior to close.

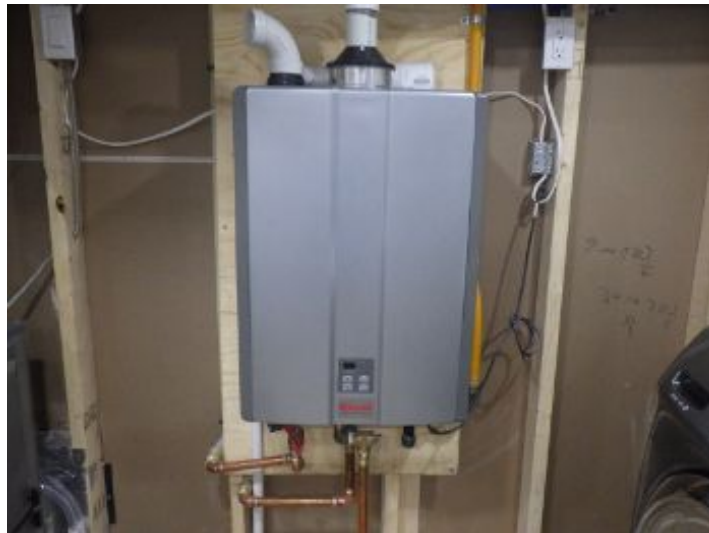
### 4. Water Heater Comments

- Children should be kept away from water heater as the high pressure release valve, if disturbed, can cause scalding.
- Serviceable at time of inspection. No warranties can be offered on this or any other appliance.

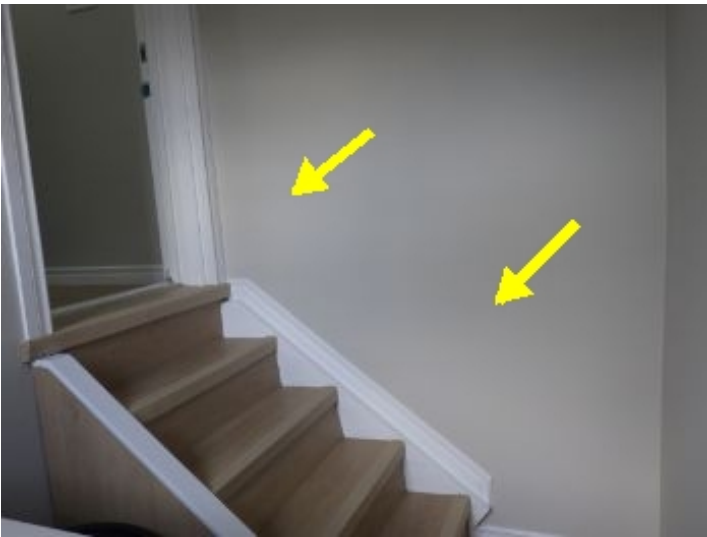
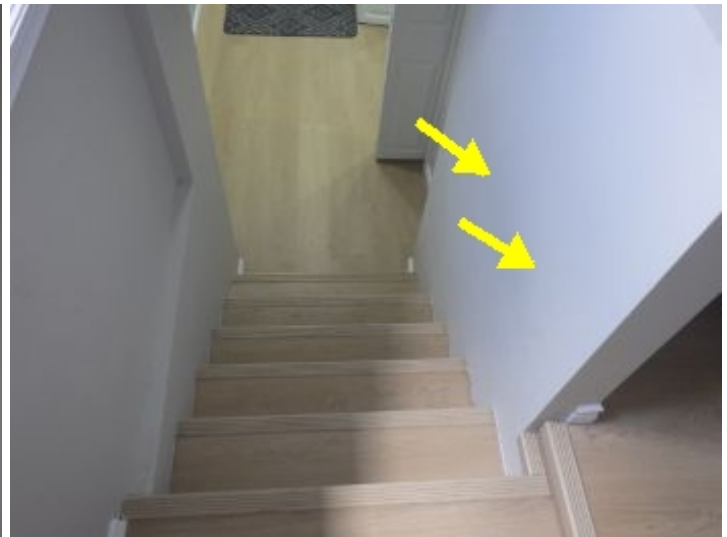
### 1. Stair Conditions

- **Recommend installing handrail as necessary for safety.**
- **Whenever three or more stairs are present a handrail is usually required.**
