Inspection Report

Property Address:
910 Walnut Falls Cir
Mansfield TX 76063

PROPERTY INSPECTION REPORT FORM

Michael Sullivan	11/7/2023
<i>Name of Client</i>	<i>Date of Inspection</i>
910 Walnut Falls Cir, Mansfield, TX 76063	
<i>Address of Inspected Property</i>	
Ernest Johnson	20120
<i>Name of Inspector</i>	<i>TREC License #</i>
<i>Name of Sponsor (if applicable)</i>	<i>TREC License #</i>

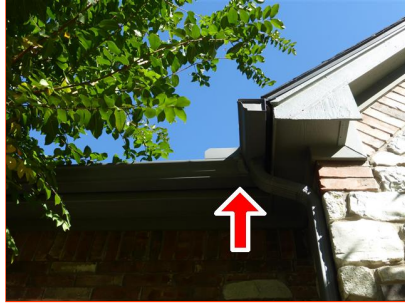
B. Item 1(Picture)

(2) The gutter appears to leak at seam on front of home. Recommend cleaning and apply gutter sealant or epoxy.

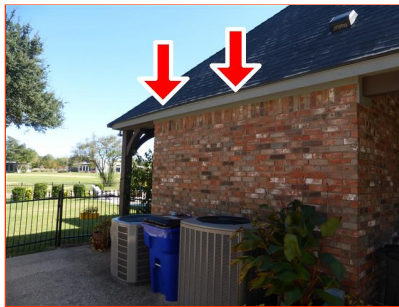
B. Item 3(Picture)

(3) Roof above exterior condensers was observed without gutters or diverter to direct water during rain. Overtime excessive splash and water infiltration can cause condenser wear.

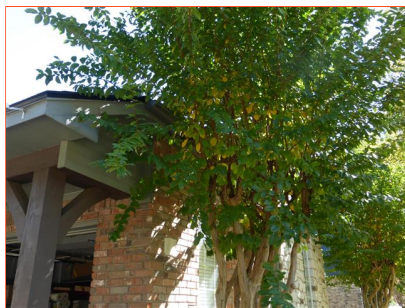
B. Item 4(Picture)

(4) Trees / Shrubs and excessive grade were observed at front, rear, and exterior sides of home. Too much foliage and excessive grade can potentially allow the entry of unwanted insects to enter and create more problems or cause water to enter the structure.

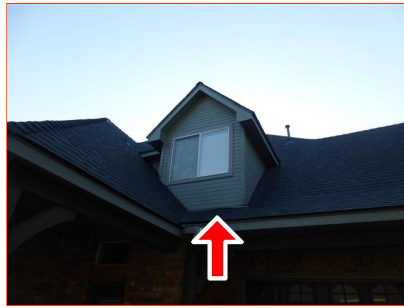
C. Item 1(Picture)

(2) Flashing located at left side of roof observed pulling up exposing nails. Recommend a qualified contractor inspect and repair.

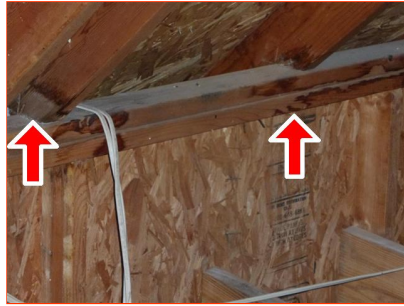
D. Item 1(Picture)

(2) Evidence of moisture stains were observed within the attic. Due to lack of heavy rain during the inspection we are unable to determine if conditions noted are older conditions or if current conditions still exist. We recommend inquiring with seller of any past issues or repairs.

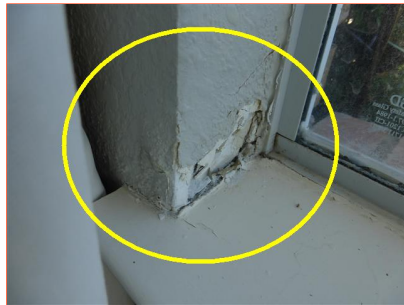
E. Item 1(Picture)

- (1) Exterior coach lamps were found without adequate sealant around fixtures and wall.
- (2) Moisture wear and damage was visible at sections of wall, trim, and window seal inside master bedroom. This makes conditions behind wall and trim unknown and we recommend inquiring with sellers of past issues or a qualified contractor inspect, evaluate, and repair.

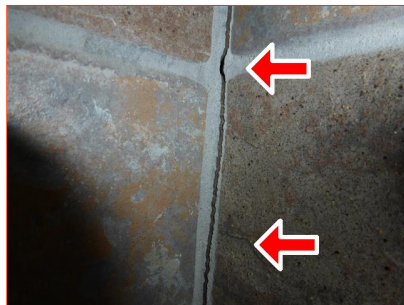
E. Item 3(Picture)

- (3) Sections of wall tiles located inside enclosures of "all" showers in the home were observed in need of caulking improvements in wall corners, edges, escutcheon's, fixtures, drains, and junctions. Caulking improvements are needed to prevent water intrusion behind walls. The exposed areas noted can lead to chronic moisture intrusion and makes wall conditions behind tiles unknown. We recommend repair or improvements using a qualified contractor as needed.

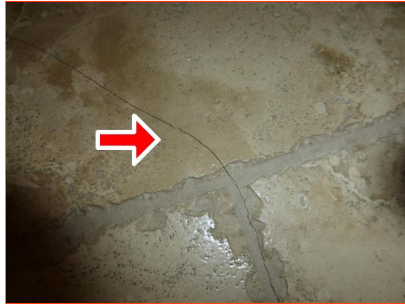
F. Item 1(Picture)

(3) Sections of floor tiles inside formal dining room were found cracked.

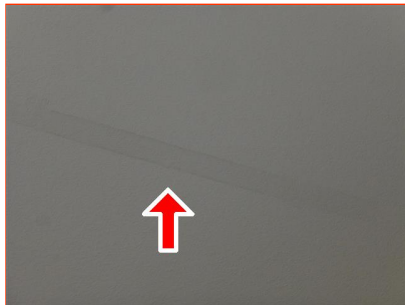
F. Item 3(Picture)

(4) We observed evidence of moisture stains at living room ceiling. It's important to note that the HVAC units are located within the attic above noted evidence. We recommend inquiring with seller of any past issues or repairs or a qualified contractor to further inspect and evaluate.

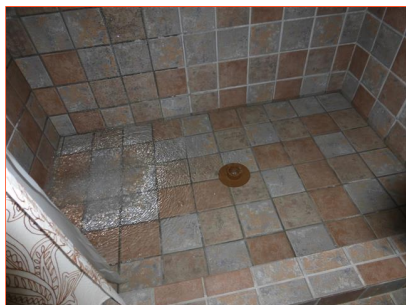
F. Item 5(Picture)

(5) During shower pan test inside guest bath 1 water was seen leaking from exterior slab. We recommend a qualified contractor further inspect, evaluate, and repair prior to close.

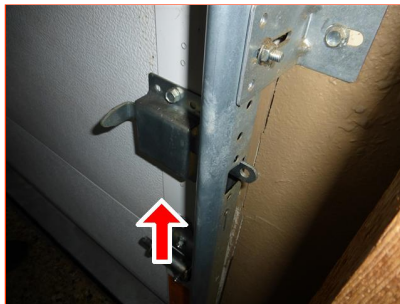
G. Item 1(Picture)

- (1) A few interior / exterior doors were observed not holding at strike plates, catching against door jam, not properly securing, were missing stops or door hardware, or were found swinging. Repairs may involve adjustment or installation of door hardware.
- (2) We found double vehicle garage door locking mechanism engaging while using mechanical overhead door operator.

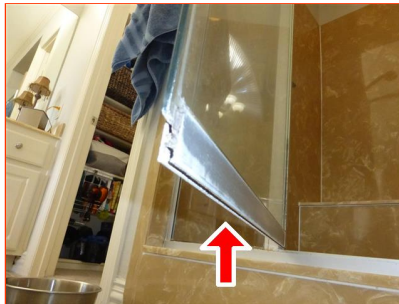
G. Item 2(Picture)

- (3) Splash guard was observed missing from bottom of master bath shower door.

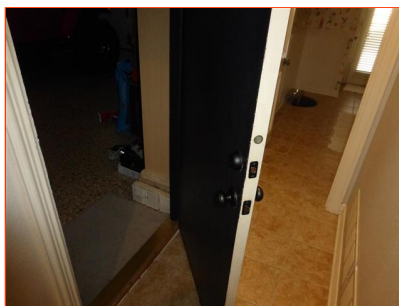
G. Item 3(Picture)

(4) Door leading from home to garage was found **not** self closing.

NOTE: R302.5

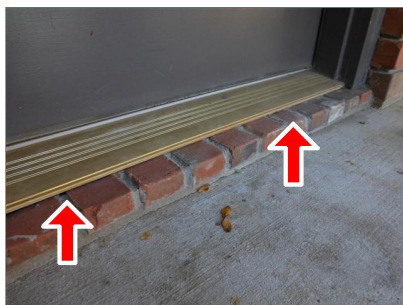
G. Item 4(Picture)

(5) Sealant improvements were found needed at **(all)** exit door thresholds.

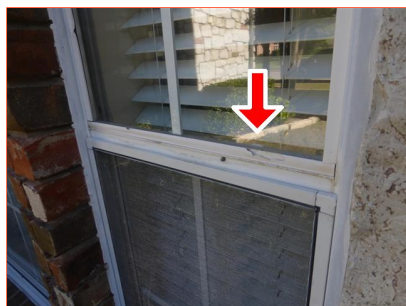
H. Item 1(Picture)

- (2) Caulking improvements were observed needed at various window edges throughout the home at interior and exterior.
- (3) We observed a few windows with torn or missing window screens.
- (4) Sections of window trim was seen worn or damaged at exterior side of a several windows.

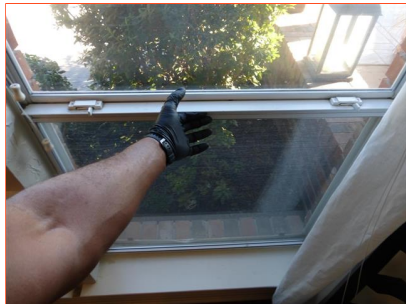
H. Item 3(Picture)

- (5) Multiple windows throughout the home were found closed stiff and could not be opened using normal force.

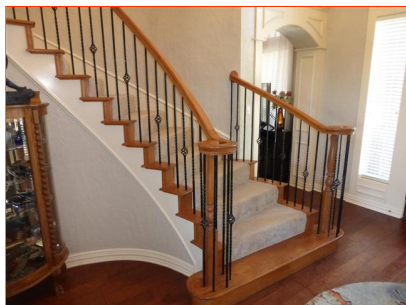
I. Item 1(Picture)

Stairs, handrails, and balusters were inspected and several balusters were observed loose at rails.

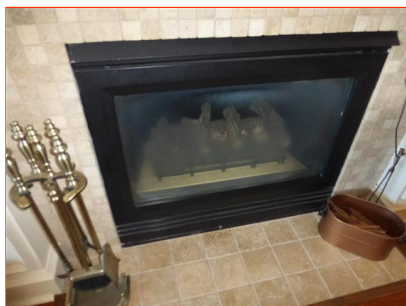
J. Item 1(Picture)

(2) Evidence of etching / film was observed at glass insert at fireplace opening.

It's important to note: The white film is sulfuric acid. All fossil fuel produces sulfur during the combustion process, and when this sulfur is mixed with moisture, sulfuric acid is created. The white film (acid) may permanently etch the glass and should be removed on a regular basis. Permanent damage might already have occurred to the glass panels and replacement may be necessary.

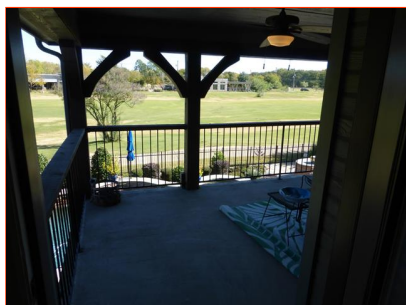
K. Item 1(Picture)

(1) Cracking and separation were visible at sections of upper balcony and wall. Sealing cracks with appropriate material may help to prevent further separation.

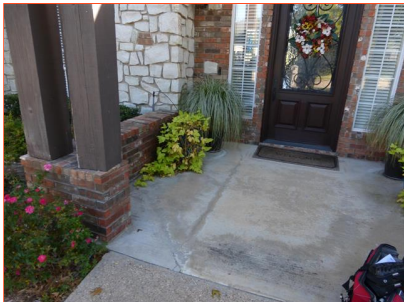
K. Item 5(Picture)

(2) Cracking was observed at sections of front porch and rear pool deck and patio. Sealing cracks with appropriate material may help to prevent further separation. This type of cracking is typically associated to the curing process or human error.

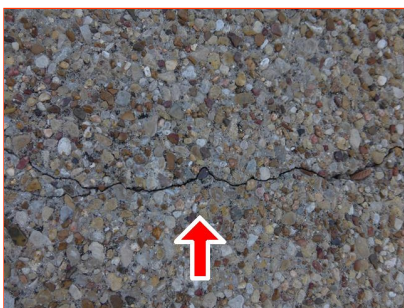
L. Item 1(Picture)

(2) Cracking and separation were observed at sections of concrete driveway. Sealing cracks with appropriate material may help to prevent further separation. If settlement or separation continues it may be necessary for qualified contractor to repair.

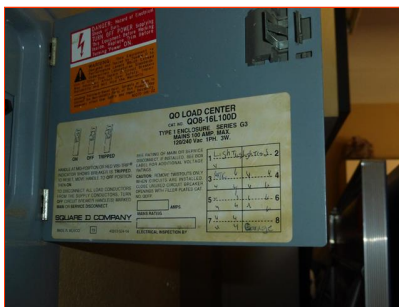
A. Item 1(Picture)

(1) Not all breakers at electrical sub panel were found properly labeled.

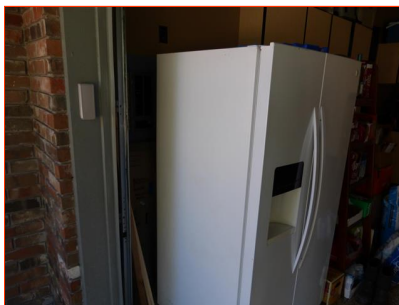
A. Item 2(Picture)

(2) Internal wiring at electrical service panels located in the garage could not be inspected due to seller item blocking panel covers. We were not able to inspect for loose wiring, double taps, neutral separation, under size wiring or overheated wires. There is an additional charge for a separate trip to return and inspect the electrical panel boxes.

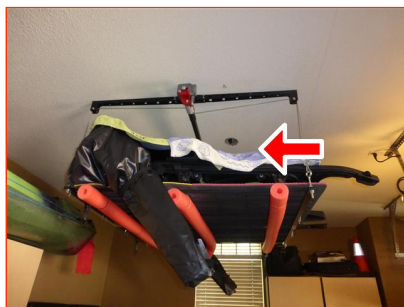
B. Item 1(Picture)

(6) Open / exposed electrical junctions were observed at garage ceiling. Electrical junctions should be enclosed within approved boxes with covers.

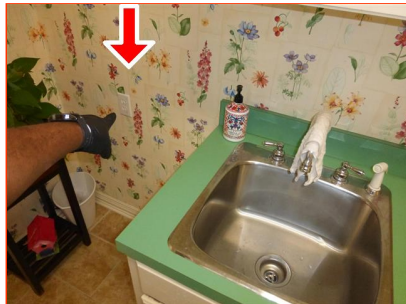
B. Item 3(Picture)

(7) Electrical outlet near laundry room sink was found **not** GFCI (Ground Fault Circuit Interrupter) protected. GFCI outlets at kitchens, baths, garages, exterior, and outlets near water sources are recommended for added protection.

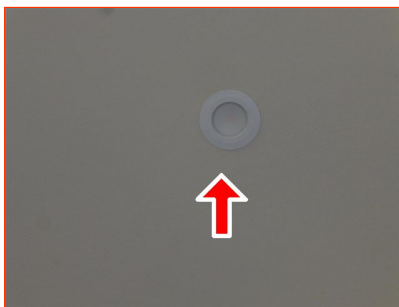
B. Item 5(Picture)

(8) It appears there may be a two way wall switch installed at main living room controlling ceiling can lights instead of a three way wall switch. This is considered a mis-wire and a licensed electrician should inspect and evaluate.

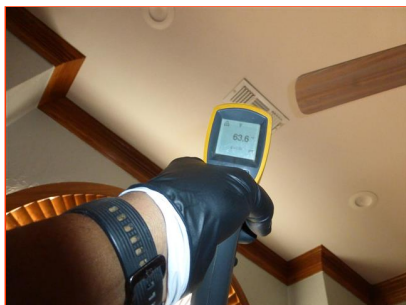
C. Item 1(Picture)

(1) Register readings were taken at each register to determine proper heating and cooling. Air register temperatures inside study room and master bath closet were found with more than 10 degree increase in temperature over other air registers. This is considered an imbalance in the ventilation system and we recommend a qualified HVAC technician inspect and evaluate.

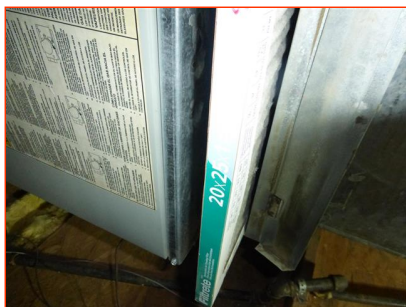
C. Item 3(Picture)

(2) Disposable air filters were found dirty. Failure to change filters regularly could result in poor health as well as high electric bills and future repairs.

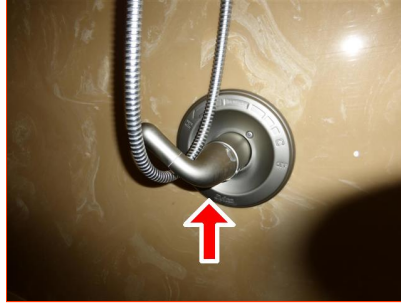
A. Item 2(Picture)

- (3) Right side hot / Cold water valve located inside master bath shower was observed producing temperatures in reverse position. Example: When setting water valve to hot position cold water would flow. Recommend a licensed plumber inspect and repair.

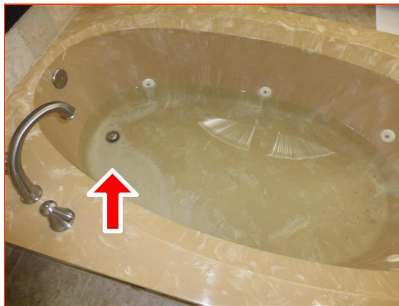
B. Item 2(Picture)

(2) Water was observed slow to drain inside master bath tub. Recommend a licensed plumber inspect and repair.

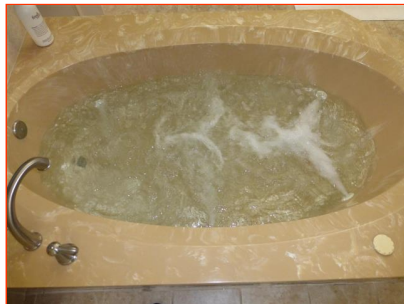
D. Item 1(Picture)

Jet tub located at master bath was observed functioning at the time of the inspection. Quick access to the motor was not observed and therefore we were not able to inspect the motor and suction lines for leaks.

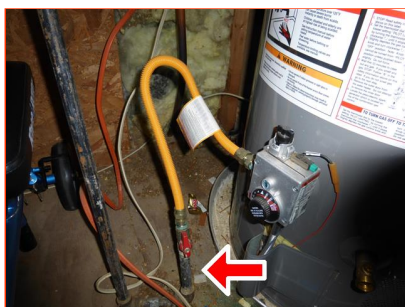
E. Item 2(Picture)

(3) We did not observe dirt legs installed at one of the water heaters and one of the furnace unit gas supply lines. Recommend a licensed plumber inspect and repair as needed.

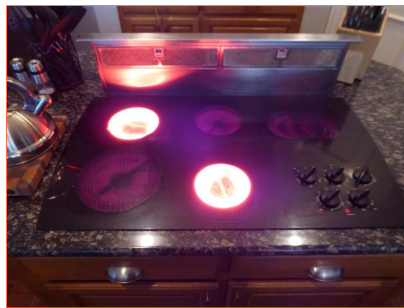
D. Item 1(Picture)

(2) Two cooktop heating elements were observed brighter than other elements which may indicate halogen cookers or possible malfunction.

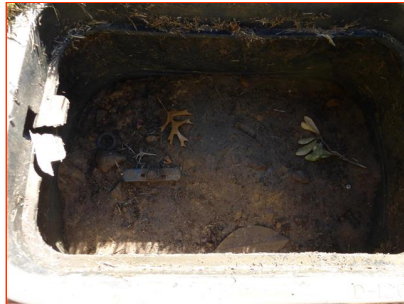
A. Item 1(Picture)

(3) Handle at sprinkler backflow valve near street was observed covered with earth and worn or rusted off.

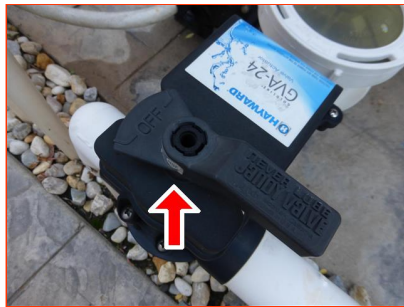
B. Item 2(Picture)

(4) Two Jandy valves were found lacking twist locks at the handles.

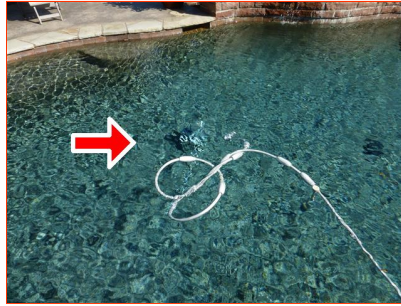
B. Item 7(Picture)

(7) Polaris was **not** functioning as intended during the inspection.

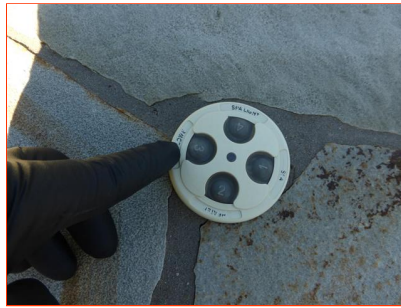
B. Item 8(Picture)

(8) Spa blower pressure switch at spa edge was inspected and found not functioning as intended during the inspection.

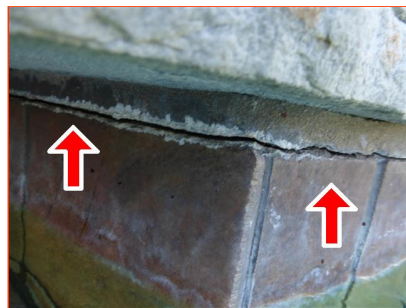
B. Item 9(Picture)

(9) Separation was visible along areas between coping and pool wall.

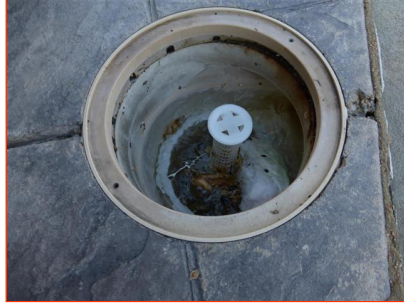
B. Item 11(Picture)

(10) During inspection inside skimmer basket we noticed cracks inside basket wall. We are unable to determine if cracks are superficial or if they penetrate through the basket material. We recommend a pool specialist inspect and evaluate.

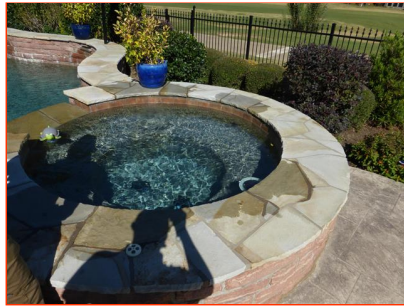
B. Item 13(Picture)

(11) Spa light was observed not functioning during the inspection. Recommend a qualified pool specialist inspect and repair.

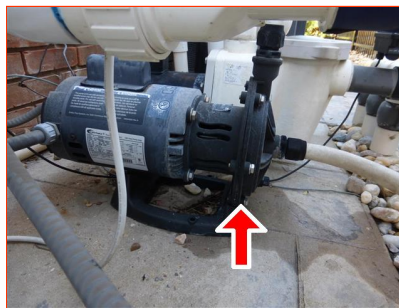
B. Item 15(Picture)

(12) Leaks were observed at identified pool equipment locations below. We recommend a licensed pool specialist inspect and repair.

A: Cleaner pump at propeller housing
