INSPECTION REPORT

For the Property at:
200 FRONT STREET WEST
HASTINGS, ON

Prepared for: TEAM VANRAHAN
Inspection Date: Wednesday, January 10, 2024
Prepared by: David Sharman

RE: Report No. 4632
200 Front Street West
Hastings, ON

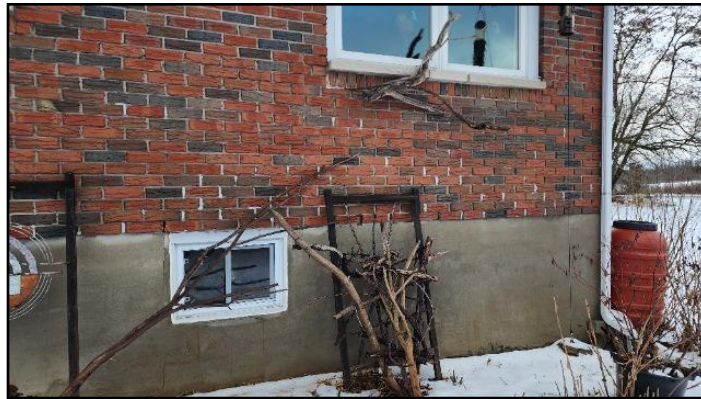
4. **Condition:** • Prior repairs

Implication(s): No implications exist for this condition

Location: Rear left corner

3. *Prior repairs*

Task: Monitor

Time: Ongoing

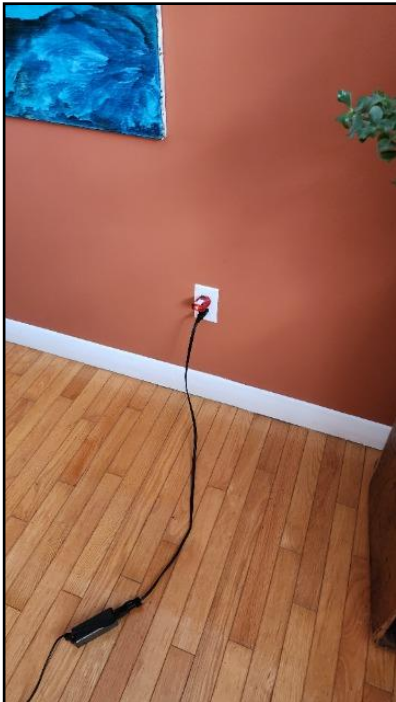
5. Condition: • Ungrounded

Implication(s): Electric shock

Location: Various locations

7. Ungrounded

Task: Repair

Time: As soon as is practicable

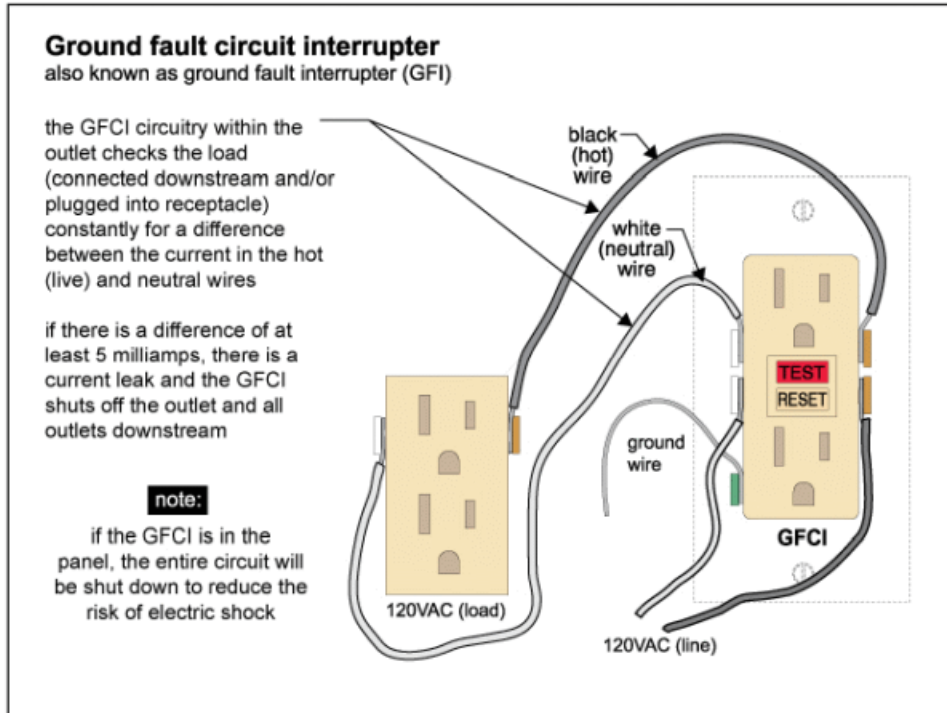
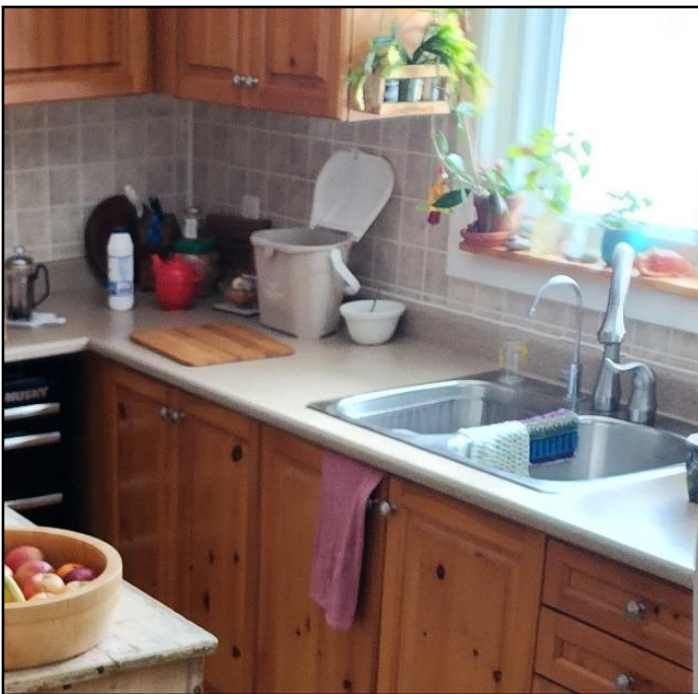
6. Condition: • No GFCI/GFI (Ground Fault Circuit Interrupter)

Although not a deficiency in a home of this age safety may be improved by upgrading these receptacles

Implication(s): Electric shock

Location: Kitchen & exterior wall

13. No GFCI/GFI (Ground Fault Circuit...

Task: Upgrade

Time: Discretionary

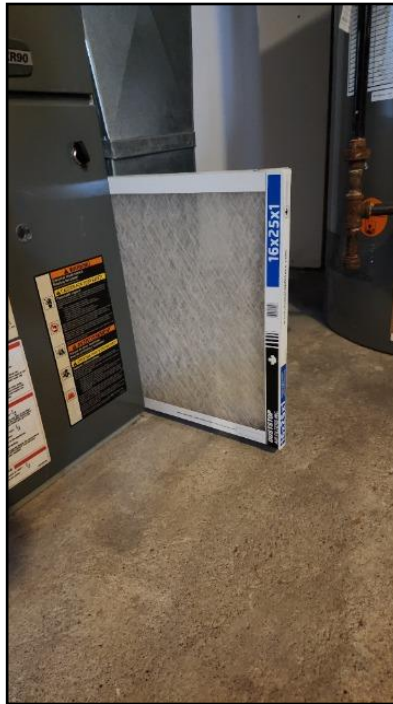
9. Condition: • Replace - regular maintenance

Implication(s): Increased heating & maintenance costs, Reduced comfort

Location: Cold air return

21. *Replace - regular maintenance*

Task: Replace

Time: Regular maintenance

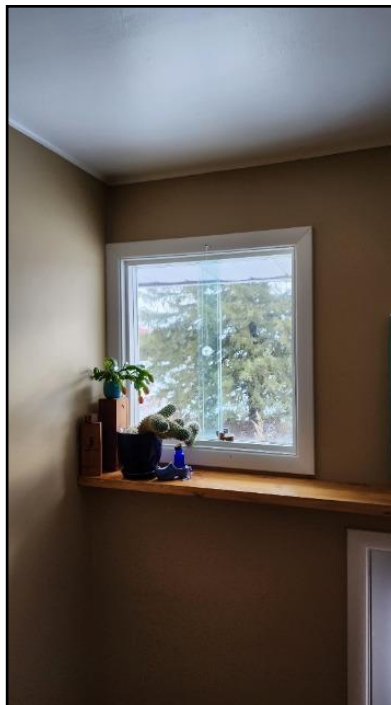
13. Condition: • Original lower quality units

Implication(s): Increased heating costs | Increased maintenance costs

Location: Kitchen

28. *Original lower quality units*

Task: Upgrade

Time: Discretionary

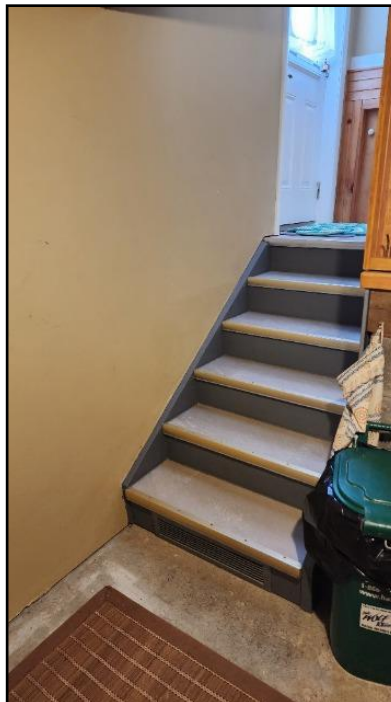
14. Condition: • Missing

Implication(s): Fall hazard

Location: Basement

29. Missing

Task: Provide

Time: Discretionary
