# INSPECTION REPORT

For the Property at:  
**22 RAGLAN STREET NORTH**  
CAMPBELLFORD, ON K0L 1L0

RE: Report No. 5158  
22 Raglan Street North  
Campbellford, ON  
K0L 1L0

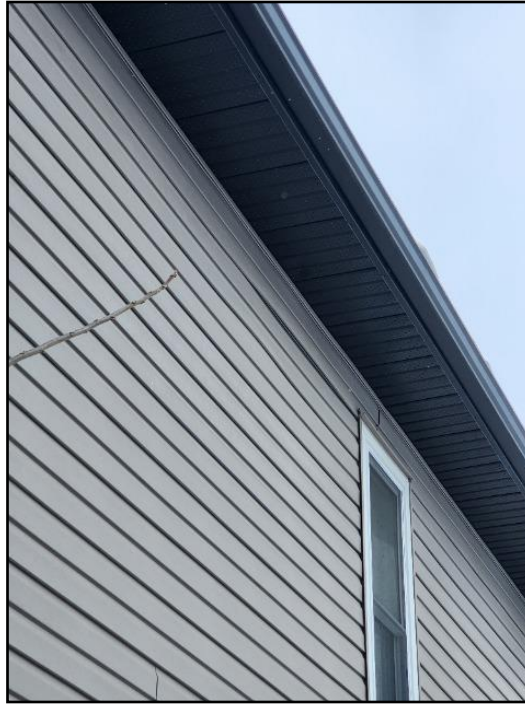
**2. Condition:** • Loose

**Implication(s):** Chance of water damage to structure, finishes and contents

**Location:** Left elevation

1. Loose

**Task:** Repair

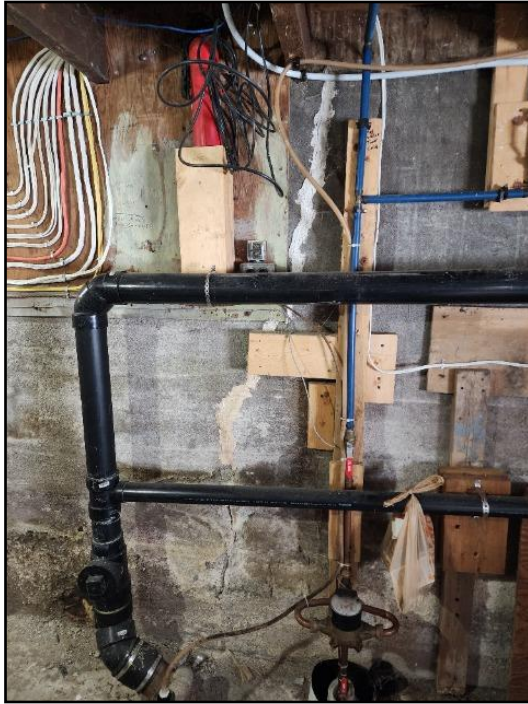
**3. Condition:** • Typical minor cracks

**Implication(s):** Material deterioration

**Location:** Front & left elevations

2. Typical minor cracks

**Task:** Monitor

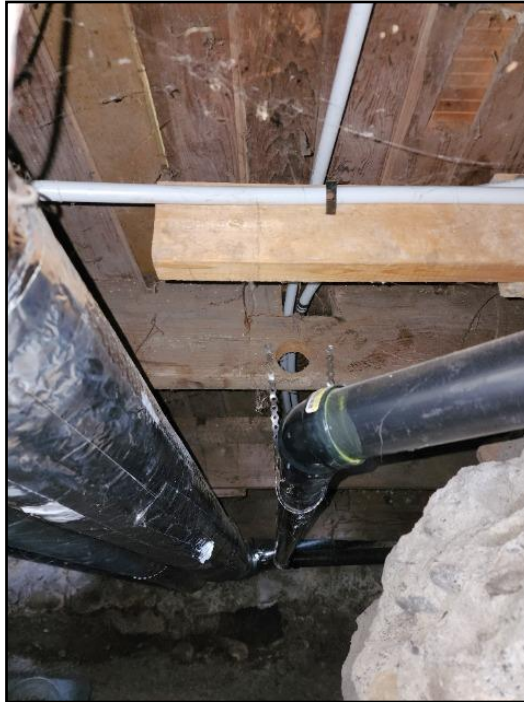
**6. Condition:** • Notches or holes  
**Implication(s):** Weakened structure  
**Location:** Crawlspace  
**Task:** Monitor  
**Time:** Ongoing

5. Notches or holes

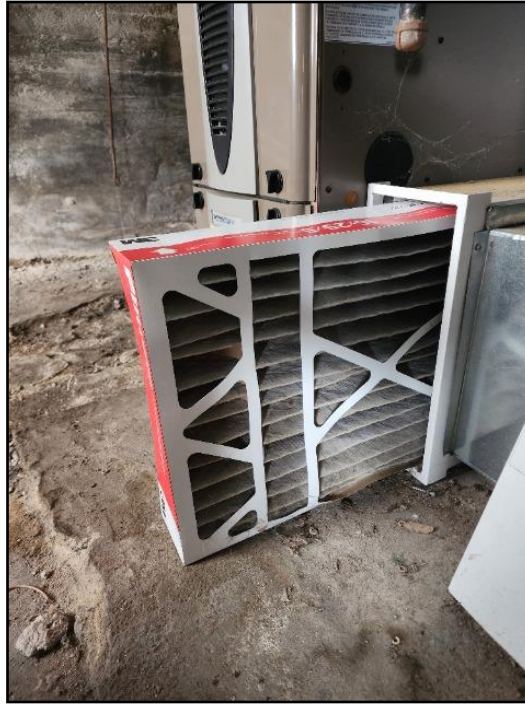
**8. Condition:** • Replace - regular maintenance

**Implication(s):** Increased heating & maintenance costs, Reduced comfort

**Location:** Cold air return

14. Replace - regular maintenance

**Task:** Replace - regular maintenance

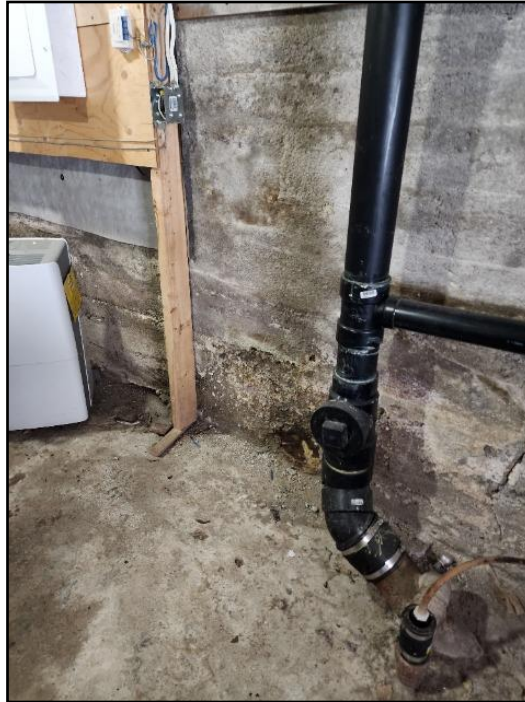
**12. Condition:** • Crumbling/spalling masonry, concrete or plaster

**Implication(s):** Chance of water damage to structure, finishes and contents | Material deterioration

21. *Crumbling/spalling masonry, concrete or...*

**Task:** Repair

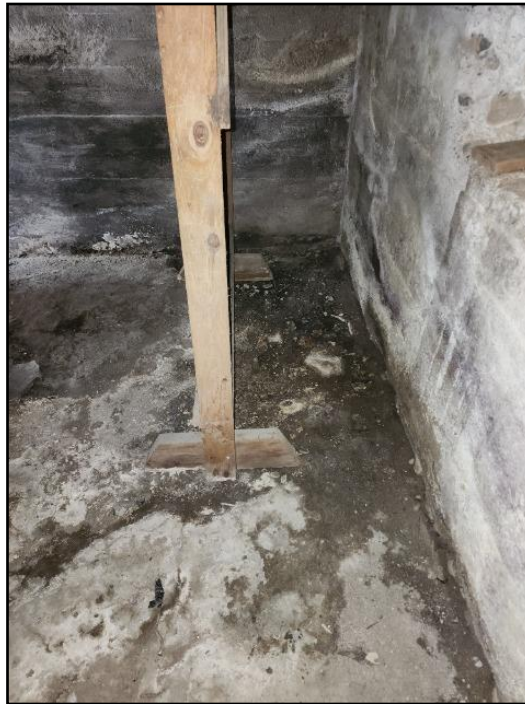
**13. Condition:** • Dampness on floor or walls

**Implication(s):** Chance of water damage to structure, finishes and contents | Material deterioration

*22. Dampness on floor or walls*

**Task:** Monitor

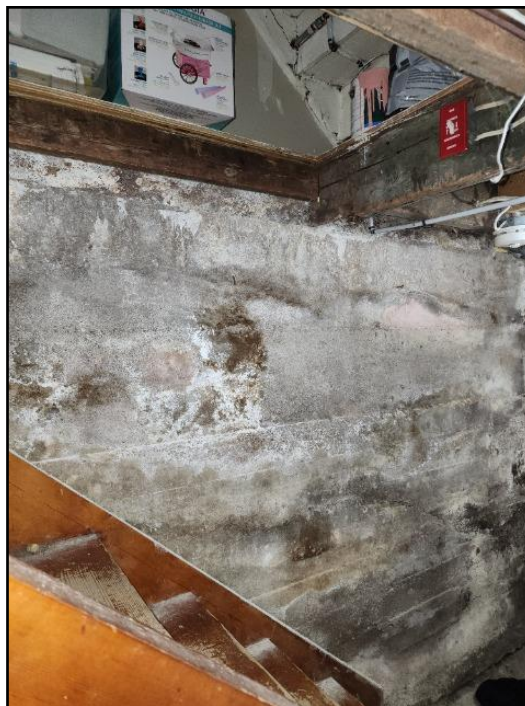
**14. Condition:** • Efflorescence

**Implication(s):** Chance of water damage to structure, finishes and contents

23. Efflorescence

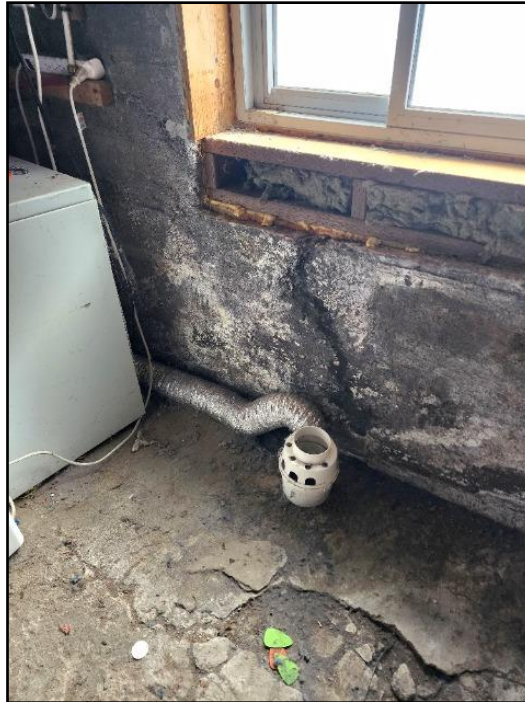
15. Condition: • Dryer not vented to exterior

**Implication(s):** Chance of condensation damage to finishes and/or structure

**24.** Dryer not vented to exterior
