# Peterson Home Inspection Services Inc.

10818 Lakeview Dr  
Carmel, Indiana 46033

Inspection Date 07/10/2024

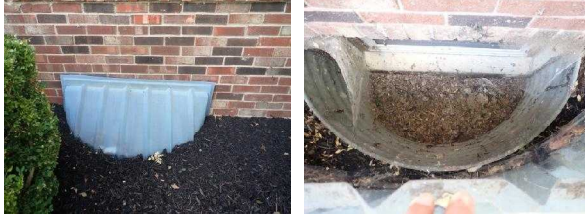
9.      Window Wells: Covered

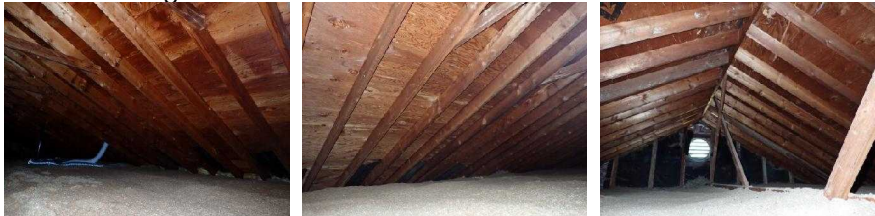
1. Method of Inspection: In Attic Where Accessible  
2.      Roof Framing: 2x Dimensional Lumber

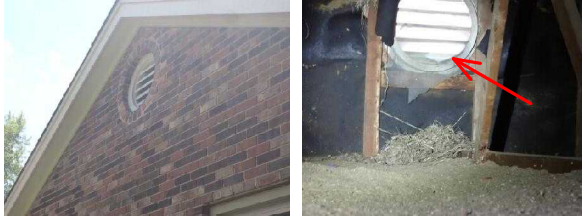
- 4.      Ventilation: Gable, Ridge and Soffit Vents: Screen was torn at the gable vent - repair is recommended to help prevent animal entry.

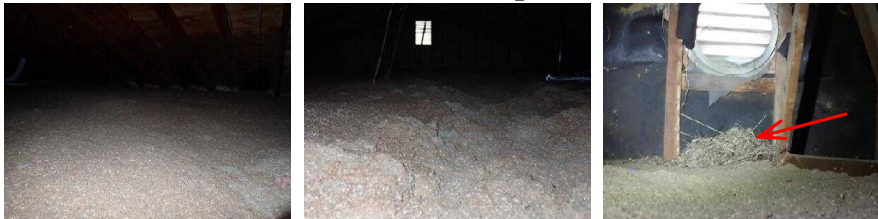
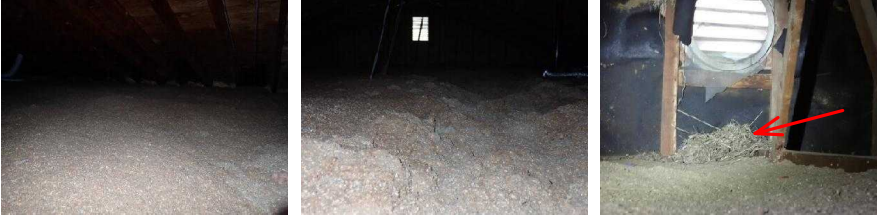
- 5.      Insulation: Cellulose: Bird nesting material was noted in the attic - recommend removal and clean up.

6. House & Garage Attic Insulation: Cellulose: Bird nesting material was noted in the attic - recommend removal and clean up.

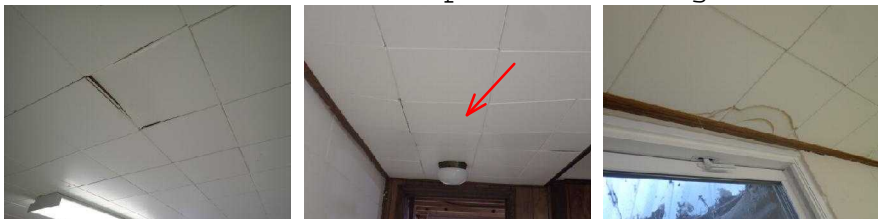
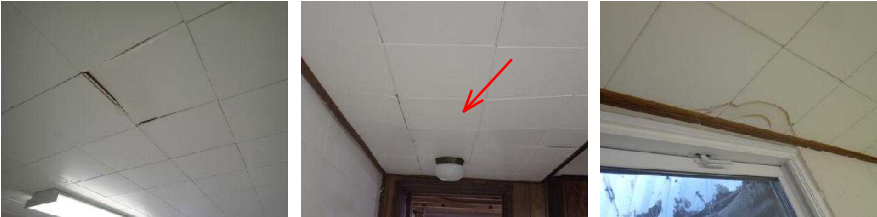
- 1.      Ceiling: Ceiling Tiles & Exposed Framing: Ceiling tiles were loose, damaged or sagging at one or more places - repair is recommended. Stains were noted due to previous leakage.

7. Main Basement Ceiling: Ceiling Tiles & Exposed Framing: Ceiling tiles were loose, damaged or sagging at one or more places - repair is recommended. Stains were noted due to previous leakage.

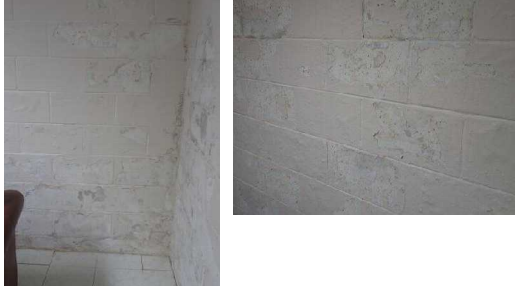
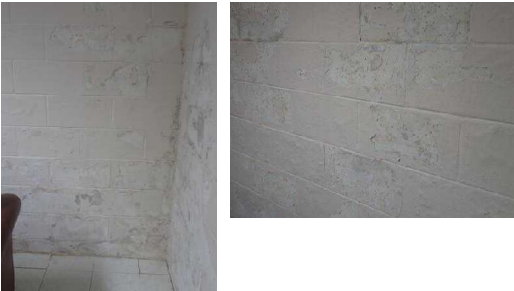
2.      Walls: Block, Paneling & Exposed Framing: Leakage stains and efflorescence were noted at the walls. Repair by a qualified contractor is recommended.

8. Main Basement Walls: Block, Paneling & Exposed Framing: Leakage stains and efflorescence were noted at the walls. Repair by a qualified contractor is recommended.

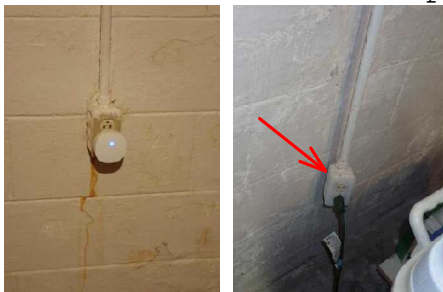
7.      Electrical: 120 VAC Outlets & Lighting Circuits: Junction boxes were not secured to the wall - repair is recommended.

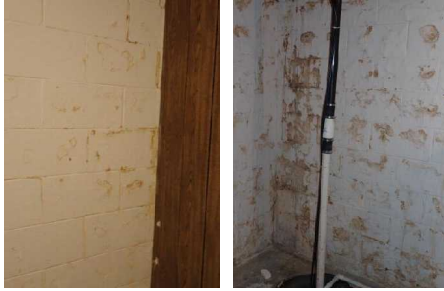
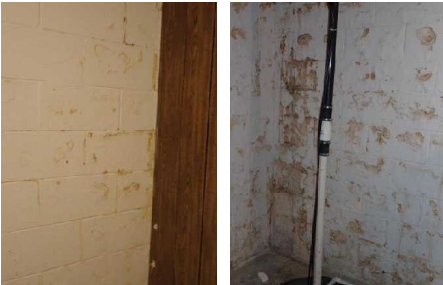
- 12.      Moisture Location: Entire Basement: Evidence was noted of ongoing water penetration. Reducing moisture intrusion is recommended to help prevent mold, wood rot and damage to the framing. Leakage is always possible with block basements. Homeowner must provide and maintain proper grading and drainage away from the house to help reduce water entry.

9. Main Basement Moisture Location: Entire Basement: Evidence was noted of ongoing water penetration. Reducing moisture intrusion is recommended to help prevent mold, wood rot and damage to the framing. Leakage is always possible with block basements. Homeowner must provide and maintain proper grading and drainage away from the house to help reduce water entry.

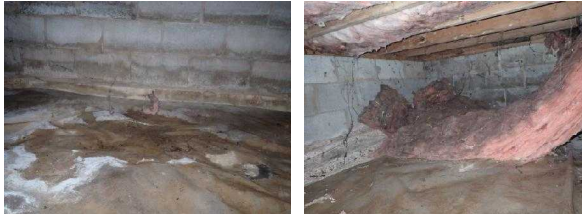
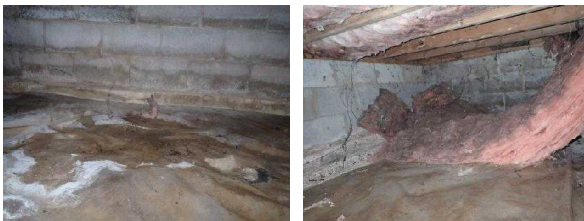
- 1. Method of Inspection: In The Crawl Where Accessible
- 2.      Access: Metal Door
- 3.      Moisture Penetration: Evidence Of Occasional Moisture Penetration: Reducing moisture intrusion is recommended to help prevent mold, wood rot and damage to the framing. Leakage is always possible with block foundations. Homeowner must maintain proper grading and drainage to help reduce water in the crawl.

11. Main Crawl Space Moisture Penetration: Evidence Of Occasional Moisture Penetration: Reducing moisture intrusion is recommended to help prevent mold, wood rot and damage to the framing. Leakage is always possible with block foundations. Homeowner must maintain proper grading and drainage to help reduce water in the crawl.

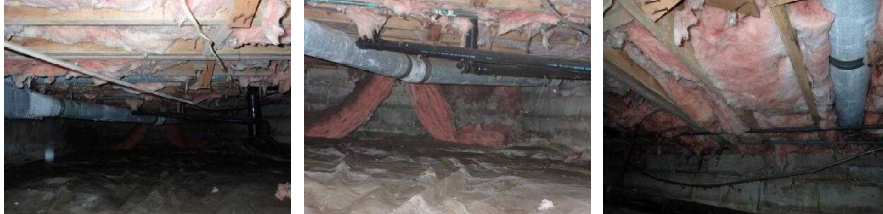
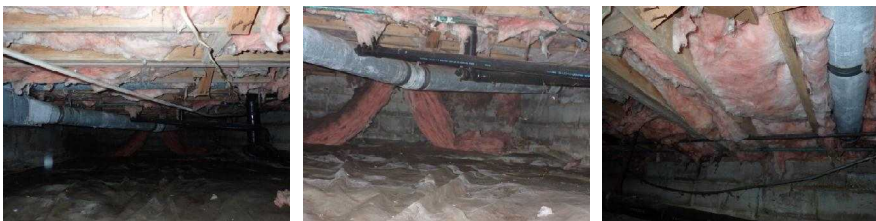
- 6.      Insulation: Underfloor: Insulation was loose and dangling. Under floor insulation may trap moisture and contribute to conditions favorable for mold growth and wood rot. Recommend this insulation be removed and the framing be further evaluated.

12. Main Crawl Space Insulation: Underfloor: Insulation was loose and dangling. Under floor insulation may trap moisture and contribute to conditions favorable for mold growth and wood rot. Recommend this insulation be removed and the framing be further evaluated.

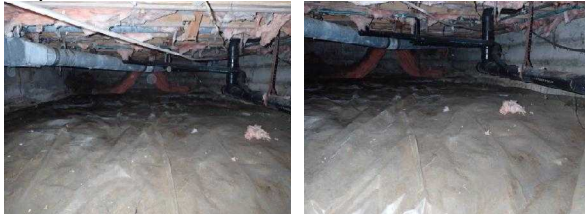
- 7.      Vapor Barrier: Entire Crawlspace

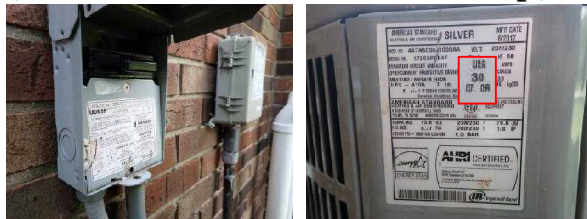
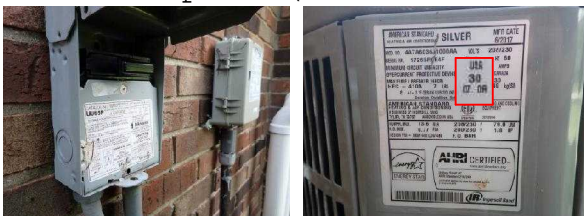
9.      Electrical Disconnect: Pull Out Switch, 30 Amp Max: 40 Amp breaker in panel (max breaker allowed is 30 Amp) - install properly sized breaker.

14. Exterior Right Side AC System Electrical Disconnect: Pull Out Switch, 30 Amp Max: 40 Amp breaker in panel (max breaker allowed is 30 Amp) - install properly sized breaker.

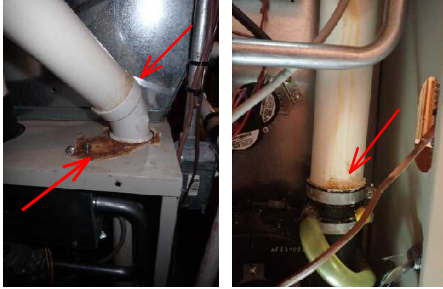
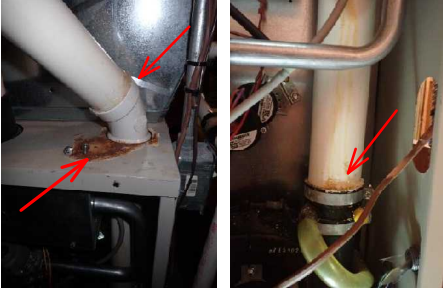
10.      Flue Pipe: PVC: Evidence of past leakage was noted at the flue pipe - joint was heavily caulked. Repair by a qualified contractor is recommended.

15. Basement Heating System Flue Pipe: PVC: Evidence of past leakage was noted at the flue pipe - joint was heavily caulked. Repair by a qualified contractor is recommended.
