# INSPECTION REPORT

For the Property at:  
**4533 HIGHWAY 37**  
THOMASBURG, ON

Prepared for: TEAM VANRAHAN  
Inspection Date: Monday, June 5, 2023  
Prepared by: David Sharman

RE: Report No. 4343, v.2  
4533 Highway 37  
Thomasburg, ON

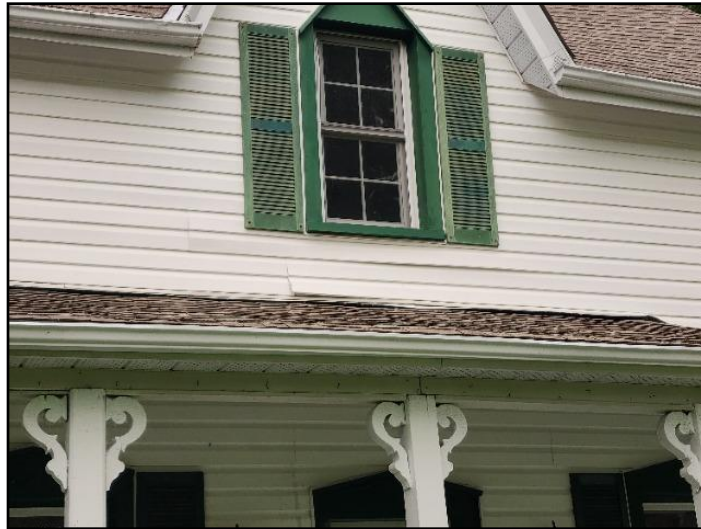
**2. Condition:** • Loose/missing pieces

**Implication(s):** Chance of water damage to structure, finishes and contents

**Location:** Front elevation

6. Loose/missing pieces

**Task:** Repair

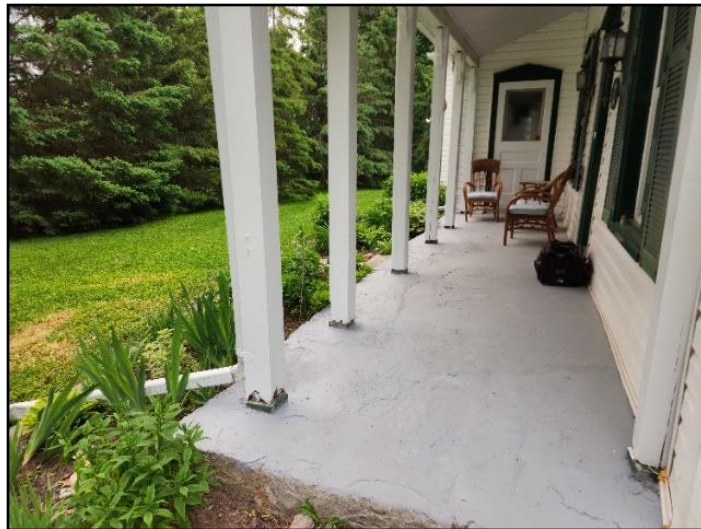
3. Condition: • Rot

Implication(s): Chance of movement | Weakened structure

Location: Porch

7. Rot

Task: Repair or replace

Seller has replaced  
rotted post on front  
porch.

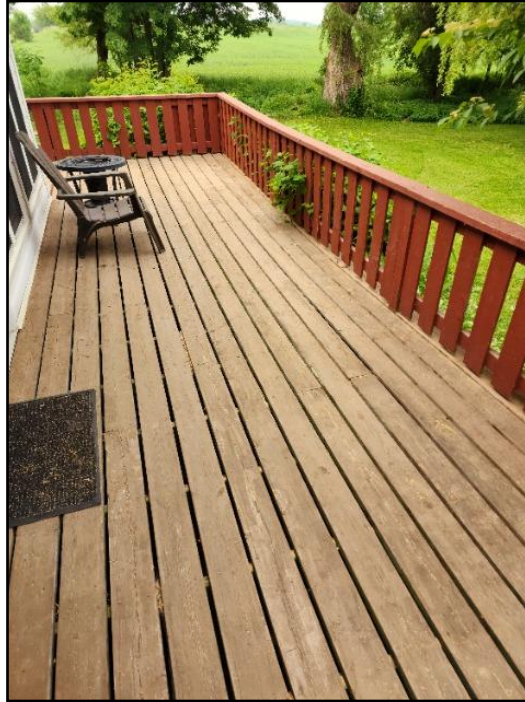
4. Condition: • Sag

Implication(s): Weakened structure | Chance of movement

Location: Raised decking

8. Sag

Task: Repair

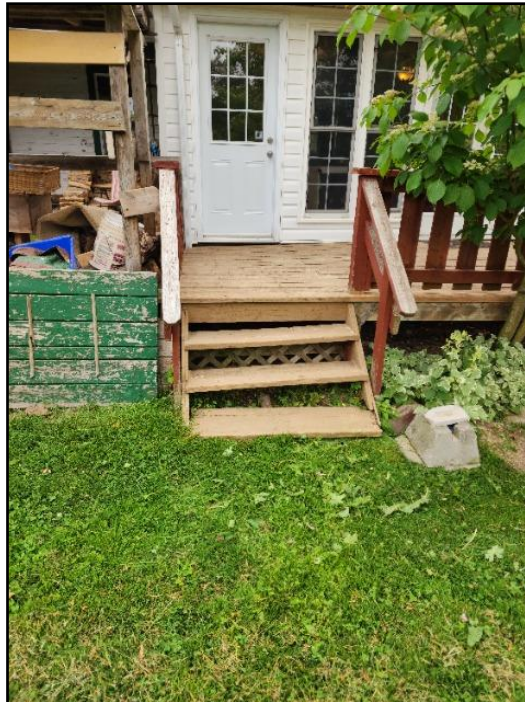
**5. Condition:** • Steps or landings settling

**Implication(s):** Trip or fall hazard

**Location:** Raised decking

9. Steps or landings settling

**Task:** Repair or replace

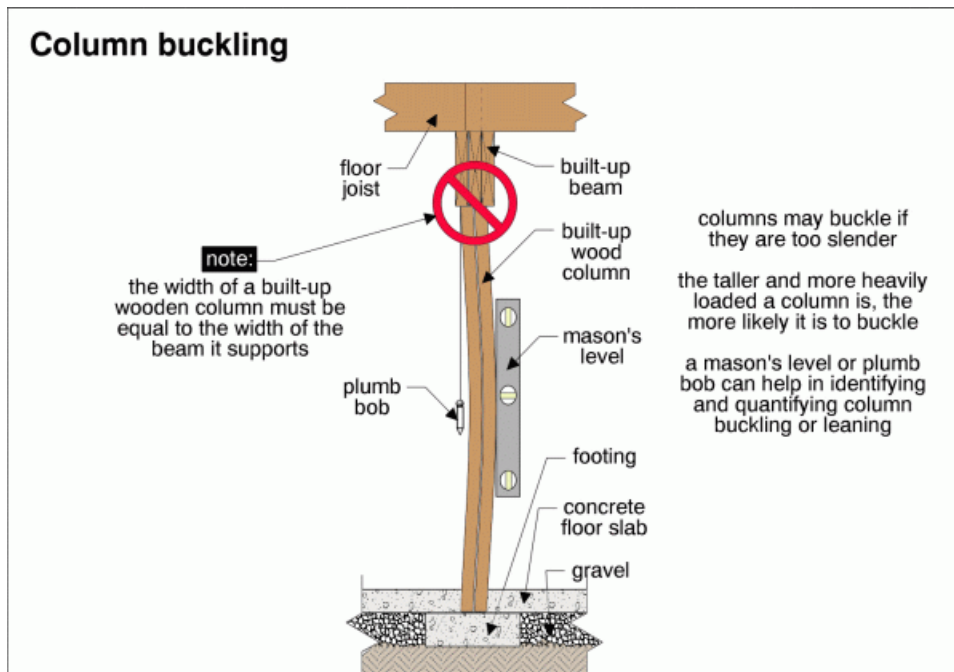
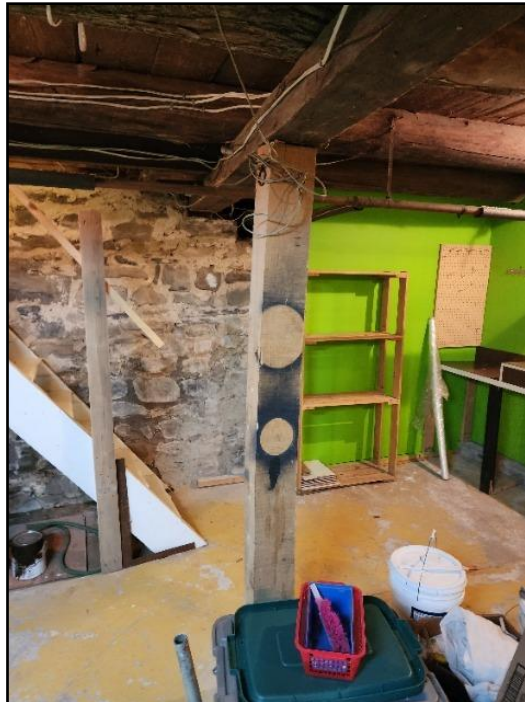
**6. Condition:** • Buckling

**Implication(s):** Chance of structural movement | Weakened structure

**Location:** Basement

10. Buckling

**Task:** Repair or replace

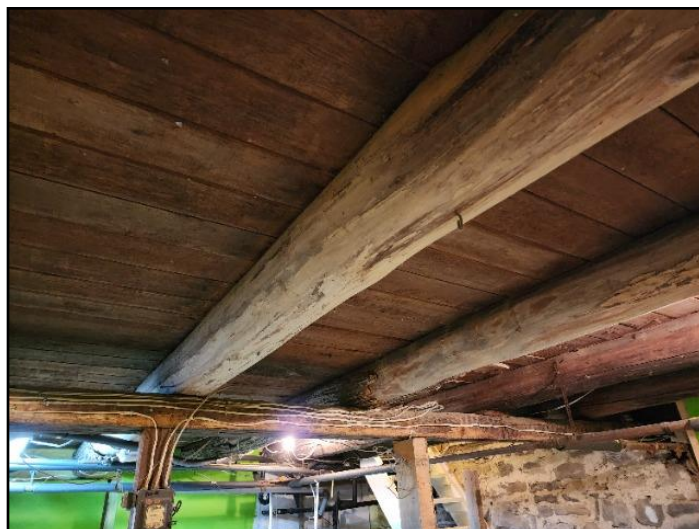
8. **Condition:** • Sagging

Sagging may be indicative of the large spacing between floor joists

**Implication(s):** Chance of structural movement | Weakened structure

**Location:** Various locations

11. Sagging

**Task:** Monitor

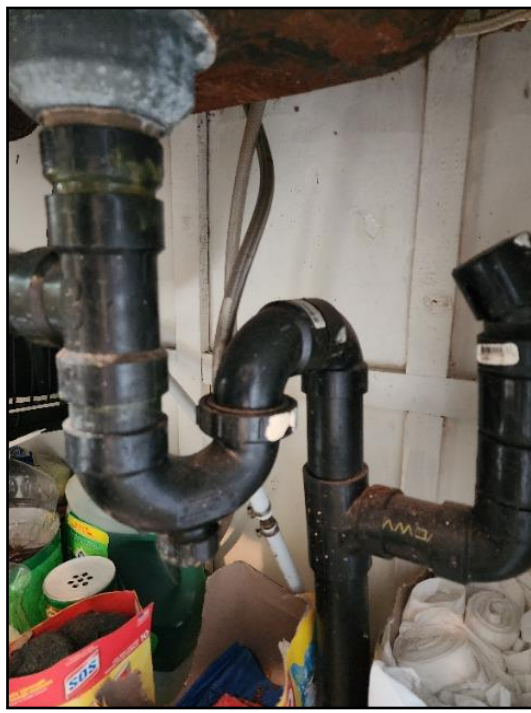
**11. Condition:** • Wrong type

30. Wrong type

**Task:** Monitor

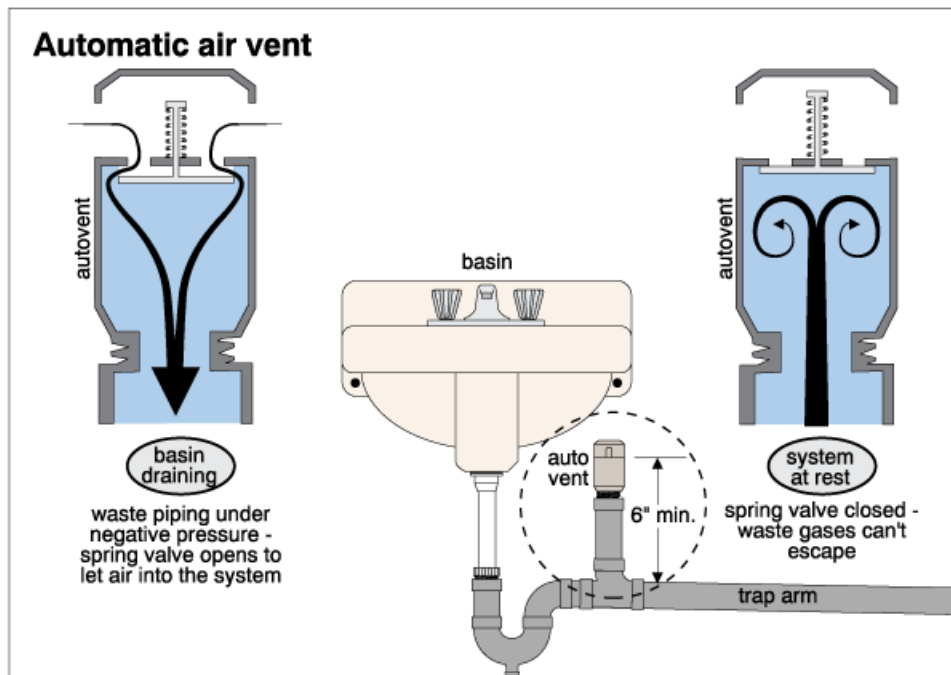
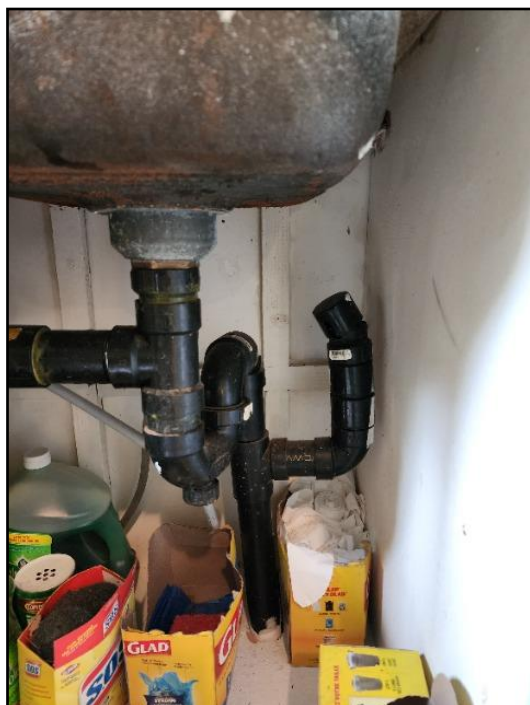
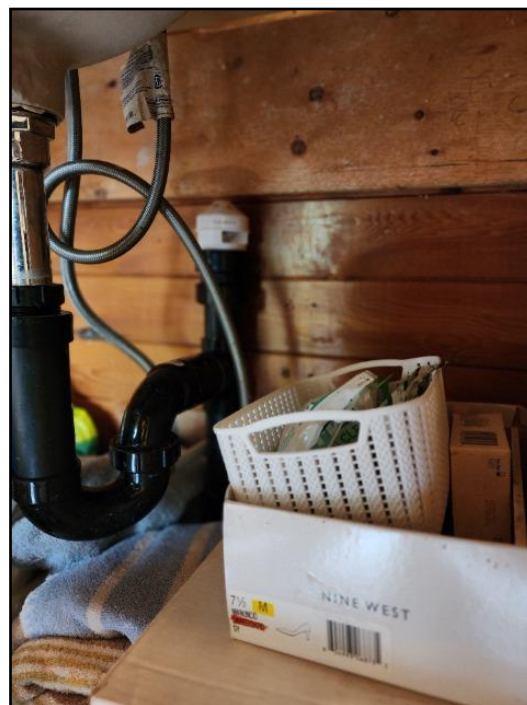
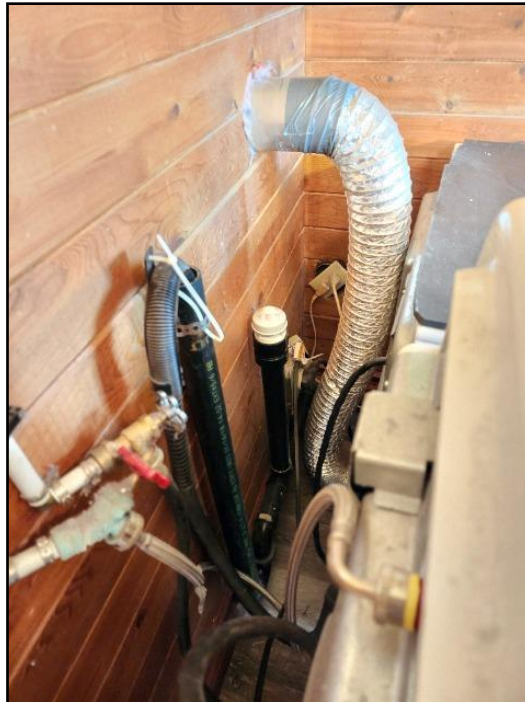
31. Kitchen

12. Condition: • Automatic air vents

Implication(s): Failure may allow sewer gasses to enter building

Task: Monitor

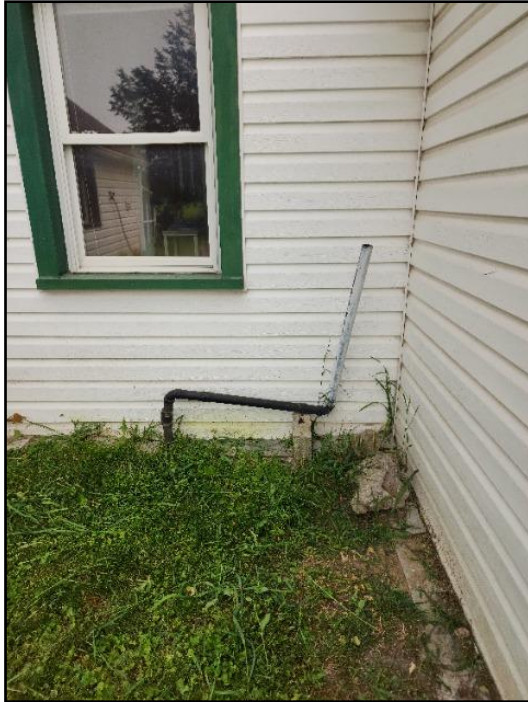
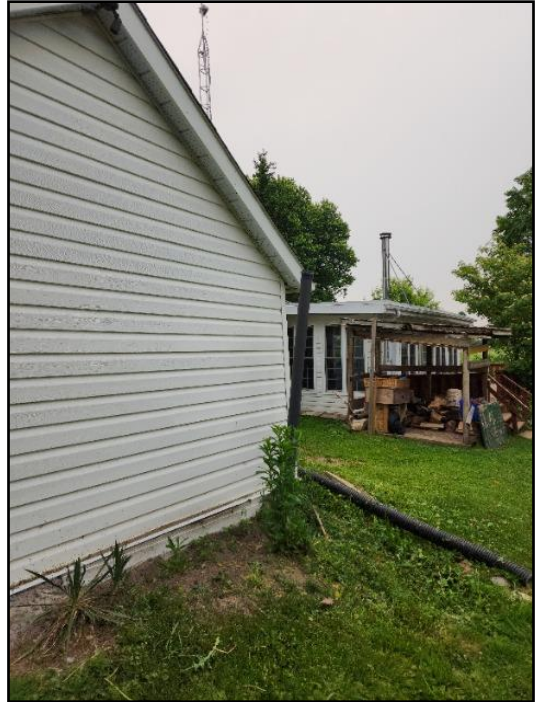
**13. Condition:** • Vent termination problems

34. Vent termination problems

35. Vent termination problems

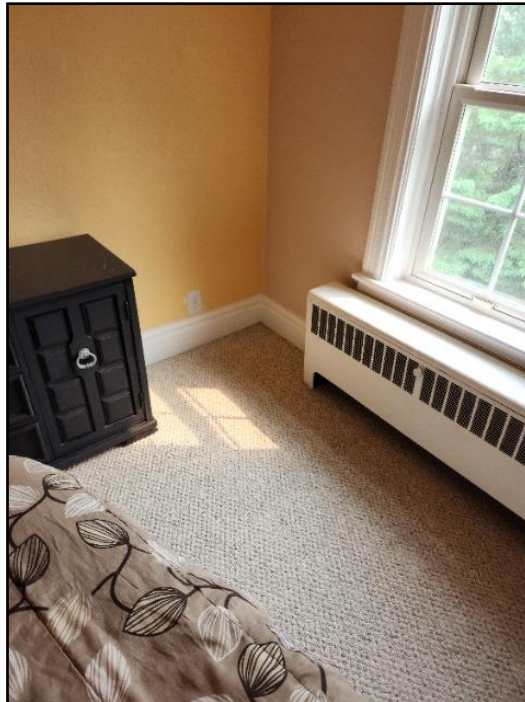
**14. Condition:** • Damage

**Implication(s):** Trip hazard

36. Damage

**Task:** Repair

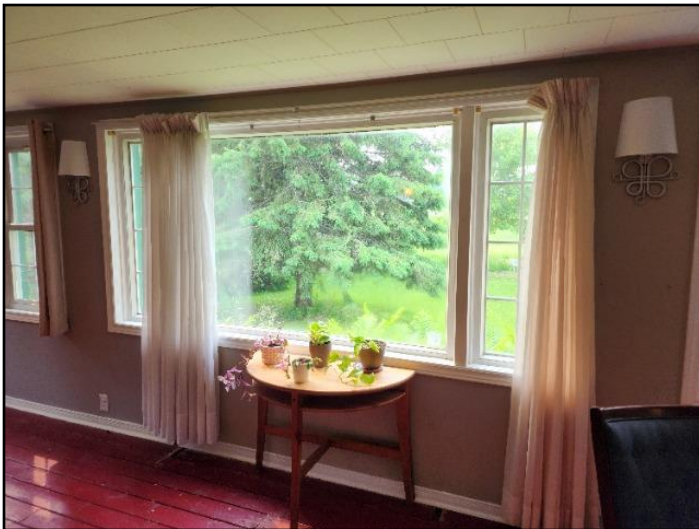
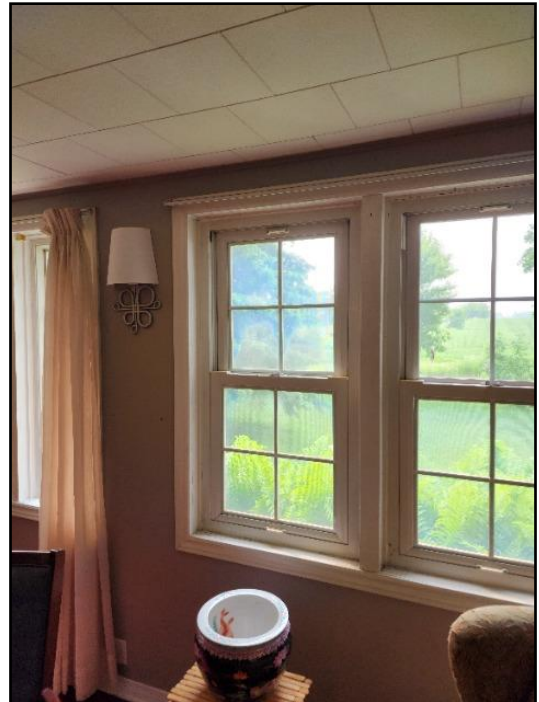
**15. Condition:** • Lost seal on double glazing

37. Lost seal on double glazing

**Task:** Repair or replace

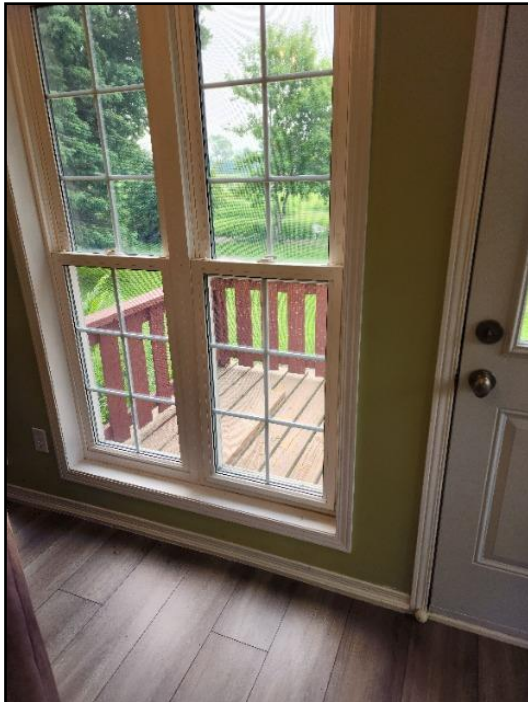
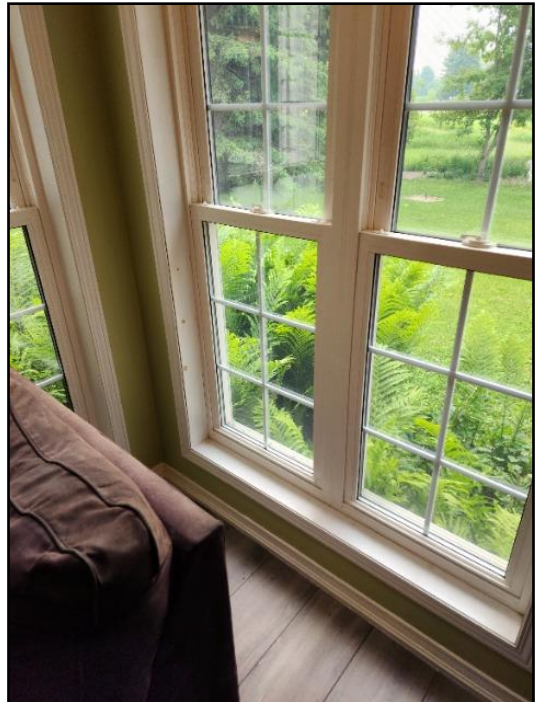
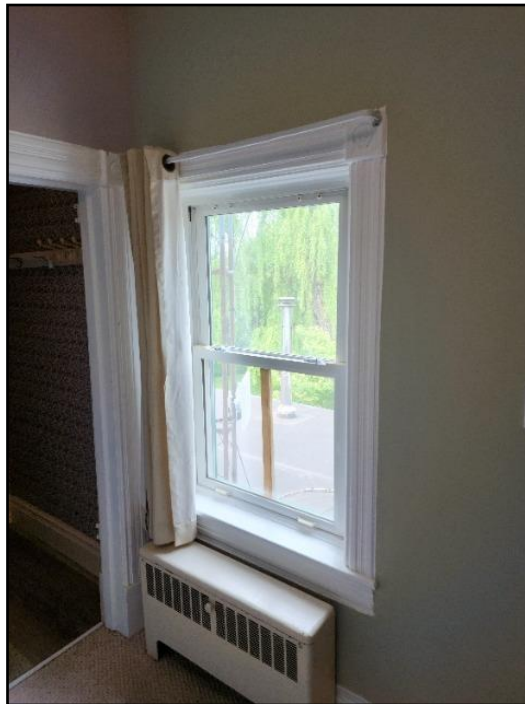
**16. Condition:** • Won't stay open

39. Won't stay open

**Task:** Repair

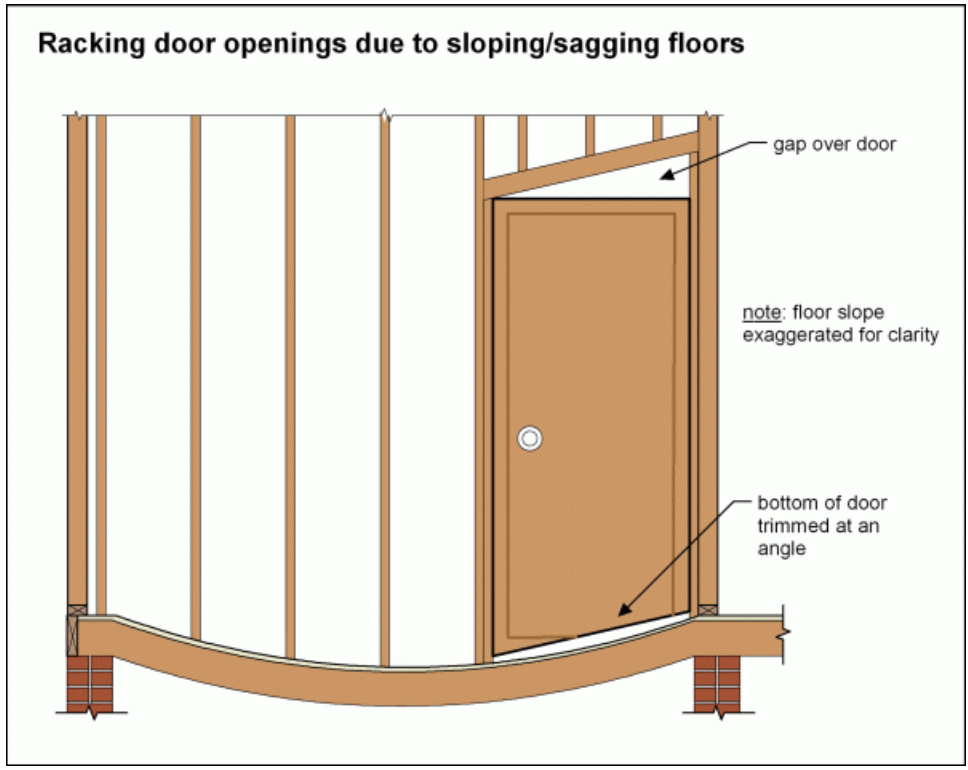
17. **Condition:** • Racked/out-of-square

**Implication(s):** Chance of damage to finishes and structure

**Location:** Various locations

**Task:** Monitor  
**Time:** Ongoing

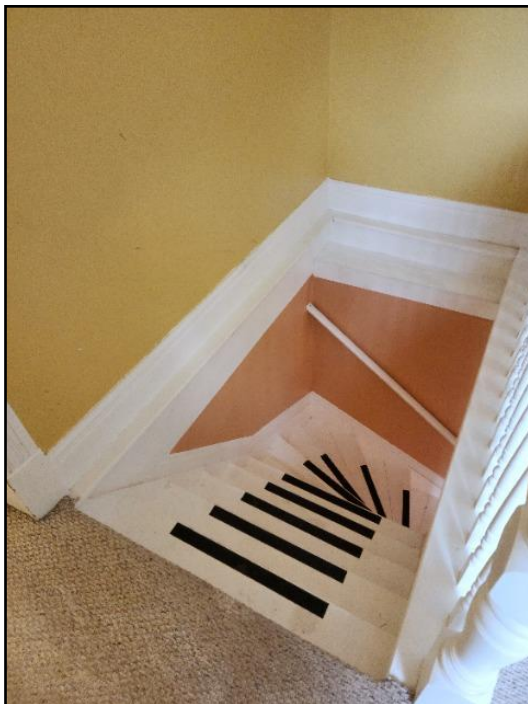
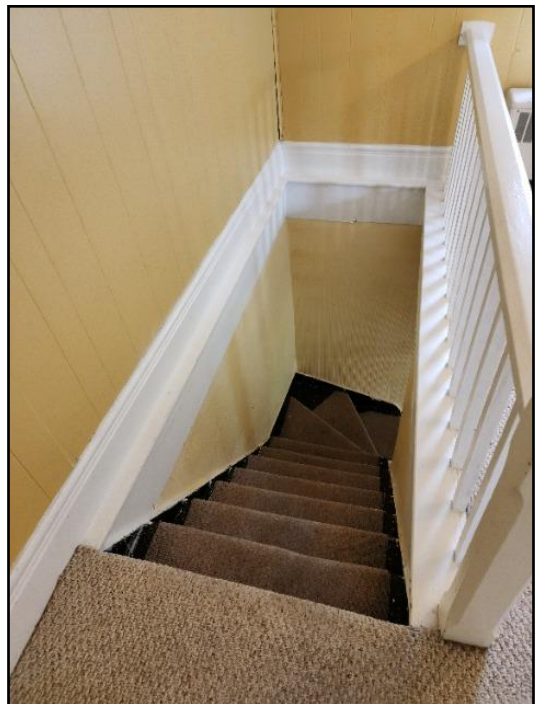
**19. Condition:** • Missing  
**Implication(s):** Fall hazard  
**Location:** Second floor  
**Task:** Provide  
**Time:** Discretionary  
**Cost:** Minor

42. Missing

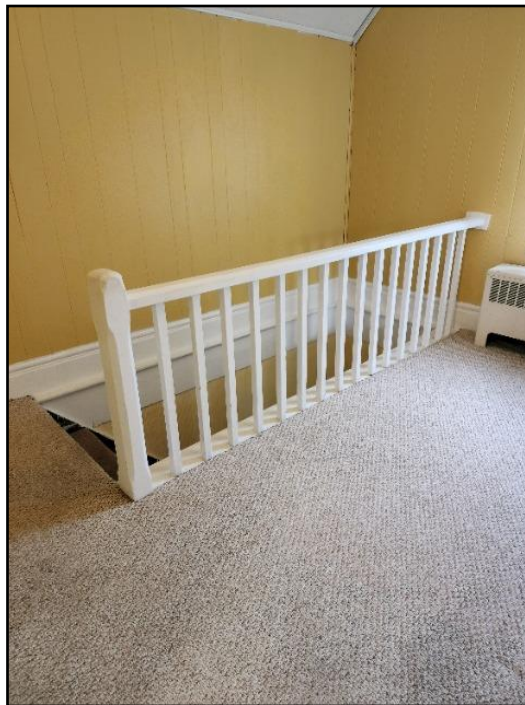
**20. Condition:** • Too far apart

**Implication(s):** Fall hazard

44. *Too far apart*
