AmeriSpec Inspection Services of Peterborough
1318 Cartier Boulevard
Peterborough ON, K9H 6S1
Phone #: 705-761-5439

Inspection Number: 156040 Inspector: Reg Deck
Inspection Date: 11/13/2024
Inspection Address: 4272 Highway 7
Norwood, ON K0L 2V0
Listing Agents: Catherine Hanrahan & Ben VanVeen Real Estate Company: Century 21 United Realty

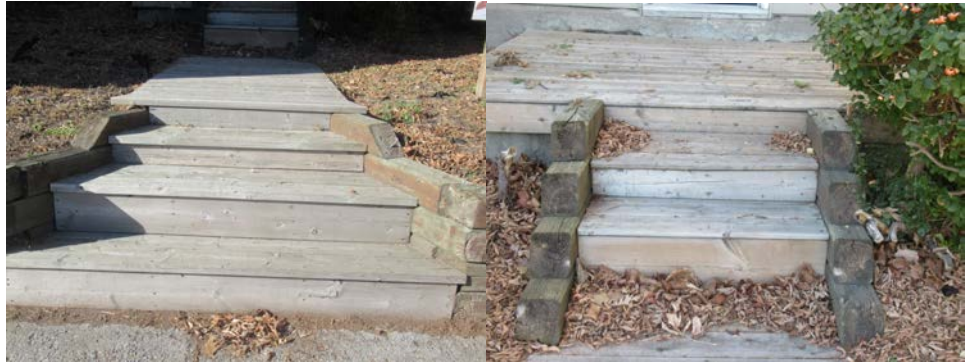
Step #	Component	Comment
1110.	Walkways	Safety. Treads/risers at the front steps are not uniformly spaced which can cause a possible trip hazard. We recommend professionally modifying the affected steps to ensure safety.

1110. Walkways **Safety. Treads/risers at the front steps are not uniformly spaced which can cause a possible trip hazard. We recommend professionally modifying the affected steps to ensure safety.**
1125. Gutters & Downspouts **Review. The gutter at the rear of the home appears to be improperly sloped towards the middle which will prohibit proper drainage of roof water away from the home. Review for repairs, as required.**
1150. Exterior Door(s) **Review. Upper level apartment door is damaged at the hardware/lockset area. Recommend review for repair or replacement, as necessary, to ensure safety and proper operation.**

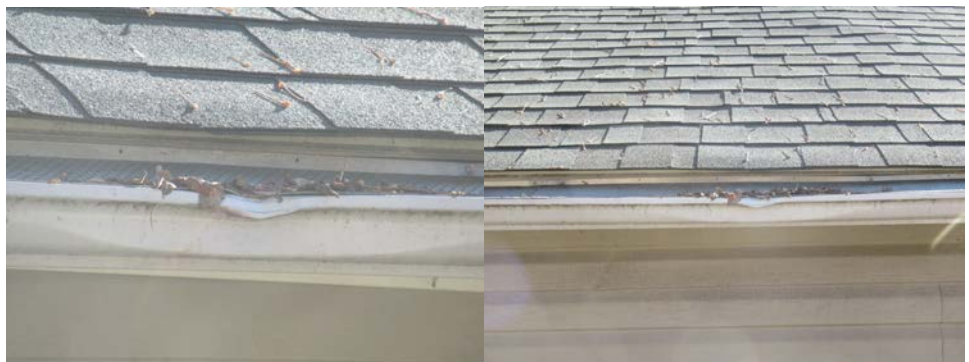
1123. Windows & Frames Maintenance Reviewing the condition of the caulking and sealing around all windows as part of routine maintenance is recommended to reduce the potential for water infiltration into and minimize air leakage from the home.
1124. Electrical Fixtures Serviceable. The electrical meters are located at the left side of the home.
1125. Gutters & Downspouts **Review. Aluminum. The gutter at the rear of the home appears to be improperly sloped towards the middle which will prohibit proper drainage of roof water away from the home. Review for repairs, as required.**

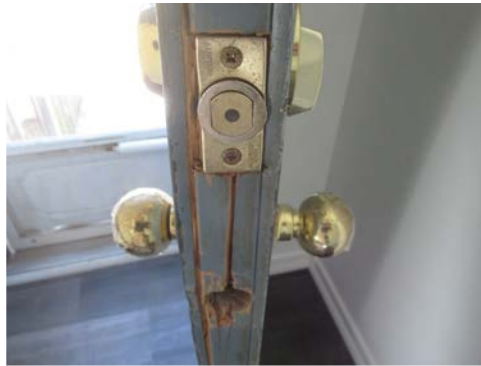
1130. Gutter & Downspout Maintenance Gutters and downspouts are an integral part of a home's storm water management system and should be monitored on a regular basis for proper operation. It is recommended that gutters and downspouts be cleaned and flushed as part of routine maintenance to reduce the potential for water backup and resultant damage to roofing materials and concealed portions of the home.
1135. Hosebib(s) Located at the left side of the home. Hosebib was winterized/inoperable at time of inspection. We recommend consulting with the current owner prior to closing to verify proper operation. The interior shut off valve is located at the open beam basement ceiling.
1150. Exterior Door(s) **Review. Metal clad. Safety tempered glass was noted in the metal clad exterior door(s) for safety. Upper level apartment door is damaged at the hardware/lockset area. Recommend review for repair or replacement, as necessary, to ensure safety and proper operation.**

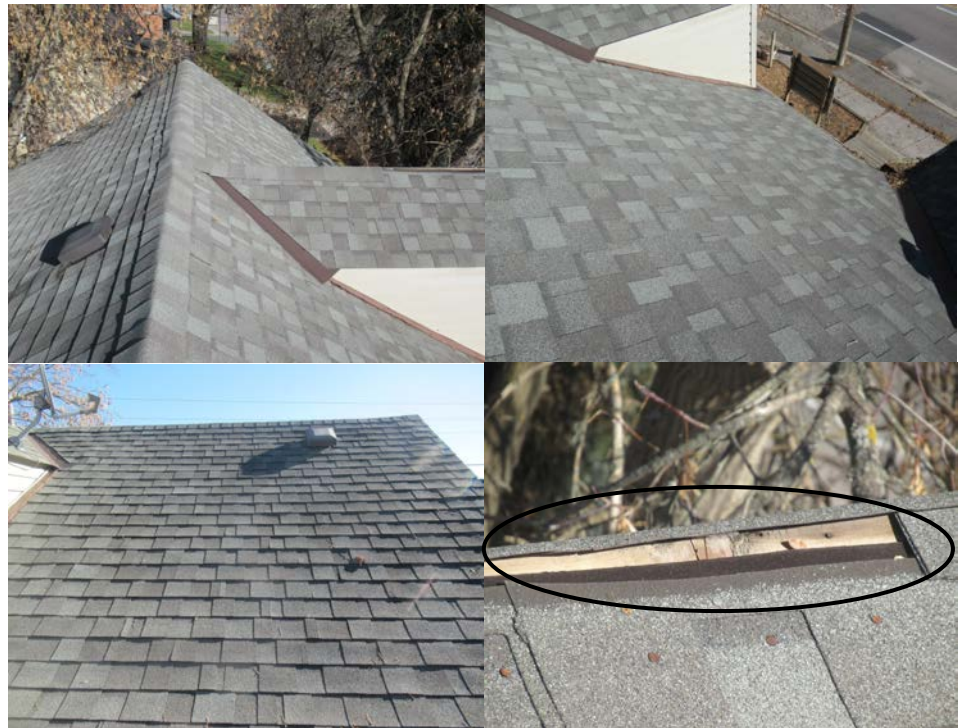
Review. Missing shingle(s) noted at the peak of the front right dormer. Review for repairs, as required, to prevent moisture infiltration into the home.

1215. Conditions **Review. Missing shingle(s) noted at the peak of the front right dormer. Review for repairs, as required, to prevent moisture infiltration into the home.**
1220. Flashings **Review. Possible sensitive area(s) with respect to water infiltration noted at the front and rear dormers. These are vulnerable area(s) present around most homes. In order to reduce the potential for water infiltration into the home around the above-noted area(s), we recommend ensuring that these area(s) are properly sealed by a qualified roofing contractor as part of routine/annual maintenance.**

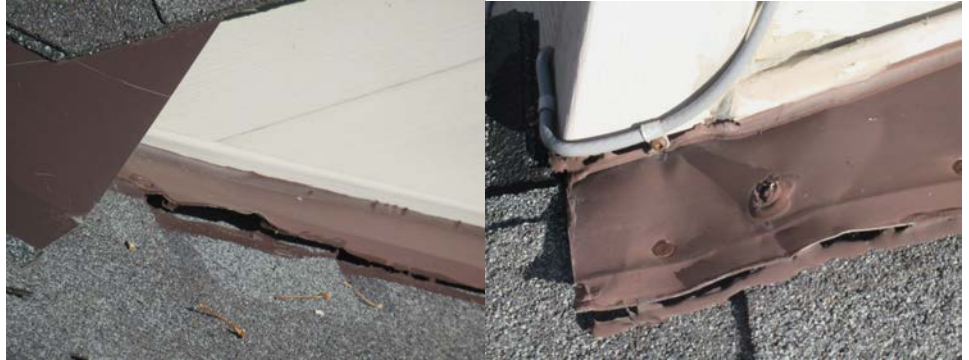
Review. Possible sensitive area(s) with respect to water infiltration noted at the front and rear dormers. These are vulnerable area(s) present around most homes. In order to reduce the potential for water infiltration into the home around the above-noted area(s), we recommend ensuring that these area(s) are properly sealed by a qualified roofing contractor as part of routine/annual maintenance.

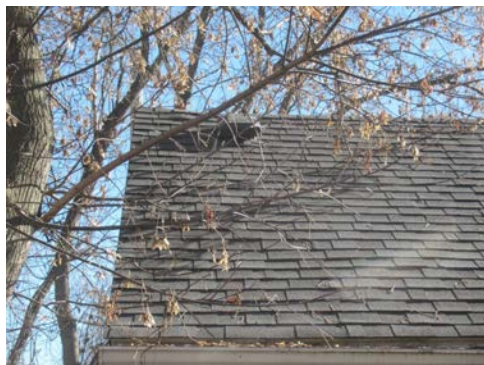
Vegetative overgrowth noted at the right side of the home. We recommend trimming all trees/vegetation away from the roof to prevent damage and premature wear to the roofing materials, prohibit rodent/pest access and reduce the potential for vegetation/debris accumulation in the gutters/downspouts.

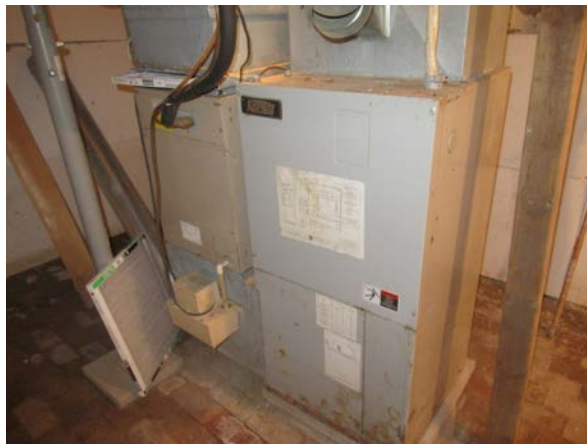
Step #	Component	Comment
2110.	System Location/ Design/Type/ Brand	Furnace. Electric. Forced air system. Located at the rear of the basement. Manufacturer: KEEP-RITE. Serial #: L9114 52767. Model #: NBCM024XKB2. Electrical disconnect(s) provided. The furnace is approximately 33 years old.

2170.	Heating Comments	Review. The timing for replacement of the heating system is unpredictable. Statistically, it has reached/is approaching the end of its life expectancy. We recommend budgeting for a replacement system in the near future.

2170. Heating Comments **Review. The timing for replacement of the heating system is unpredictable. Statistically, it has reached/is approaching the end of its life expectancy. We recommend budgeting for a replacement system in the near future.**

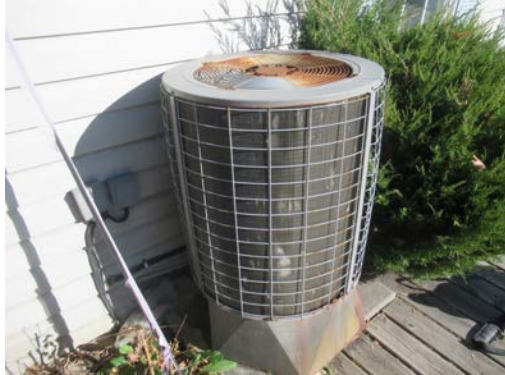
Step #	Component	Comment
2305.	System Location/ Design/Type/ Brand	The air conditioner compressor is located at the left side of the home. Manufacturer: YORK. Serial #: EKBM 318114. Model #: EASE-F024AA. No exterior electrical disconnect noted.

2310.	Age/Life Expectancy	Review. The air conditioner is approximately 31 years old. The average life expectancy of a unit of this type in this geographic area is typically 20 - 25 years. Based on the age of the unit, the risk of failure is high.
2315.	Test Status	As damage to the air conditioner compressor can occur if an air conditioner unit is operated when the temperature is below 65°F (18°C) or the electrical power to the unit has been on for less than 24 hours, the unit was NOT tested. At the time of the inspection one of these conditions existed. If concerned, we suggest consulting with the current owner for further information regarding past performance of the air conditioner or a qualified HVAC contractor for further evaluation.

2310. Age/Life Expectancy **Review. The air conditioner is approximately 31 years old. The average life expectancy of a unit of this type in this geographic area is typically 20 - 25 years. Based on the age of the unit, the risk of failure is high.**
-

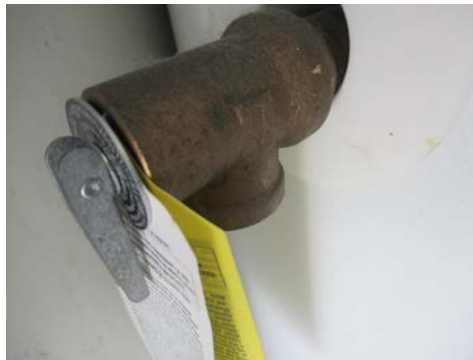
2405.	Waste Disposal System	Serviceable. The property is connected to a public/municipal sewer system.
2410.	Supply Piping	Serviceable. Where visible, the supply piping entering the home is copper.
2412.	Distribution Piping	Serviceable. Where visible, the distribution plumbing in the home is comprised of copper piping and PEX plastic tubing.
2415.	Drain/Waste/Venting	Serviceable. Where visible, the waste plumbing in the home is ABS (plastic).
2420.	Domestic Water Heater – Main Floor	Serviceable. Electric. Located at the left side of the basement. Unit has a 184-litre capacity. Cold water shut off valve, electrical disconnect(s) and Temperature/Pressure relief valve present. Unit appears to be approximately 2 years old. The average life expectancy is typically 12 - 15 years.
2420b.	Domestic Water Heater – Apartment	Electric. Located at the upper level kitchen. Unit has a 30-gallon capacity. Cold water shut off valve, electrical disconnect(s) and Temperature/Pressure relief valve present. Unit appears to be approximately 14 years old. The average life expectancy is typically 12 - 15 years. Review. Temperature/Pressure relief valve does not have a proper extension pipe. We recommend that one be installed for additional safety.

- 2420b. Domestic Water Heater - Apartment **Review. Temperature/Pressure relief valve does not have a proper extension pipe. We recommend that one be installed for additional safety.**

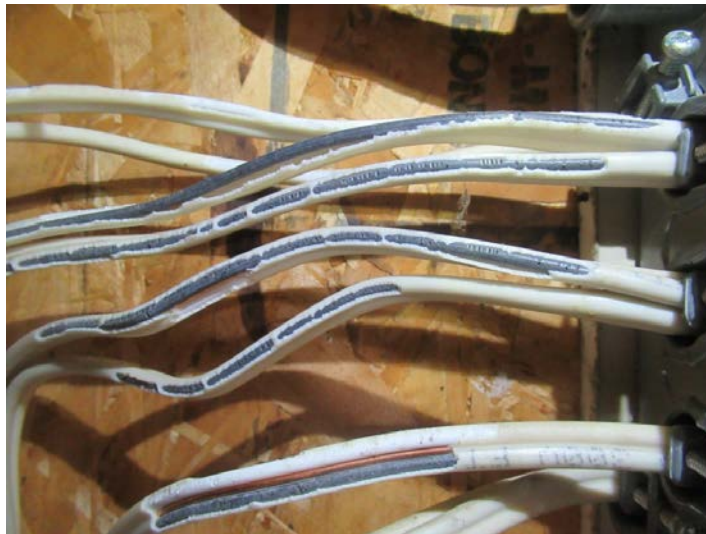
Review. Overload protection of the distribution wires provided by breakers. Where visible, the electrical distribution wiring in the home is copper. Evidence of pest/rodent damage to the wiring noted at the exterior of the main floor panel and at the open beam basement ceiling. To ensure safety, we recommend further review by a licensed electrical contractor for repairs, as required. See Electrical - Comments section for additional information.

2520. Distribution Wiring **Review. Evidence of pest/rodent damage to the wiring noted at the exterior of the main floor panel and at the open beam basement ceiling. To ensure safety, we recommend further review by a licensed electrical contractor for repairs, as required. See Electrical - Comments section for additional information.**

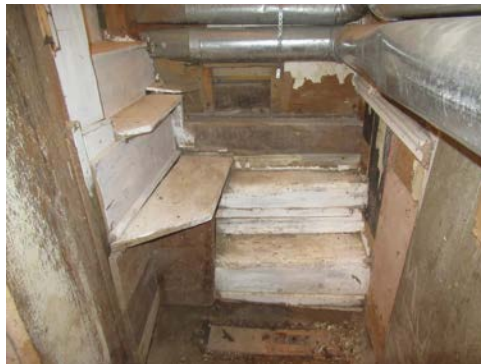
Step #	Component	Comment
3501.	Type/Condition	Unfinished Basement/Crawlspace.
3515.	Stairs	Safety. Treads/risers are not uniformly spaced which can cause a possible trip hazard. We recommend professionally modifying the affected step(s) to enhance safety.

3515. Stairs **Safety. Treads/risers are not uniformly spaced which can cause a possible trip hazard. We recommend professionally modifying the affected step(s) to enhance safety.**
3549. Electrical **Review. Evidence of pest/rodent damage to the wiring noted at the exterior of the main floor panel and at the open beam basement ceiling. To ensure safety, we recommend further review by a licensed electrical contractor for repairs, as required. See Electrical - Comments section for additional information.**

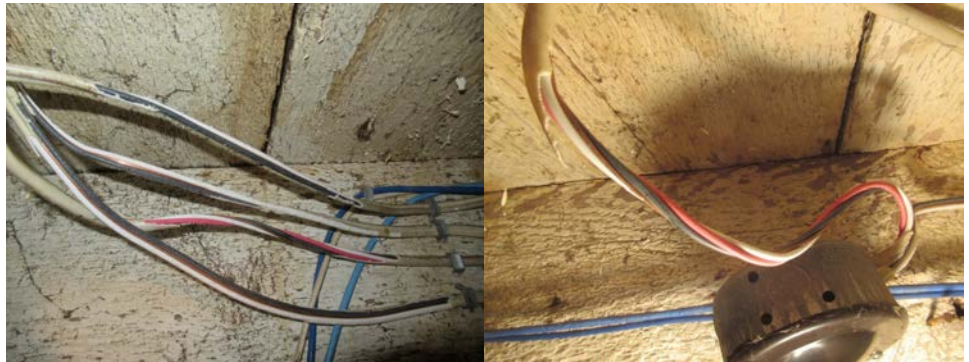
- 3545. Joists Serviceable. 2" x 8" joists noted. Where visible, the joists appear to be in good condition with no evidence of any obvious distress or damage.
- 3546. Support Posts/Columns Serviceable. Metal jack posts. No evidence of any obvious distress was observed at the time of the inspection.
- 3547. Beams Serviceable. Wood. No evidence of any obvious distress was observed at the time of the inspection.
- 3548. Windows Not Present.
- 3549. Electrical **Review. Evidence of pest/rodent damage to the wiring noted at the exterior of the main floor panel and at the open beam basement ceiling. To ensure safety, we recommend further review by a licensed electrical contractor for repairs, as required. See Electrical - Comments section for additional information.**

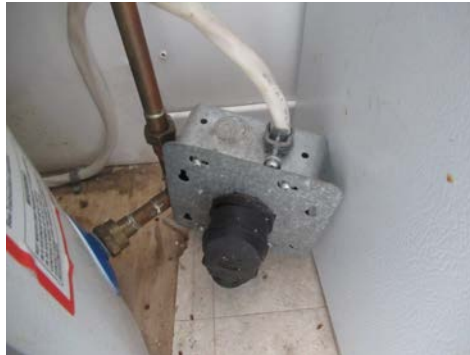
3870. Range/Cooktop Electric. Unit tested operable at time of inspection. **Review. 220-volt outlet is loose and/or not properly secured. Recommend securing for safety. See Electrical - Comments section for additional information.**
