# Your Inspection Report

4092 Highway 620  
Wollaston, ON K0L 1A0

**INSPECTION DATE:**  
Monday, August 17, 2026

Report No. 2499

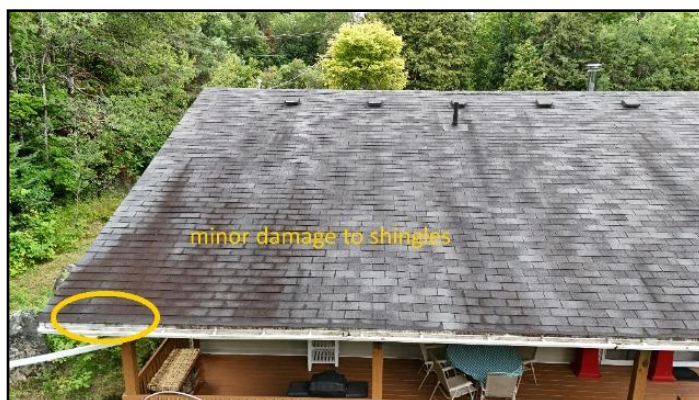
**1. Condition:** • [Damage](#)

**Implication(s):** Chance of water damage to structure, finishes and contents

**Location:** Rear Roof

**12. Damage**

**Task:** Repair

**Time:** Less than 1 year

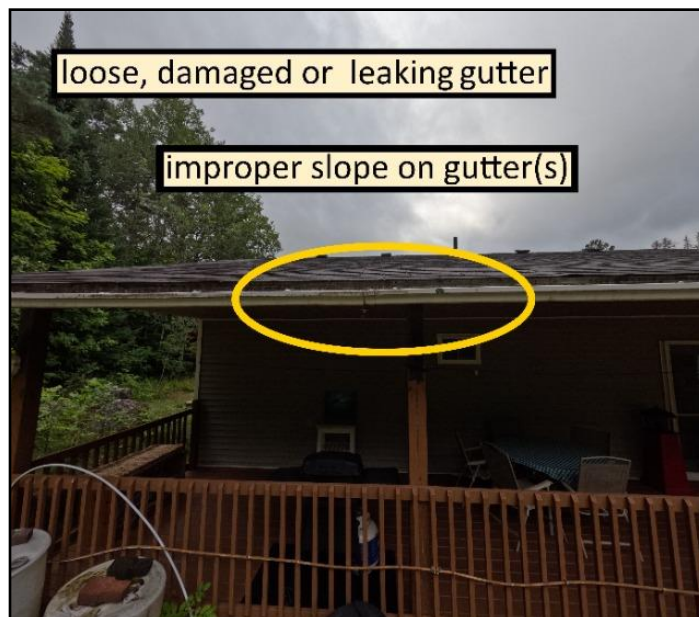
**2. Condition:** • [Improper slope, ponding](#)

**Implication(s):** Chance of water damage to structure, finishes and contents

**Location:** Rear Exterior

45. Improper slope, ponding

**Task:** Repair

**Time:** Less than 1 year

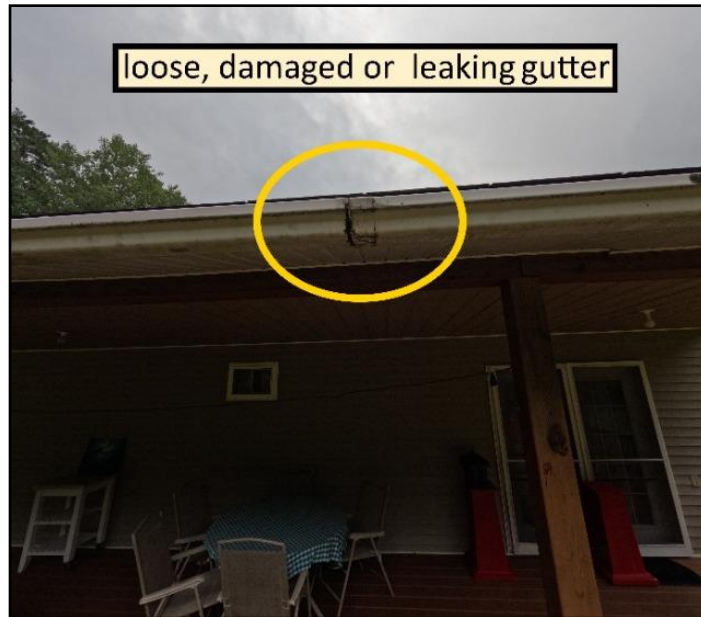
3. Condition: • [Leak](#)

**Implication(s):** Chance of water damage to structure, finishes and contents

**Location:** Rear Exterior

46. Leak

**Task:** Repair

**Time:** Less than 1 year

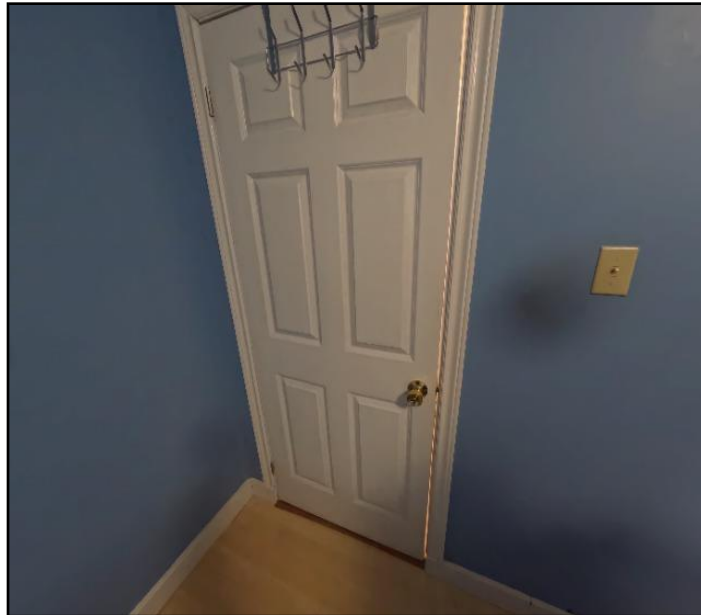
**13. Condition:** • [Loose or poor fit](#)

**Implication(s):** Chance of damage to finishes and structure

**108.** *Loose or poor fit*

**Task:** Repair
