# 14504 Laurinburg Dr

## Austin, Texas 78717

| Type | Home Inspection Report -<br>14504 Laurinburg Dr |

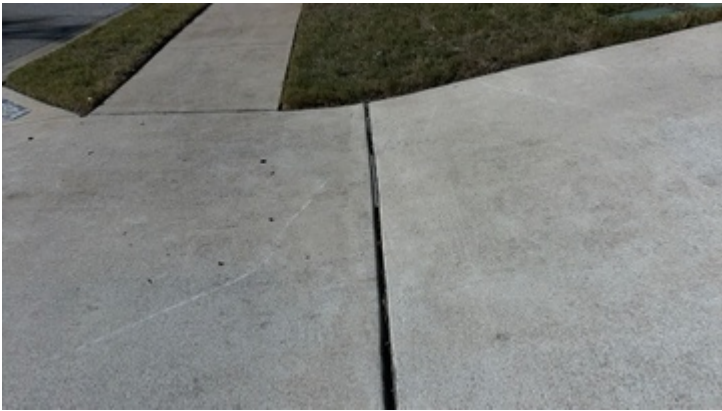
### Missing / Deteriorated Expansion Joint Materials

Expansion joint materials are missing / deteriorated. Recommend repairs or replacing by a qualified professional.

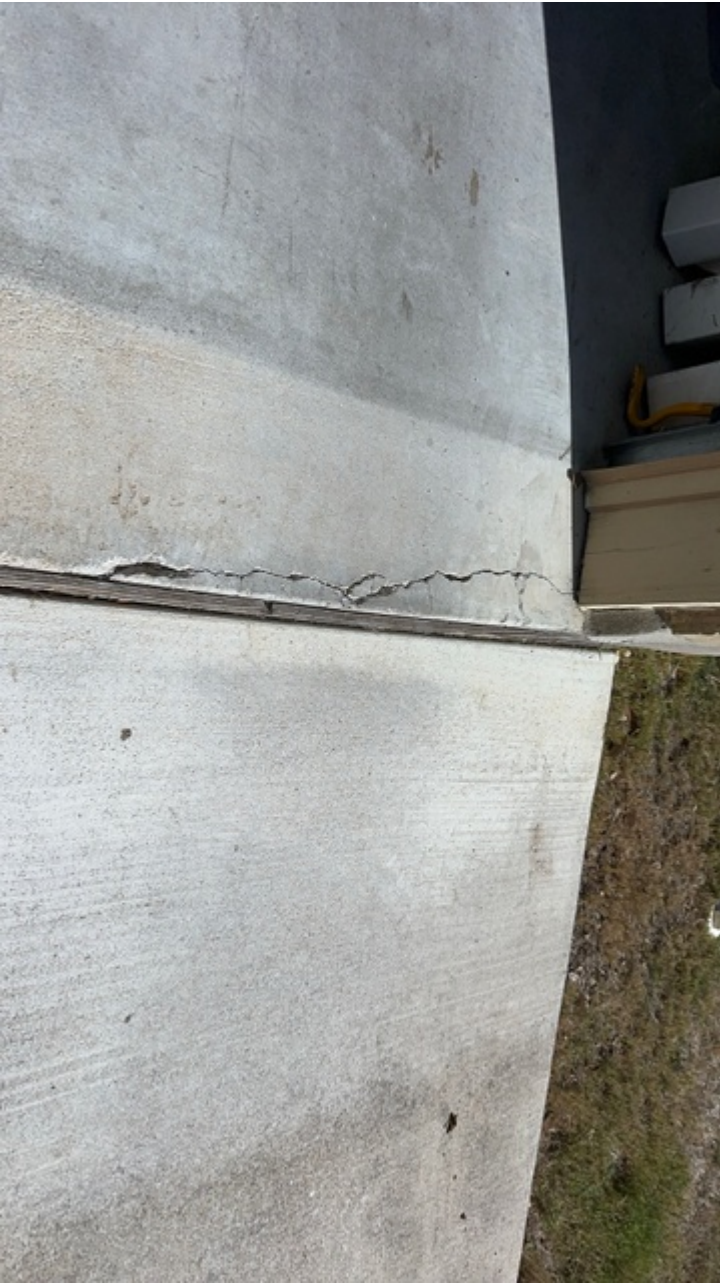
### Minor Cracks in the Driveway

The driveway has minor cosmetic cracks. Recommend repairs or replacing by a qualified professional.

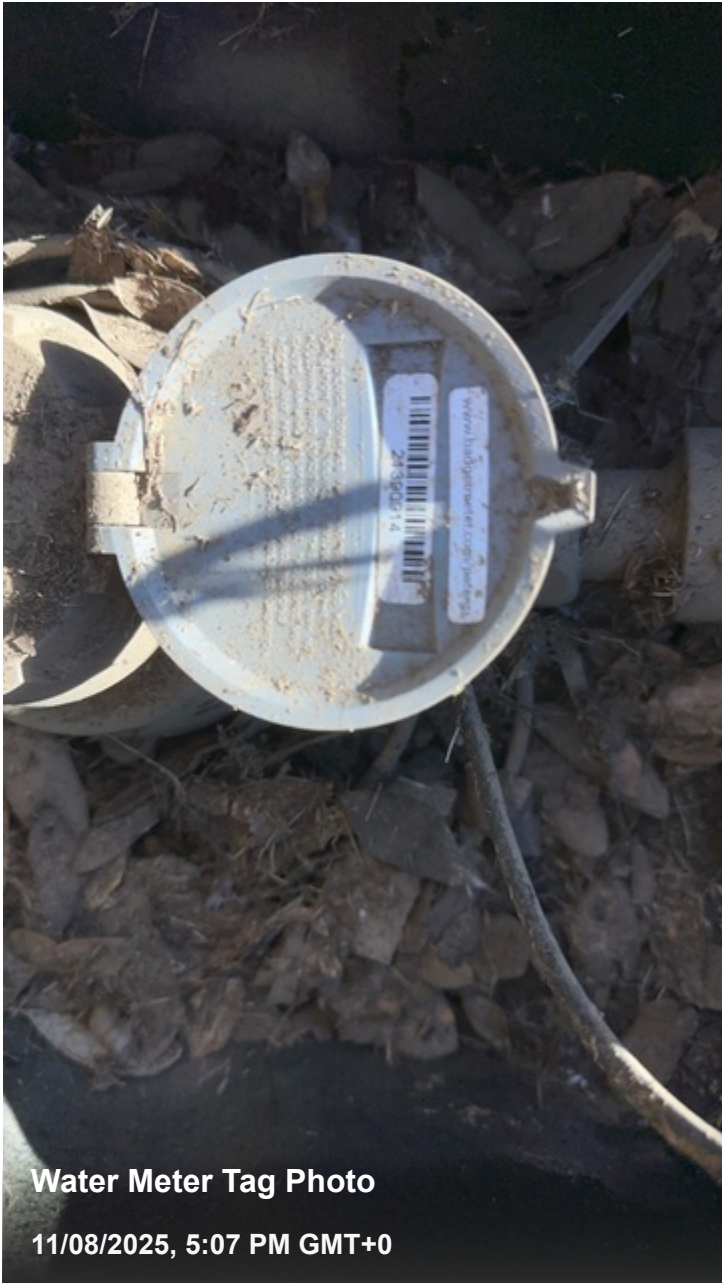
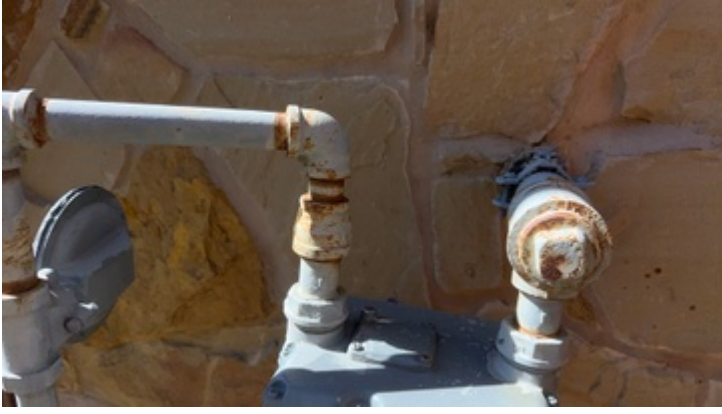
Missing Rust-inhibiting Paint on Gas Line

The gas line should have rust-inhibiting paint. Recommend repairs or replacing by a qualified professional.

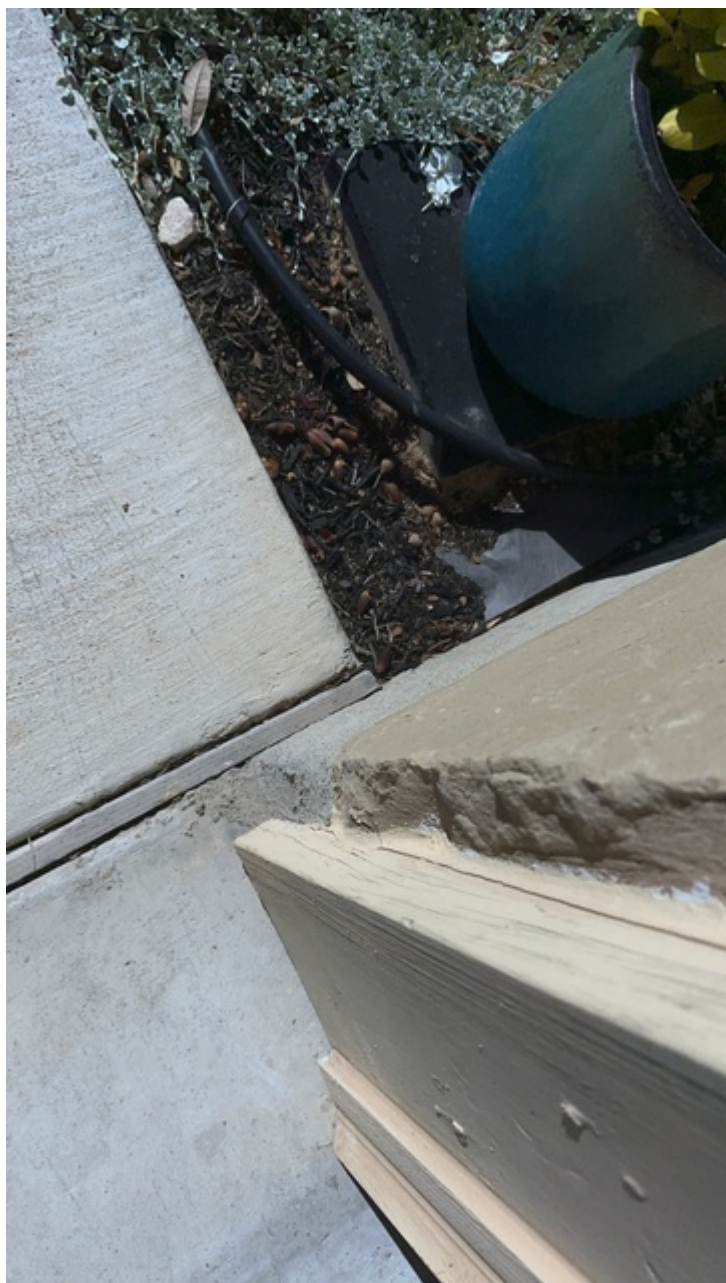
### Trim Needs Paint Touch Up

The exterior trim needs to be touched up. Recommend repairs or replacing by a qualified professional.

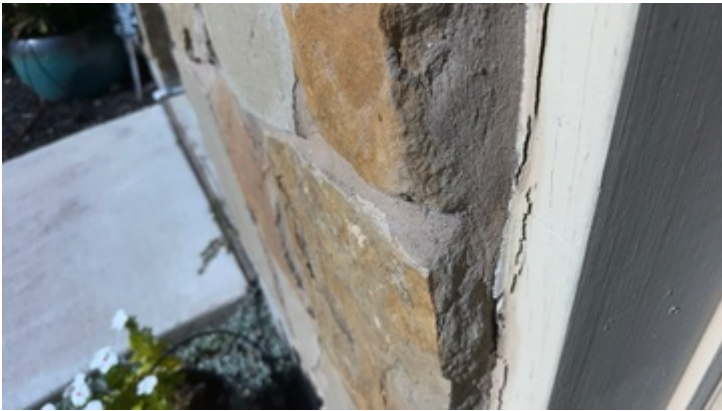
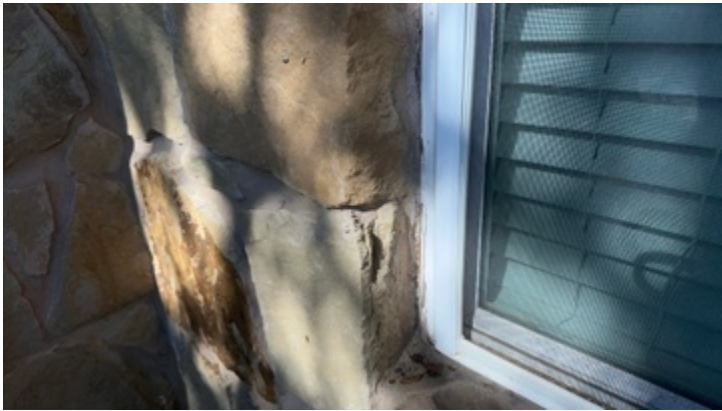
### Missing Exterior Caulk

One or more exterior areas need caulking. Recommend repairs or replacing by a qualified professional.

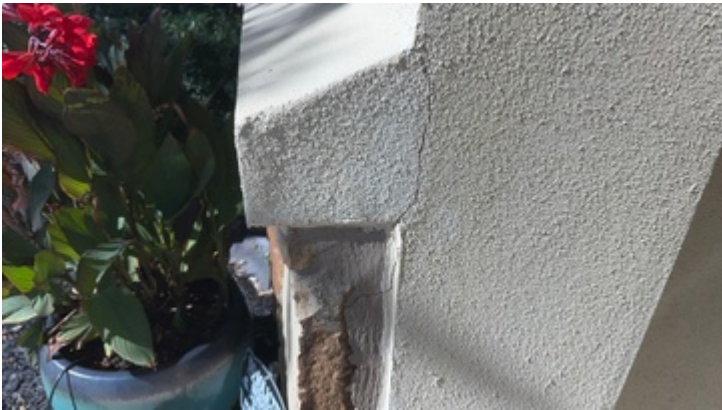
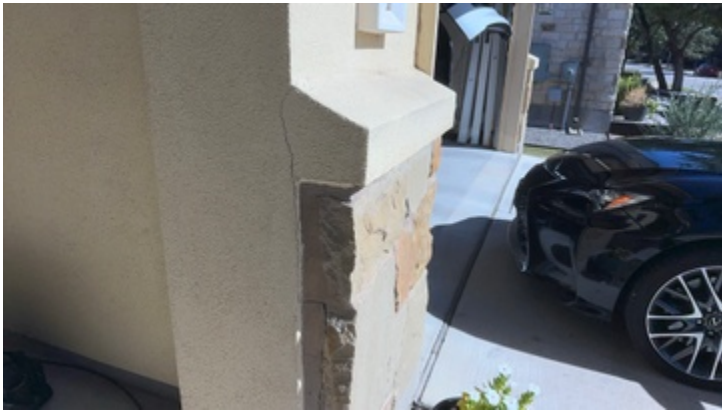
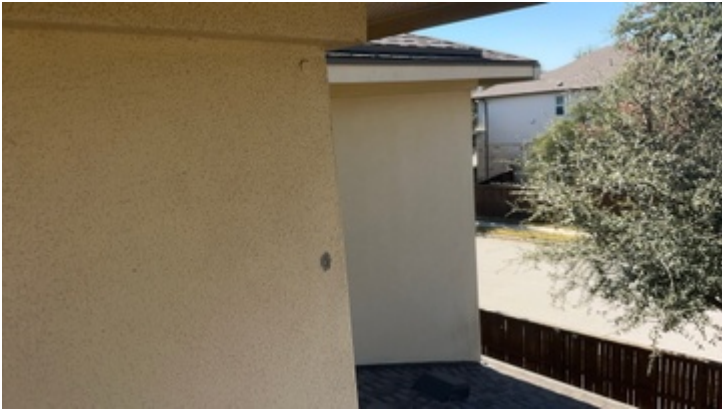
Cracked / Damaged Stucco

The exterior stucco is showing signs of cracking or damage. Recommend repairs or replacing by a qualified professional.

Numerous locations

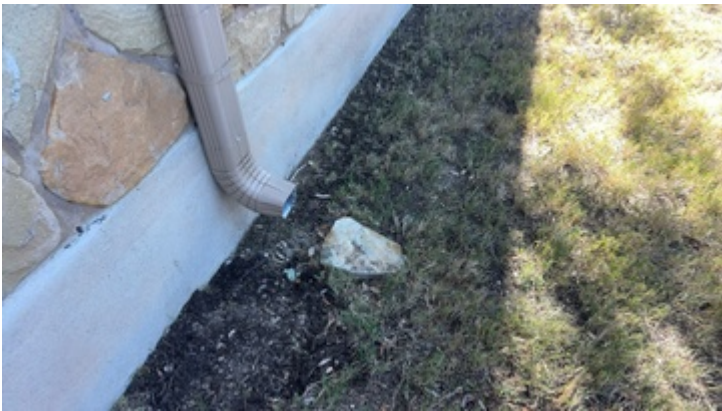
## Missing Downspout Splash Blocks

There are no splash blocks for the downspouts. Recommend repairs or replacing by a qualified professional.

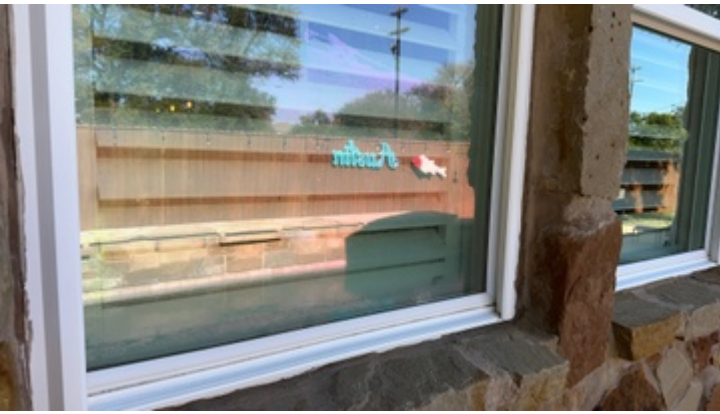
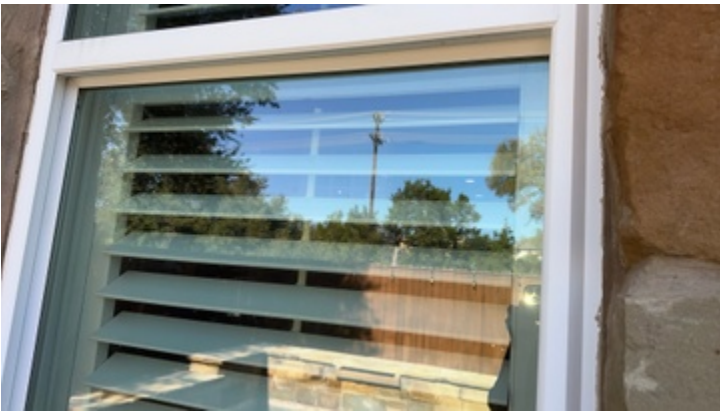
Deteriorated / Failed Window Seal

One or more windows have condensation between the window panes. Recommend repairs or replacing by a qualified professional.

8 or more

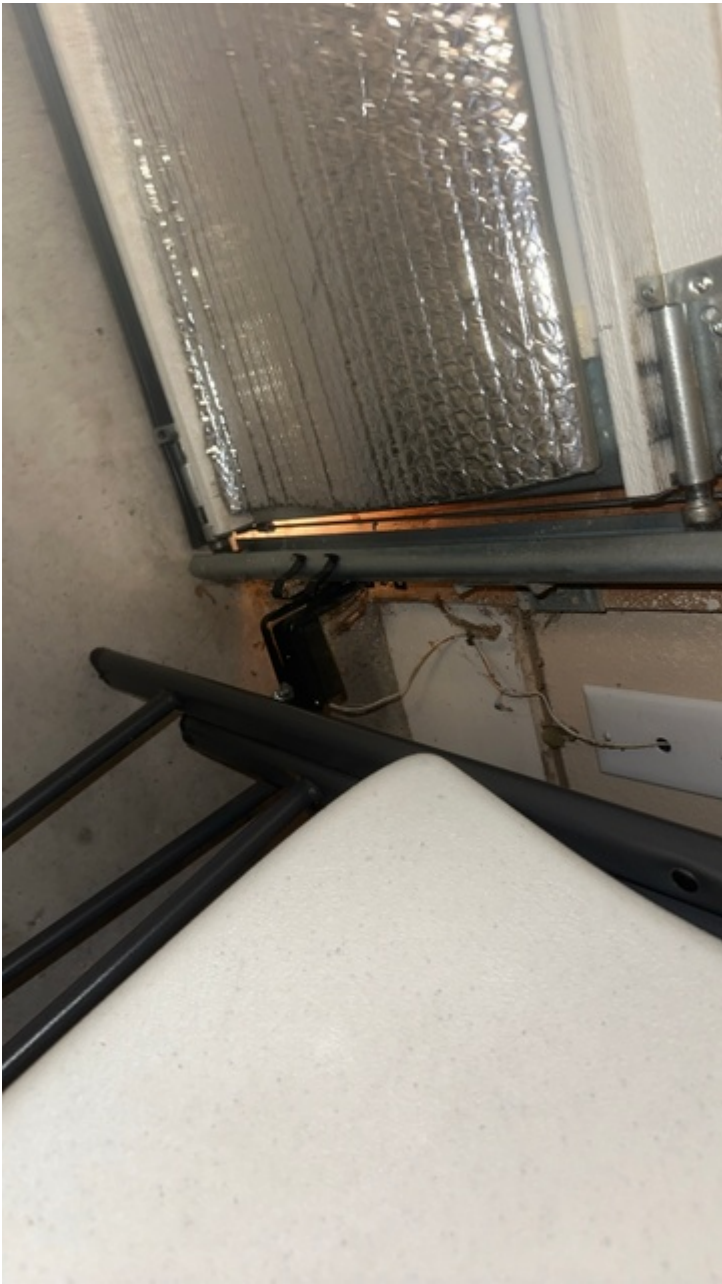
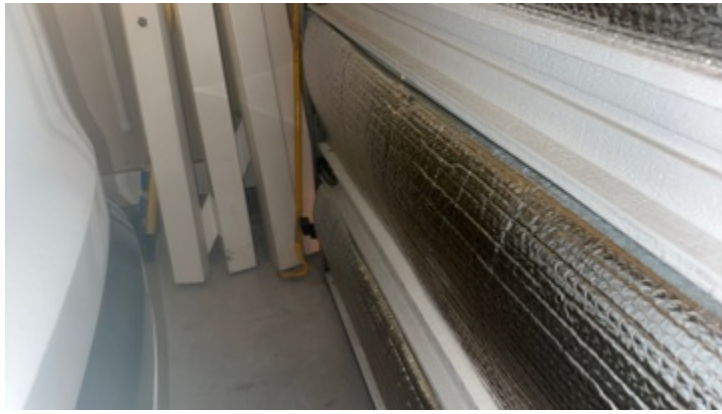
## Damaged or Missing Weatherstripping

The weatherstripping is damaged or missing. Recommend repairs or replacing by a qualified professional.

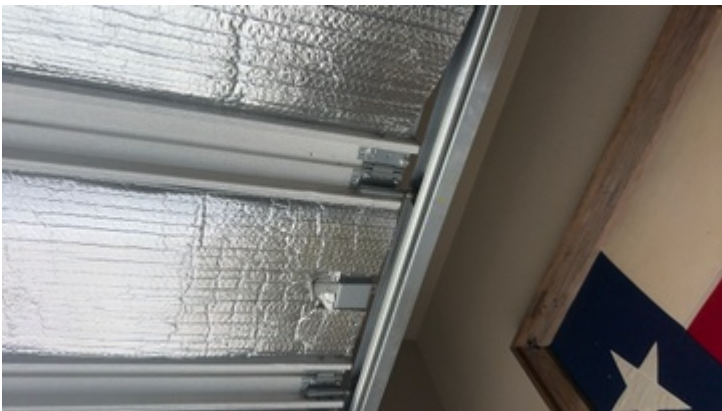
## Garage Door Manual Locks Are Not Disabled

The garage door manual lock was not disabled. Recommend repairs or replacing by a qualified professional.

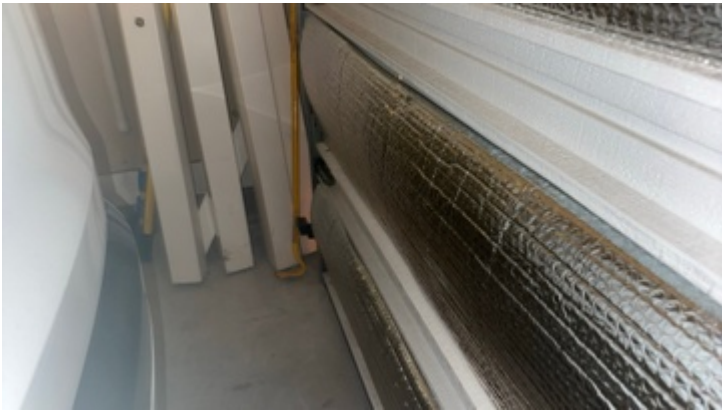
## Poorly Located Garage Door Proximity Sensor

The garage proximity laser is too high off the ground. Recommend repairs or replacing by a qualified professional.

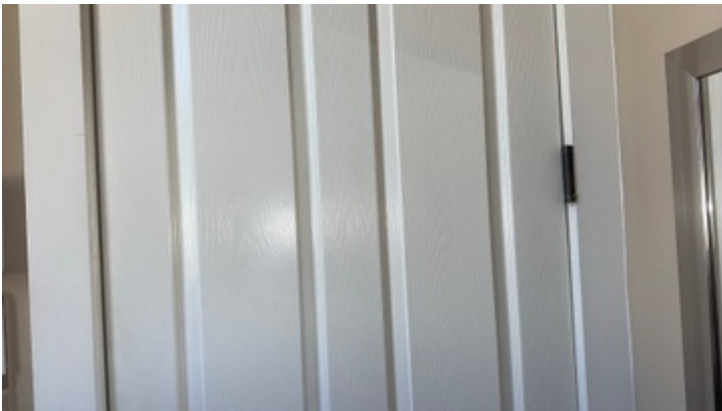
## Missing / Inoperable Self-Closing Door Hinges

The self-closing door hinges are missing / inoperable. Recommend repairs or replacing by a qualified professional.

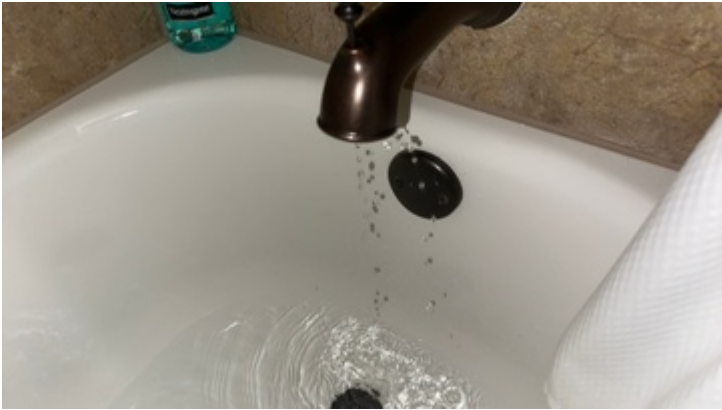
**Inoperable Shower Diverter Valve**

The shower diverter valve is not working correctly. Recommend repairs or replacing by a qualified professional.

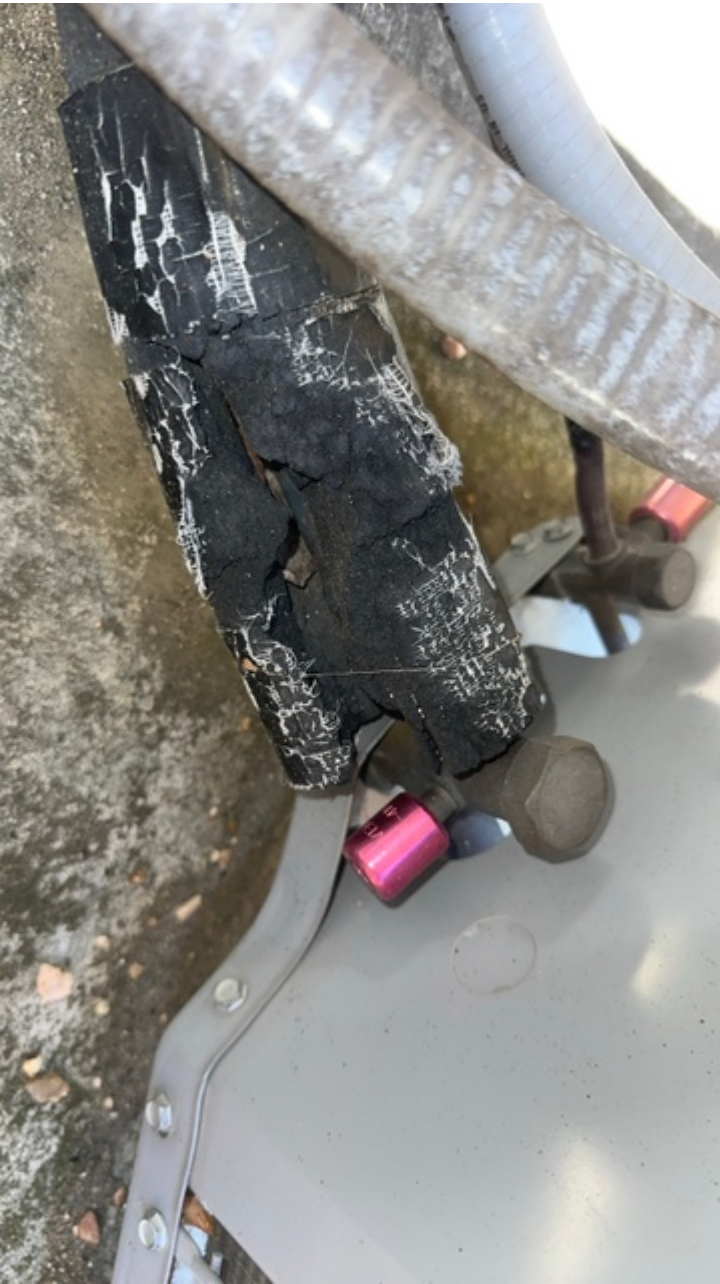
Missing or Damaged HVAC Line Insulation

The refrigerant line insulation is missing or damaged. Recommend repairs or replacing by a qualified professional.

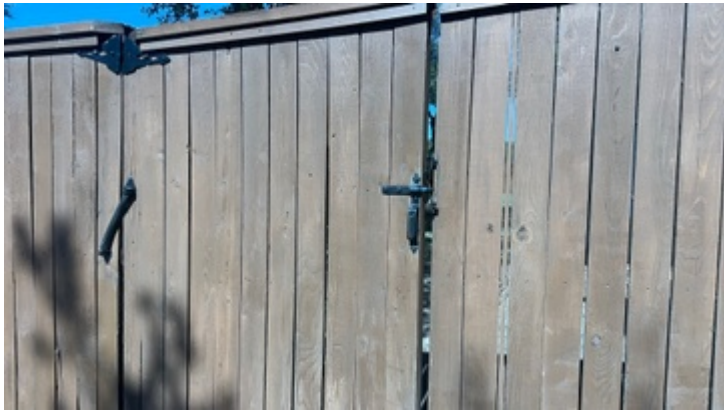
### Inadequate Pool Gate

The pool gates should be self-closing for safety. Recommend repairs or replacing by a qualified professional.

**2 gates**
