# Property Inspection Report

19880 Silverwood Drive, Lake Elsinore, CALIFORNIA 92530

Date of Inspection: 9/25/2026 Time: 01:00PM

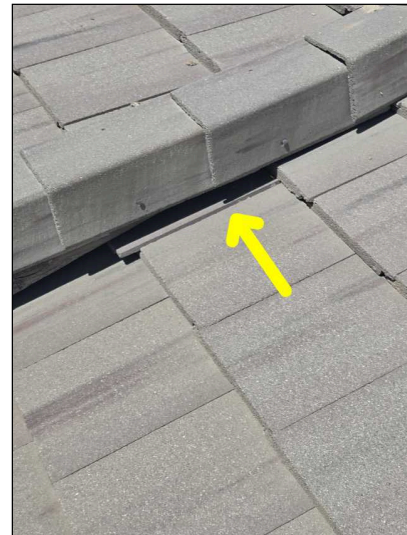
| Page 20 Item: 1 | Roof Condition | 1.2. 1 cracked and slipped tiles observed on the roof system. Recommend correction by a licensed roofing contractor |

Slipped

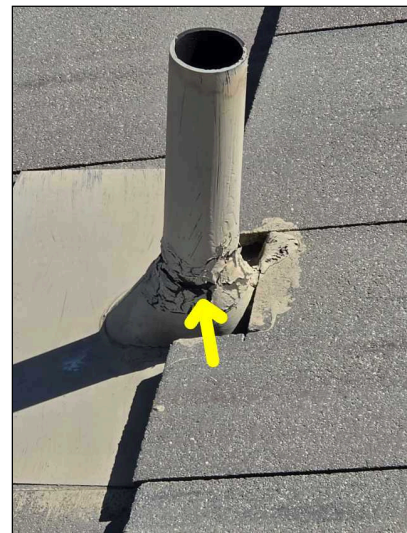
| Page 24 Item: 2 | Plumbing Vents | 2.1. Recommend re-sealing all through the roof vents, flashings, and roof projections as a part of routine maintenance. Cracking around plumbing vents observed. |

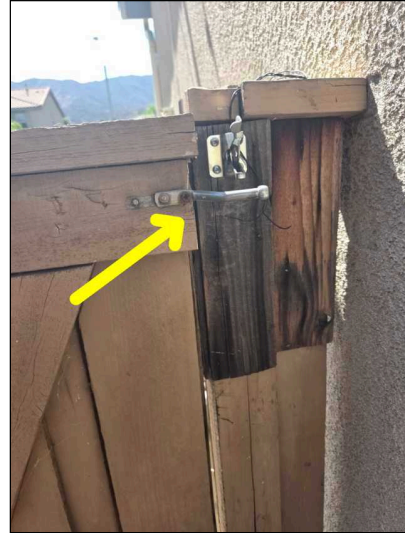
| Page 34 Item: 8 | Gate Condition | 8.1. Damaged gate observed. Not fully functional. Recommend repair or replacement. |

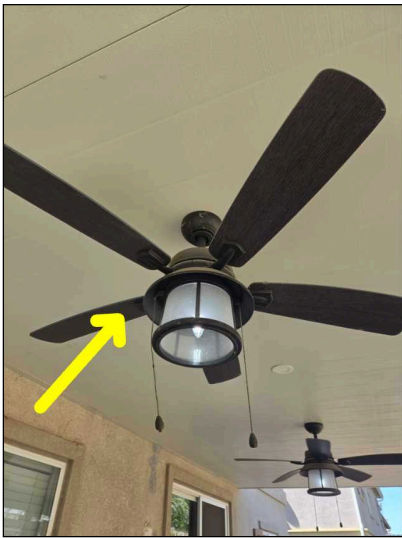
Page 36 Item: 14 Patio Enclosure

14.2. One ceiling fan was not functional. Recommend correction by a licensed contractor

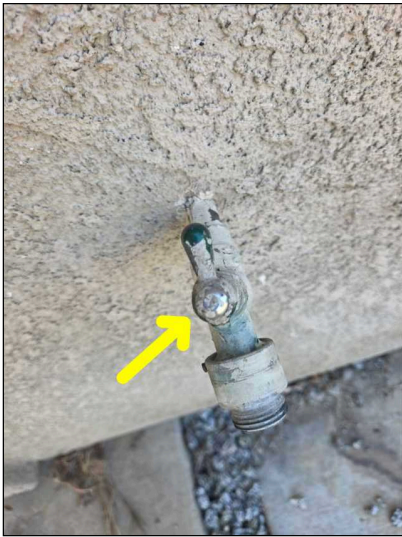
| Page 36 Item: 15 | Exterior Faucet Condition | Broken faucet handle. Recommend correction |

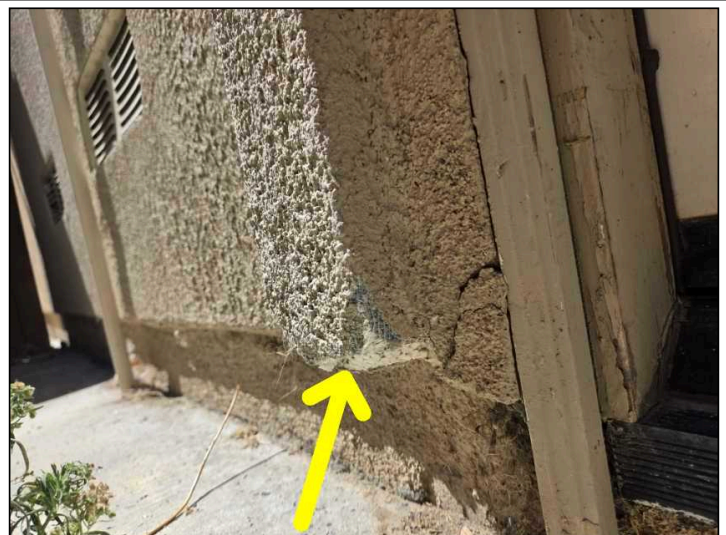
| Page 39 Item: 1 | Siding Condition | 1.2. Observed multiple cosmetic based defects at the exterior area. See photos. Recommend correction as needed |

Paint needed

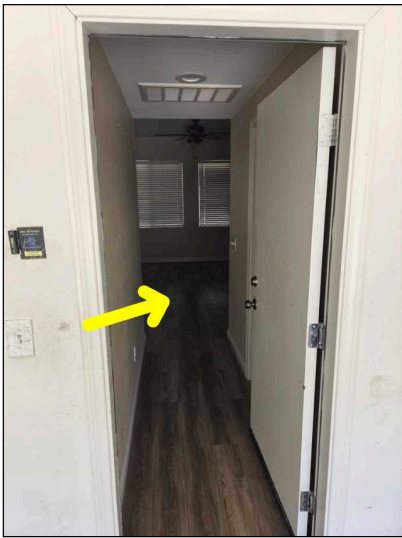
| Page 46 Item: 5 | Fire Door | 5.1. The house entry door is not fully self-closing and is required to be, to maintain the necessary firewall separation between a garage and living quarters, and will need to be serviced. Recommend replacement of proper hinge to spring closed |

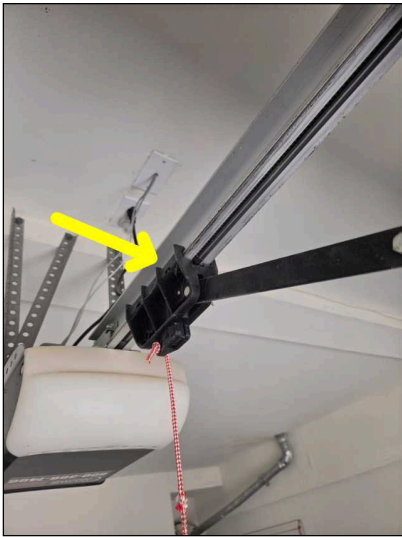
| Page 47 Item: 8 | Garage Door Parts | 8.1. Vibration/noise observed at chain drive. Lubrication is more than likely the solution. Recommend correction |

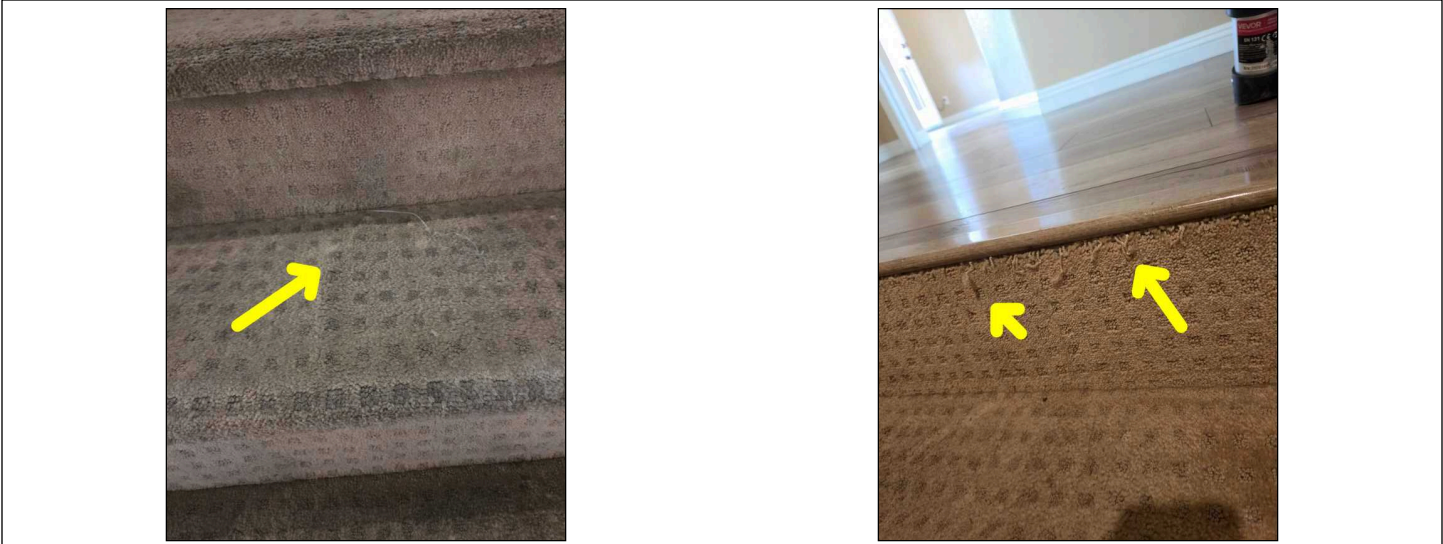
| Page 67 Item: 7 | Stairs & Handrail | 7.1. Carpet on stairs approaching end of life. Recommend correction and cleaning |

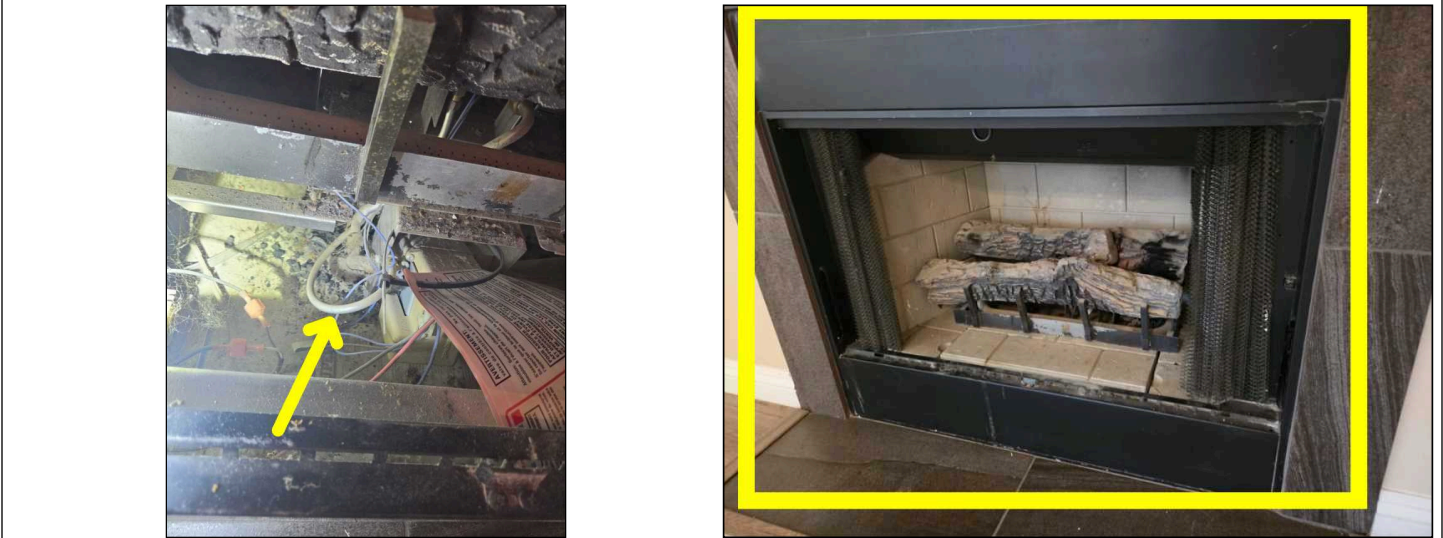
| Page 68 Item: 9 | Fireplace | <p>9.4. Missing glass doors on the fireplace. Recommend correction</p> <p>9.5. The fireplace did not function with the switch or components within. This does not mean they are broken however it takes a particular professional to get up and running. Recommend correction</p> |

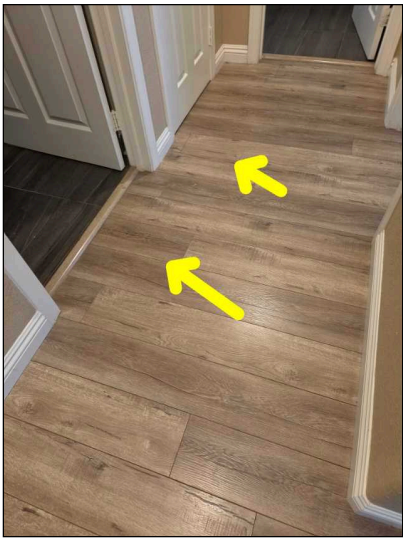
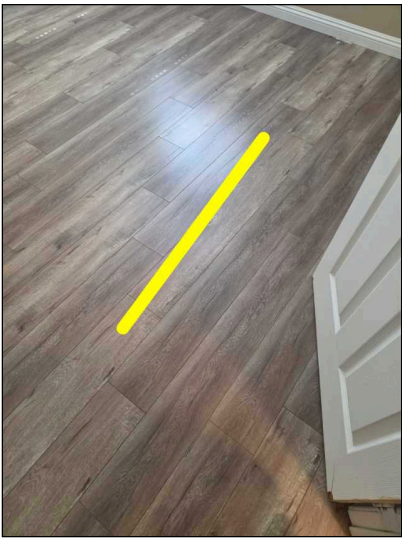
| Page 73 Item: 2 | Floor Condition | <p>2.2. Unlevel area observed in 1 of the rooms and hallway area. Unable to determine cause. Monitor or correct as needed.</p> |

Unlevel

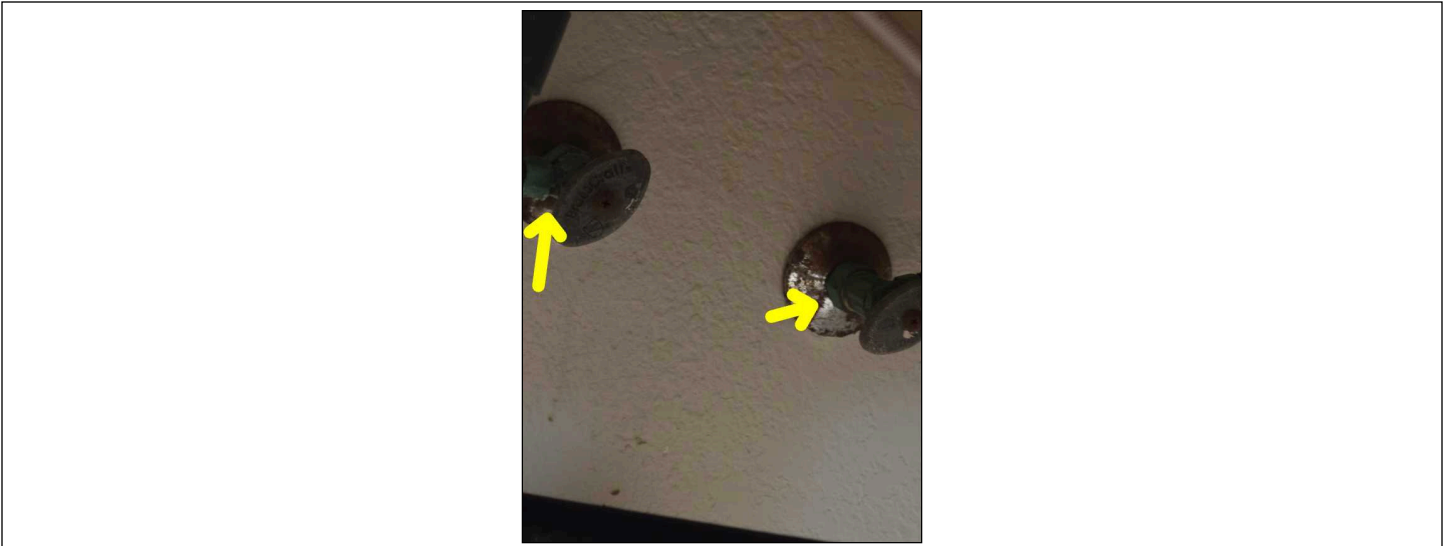
| Page 83 Item: 3 | Plumbing | 3.2. Supply lines show signs of corrosion in various locations under the sinks and toilets. This is susceptible to water leaks and moisture intrusion. Refer to a licensed plumbing contractor for repairs. |

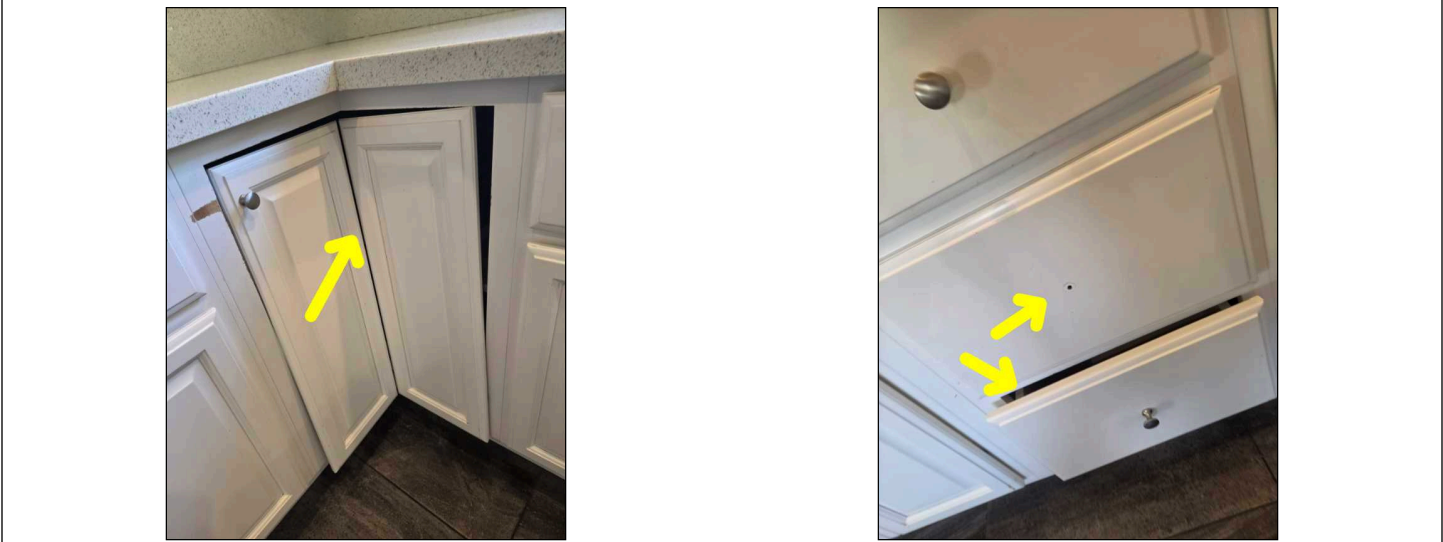
Page 87 Item: 3    Cabinets/Pantry    3.1. Service needed in multiple places.

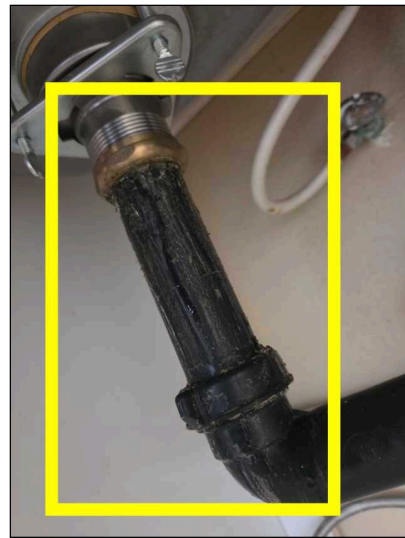
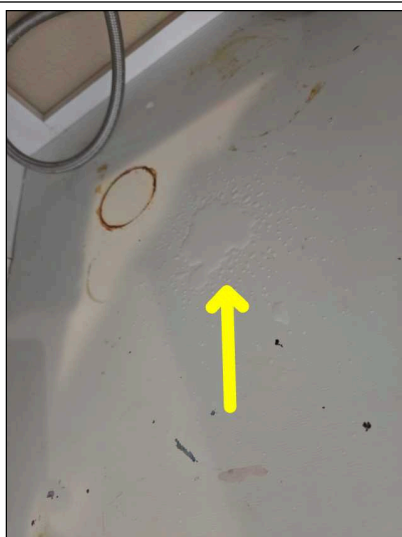
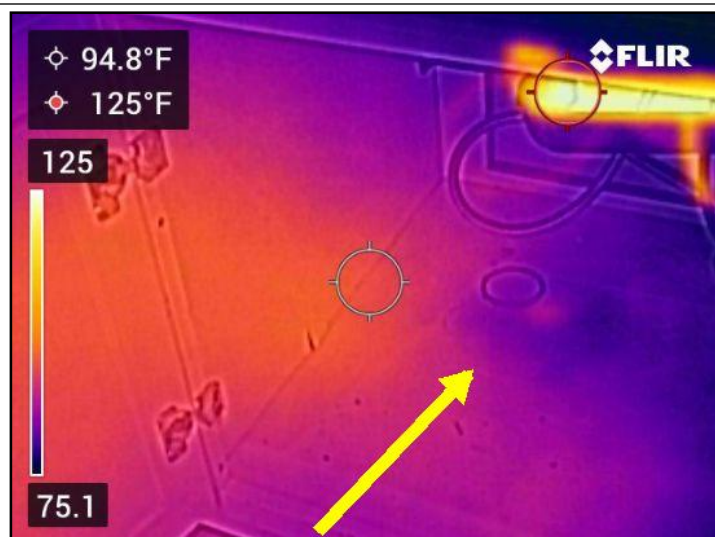
5.1. Observed signs of oxidation at one or more plumbing fixtures underneath the sink area. This is indicative of a previous leak that has sealed itself. Recommend replacing these valves to prevent future leaks using a licensed plumber.

5.2. Active leaking noted at the water line just below the faucet below the sink areas. Advise further evaluation and repair by a licensed plumber or qualified professional.

leak

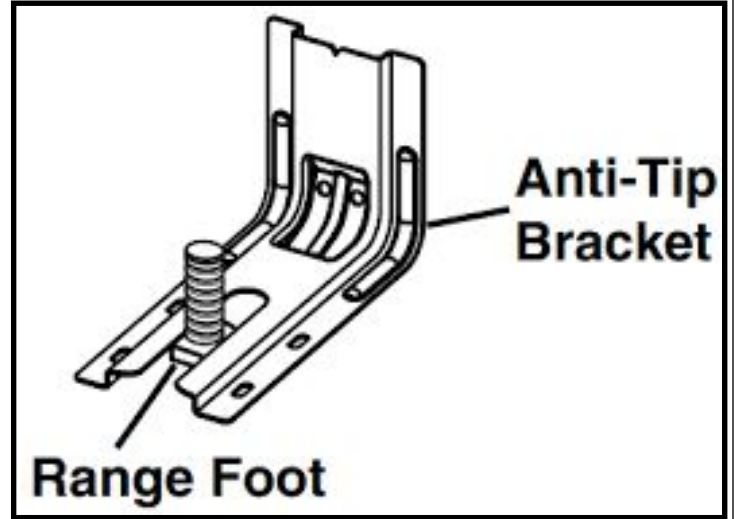
Oven &amp; Range

8.2. CAUTION: The oven/range is not equipped with an anti-tip device, which prevents the range from tipping, or its contents from spilling, should a child attempt to climb on it or its open door. This is a recommended safety feature that should be installed, and particularly if small children occupy or visit the residence.

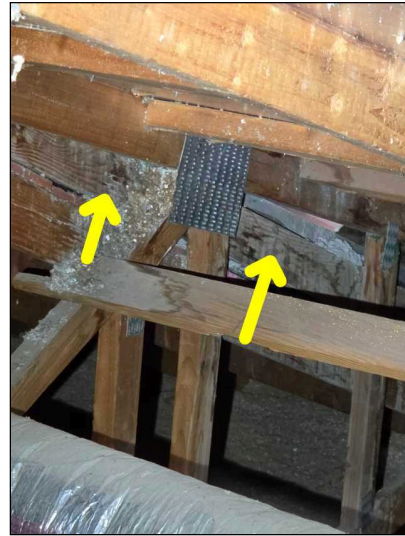
Page 95 Item: 3    Structure

3.1. There is an area on the roof where the various level transition appears to have been previously repaired. From inside the attic space there has been visual moisture intrusion and daylight shining through. Recommend further evaluation by a licensed roofing contractor

Evidence of moisture intrusion

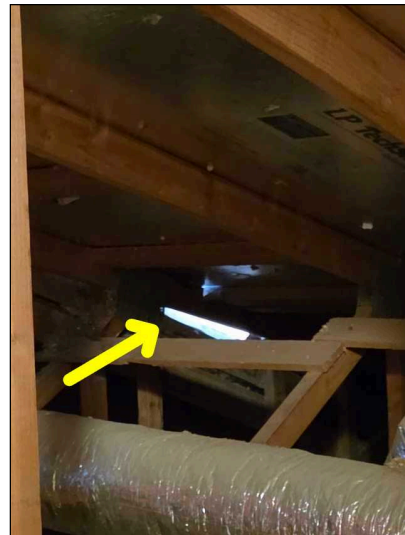
Open area

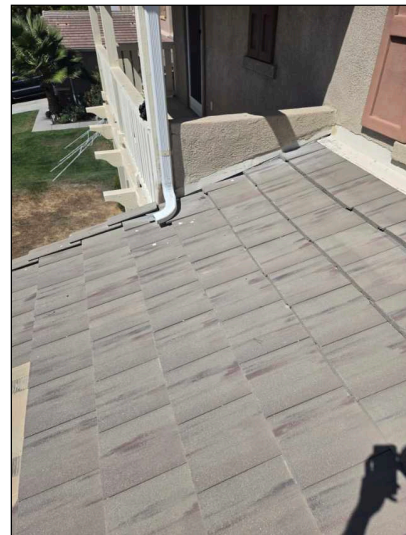
1.2. 1 cracked and slipped tiles observed on the roof system. Recommend correction by a licensed roofing contractor

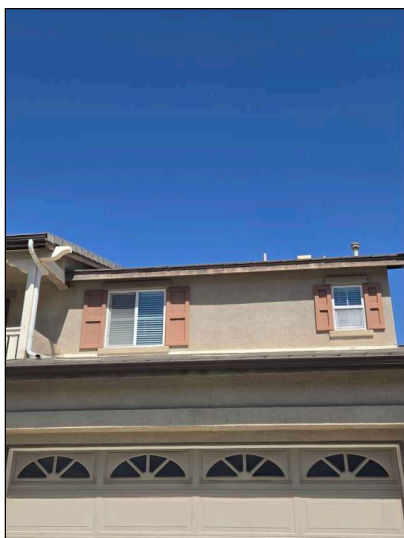
Minor deterioration

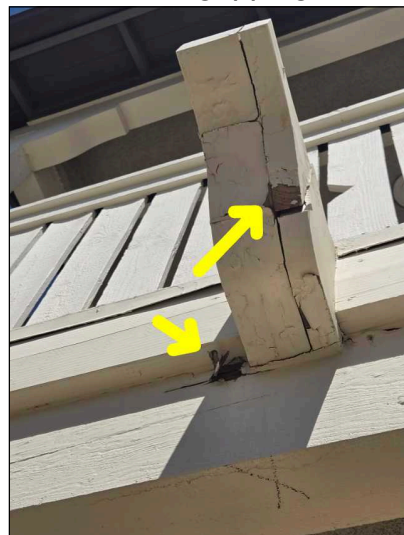
Rust

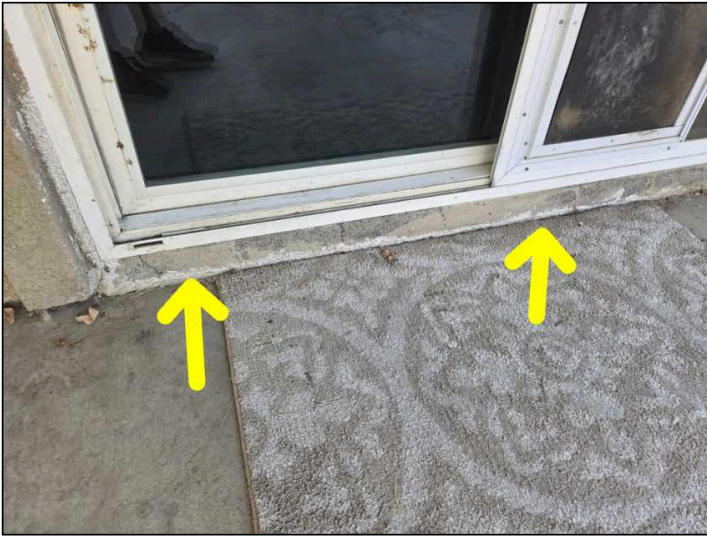
Deterioration

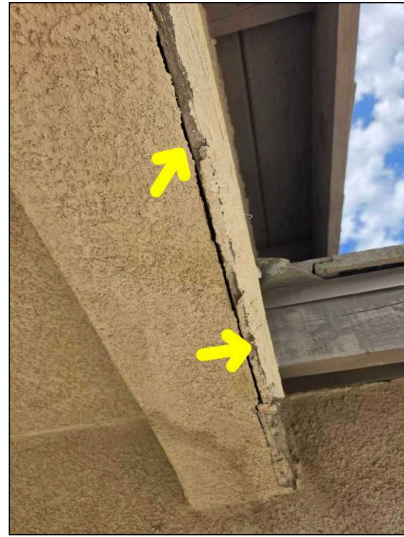
Stucco needed

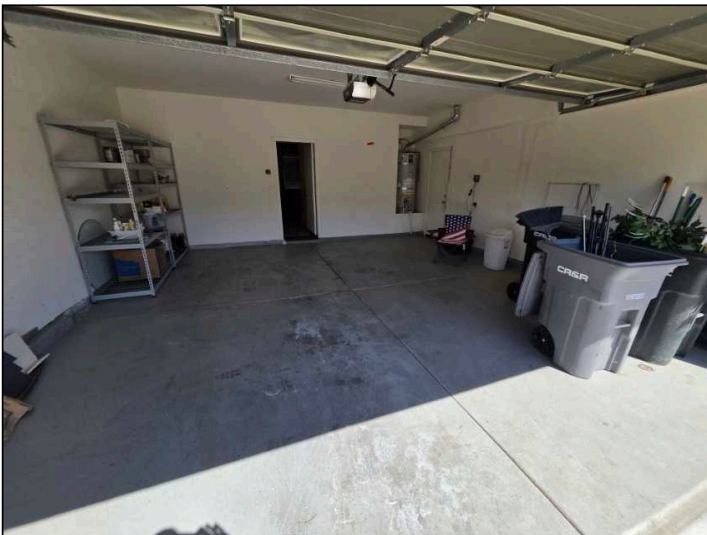
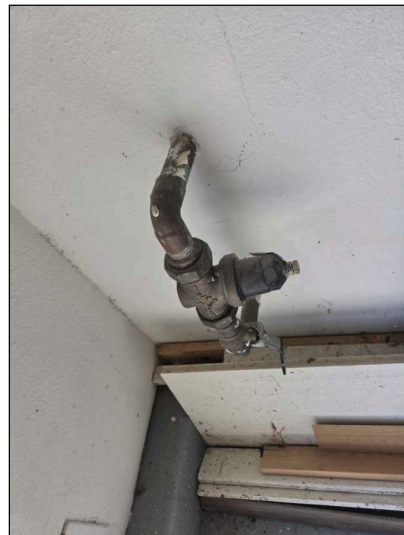
1.2. Observed staining in the garage area. Unable to determine cause however there is a water source above. Recommend further evaluation as needed.

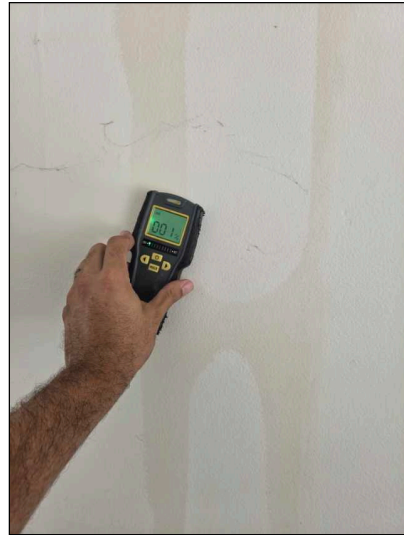
No active moisture

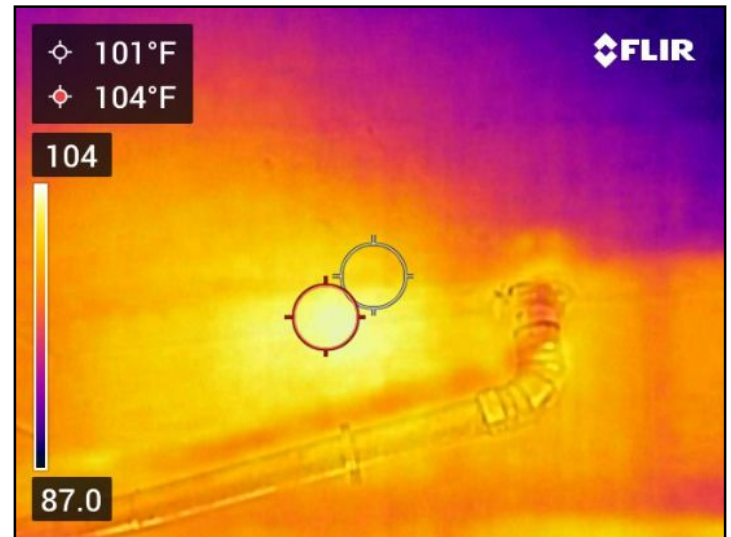
Weird vibration noise at water meter and secondary

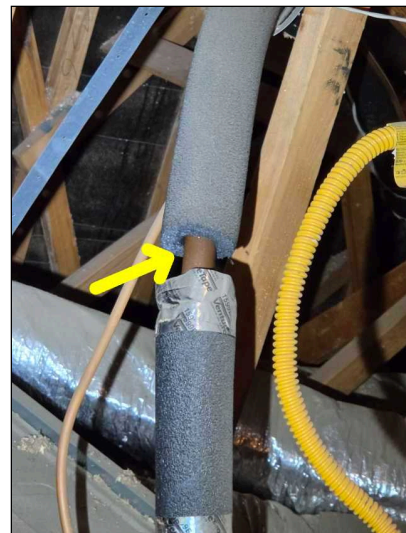
8.1. Missing insulation in areas around refrigerant line. Seek a licensed HVAC contractor for further evaluations and repairs.

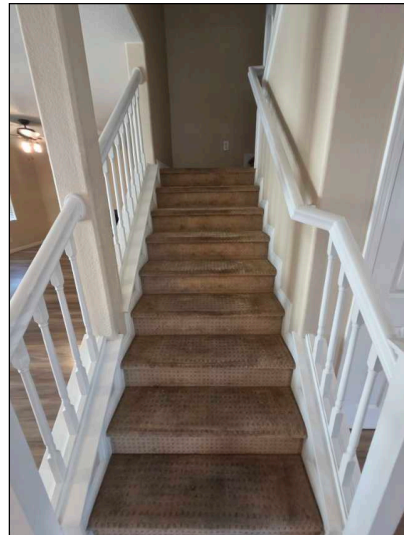
Recommend cleaning

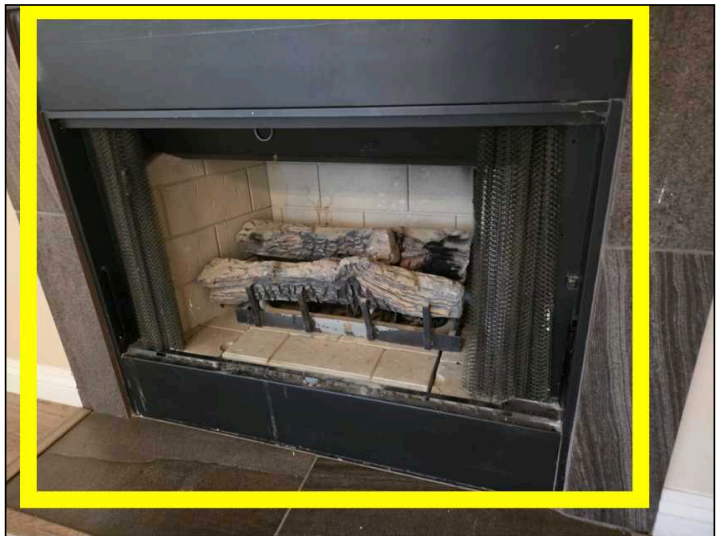
9.4. Missing glass doors on the fireplace. Recommend correction

9.5. The fireplace did not function with the switch or components within. This does not mean they are broken however it takes a particular professional to get up and running. Recommend correction

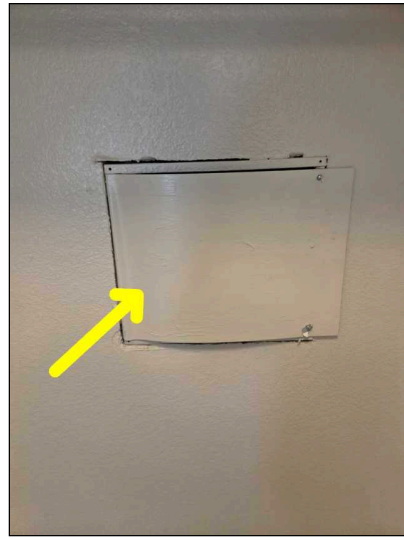
Proper cover recommended

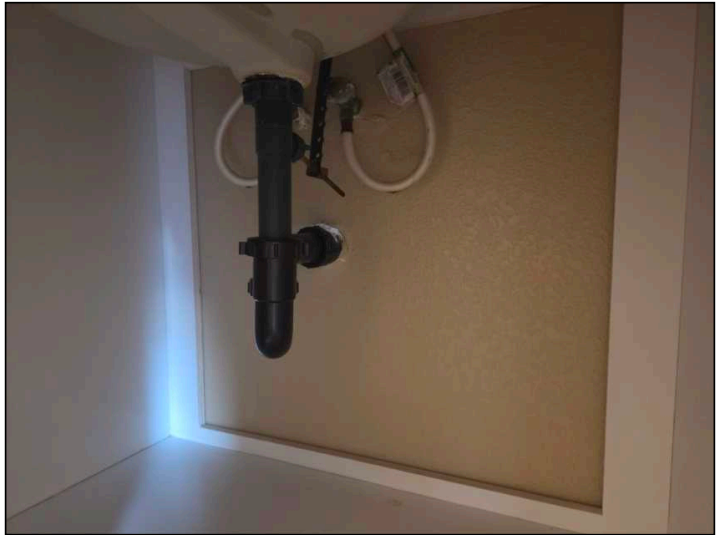
Rust

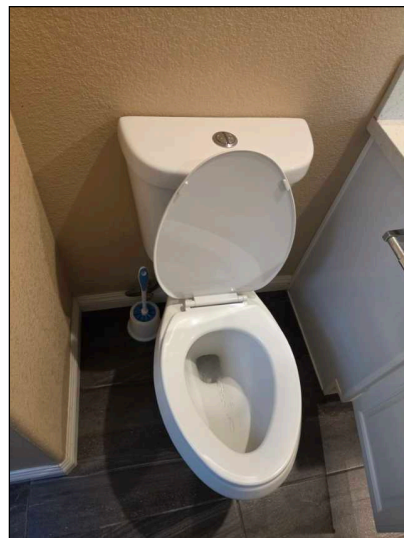
Plumbing knock

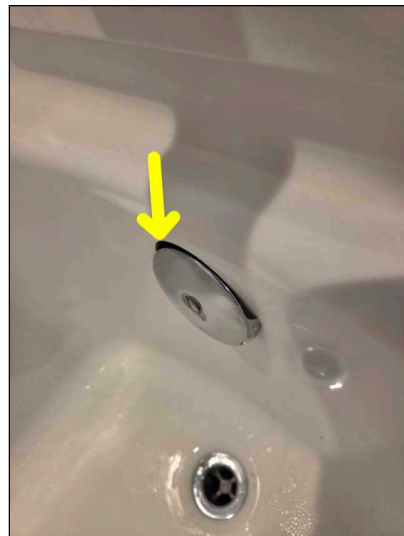
Improperly installed

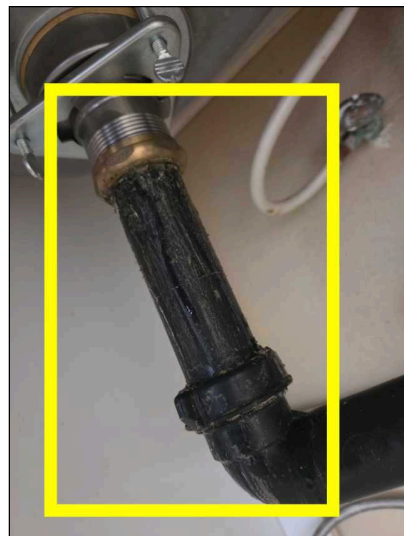
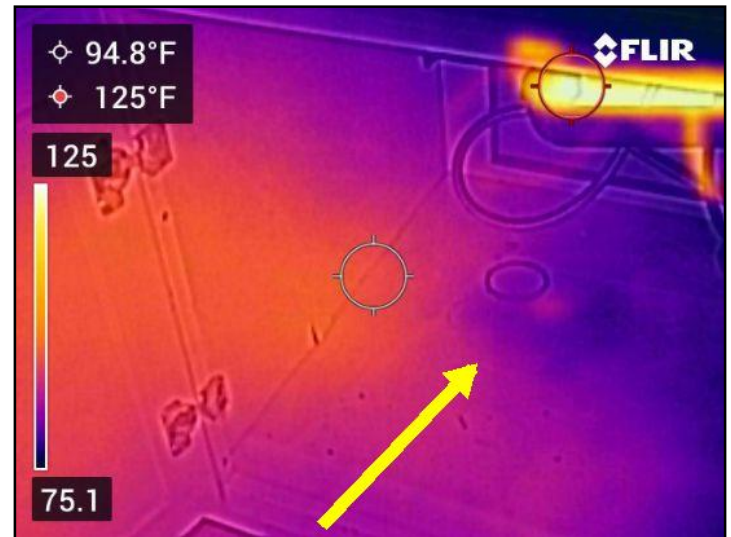
5.1. Observed signs of oxidation at one or more plumbing fixtures underneath the sink area. This is indicative of a previous leak that has sealed itself. Recommend replacing these valves to prevent future leaks using a licensed plumber.

5.2. Active leaking noted at the water line just below the faucet below the sink areas. Advise further evaluation and repair by a licensed plumber or qualified professional.

leak

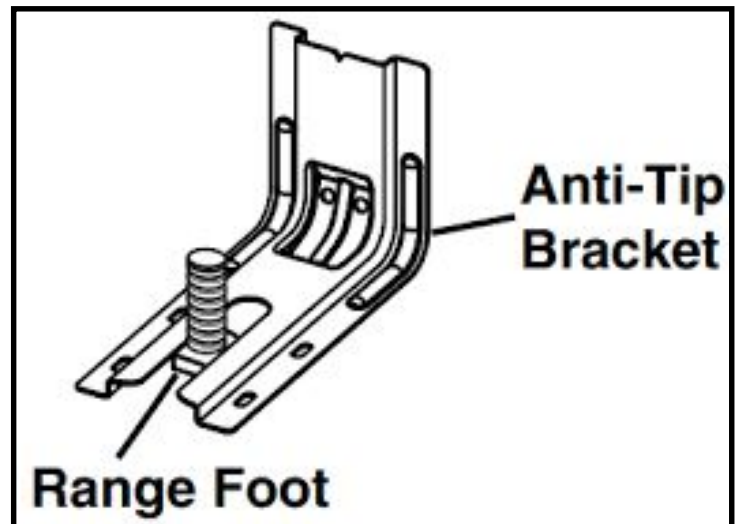
8.2. CAUTION: The oven/range is not equipped with an anti-tip device, which prevents the range from tipping, or its contents from spilling, should a child attempt to climb on it or its open door. This is a recommended safety feature that should be installed, and particularly if small children occupy or visit the residence.

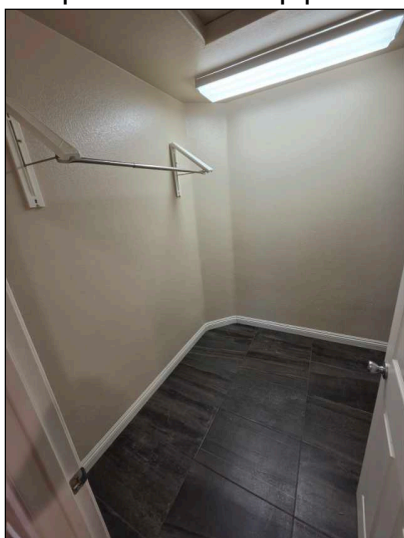
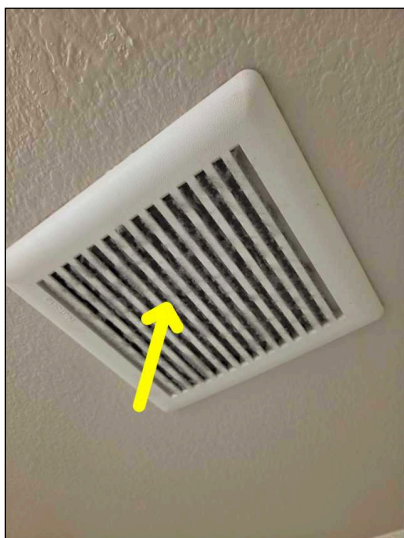
Unfinished
