# WOOD DESTROYING PESTS AND ORGANISMS INSPECTION REPORT

| BUILDING NO.<br><b>19880</b> | STREET, CITY, STATE, ZIP<br><b>Silverwood Drive, Lake Elsinore CA 92530</b> | Date of Inspection<br><b>9/23/2026</b> | No. of Pages<br><b>5</b> |
| General Description:<br>Two story, stucco framed, residence, concrete slab, tile roof, vacant | | Inspection Tag Posted:<br>Garage | |

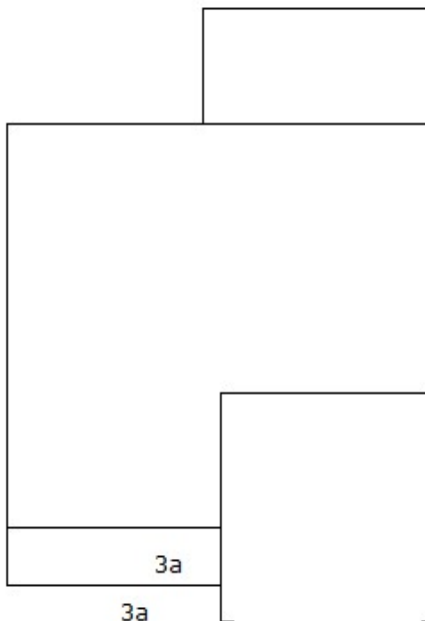
Fungus Damage noted at balcony header and handrail. Marked 3a on diagram.

Others to remove and replace damage.
