# INSPECTION REPORT

For the Property at:  
**2826 TELEVISION ROAD**  
PETERBOROUGH, ON

RE: Report No. 5819  
2826 Television Road  
Peterborough, ON

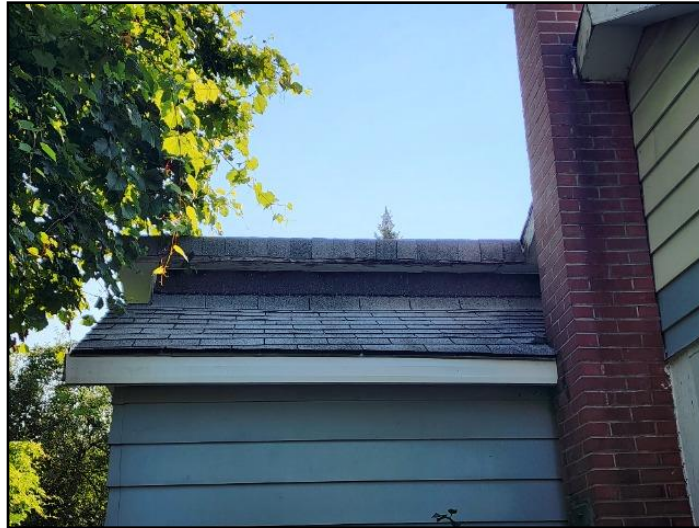
**2. Condition:** • Missing

**Implication(s):** Chance of water damage to structure, finishes and contents

**Location:** Rear elevation

4. Missing

**Task:** Provide

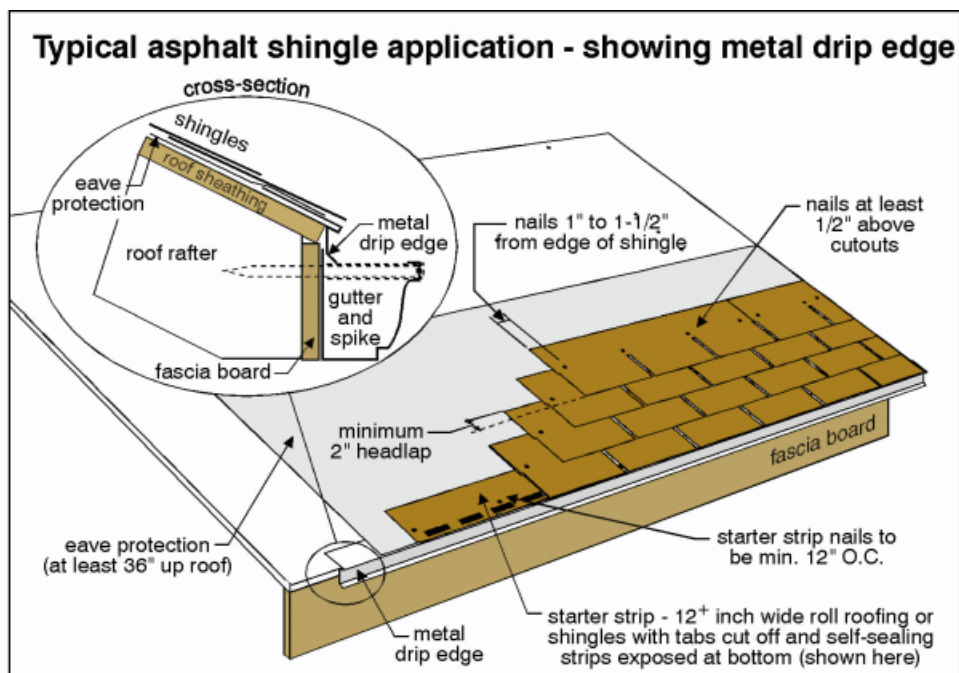
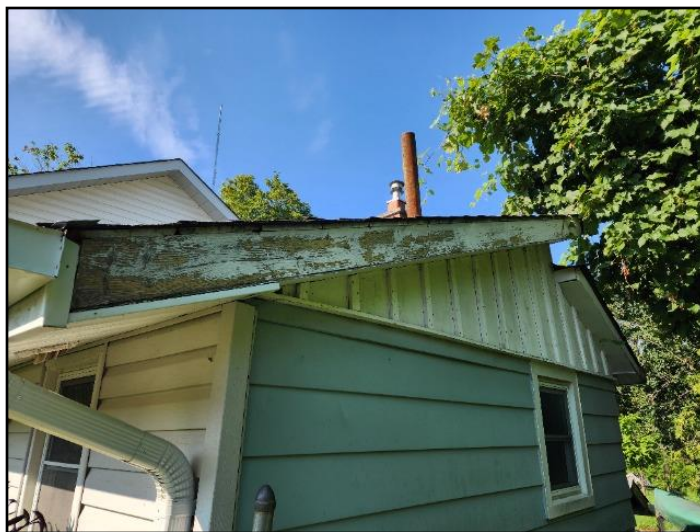
**3. Condition:** • Missing

**Implication(s):** Chance of water damage to structure, finishes and contents

**Location:** Right elevation

5. Missing

**Task:** Provide

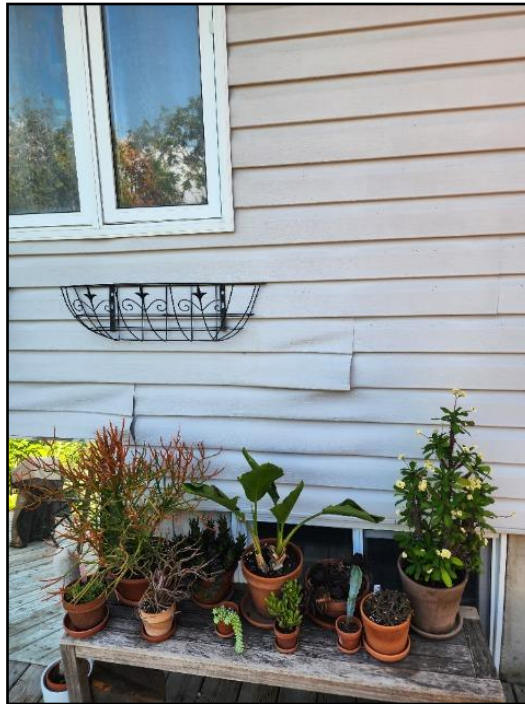
**4. Condition:** • Heat damage

**Location:** Rear elevation

6. Heat damage

**Task:** Replace

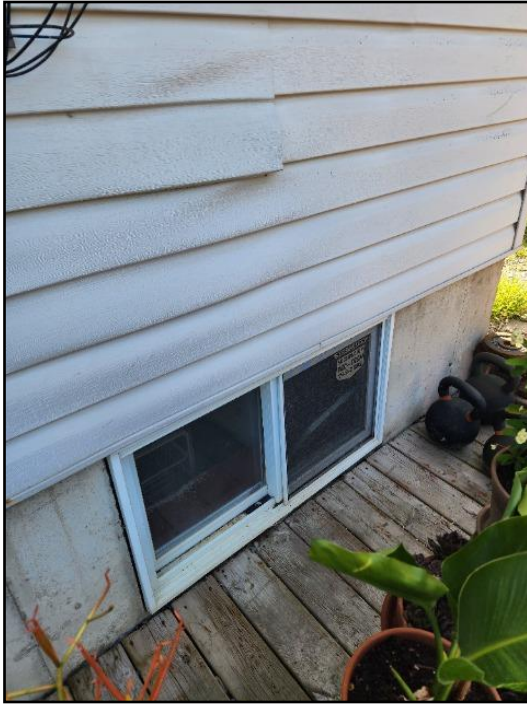
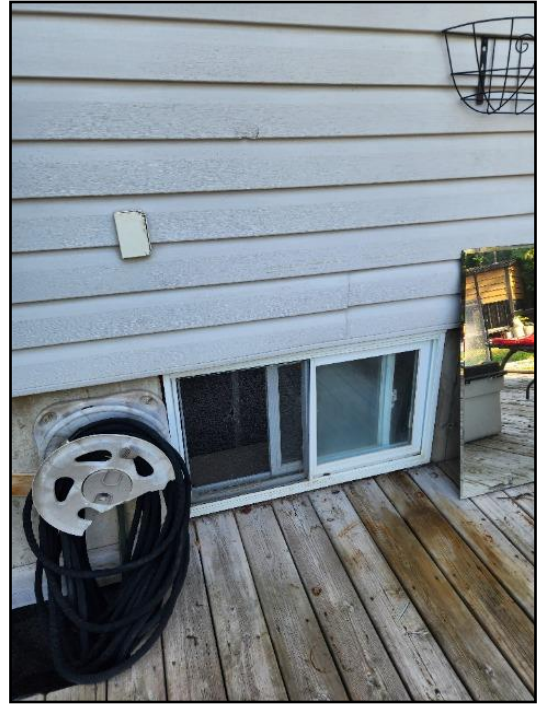
**5. Condition:** • Caulking missing, incomplete or deteriorated

**Implication(s):** Chance of water damage to structure, finishes and contents | Increased heating and cooling costs

**Location:** Rear elevation

7. Caulking missing, incomplete or deteriorated

**Task:** Provide

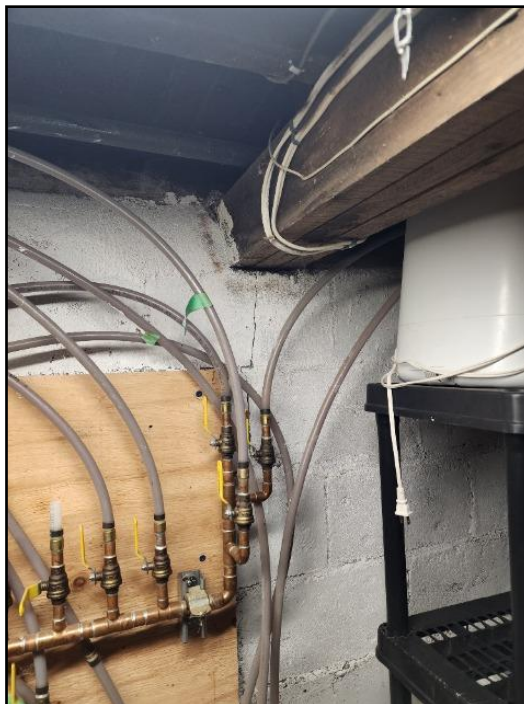
**6. Condition:** • Typical minor cracks

**Location:** Utility room

9. Typical minor cracks

**Task:** Monitor

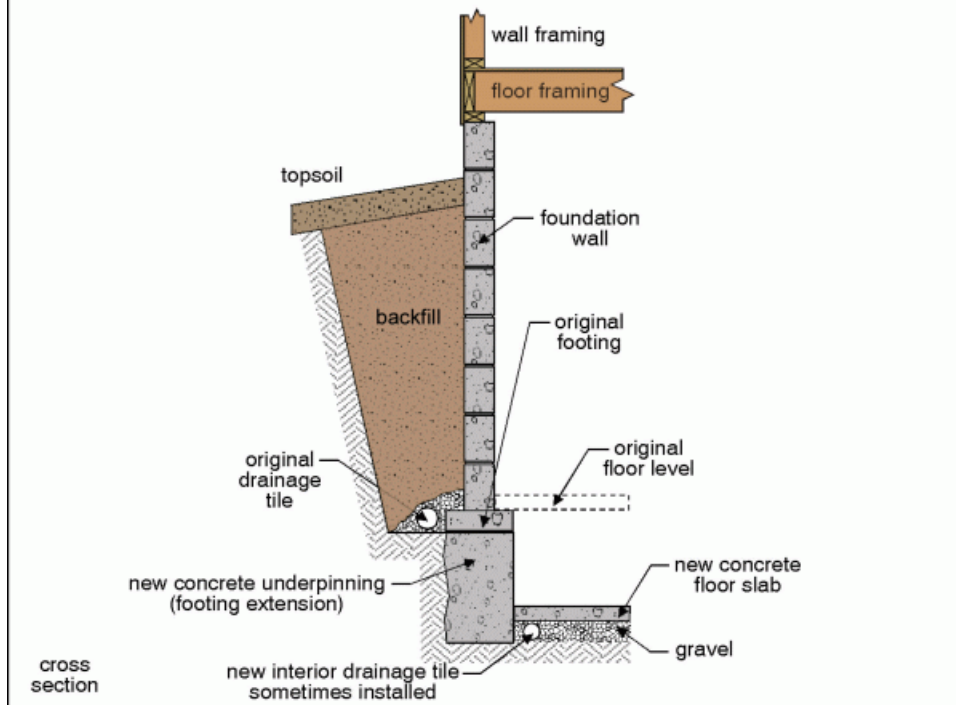
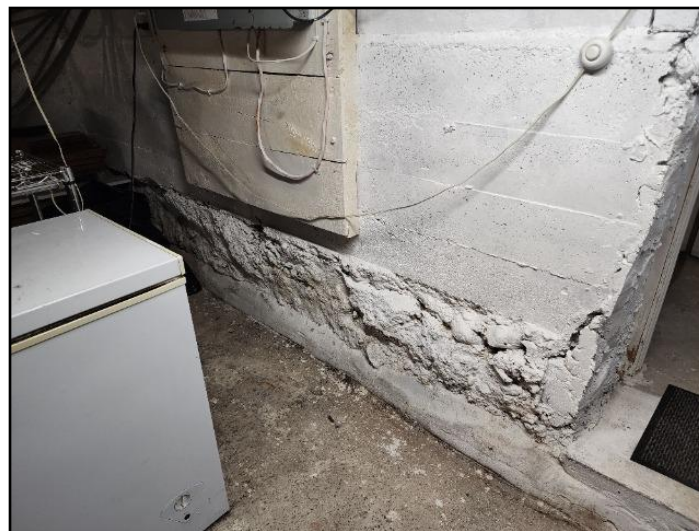
**7. Condition:** • Basement lowered or underpinned

**Implication(s):** Chance of structural movement

**Location:** Utility room

10. Basement lowered or underpinned

**Task:** Monitor

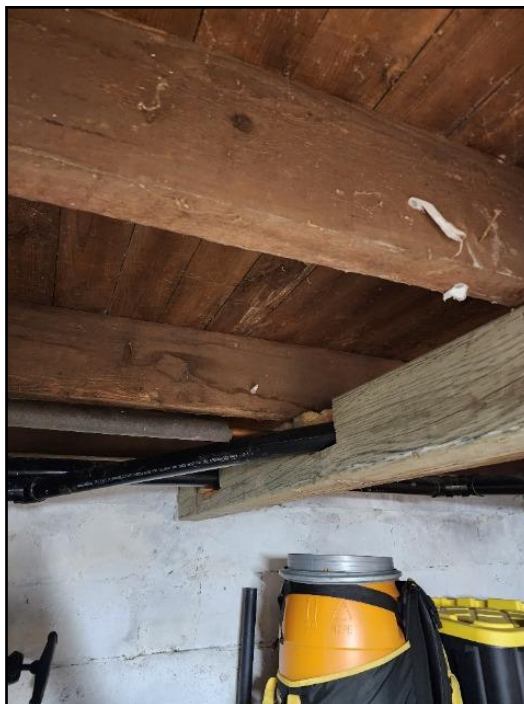
**8. Condition:** • Notches or holes

**Location:** Utility room

11. Notches or holes

**Task:** Monitor

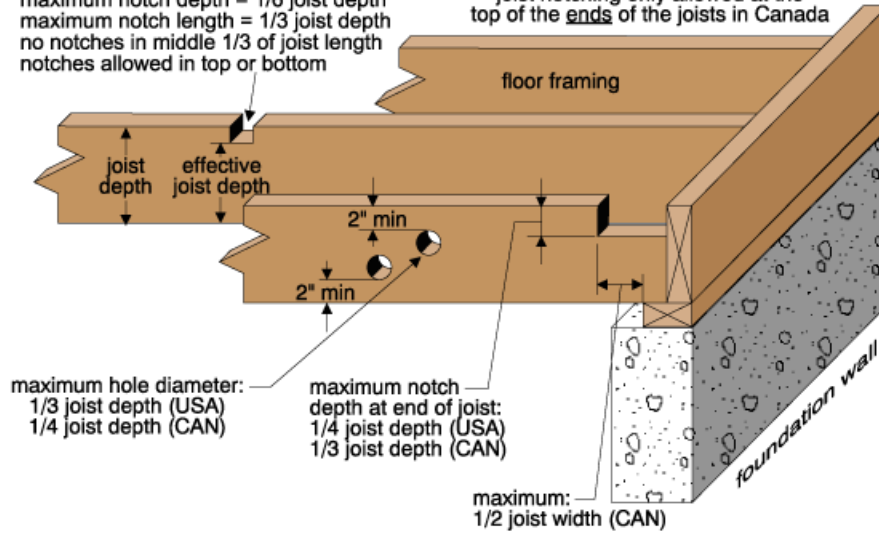
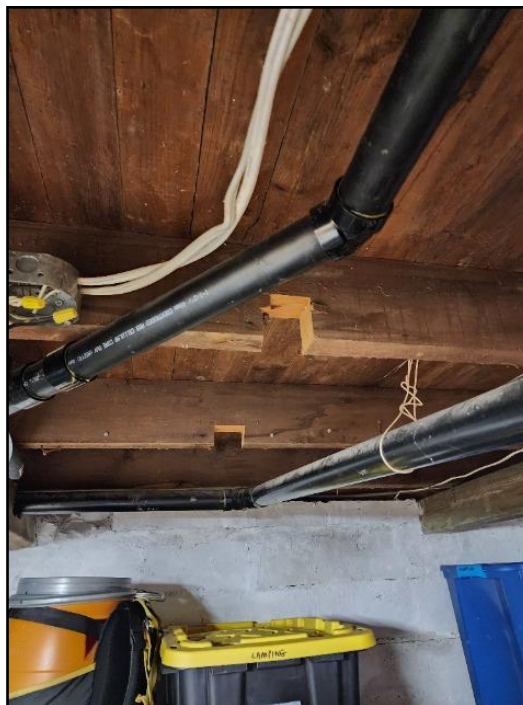
10. **Condition:** • Notches or holes

maximum notch depth =  $\frac{1}{6}$  joist depth  
maximum notch length =  $\frac{1}{3}$  joist depth  
no notches in middle  $\frac{1}{3}$  of joist length  
notches allowed in top or bottom

**note:**  
joist notching only allowed at the top of the ends of the joists in Canada

12. Notches or holes

**Task:** Repair or replace

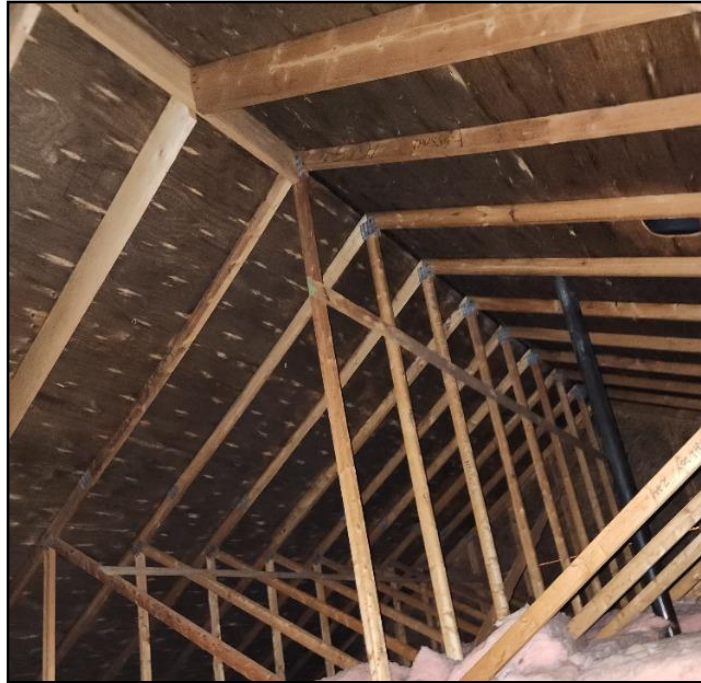
11. Condition: • Mold

The mold may be indicative of the lower level of insulation noted in the attic

13. Mold

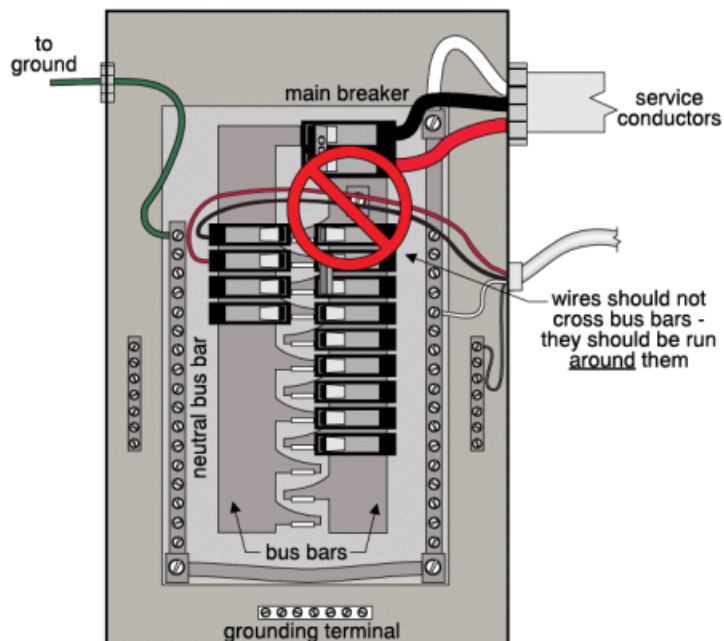
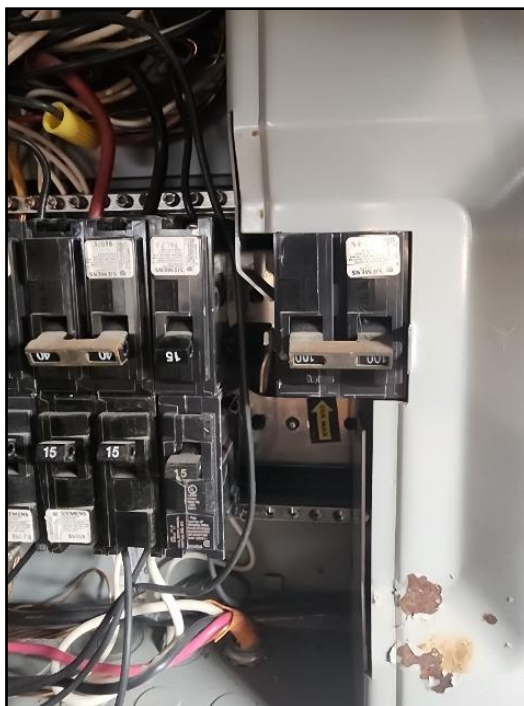
**12. Condition:** • Wire crossing bus connections

**Implication(s):** Electric shock | Fire hazard

**Wires shouldn't cross bus bars**

16. Wire crossing bus connections

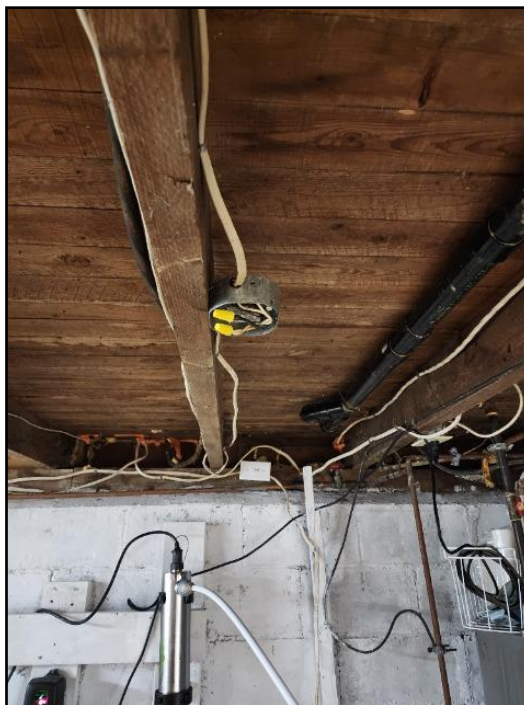
13. Condition: • Cover missing

**Implication(s):** Electric shock | Fire hazard

**17.** *Cover missing*

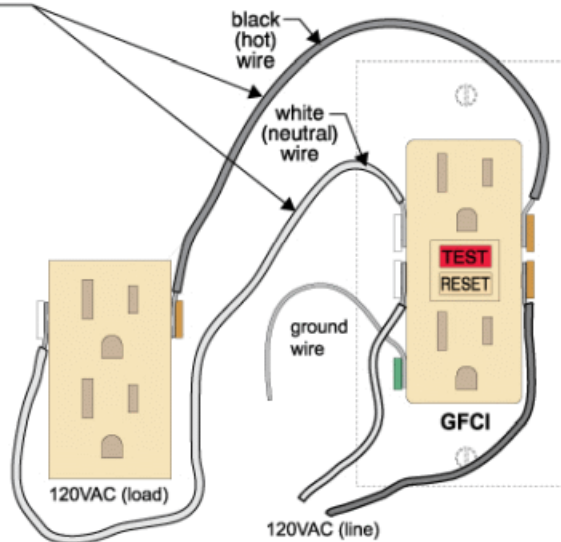
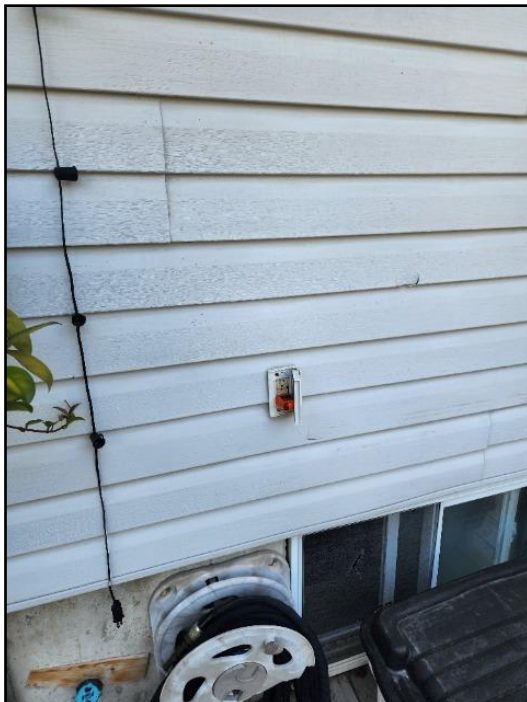
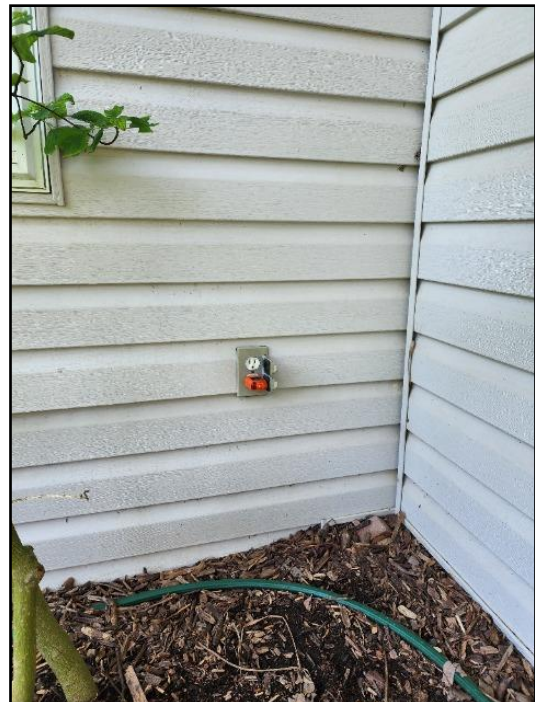
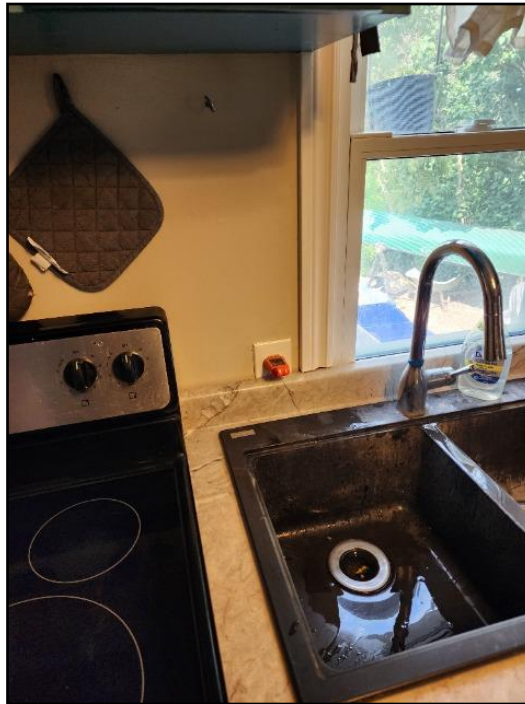
**14. Condition:** • No GFCI/GFI (Ground Fault Circuit Interrupter)

Although not a deficiency in a home of this age, safety may be improved by upgrading these receptacles.

18. No GFCI/GFI (Ground Fault Circuit...

20. No GFCI/GFI (Ground Fault Circuit...

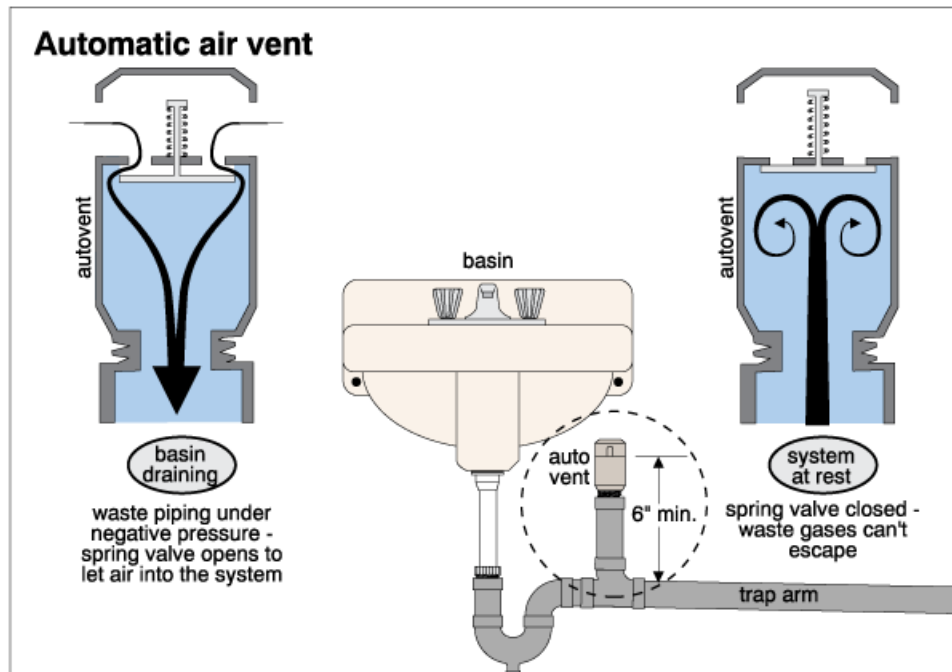
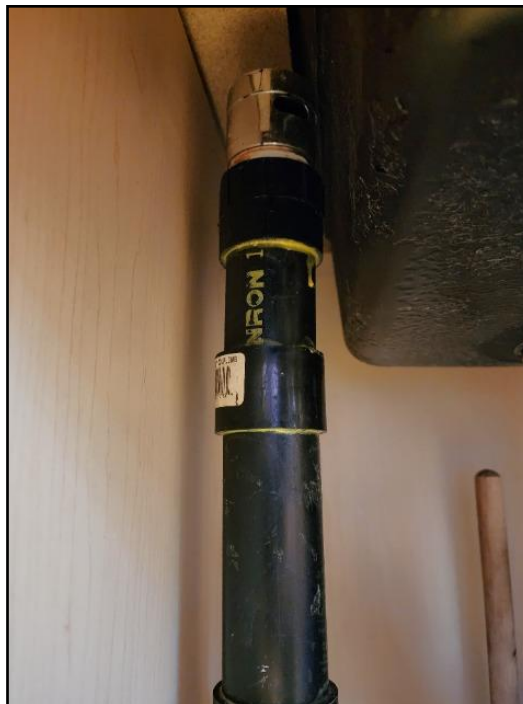
18. Condition: • Automatic air vents

Implication(s): Failure may allow sewer gasses to enter building

35. Automatic air vents

Task: Monitor

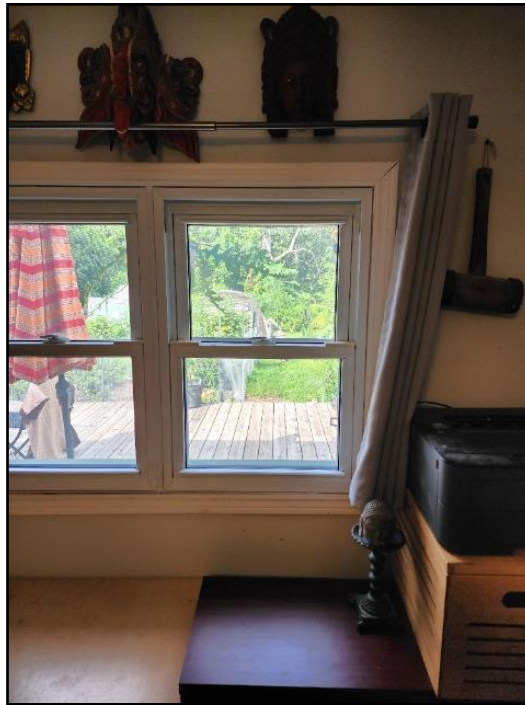
**19. Condition:** • Cracked

**36.** *Cracked*

**Task:** Replace

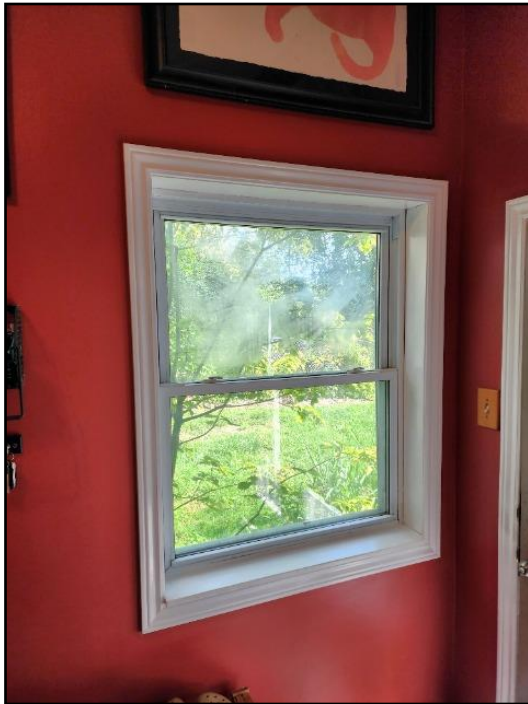
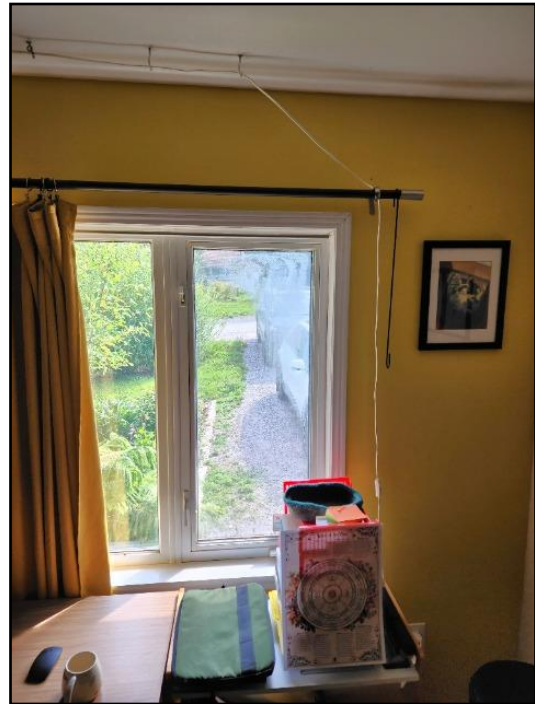
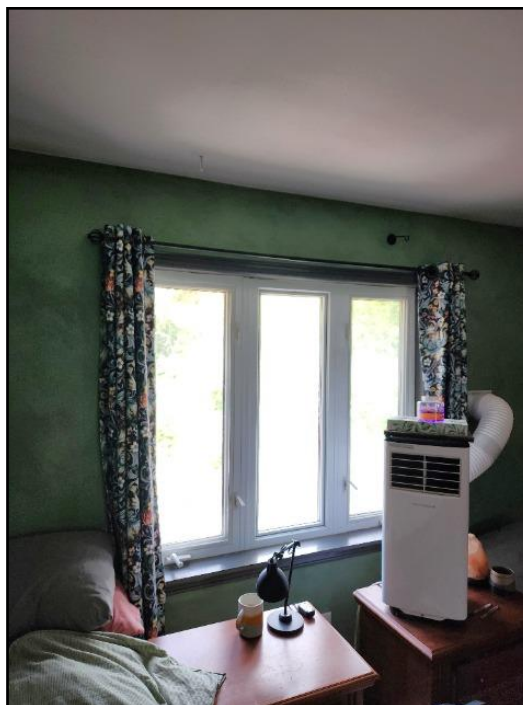
**20. Condition:** • Lost seal on double glazing

37. Lost seal on double glazing

**Task:** Repair or replace

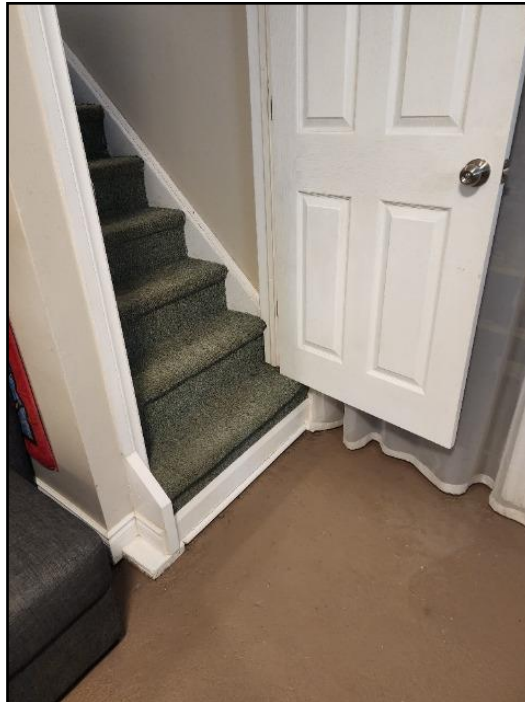
21. Condition: • Door opens over a step

Implication(s): Trip or fall hazard

40. Door opens over a step

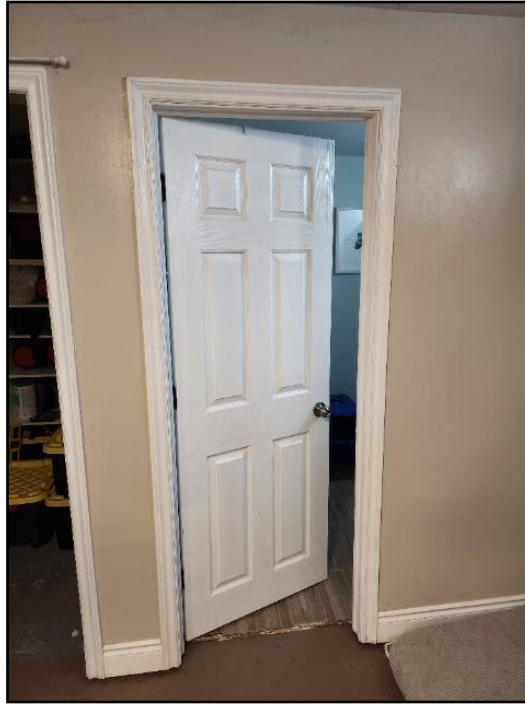
**22. Condition:** • Binds

41. Binds

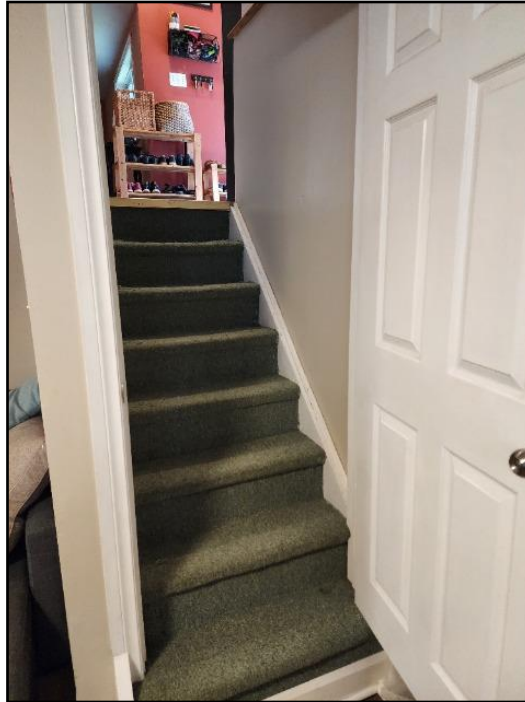
**23. Condition:** • Missing

**Implication(s):** Fall hazard

42. Missing
