INSPECTION REPORT

For the Property at:
114 OAKWOOD CRESCENT
PETERBOROUGH, ON K9J 1N3

Prepared for: TEAM VANRAHAN
Inspection Date: Wednesday, September 17, 2025
Prepared by: David Sharman

RE: Report No. 5453
114 Oakwood Crescent
Peterborough, ON
K9J 1N3

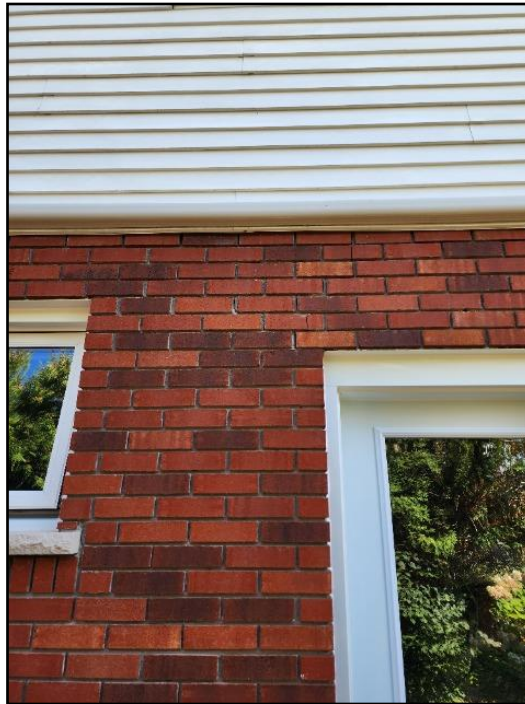
4. Condition: • Typical minor cracks

Implication(s): Chance of frost damage & material deterioration

Location: Left elevation

3. Typical minor cracks

Task: Repair

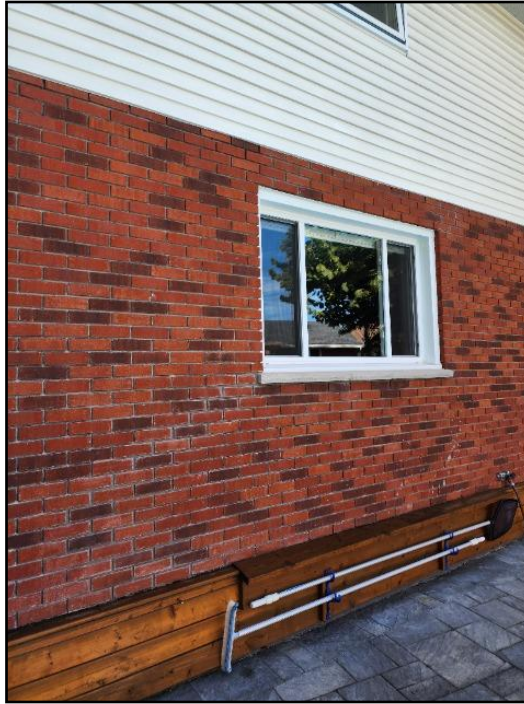
5. Condition: • Prior repairs

Location: Rear left corner

4. Prior repairs

Task: Monitor

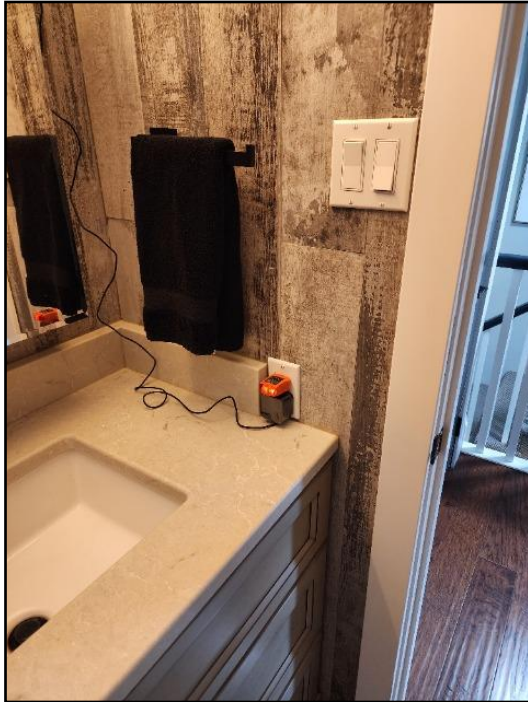
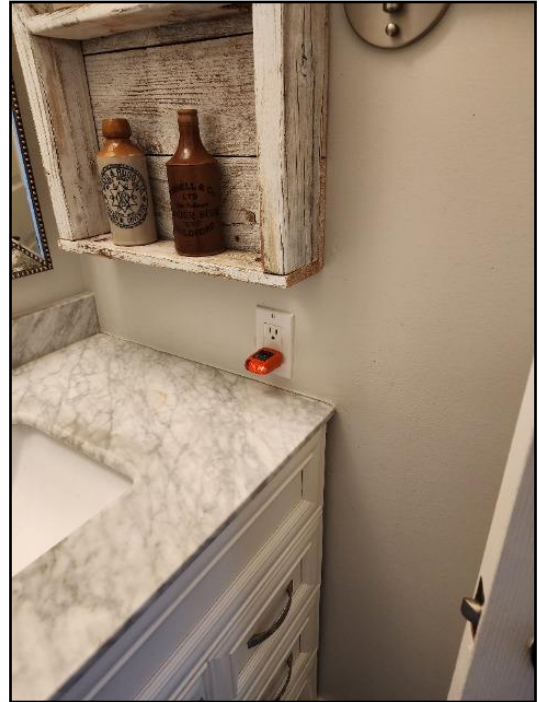
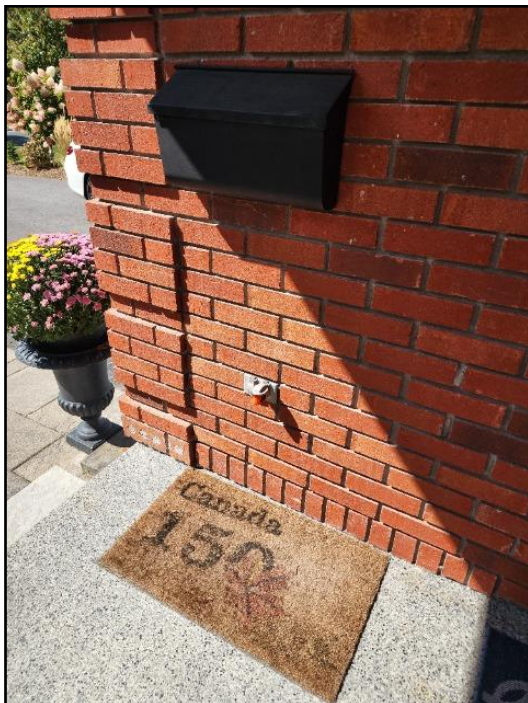
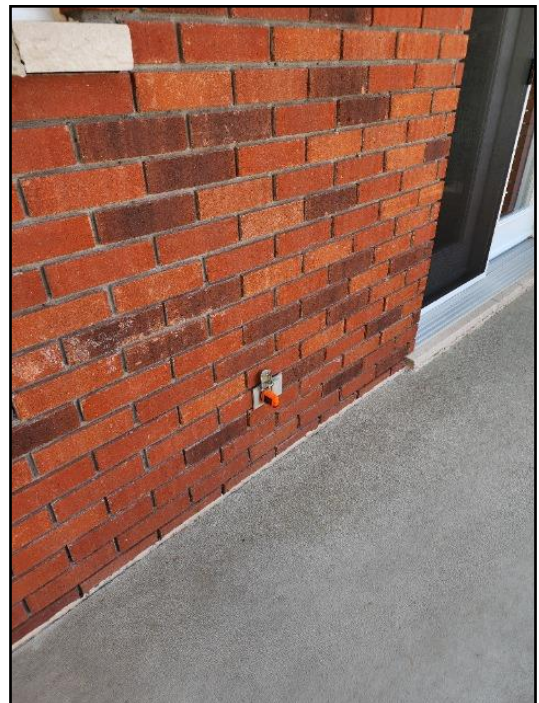
6. Condition: • No GFCI/GFI (Ground Fault Circuit Interrupter)

Implication(s): Electric shock

Location: Bathroom, ensuite & exterior wall

8. No GFCI/GFI (Ground Fault Circuit...

Task: Upgrade

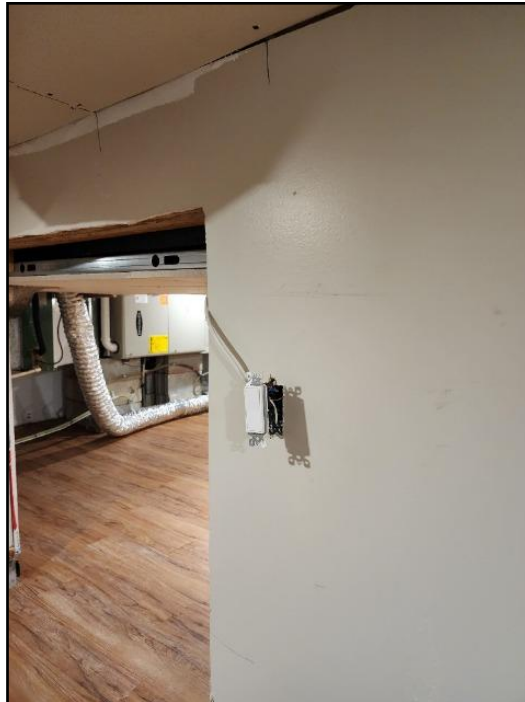
7. Condition: • Loose

Implication(s): Electric shock

Location: Crawlspace

12. Loose

Task: Repair

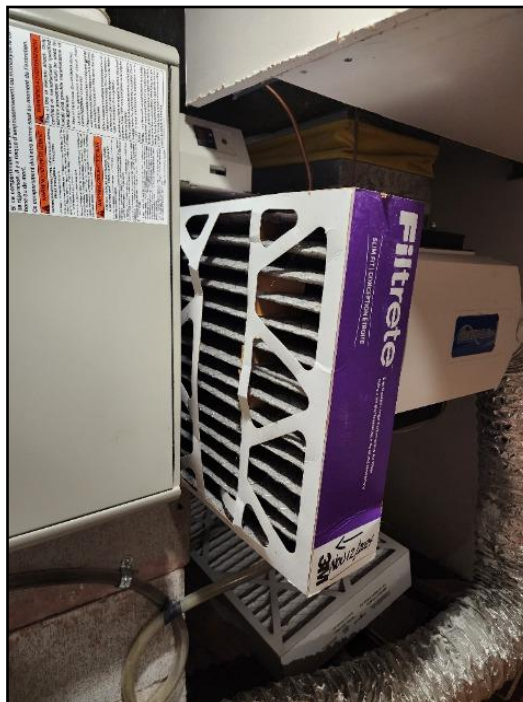
8. Condition: • Replace - regular maintenance

Implication(s): Increased heating & maintenance costs, Reduced comfort

Location: Cold air return

20. Replace - regular maintenance

Task: Replace - regular maintenance

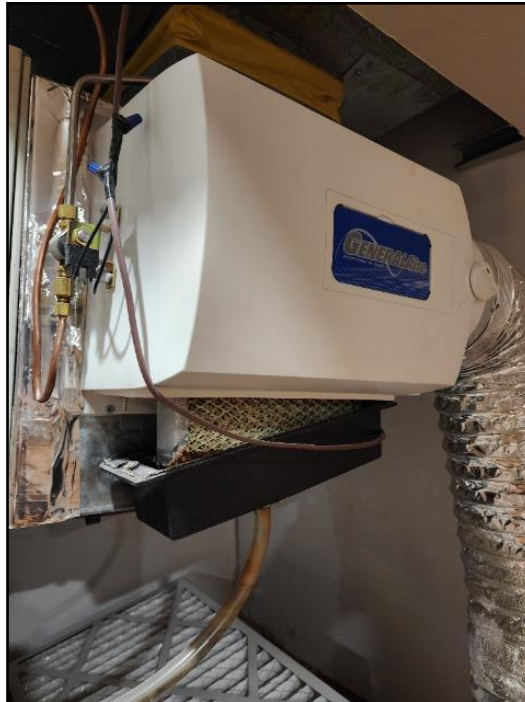
9. Condition: • Clean pad/mesh - regular maintenance

21. Clean pad/mesh - regular maintenance

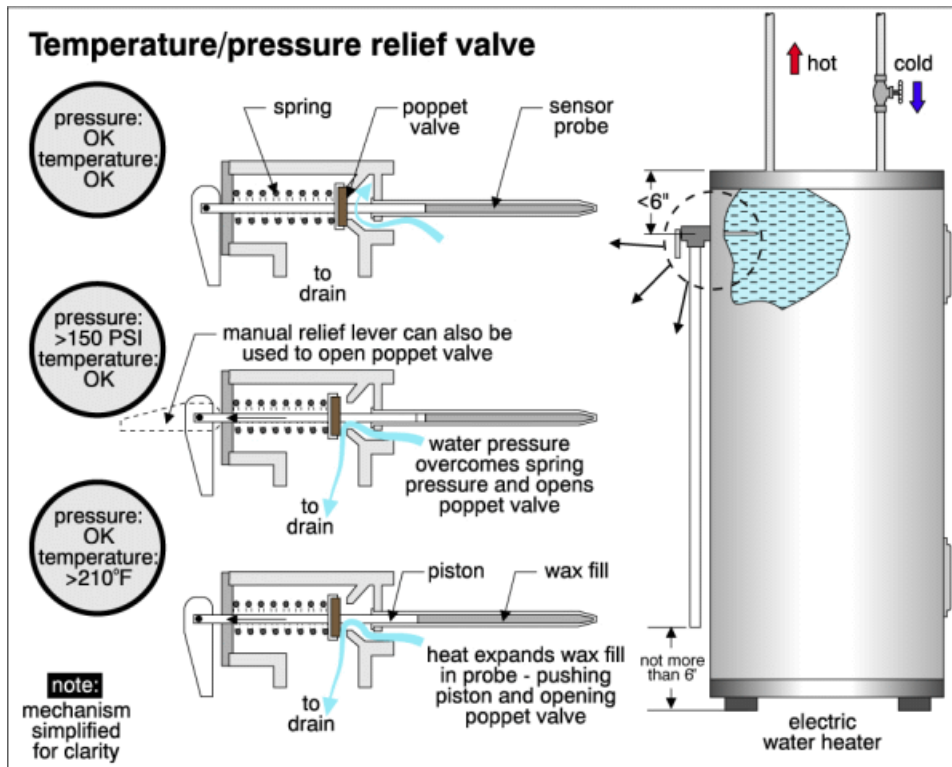
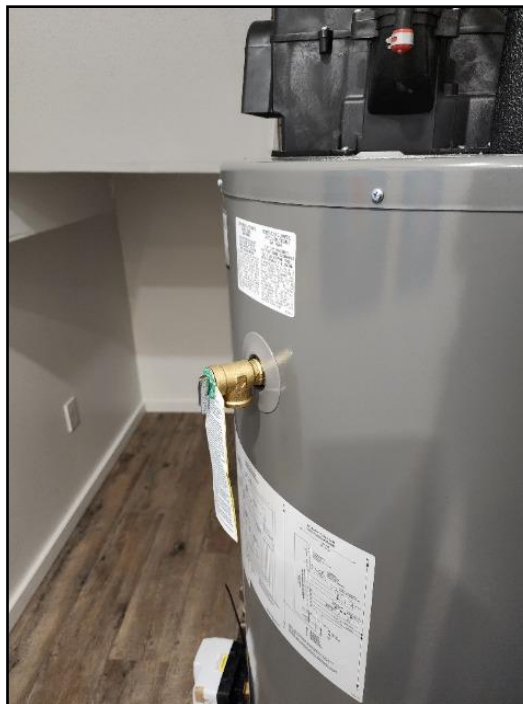
12. Condition: • Discharge tube missing

Implication(s): Scalding. Possible water damage to finishes, storage and structure

32. Discharge tube missing

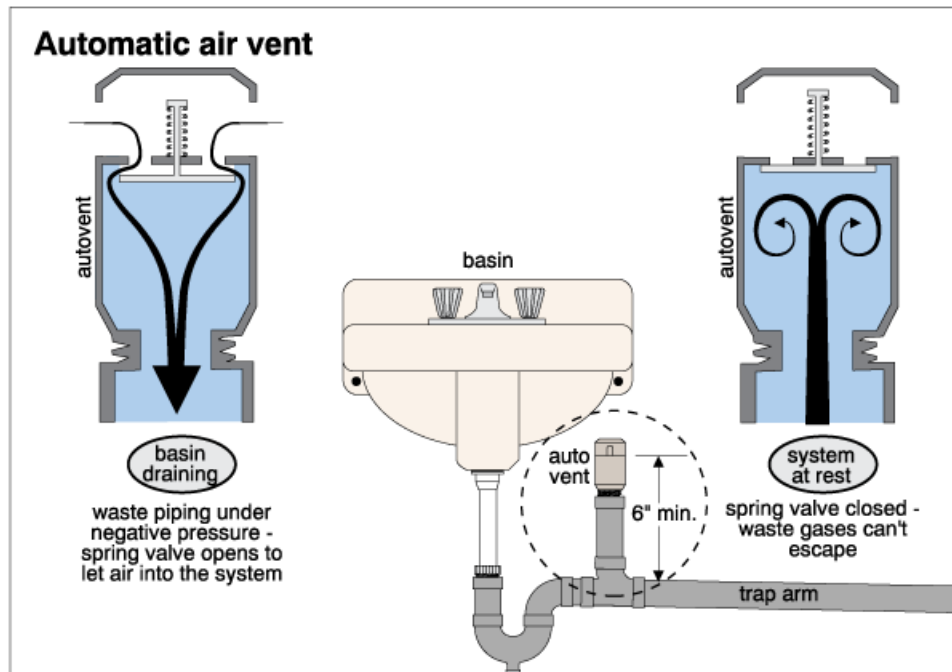
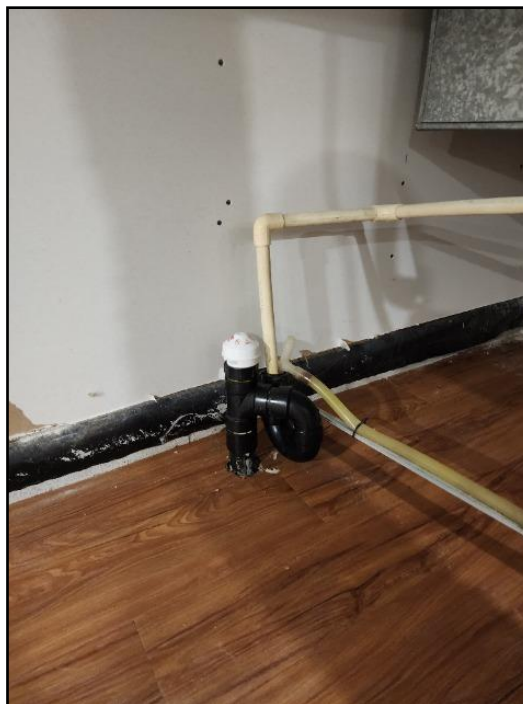
13. Condition: • Automatic air vents

Implication(s): Failure may allow sewer gasses to enter building

33. Automatic air vents

Task: Monitor

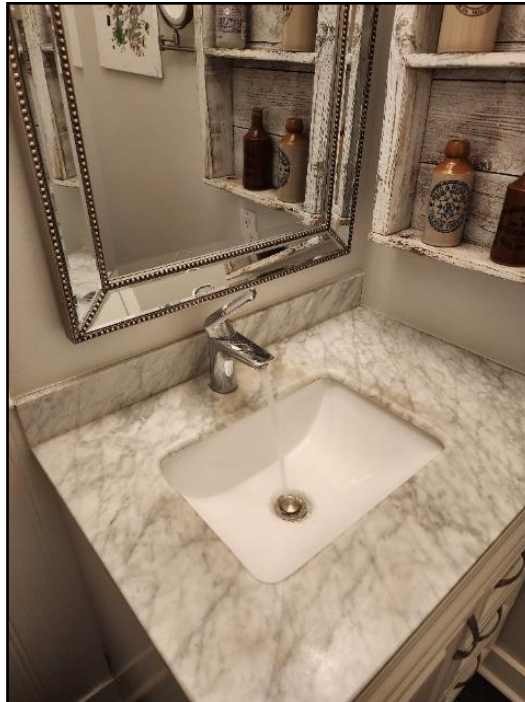
14. Condition: • Hot and cold reversed

34. *Hot and cold reversed*

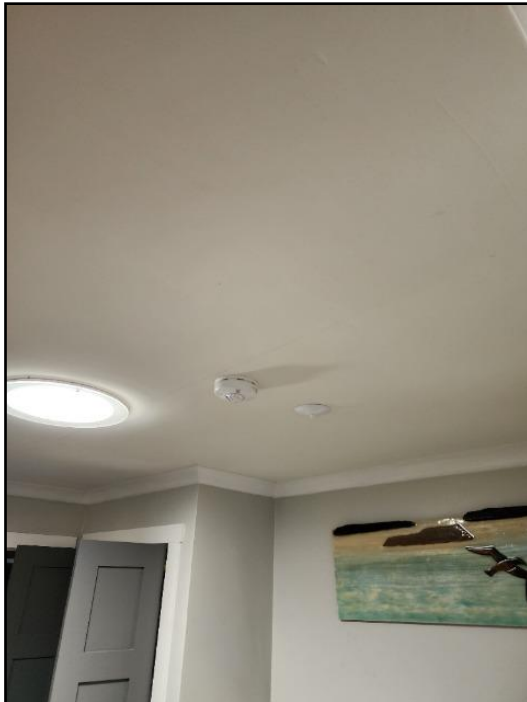
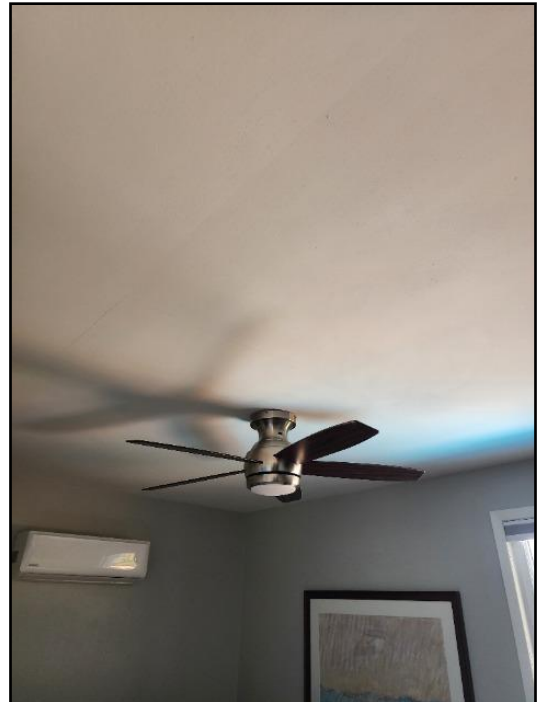
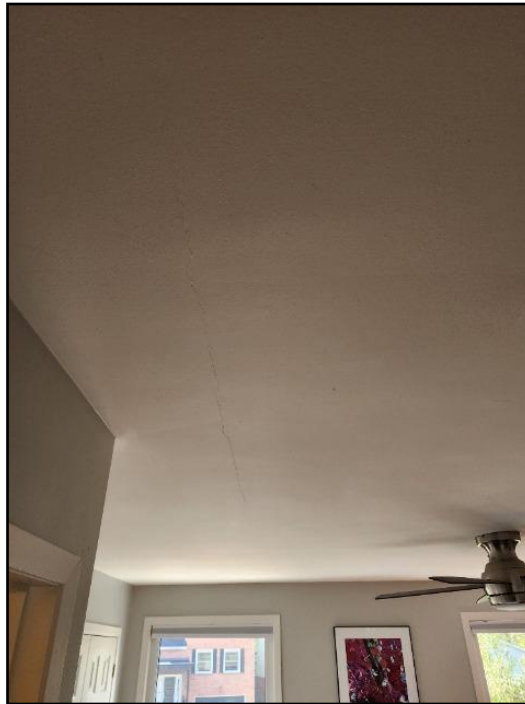
15. Condition: • Minor cracking

Implication(s): Material deterioration

35. Minor cracking

Task: Repair

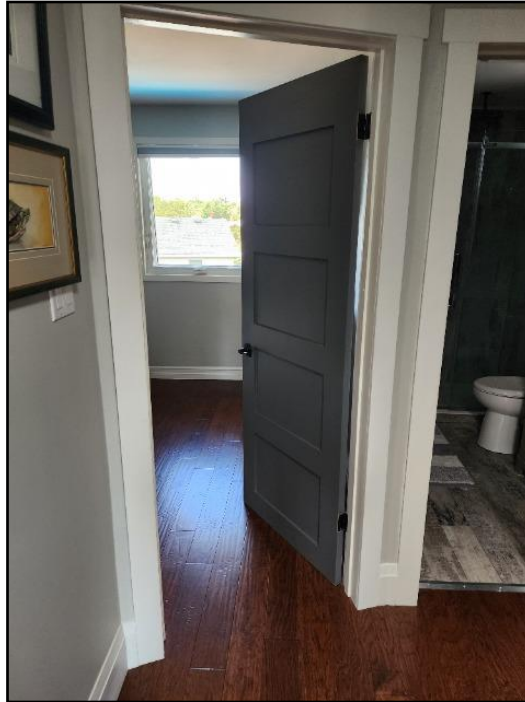
16. Condition: • Binds

Implication(s): Wear and/or damage to flooring and/or door

38. Binds

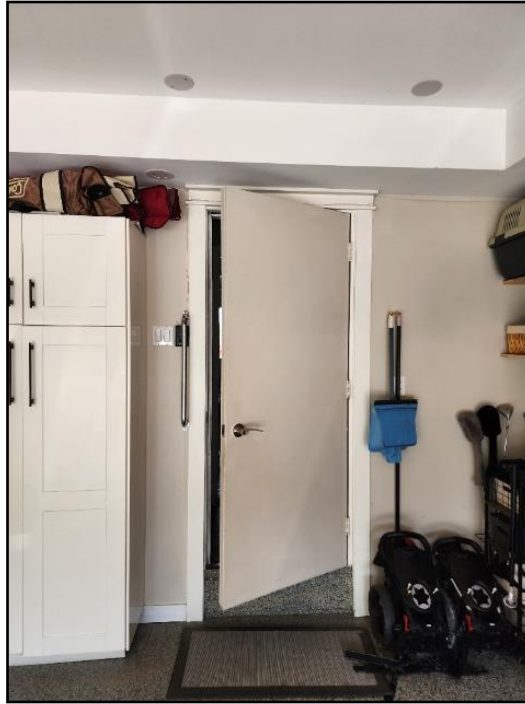
17. Condition: • Self closer missing, damaged or disconnected

Implication(s): Hazardous combustion products entering home

39. Self closer missing, damaged or disconnected
