Foundation Inspection
Hercules Foundation Repair
Mr. Colin Alexander
Tel: 210-556-6767
Email: herculesfoundationtx@gmail.com

Final Inspection: Re: Structural foundation inspection of the house at **1202 Petunia Lane, Pflugerville, Texas 78660**

Foundation Repair Plan

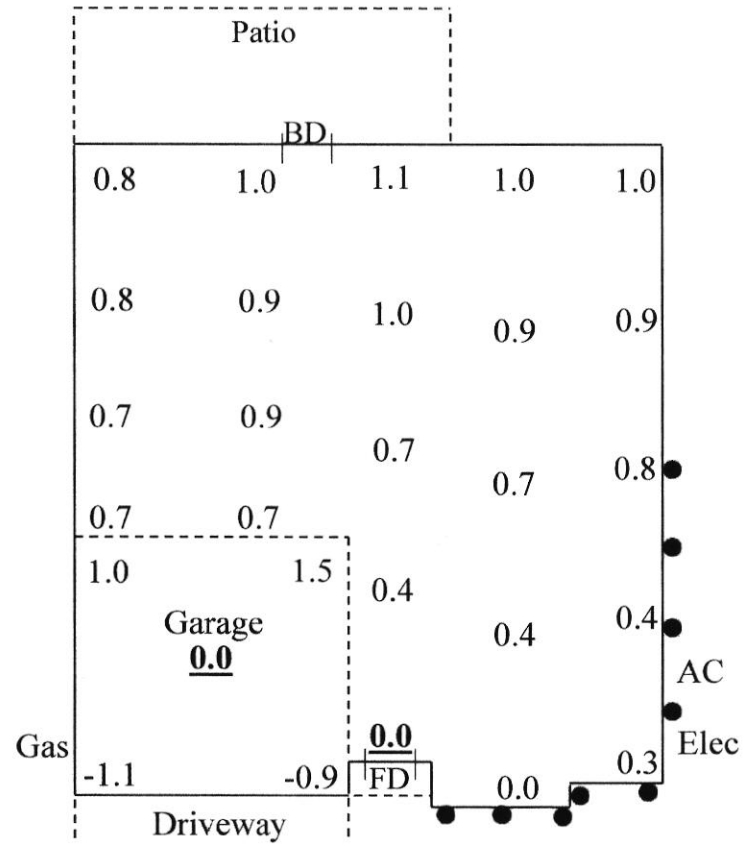
SK-1

All specified **pressed concrete piers** were installed under the **slab on grade, one-story, brick veneer, fiber cement siding, single-family residence**. At the time of the inspection, the work pertaining to the leveling and repairing of the foundation and the backfilling of the soil along the perimeter of the house was complete.
