# Oasis Utility Services

# Well Productivity Report

*Thank you for your business and confidence in Oasis Utility Services! On July 22<sup>nd</sup> 2026, a Well Productivity Test was performed at the address of 20899 Black Canyon Road in Ramona, California. All well equipment components relative to the well productivity were inspected and evaluated using a three-tier rating (Optimal, Functional, Not Functional). These findings will indicate the well productivity upon the date of inspection and were not recorded to any regulatory database. Notable observations and conclusions from these findings are as follows:*

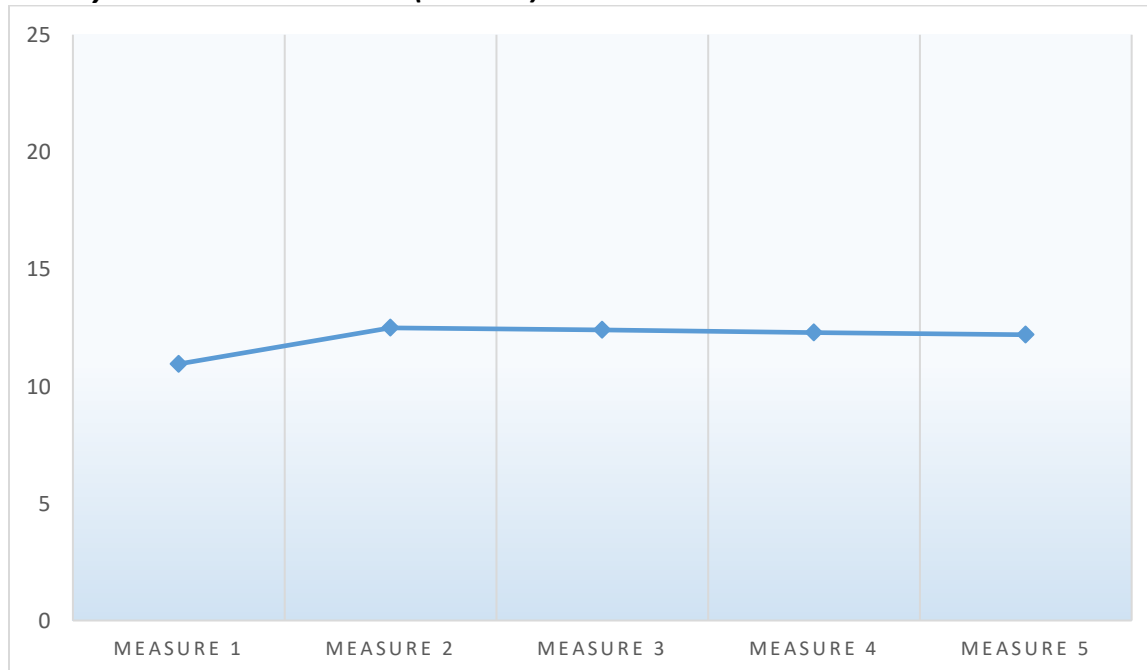
**Well System Production Curve (Well # 1):**

**Average observed Gallons Per Minute : 12.07**

*This well produces an adequate supply of ground water at an average rate of 12.07 Gallons Per Minute (gpm), placing this well output in the 70<sup>th</sup> percentile relative to the well sample population. The water supply curve should be considered linear, meaning the GPM rate stabilizes over time, in a range of 10.95gpm to 12.2gpm. This well productivity is adequate, as defined by the San Diego County well productivity requirement of >3gpm. It is not expected that this distribution system (property usage) will experience any supply outages. It is always recommended a Pump Saver system be incorporated on well pump systems to prevent failure. It is recommended all repairs be completed by a reputable licensed C57 contractor; **Contact Southern California Well Service 760-440-8520**, for any well equipment needs or repairs. These findings do indicate the well productivity at the time and date of the recording. Natural or man-made events occurring subsequent to these findings can potentially affect the well productivity.*
