📍 **2318 Sumac Street, Peterborough**  
ON K9K 2J9

📅 **INSPECTION DATE**  
**10/01/2026 9:00AM**

👤 **PREPARED FOR**  
**Team VanRahan**

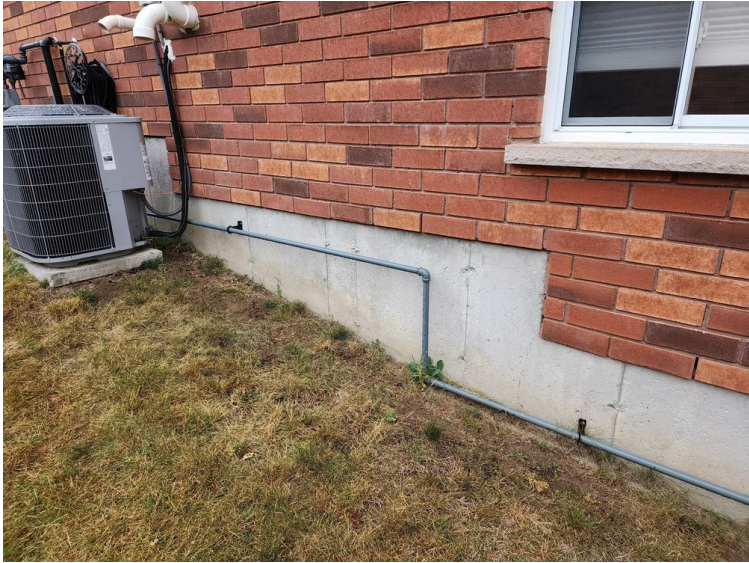
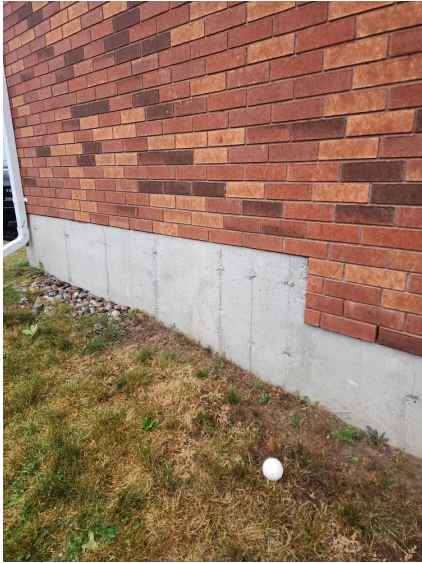
4.11 Typical minor cracks

Location: Right elevation

Implication: Material deterioration

| 4.11 Foundations<br><b>Typical minor cracks</b><br><b>Service:</b> Monitor - Ongoing<br><b>Implication:</b> Material deterioration<br><b>Location:</b> Right elevation | <div>Recommendations</div> |

Recommended: **Monitor - Ongoing**

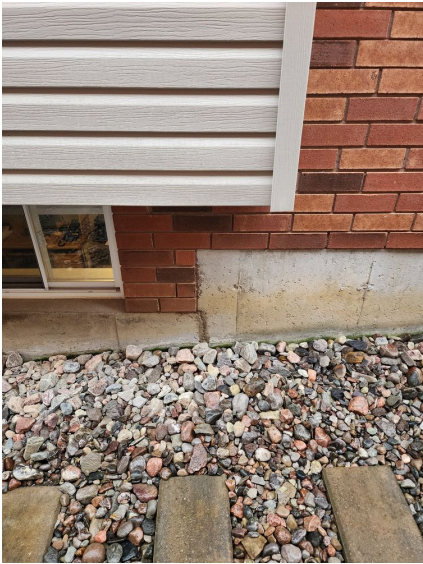
4.12 Foundations

Prior repairs

Implication: Possibility of a weakened structure

Location: Left elevation

Service: Monitor - Ongoing

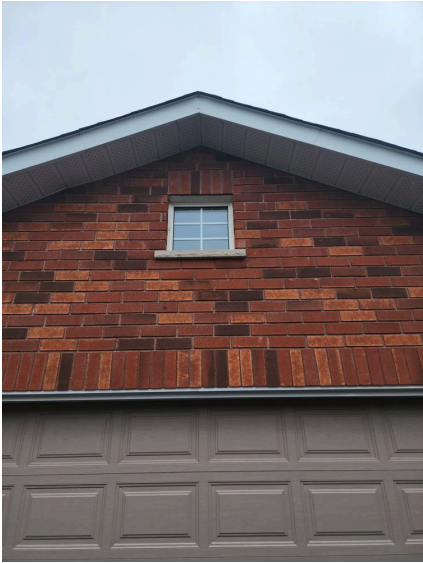
4.13 Walls

Masonry veneer walls: Typical minor cracks

Implication: Chance of frost damage & material deterioration

Location: Garage

Service: Repair

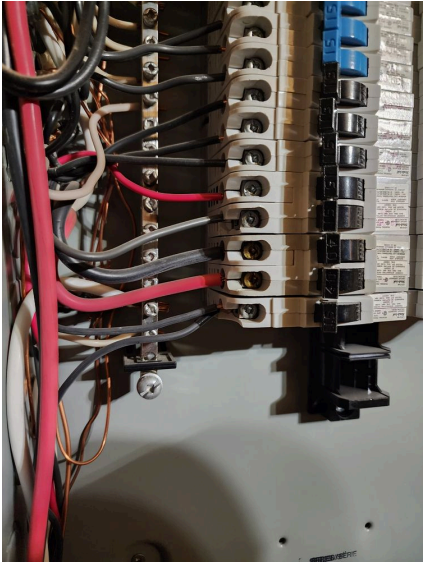
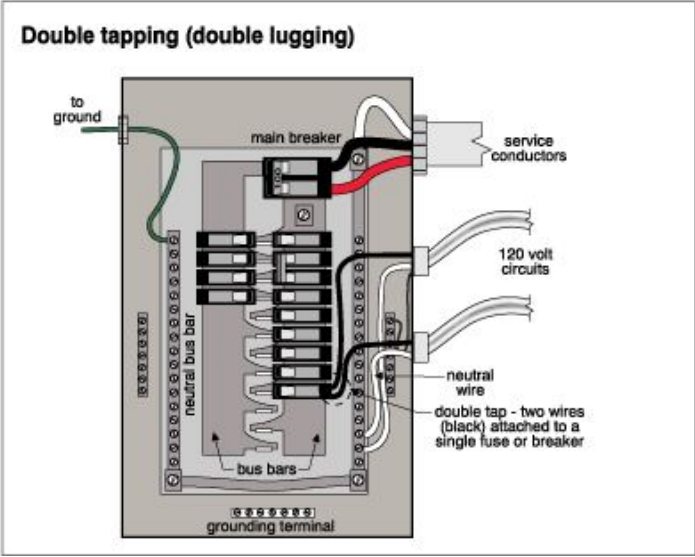
5.19 Service box, grounding and panel

Distribution panel: Double taps

Implication: Fire hazard

Location: Distribution panel

Service: Correct

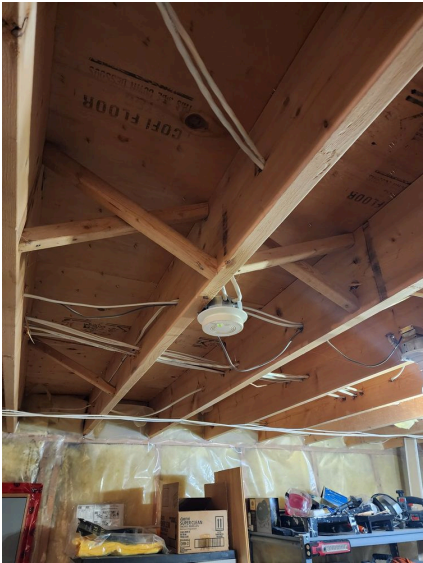
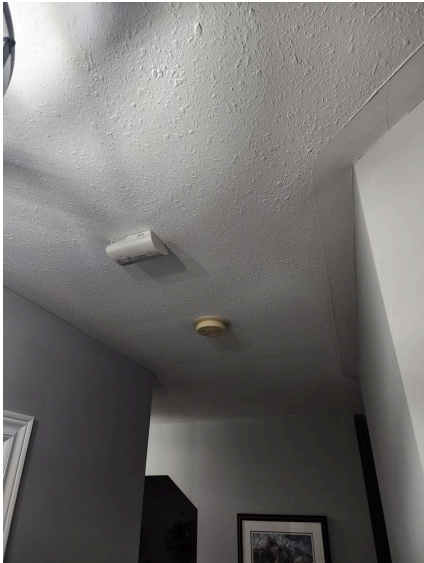
5.20 Distribution system

**Smoke alarms (detectors): Past life expectancy**

- Service:** Replace
- Implication:** Life safety hazard
- Location:** Throughout
- Estimated Cost:** Minor
- Estimated Timeline:** Immediately

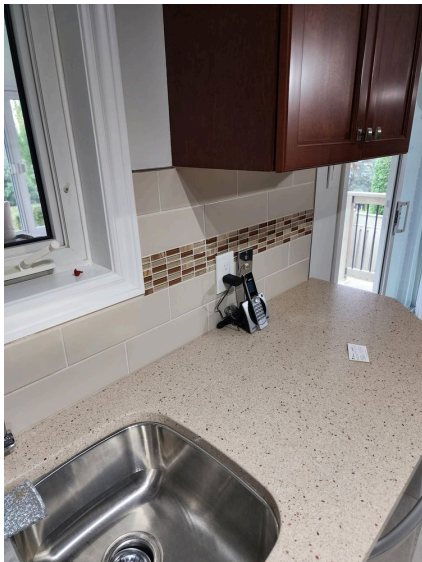
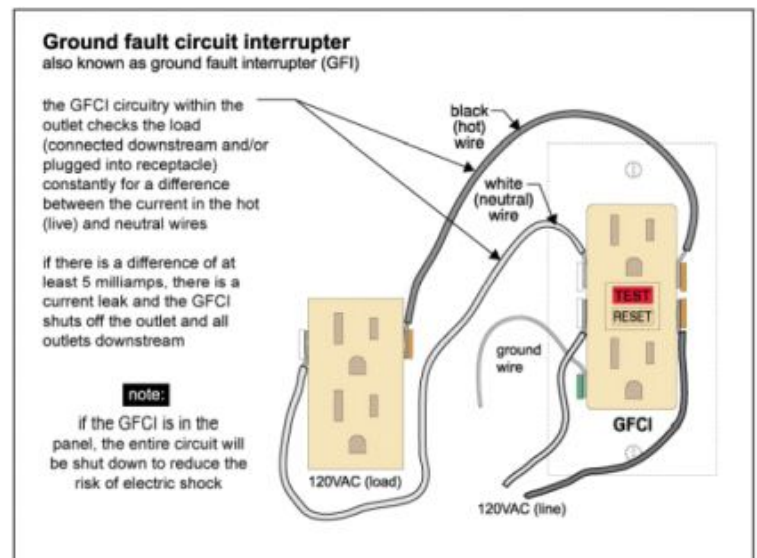
### 5.21 Distribution system

## Outlets (receptacles): No GFCI/GFI (Ground Fault Circuit Interrupter) - Single

**Implication:** Electric shock

Although not a deficiency in a home of this age, safety may be improved by upgrading this receptacle.

**Location:** Kitchen

**Service:** Upgrade

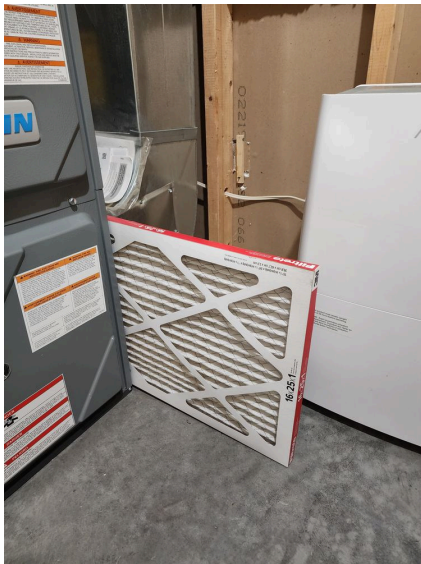
## 6.25 Gas furnace

### Mechanical Air Filter

**Implications:** Reduced comfort. Increased heating & cooling costs

**Location:** Cold air return

**Service:** Replace - Regular Maintenance

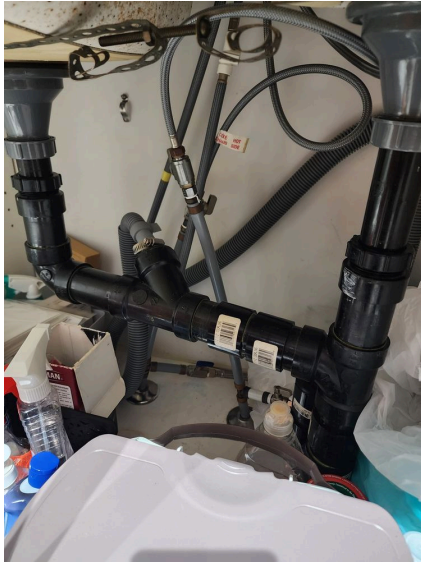
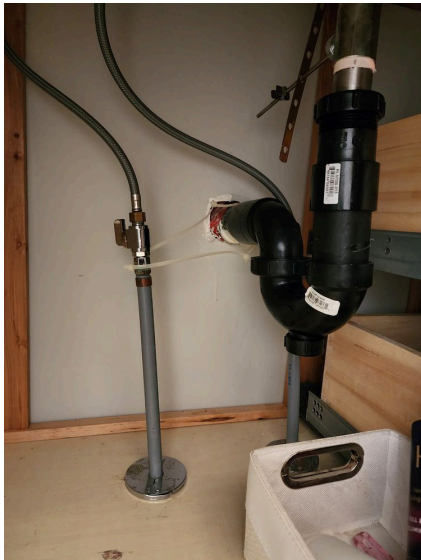
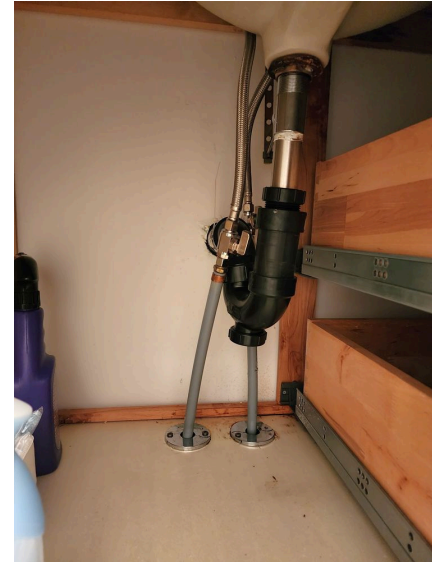
- 9.27 Supply plumbing
- Water supply piping in building: Polybutylene
- Service: Monitor - Ongoing
- Implication: Chance of water damage to structure, finishes and contents
- Location: First floor

### Polybutylene pipe - crimp fitting

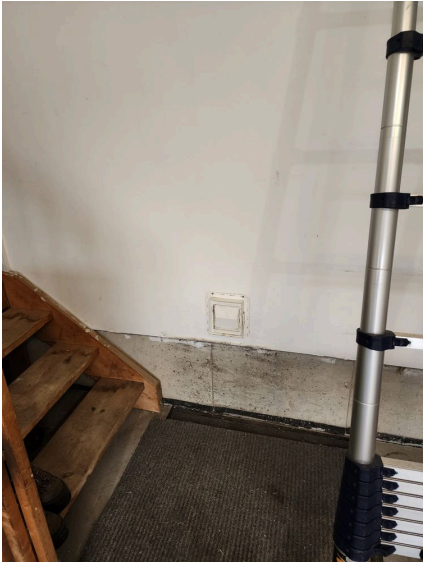
10.24 Appliances

Exhaust ducts connected to laundry-drying equipment must discharge directly outdoors.

Dryer: Dryer not vented to exterior

Chance of condensation damage to finishes and/or structure

Recommended: **Correct** • Estimated Timeline: **As soon as is practicable** • Estimated Cost: **Minor**
