## Home Inspection Report

PROPERTY INSPECTED:  
1175 Forest Trail Place  
Oakville, ON L6M 3H7

Date of Inspection: 06/05/2026

Inspection No. 141168-1948

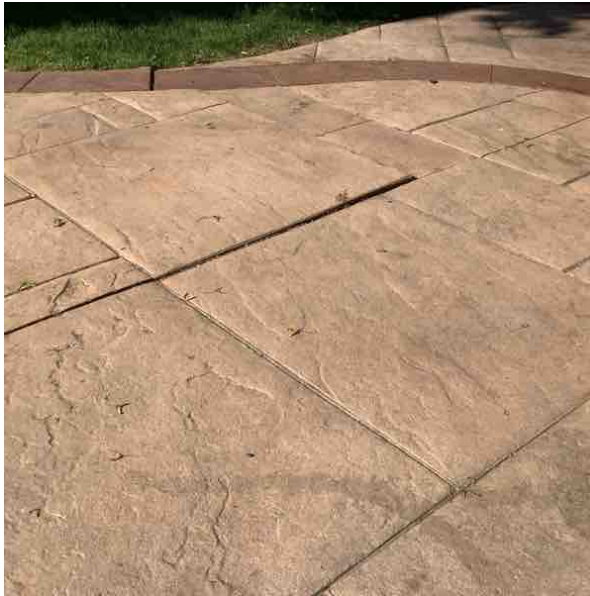
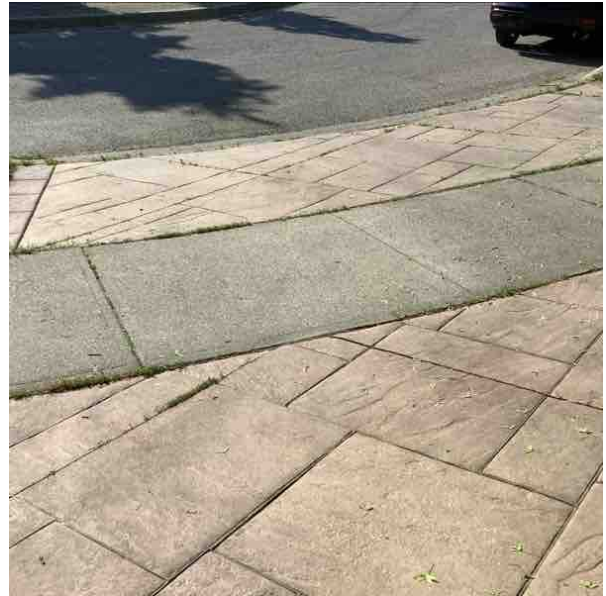
2.3.2 The concrete driveway is in satisfactory condition overall. One spot shows some lift and some small areas where vegetation is growing in between slots of the concrete was noted but regular maintenance is recommended.

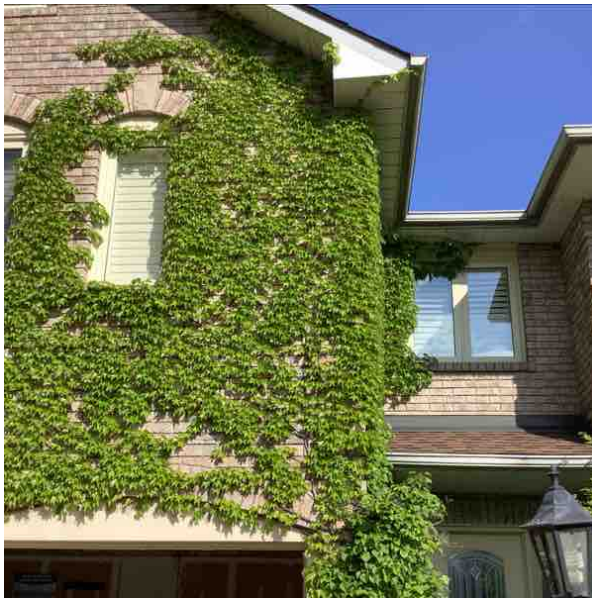
3.3.2 Vines and vegetation may damage the wall surface. Maintain, trim or remove as necessary.

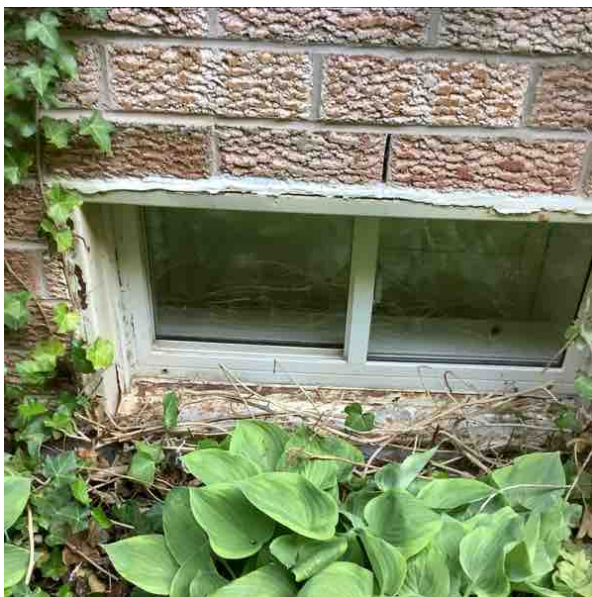
3.5.3 The caulking around some of the window(s) is cracked, missing or deteriorated. Recaulk all windows where required to maintain a weather-resistant seal and prevent water damage to structure and interior finishes.

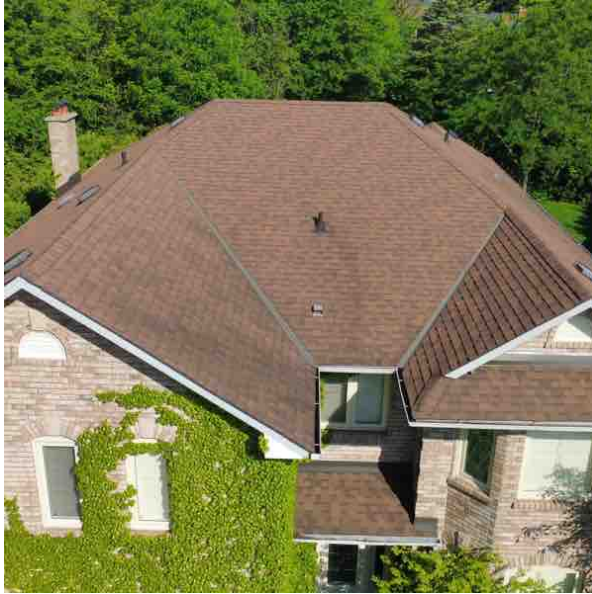
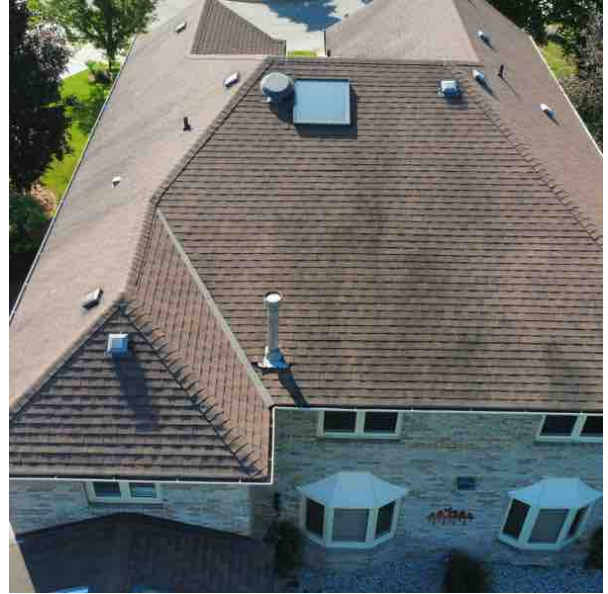
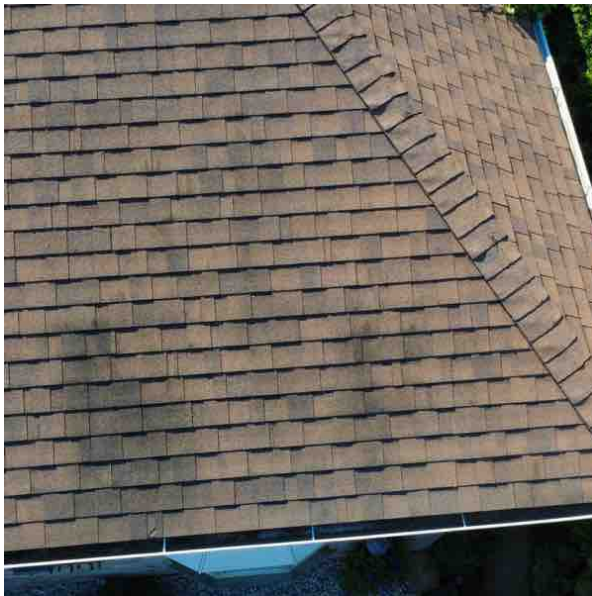
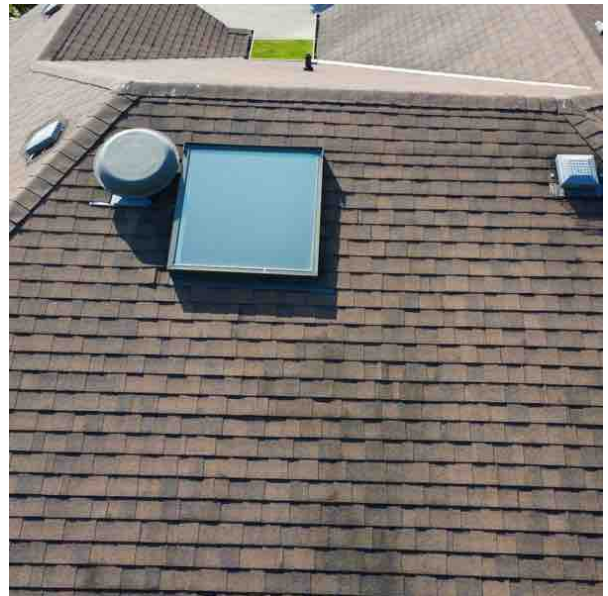
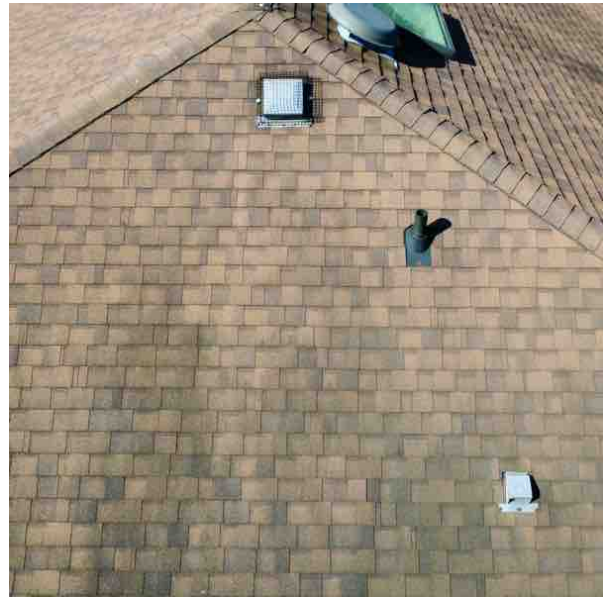
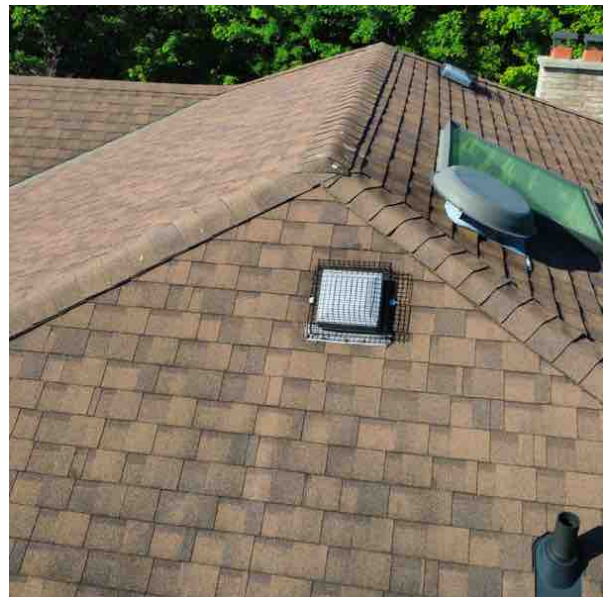
4.2.4 **Asphalt shingles are premium quality, estimated to be 15- 20 years old, middle of life cycle and in satisfactory condition.**

**Typical life expectancy is 25+ years.**

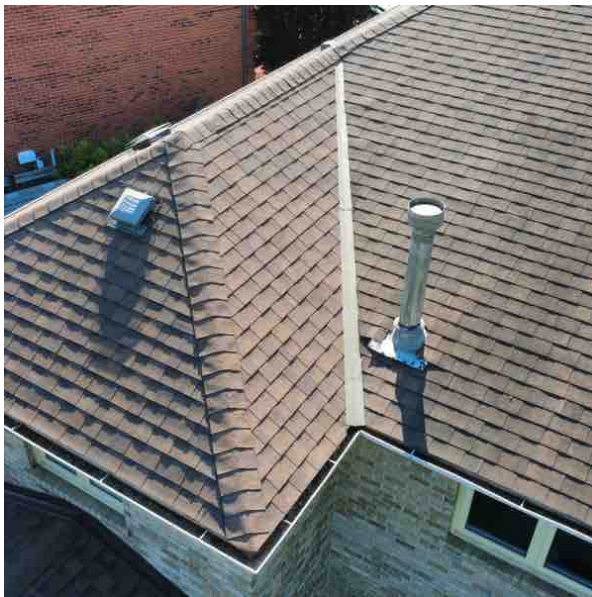
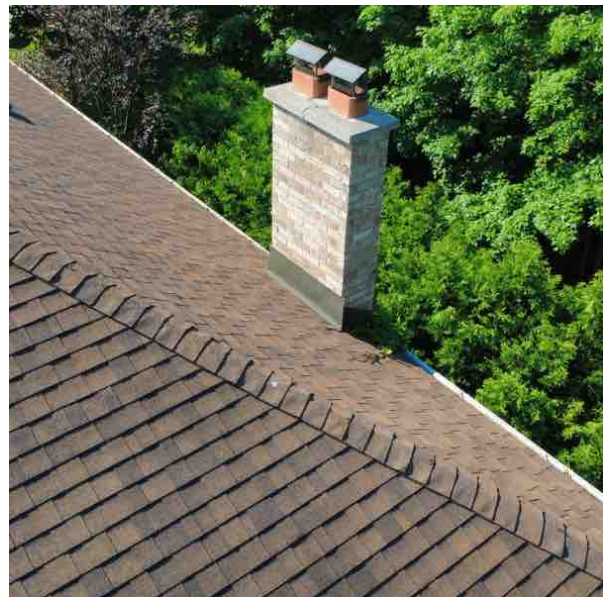
4.5.2 The masonry chimney and metal chimney were in satisfactory condition.

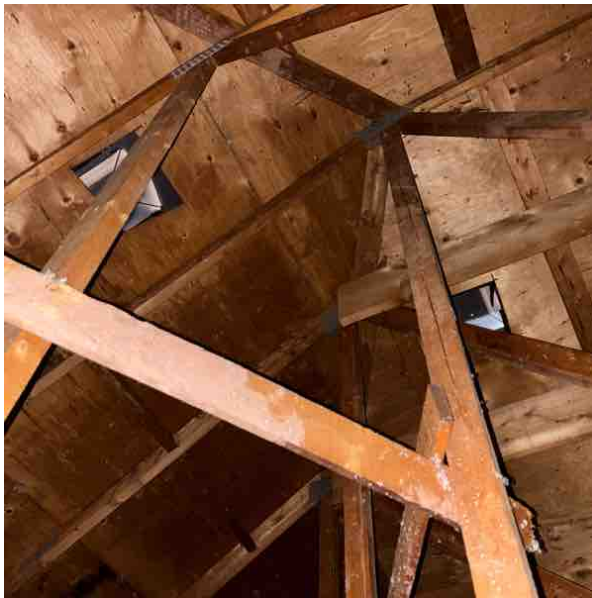
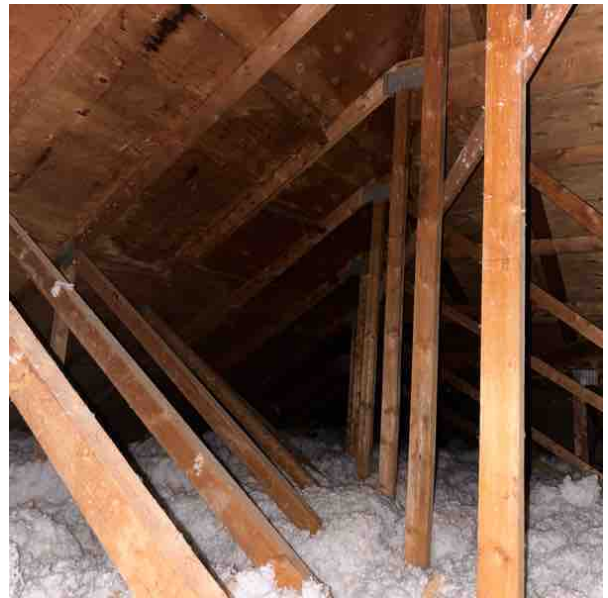
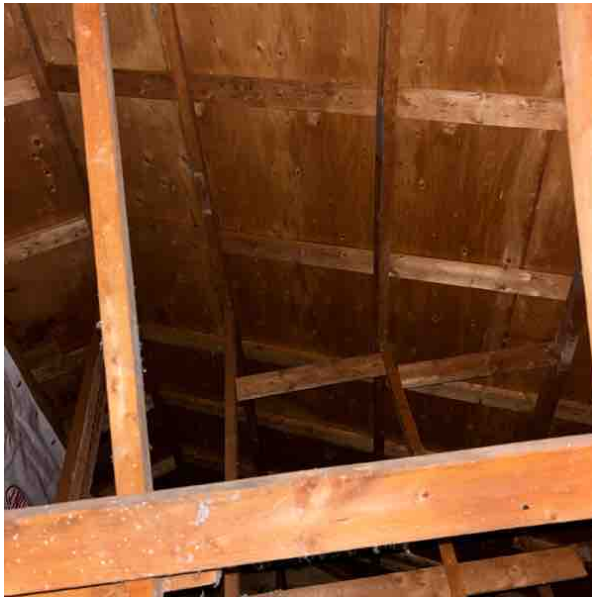
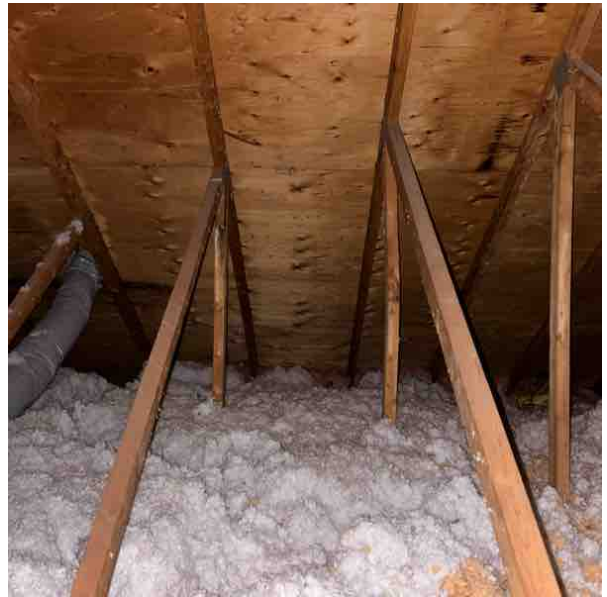
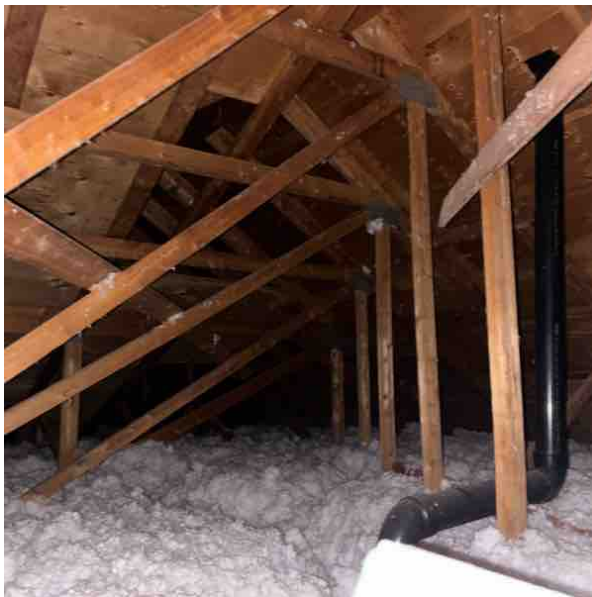
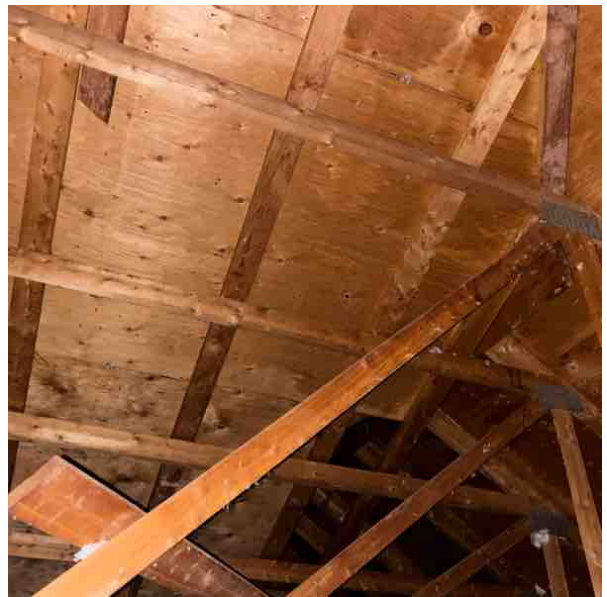
5.2.2 **Truss frames are solid, Sheathing was dry & without noticeable stains, insulation has decent levels with uniform coverage and the attic overall is in satisfactory condition.**

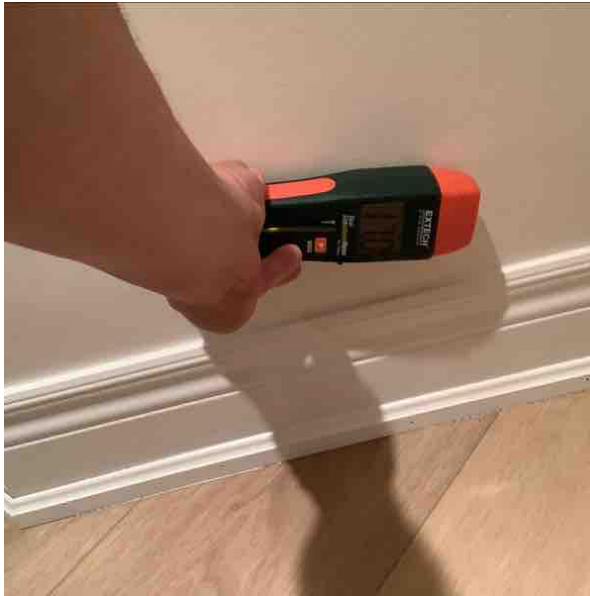
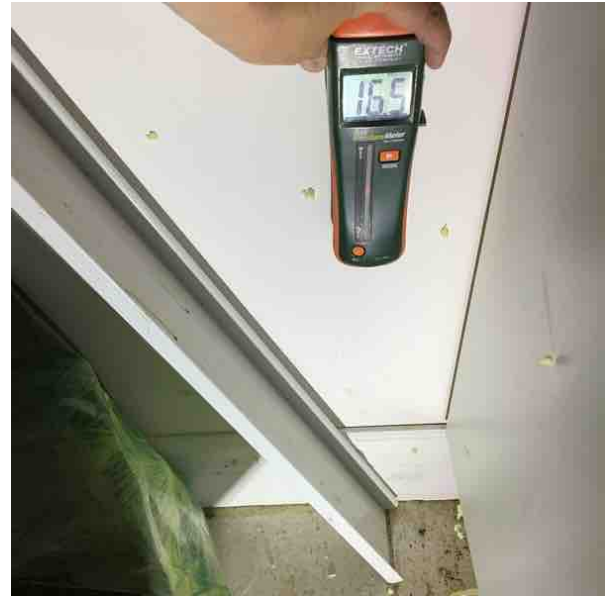
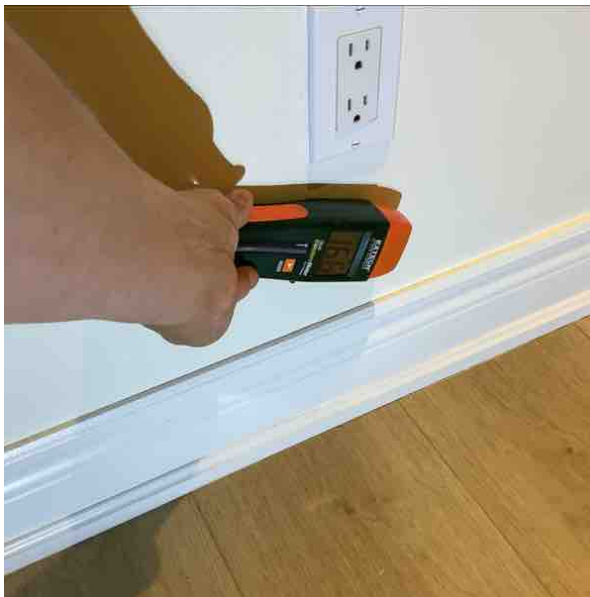
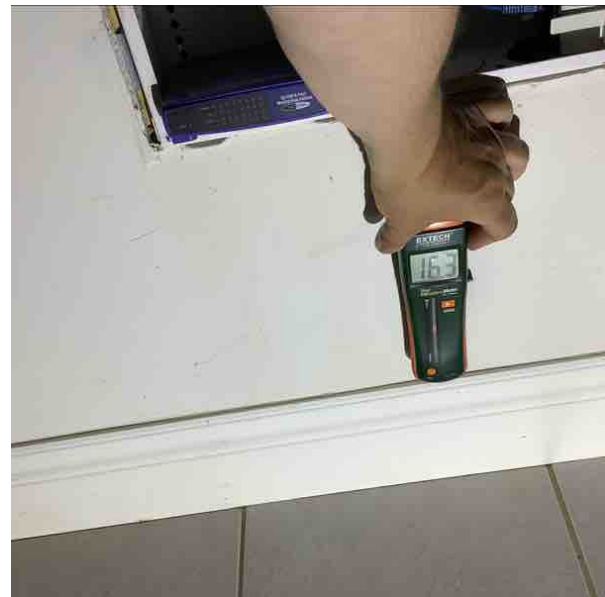
7.2.3 **Concrete foundation was concealed, had normal moisture readings, no signs of seepage, nor efflorescence or water stains, and is in satisfactory condition.**

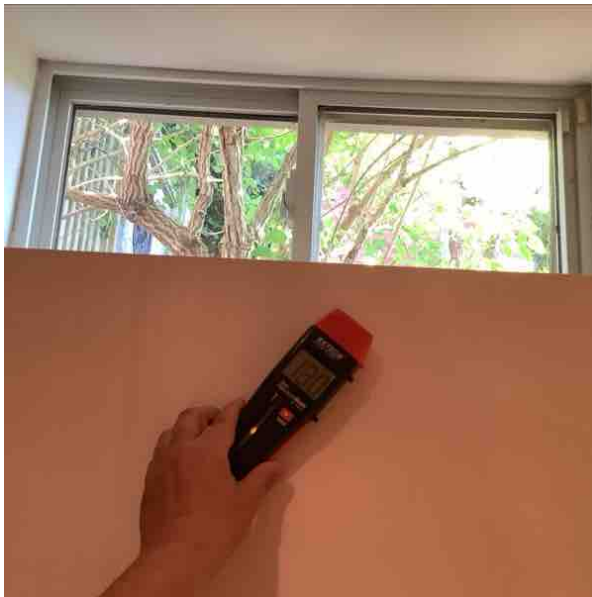
7.2.4 Finished interior walls were dry at time of inspection when tested with moisture meter.

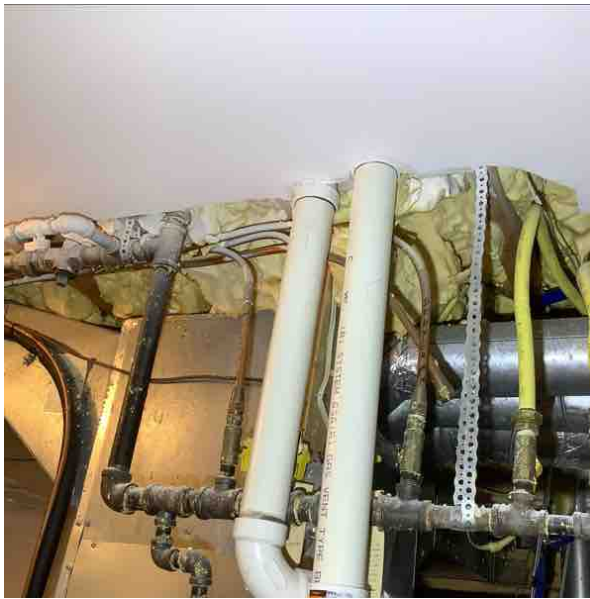
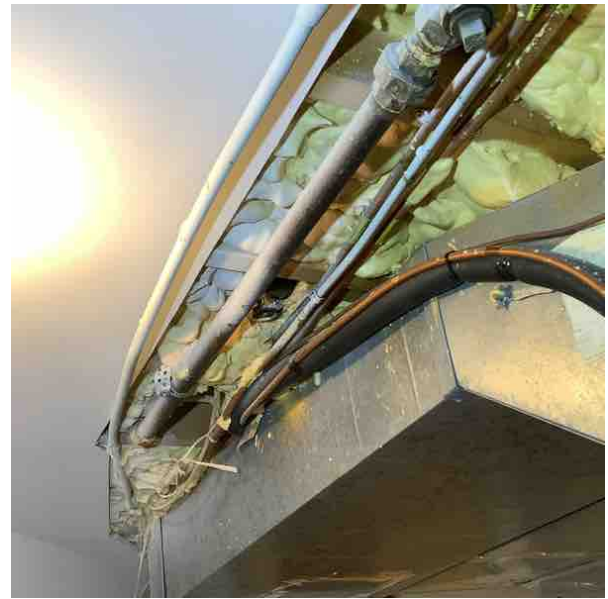
7.4.2 Solid wood floor joists were visible in the basement utility room.

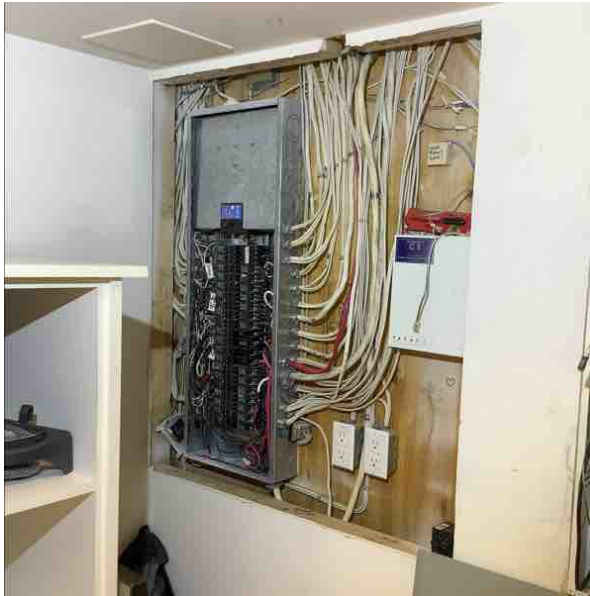
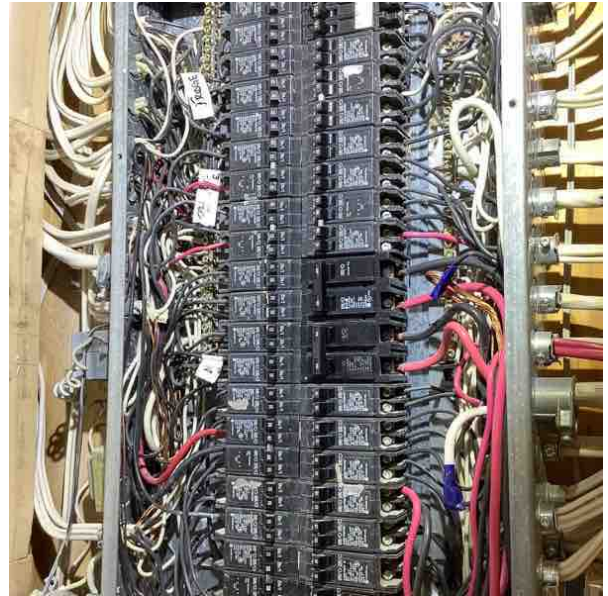
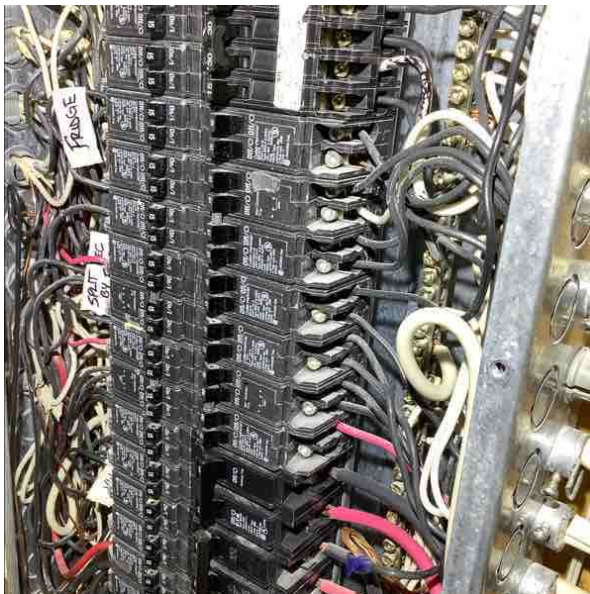
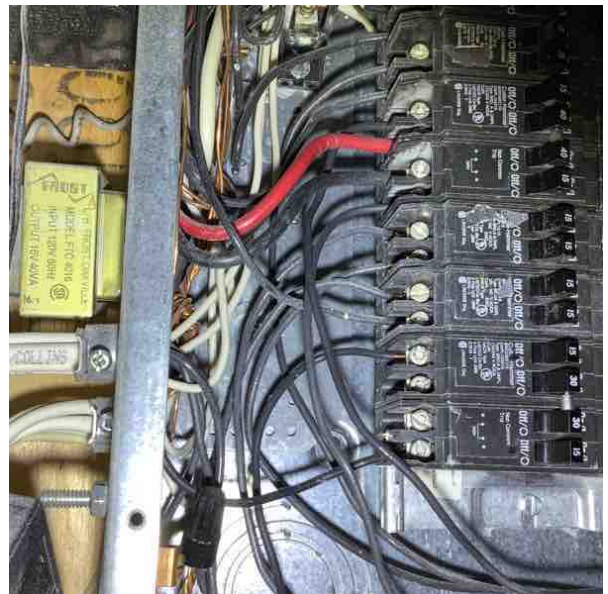
8.6.2 200 amp Distribution panel has room for expansion, has breakers, grounded copper wiring, showing no scorching or burn marks, professionally installed and is in satisfactory condition.

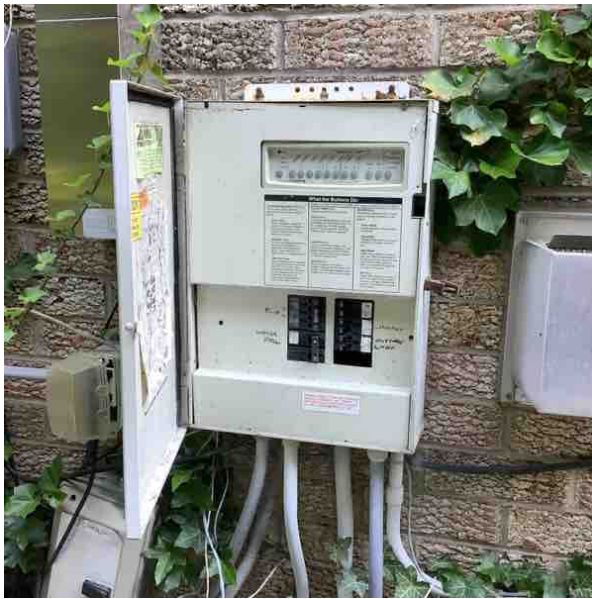
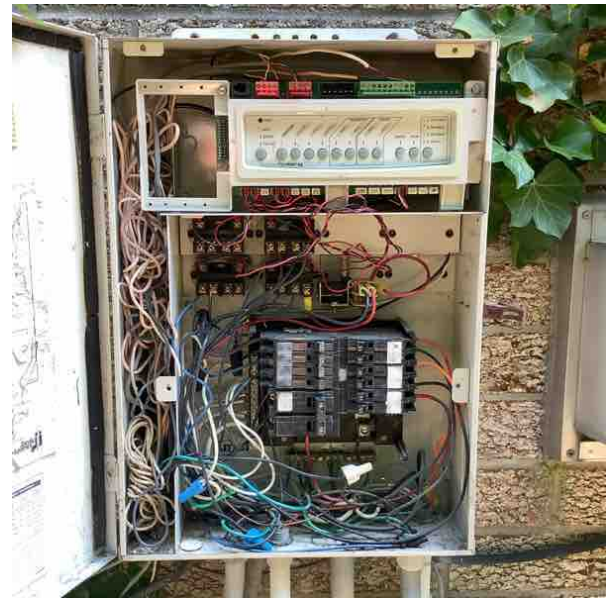
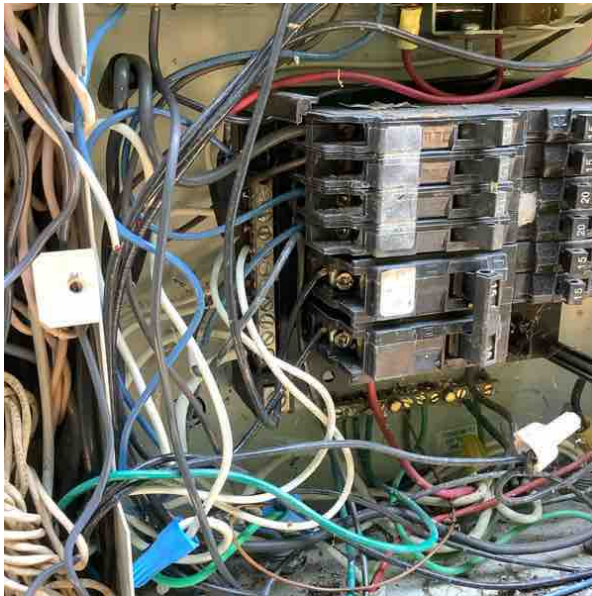
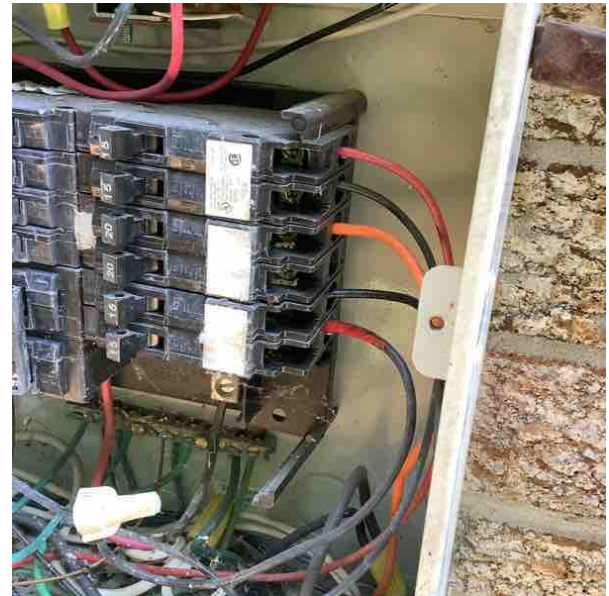
8.7.2 60 amp Sub panel, has breakers, copper wiring and is in satisfactory condition.

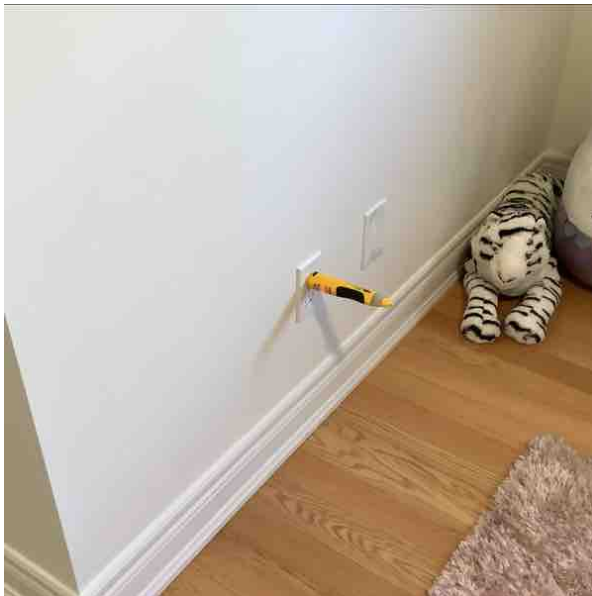
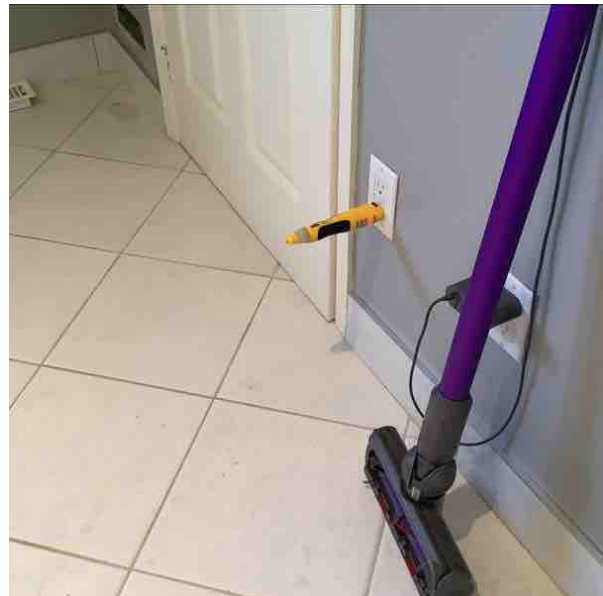
Ungrounded 3 prong receptacle

One bedroom receptacle had reverse polarity.

8.10.2 During the inspection, some electrical deficiencies were identified. Examples of these conditions are noted below. An ESA certified electrician is recommended to correct these conditions and may discover other issues that also require correction.

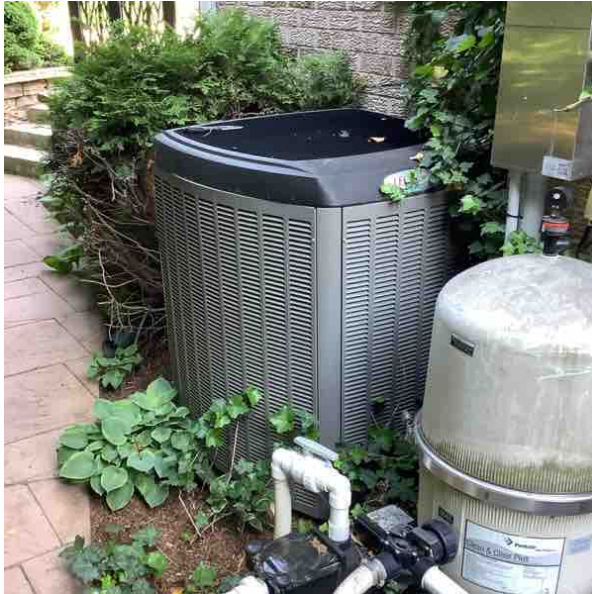
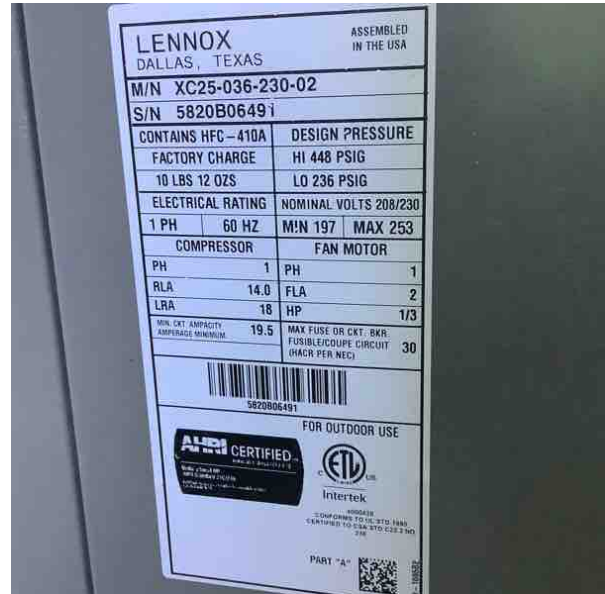
9.3.3 **Lennox AC unit has 2.5 ton cooling, 6 years old, middle of life cycle, and is in satisfactory condition.**

**Typical life expectancy is around 15 - 20 years.**

9.3.4 While it was functional, recommend a HVAC technician service the unit annually to maintain performance and prolong service life.

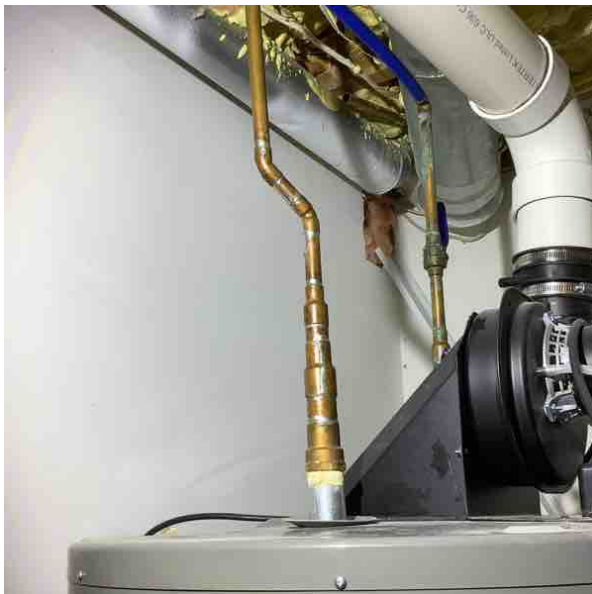
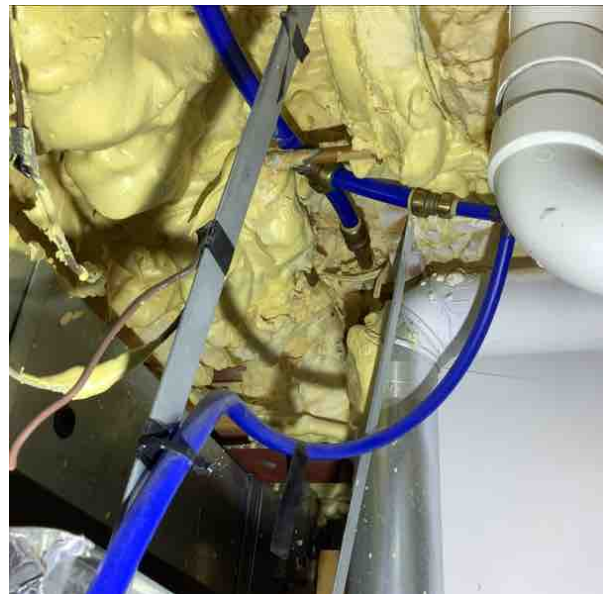
10.4.3 **Predominately Copper piping throughout, with some Pex piping that was visible in utility room. Copper was present underneath sinks.**

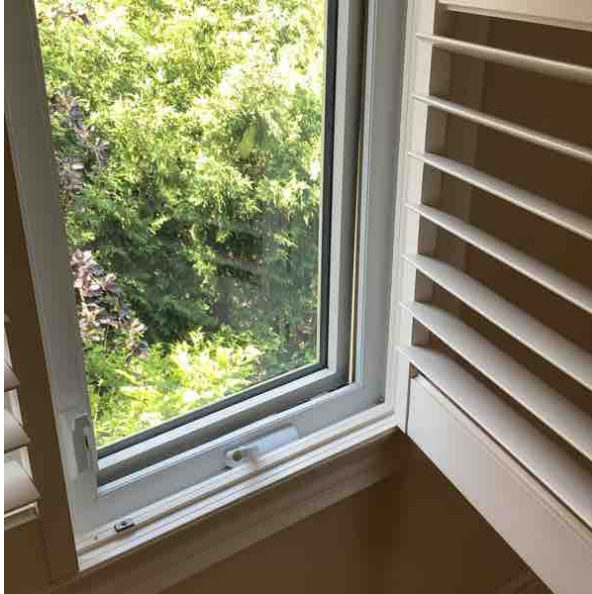
11.3.3 West bedroom window is out of place and has a small gap at the bottom right corner. Recommend a qualified contractor repair.

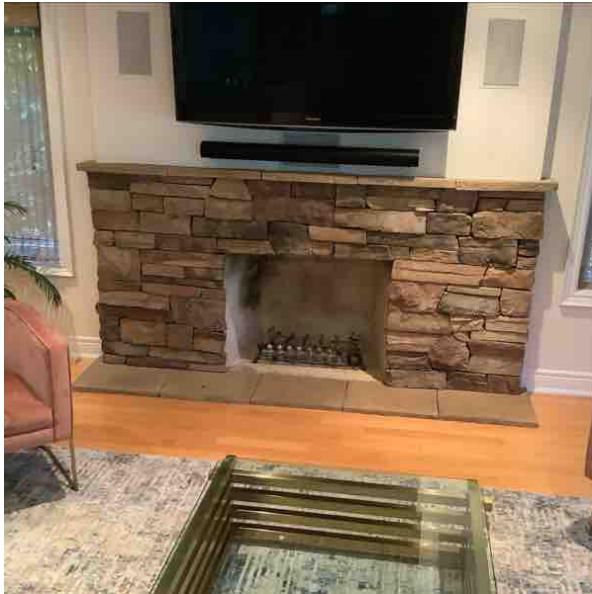
12.1.2 The wood-burning fireplace is present, however was not operated / tested and the functionality / safety was not determined. A qualified wood heating technician should assess the fireplace to determine functionality and compliance with modern safety standards.

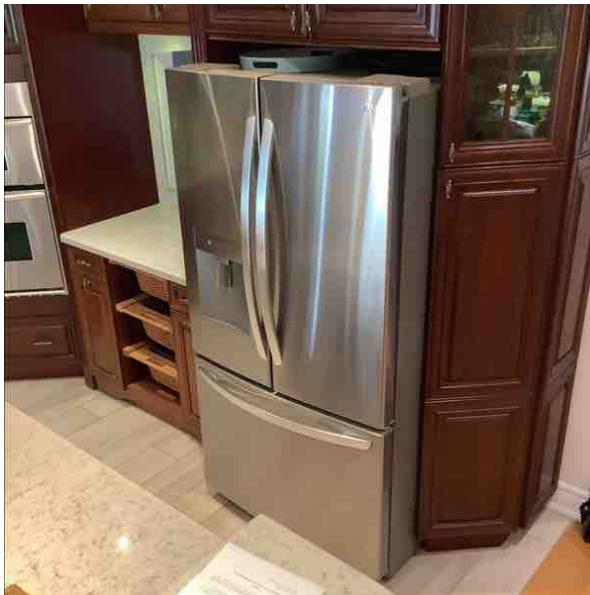
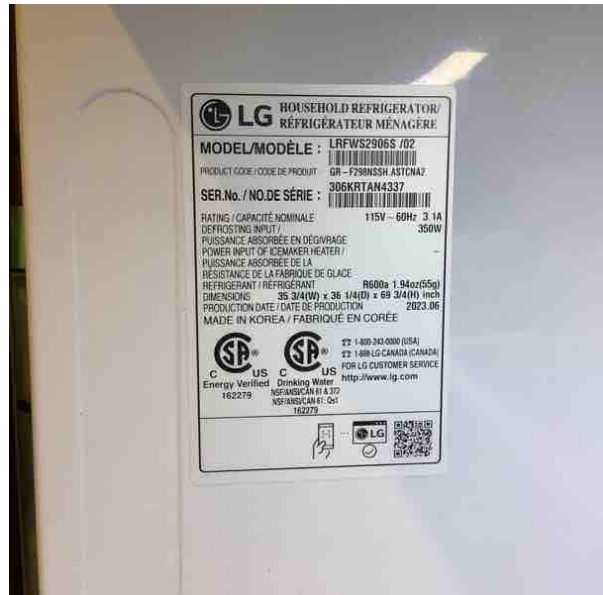
13.1.2 LG refrigerator & freezer were tested and found to be functional.

Water feature was tested but was not functional, recommend a handyman or qualified contractor connect / repair.

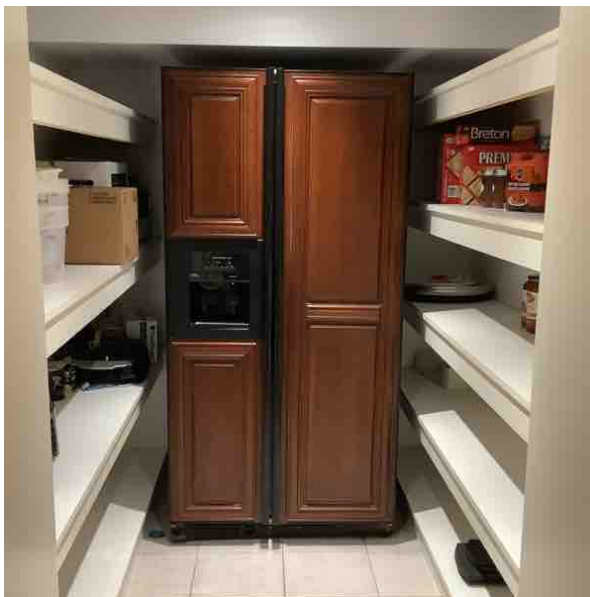
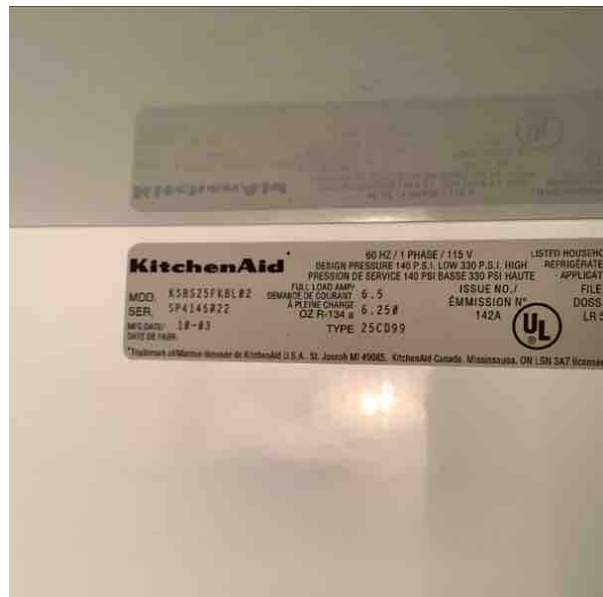
13.1.3 Basement Kitchen Aid refrigerator & freezer were tested and found to be functional.

Water & ice features were tested, but neither were functional.

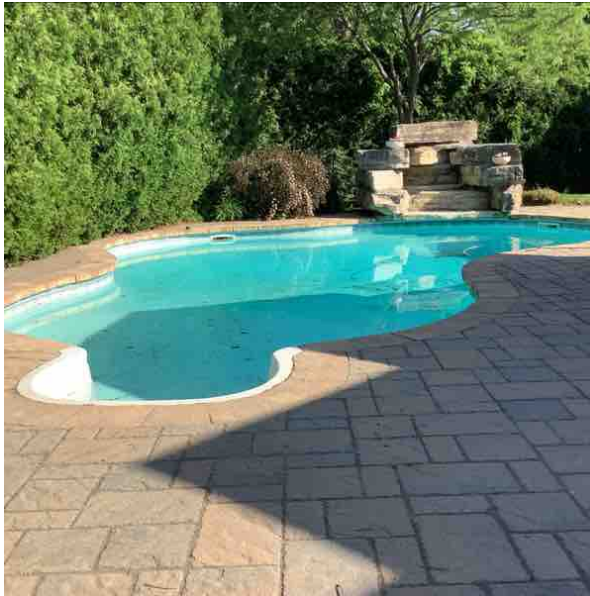
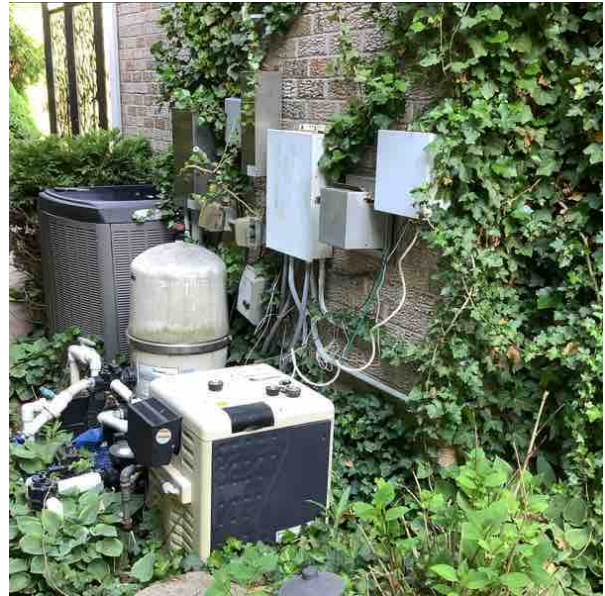
14.1.1 A pool is present, but was not inspected. Recommend a qualified pool technician review the pool, deck & components (ex liner, decking, filter, pump, etc..).
