# INSPECTION REPORT

**335 DOURO THIRD LINE**  
DOURO-DUMMER, ON K0L 2H0

Inspection Date: Tuesday, July 14, 2026

RE: Report No. 5801  
335 Douro Third Line  
Douro-Dummer, ON  
K0L 2H0

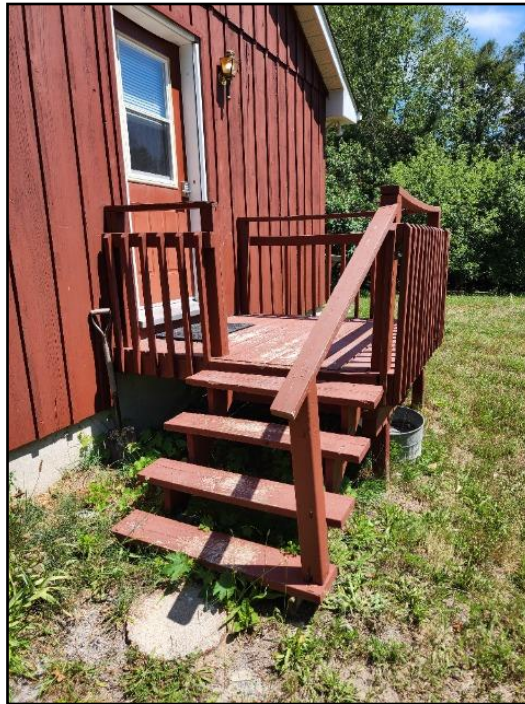
**2. Condition:** • Movement

**Implication(s):** Weakened structure | Chance of continued movement

**Location:** Side porch

3. Movement

**Task:** Repair or replace

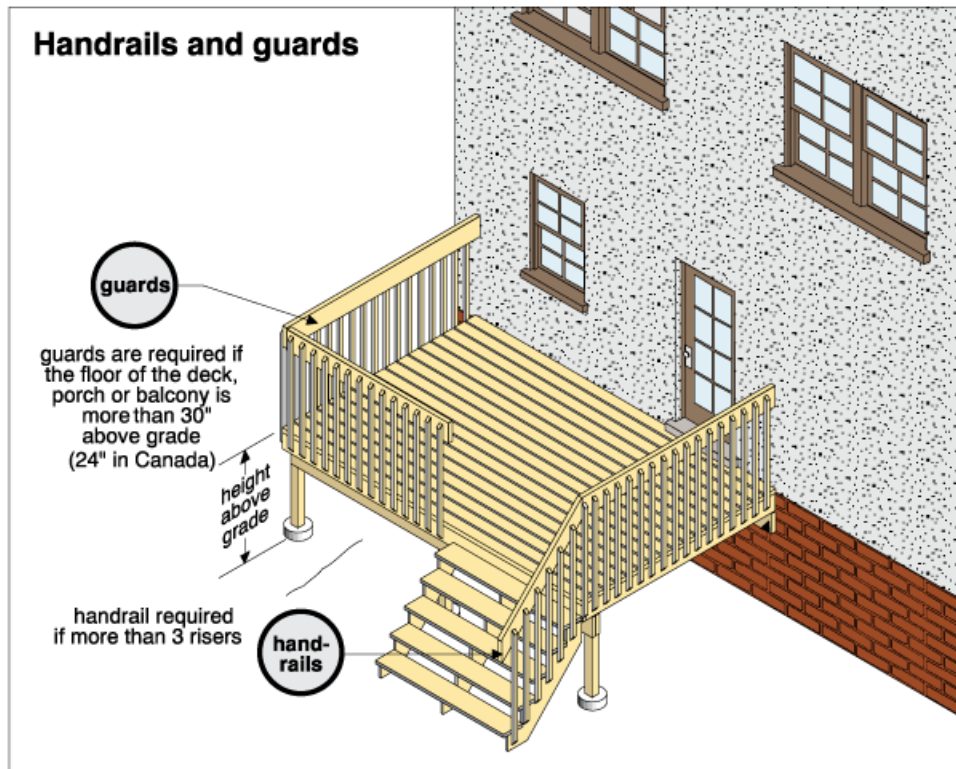
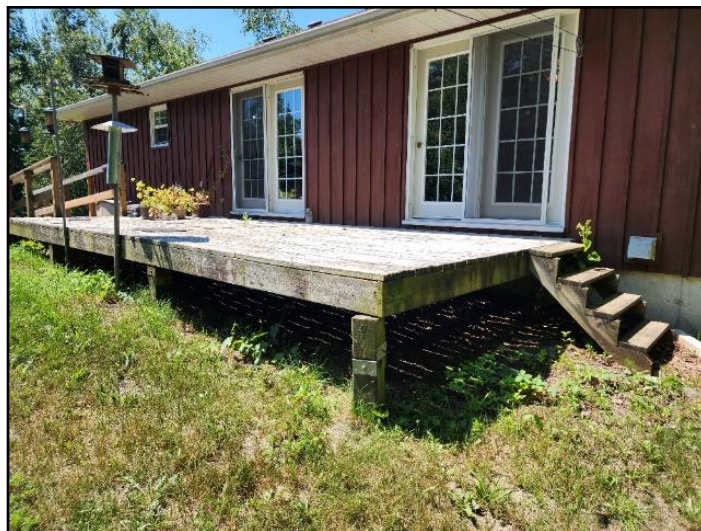
**3. Condition:** • Missing

**Implication(s):** Fall hazard

**Location:** Rear decking

4. Missing

**Task:** Provide

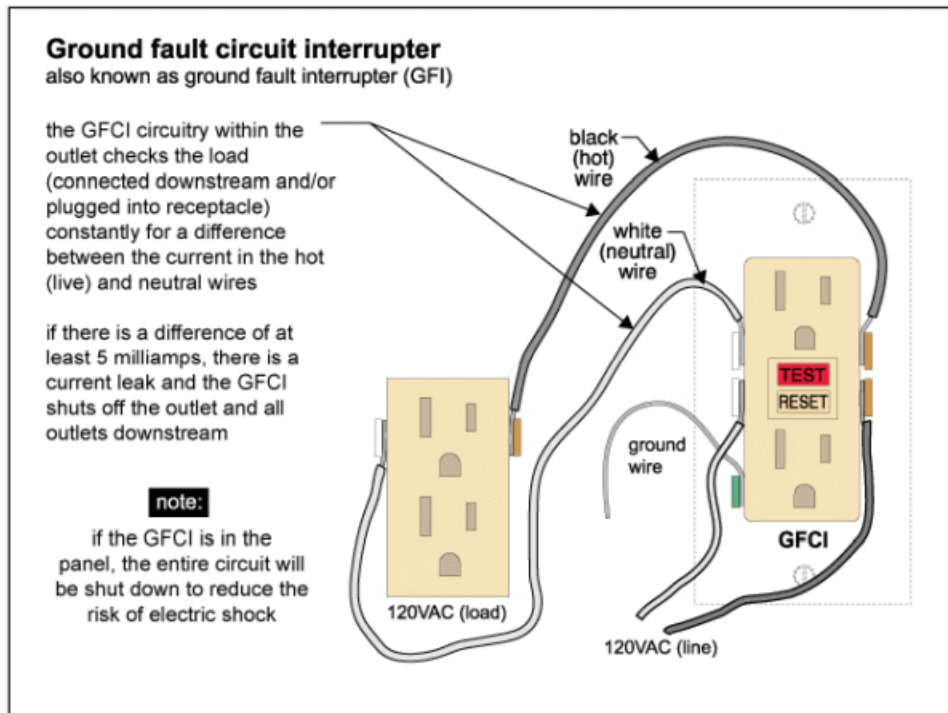
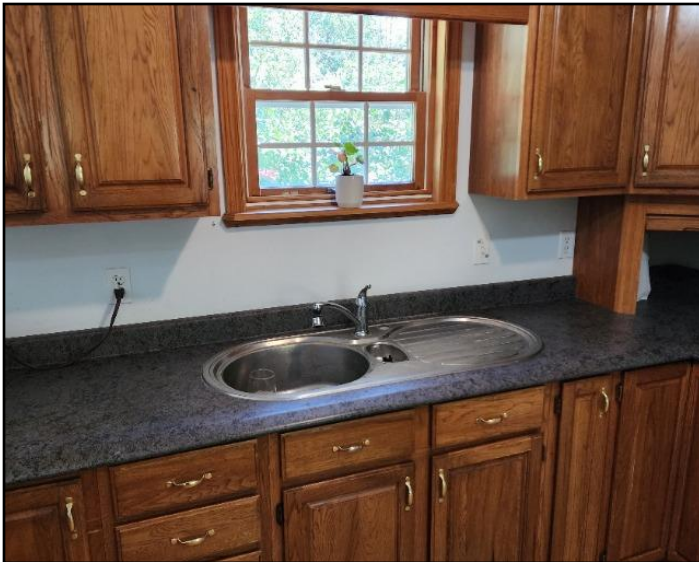
#### **5. Condition:** • No GFCI/GFI (Ground Fault Circuit Interrupter)

Although not a deficiency in a home of this age safety may be improved by upgrading these receptacles

**Implication(s):** Electric shock

**Location:** Kitchen & laundry

7. No GFCI/GFI (Ground Fault Circuit...

**Task:** Upgrade

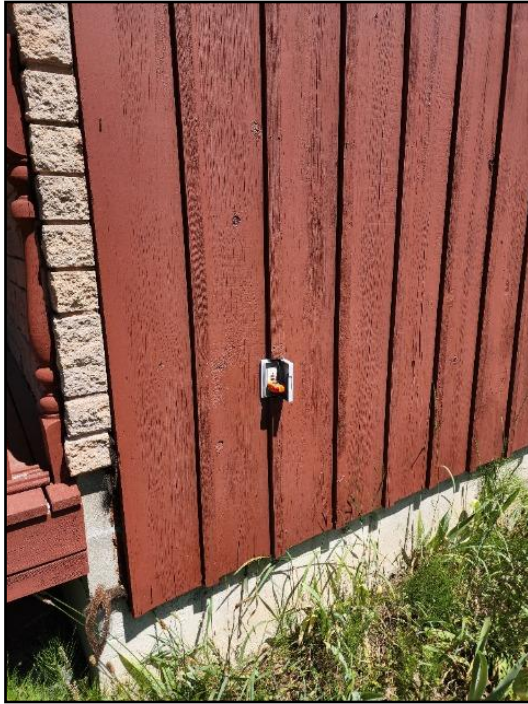
**6. Condition:** • Test faulty on GFCI/GFI (Ground Fault Circuit Interrupter)

**Implication(s):** Safety hazard

**Location:** Exterior

9. Test faulty on GFCI/GFI (Ground Fault...

**Task:** Replace

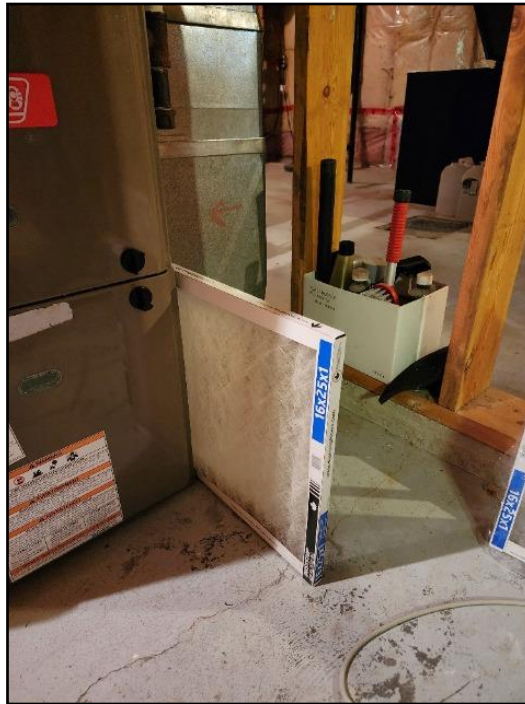
**7. Condition:** • Replace - regular maintenance

**Implication(s):** Increased heating & maintenance costs, Reduced comfort

**Location:** Cold air return

19. Replace - regular maintenance

**Task:** Replace - regular maintenance

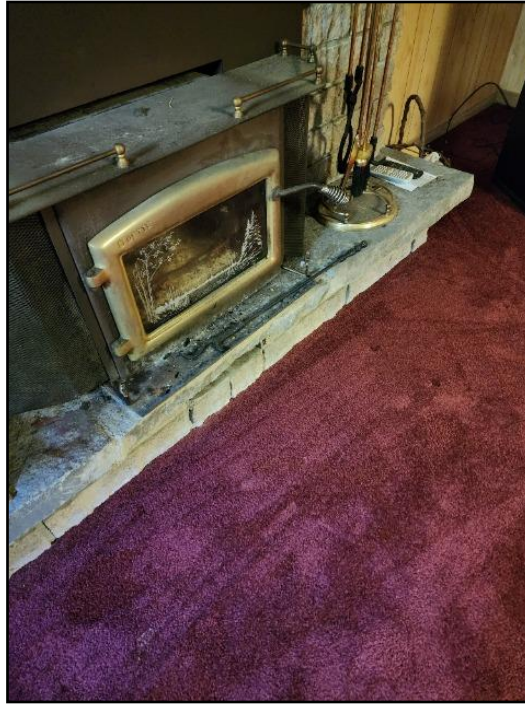
**8. Condition:** • Too small

**Implication(s):** Fire hazard

20. Too small

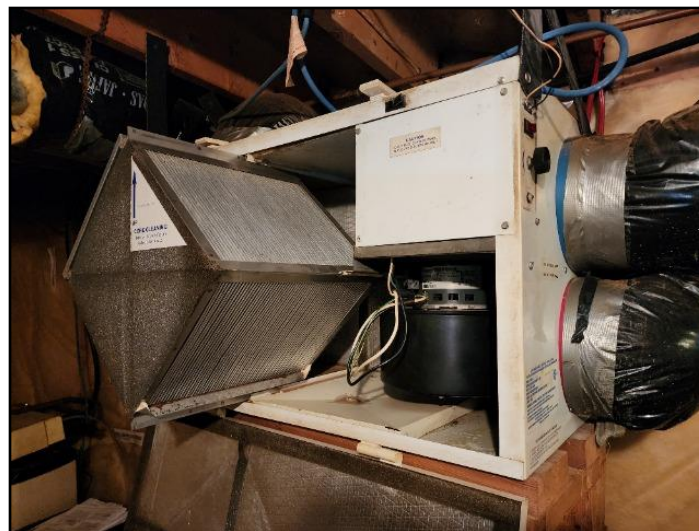
**9. Condition:** • Clean core - regular maintenance

21. Clean core - regular maintenance

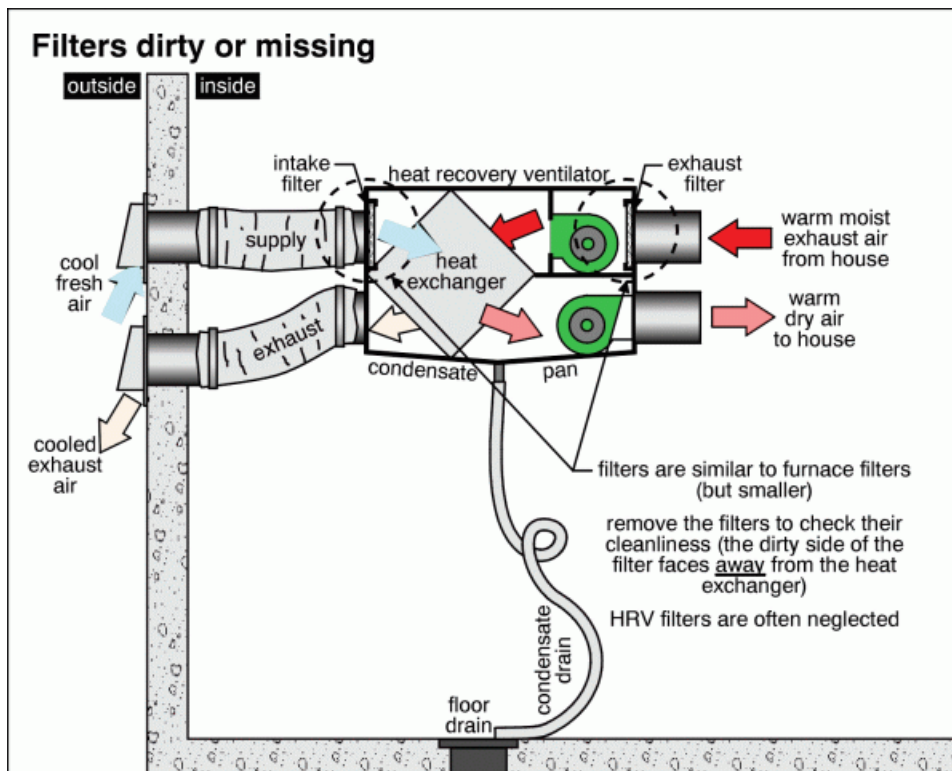
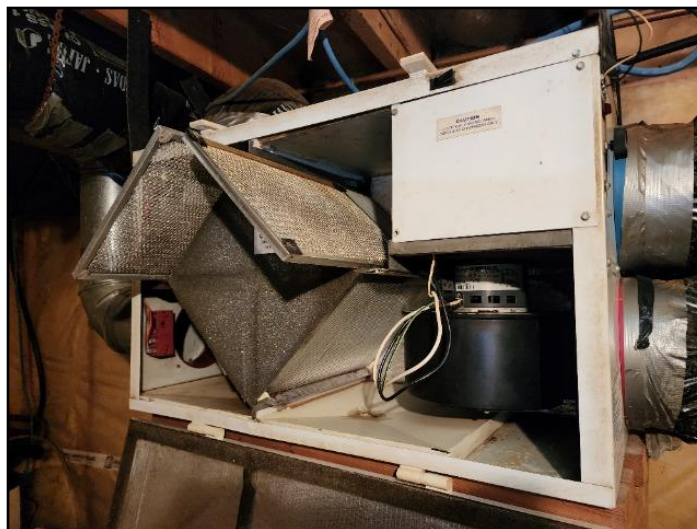
**10. Condition:** • Clean filters - regular maintenance

22. Clean filters - regular maintenance

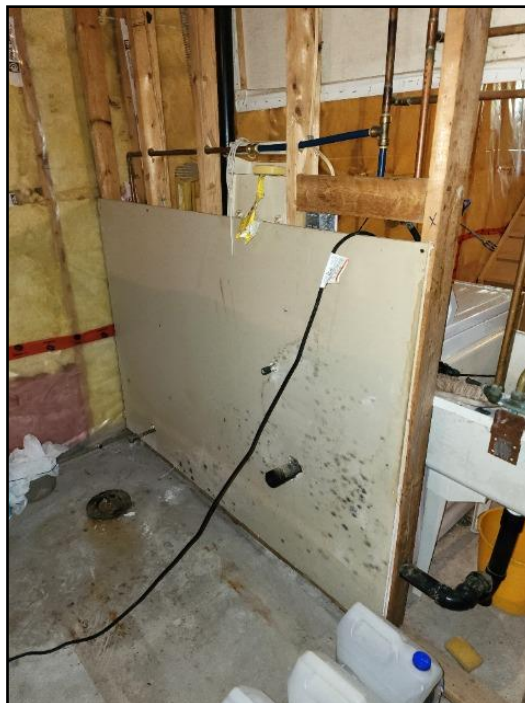
**14. Condition:** • Mold or mildew

**Implication(s):** Chance damage to structure, finishes and contents | Contaminants may enter building air

33. *Mold or mildew*

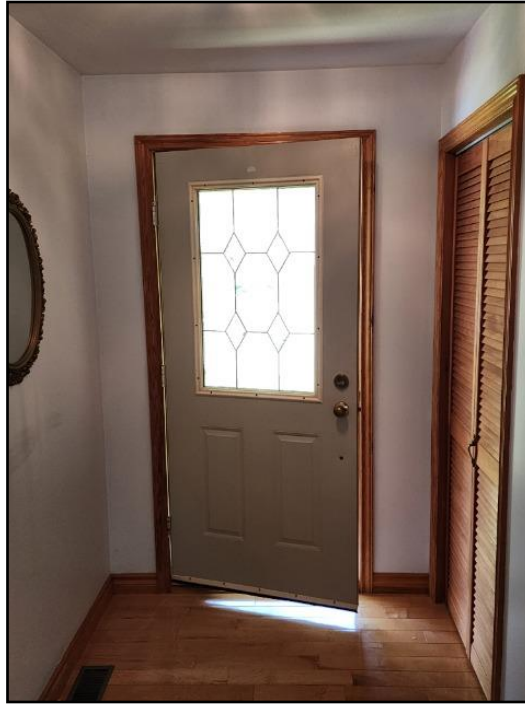
**15. Condition:** • Loose or poor fit

**Implication(s):** Chance of damage to finishes and structure

34. Loose

**Task:** Repair

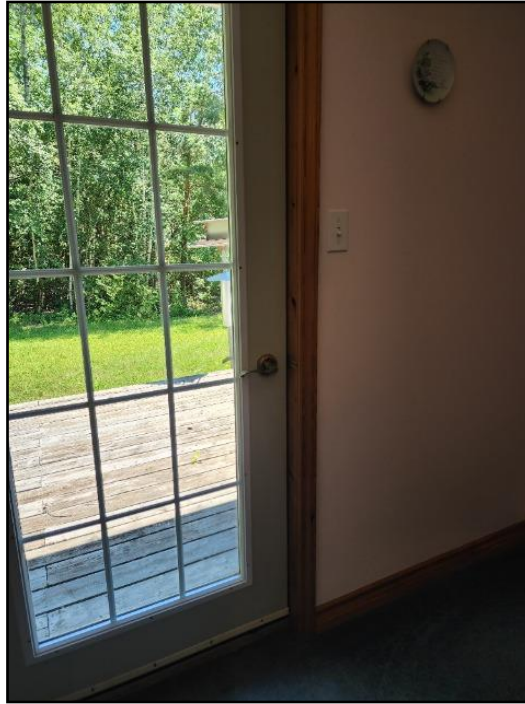
**16. Condition:** • Lock mechanism faulty/damaged/missing

**35.** *Lock mechanism faulty*

**Task:** Repair or replace
