Re: Foundation Inspection:
292 Langely
Kyle, TX

Mr. Lloyd Moskal
Foundation Inspection
292 Langely
Kyle, TX

FOUNDATION & ELEVATION ASSESSMENT PLAN

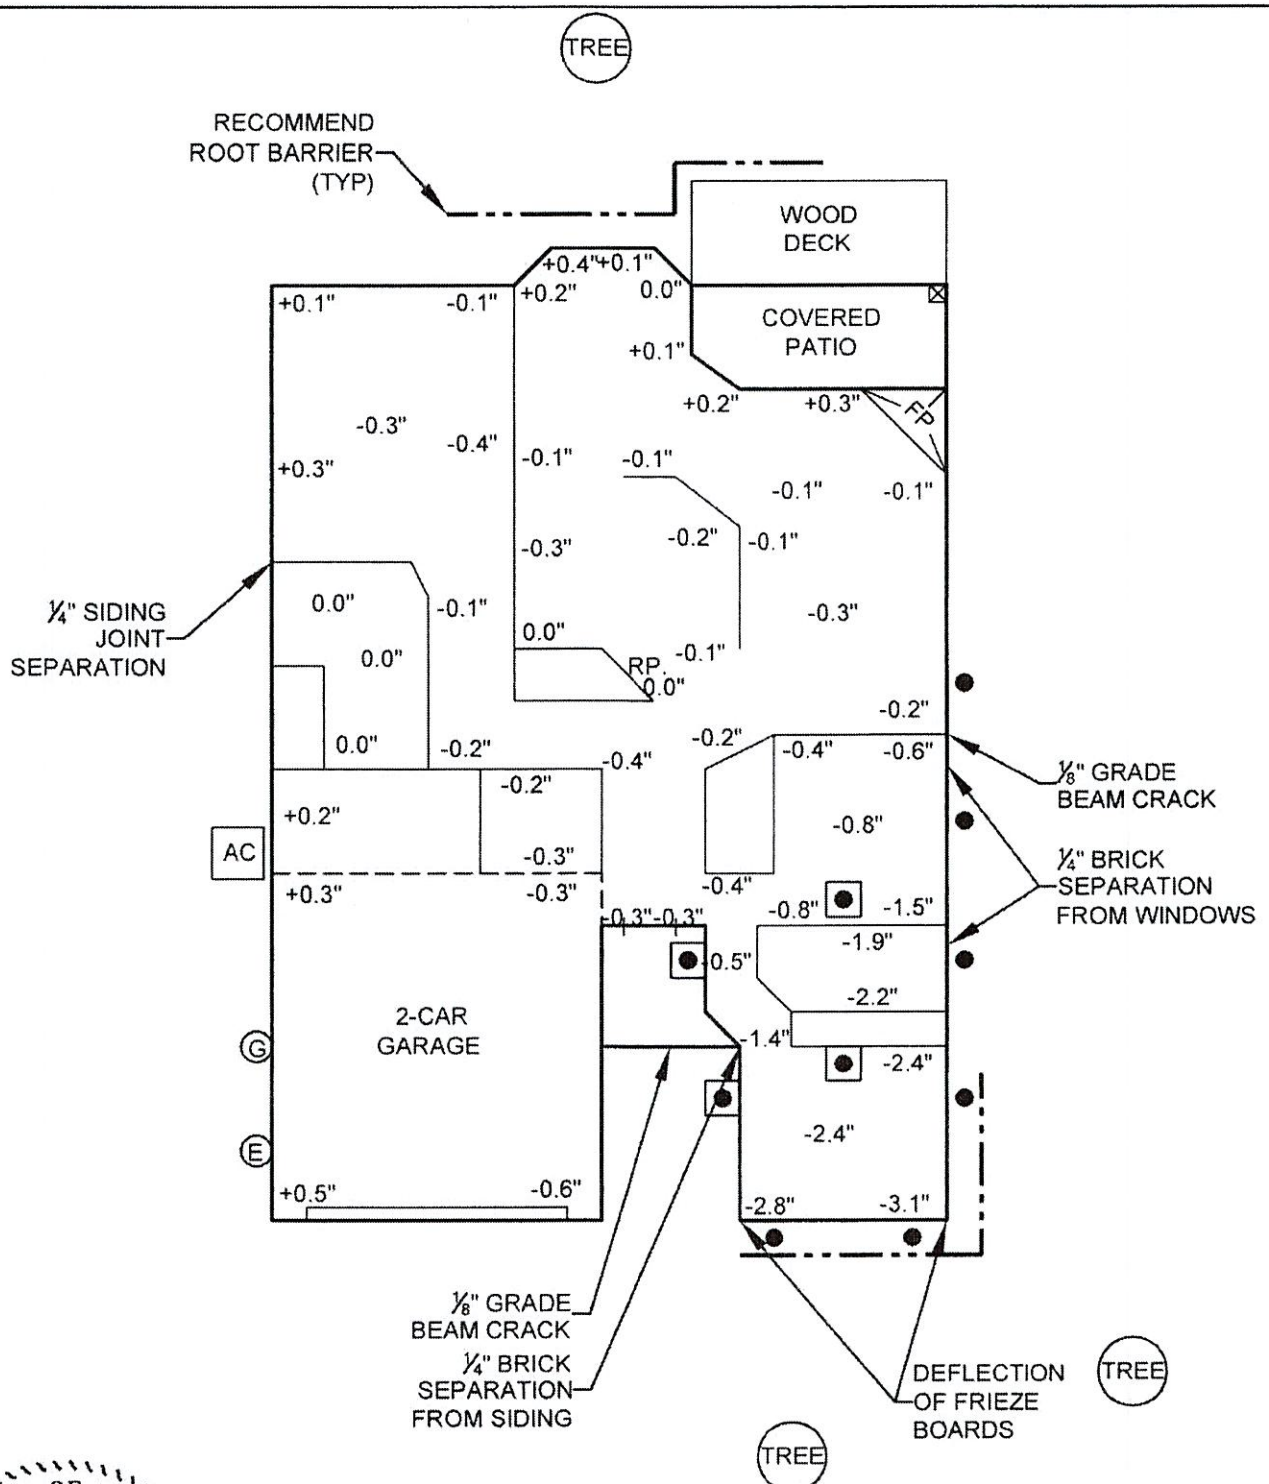
SHEET:
SK-1

Some evidence of foundation movement was observed during the inspection which is noted on the attached Foundation and Elevation Assessment Plan (SK-1). The evidence consisted primarily of sheetrock cracks, doors out of plumb, tile cracks, grade beam cracks, deflection of frieze boards, siding joint separation, brick separation from siding, and brick separation from windows.

and works by measuring the difference in elevations between the base unit and the handheld unit. The basepoint for the residence was reportedly set to 0.0 inch and located near the center of the residence. Negative elevations referenced are below the basepoint, and positive elevations are higher than the basepoint. The lowest point was recorded near the southeast corner of the residence. The highest point was recorded near the southwest corner of the garage. The elevation differential between the low and high points of the residence was found to be about 3.6 inches. These elevations are shown on the attached Foundation and Elevation Assessment Plan (SK-1).

Multiple trees are located in close proximity to the perimeter of the foundation on the north and south sides of the residence. The approximate locations of the trees are marked on the Foundation and Elevation Assessment Plan (SK-1). The trees are located close enough to the residence that the tree roots will influence the performance of the foundation and floor slab. Depending on the species, trees are capable of removing moderate to significant amounts of water from the subsurface soils. This is probably more notable during the drier months or periods of low rainfall when the trees begin pulling moisture from the bearing soil beneath the foundation. This is called transpiration and will cause expansive clay soil to shrink. Since a slab on grade foundation system relies on the soil for support, the foundation of the residence will settle as the soil shrinks.

I recommend a minimum of ten (10) steel piles be installed at the residence. Pile locations are shown on the Foundation and Elevation Assessment Plan (SK-1). In addition, a Ground Penetrating Radar (GPR) scan was performed on the interior floor slab. The approximate location of the grade beams detected by the GPR scan is shown on the attached Grade Beam and Pile Layout Plan (SK-2). In addition, based on the GPR scan, the floor slab of the main residence appears to be approximately four (4) to five (5) inches thick with post tension cables approximately every thirty-four (34) inches on center each way. The steel piling system used should have an evaluation service report (ESR) recognized by ICC-ES showing compliance with the 2021 International Residential Code (IRC) and should meet or exceed the foundation repair amendments. The steel piling system should also have a minimum allowable working load of 20 kips and be capable of uniformly raising the foundation as applicable.

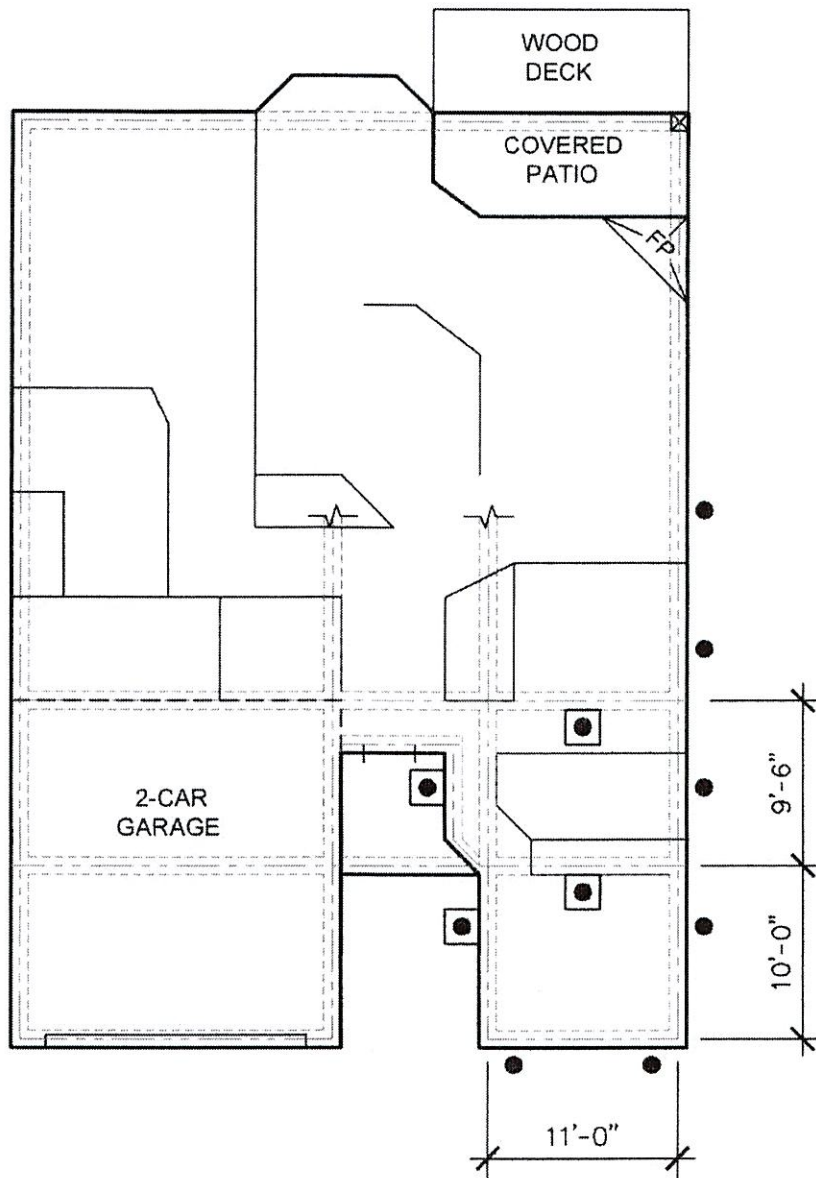
SHEET:
SK-2

PLAN NOTES
 INTERIOR FLOOR SLAB APPEARS TO BE APPROX. 4 TO 5 INCHES THICK WITH POST TENSION CABLES APPROX 34" O.C. EACH WAY
