## HOME INSPECTION REPORT (TREC REI 7-6)

101 Monarch Lane  
Austin, TX 78737

# PROPERTY INSPECTION REPORT FORM

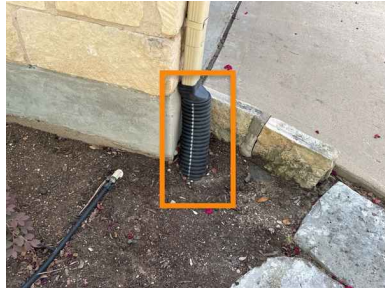
*Underground Drainage Observed:* Underground drainage was noted at the time of inspection. This is not tested as it is beyond the scope of this inspection.

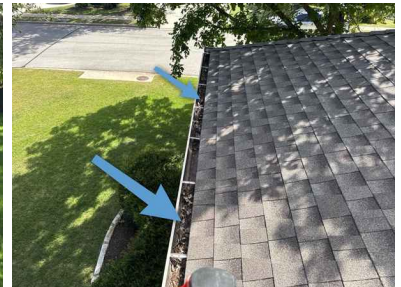
**1: Debris In Gutters**

Gutters were filled with debris/foilage at multiple locations. These gutters should be cleaned to allow for proper drainage.

Pyka: Gutters were cleaned by Proverbs 3:5 on 6-30-2026.

Recommendation: Contact a qualified professional.

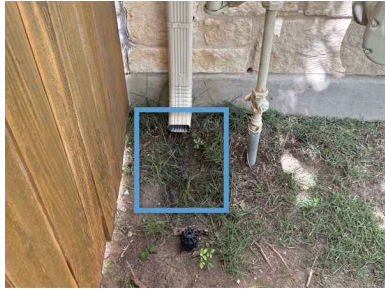
**2: Missing Splash Blocks**

The gutter downspouts are missing splash blocks at multiple locations. These should be added to prevent soil erosion.

Recommendation: Recommended DIY Project

Pyka: Homeowner added splash blocks on 7-3-2026.

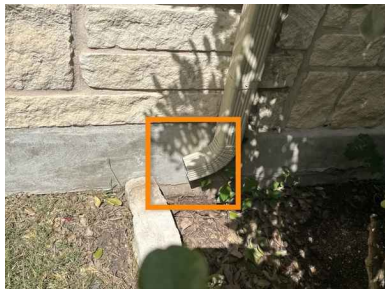
**3: Gutter elbow redirect**

The elbow downspout at the front left side of the home and should be replaced to direct water runoff away from structure.

Recommendation: Contact a qualified gutter contractor

Pyka: Homeowner modified the elbow on 7-3-2026.

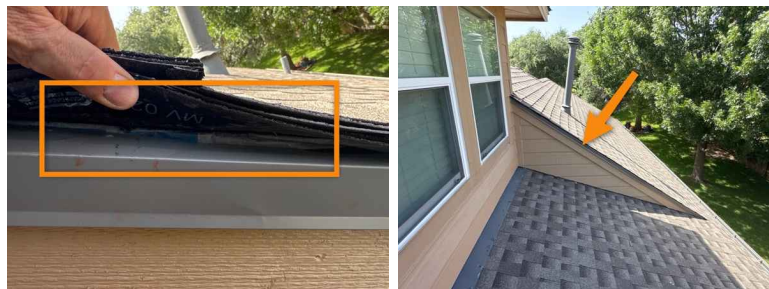
### 4: Exposed Decking

Exposed decking was observed at the roof intersections at the right side of the home due to gaps in the drip edge/trim/siding. This condition is conducive to moisture/pest intrusion.

Recommendation: Contact a qualified roofing professional.

Pyka: LoveRain inspected on 7-1-2026 and noted decking is covered by synthetic underlayment drip edge, starter and shingles and covered by a full warranty back by LoveRain Roof Company.

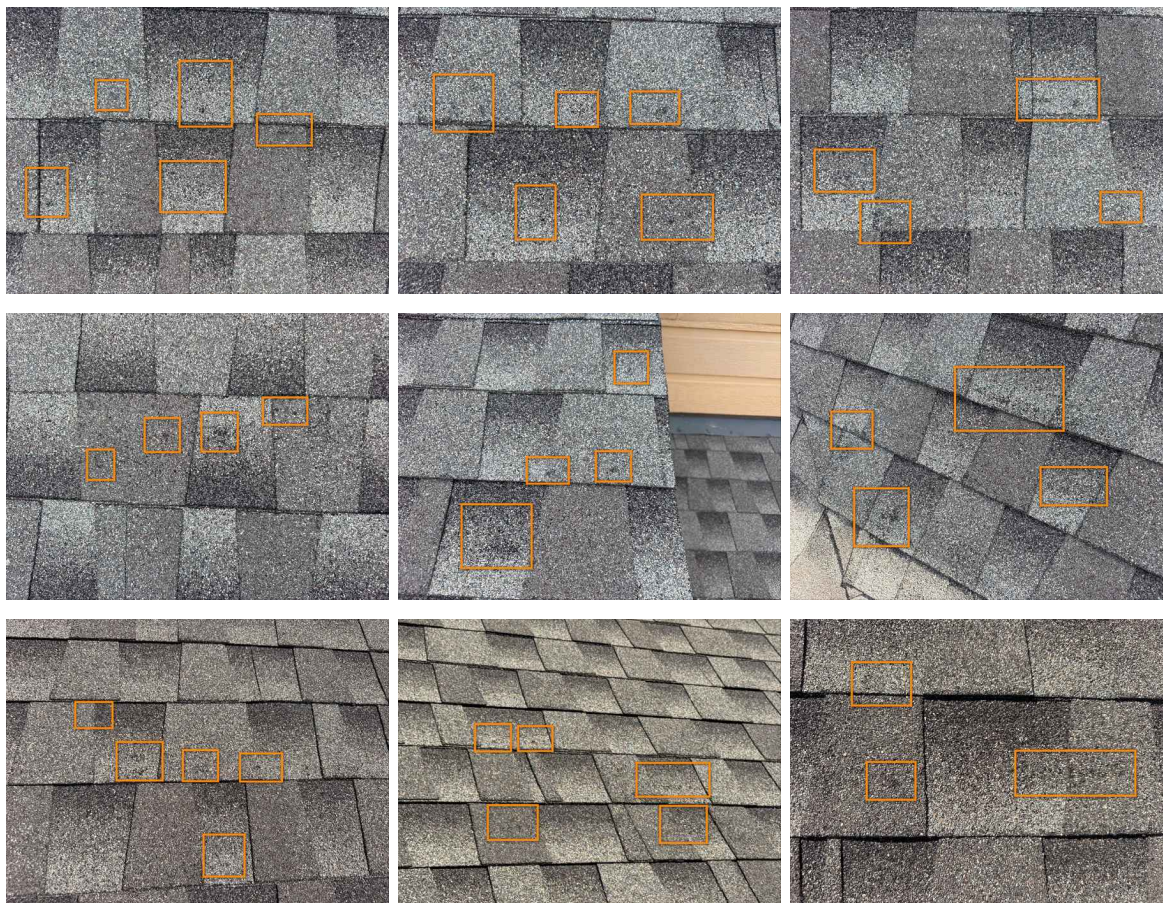
**5: Scarring/Possible Impact Type Damage****Recommendation**

Scarring or possible impact or weather damage was present in multiple locations throughout the roof covering. Recommend further evaluation by a roofing professional.

Recommendation: Contact a qualified roofing professional.

Pyka: LoveRain inspected on 7-1-2026 and noted blemishes occur on every roof and do not compromise the function of the roof system. LoveRain roofs are fully warranted should there be any issues.

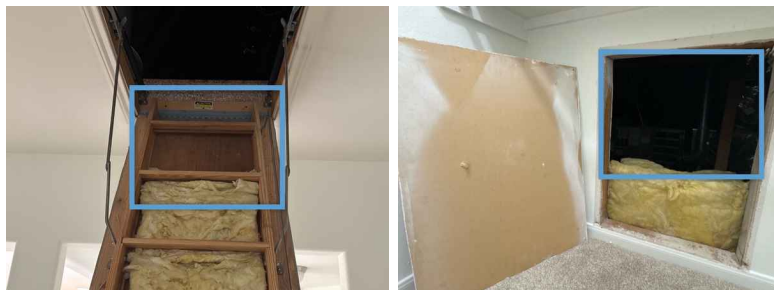
**1: Missing Insulation On The Attic Hatch**

The attic access stairway/hatch above a conditioned space was not properly insulated. This access point should be properly insulated on top of the hatch to ensure proper R-value at this location.

Recommendation: Recommended DIY Project

Pyka: Homeowner added insulation on 7-3-2026.

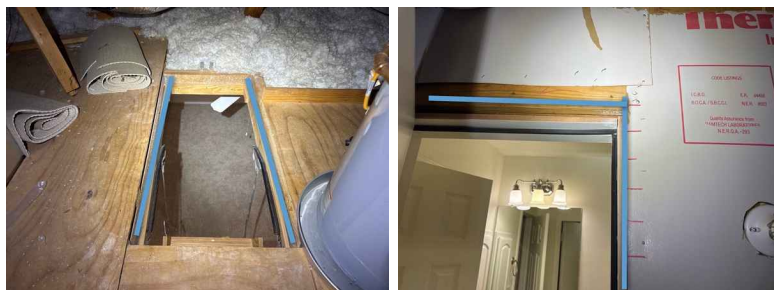
**2: Missing Polyseal Around Hatch**

Poly seal spray foam was missing around the perimeter of the attic access hatch/stairway.

Recommendation: Contact a qualified professional.

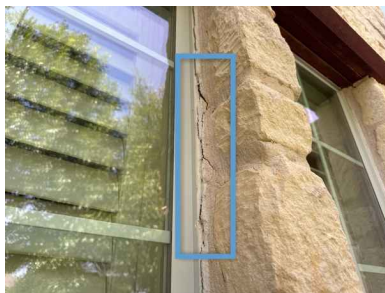
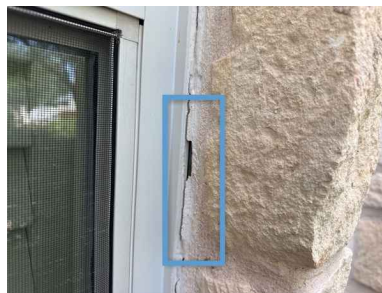
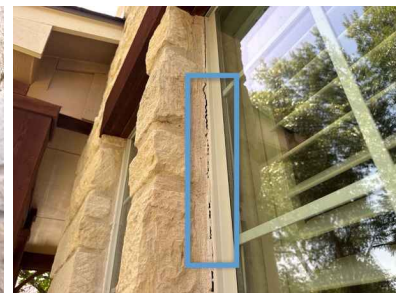
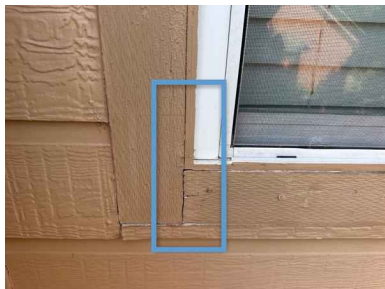
## 2: Improperly Sealed Windows

All exterior windows should be sealed throughout the home to prevent pest/moisture intrusion.

Recommendation: Contact a handyman or DIY project

Pyka: Contractor, Joe Gonzales, added sealant on 7-6-2026.

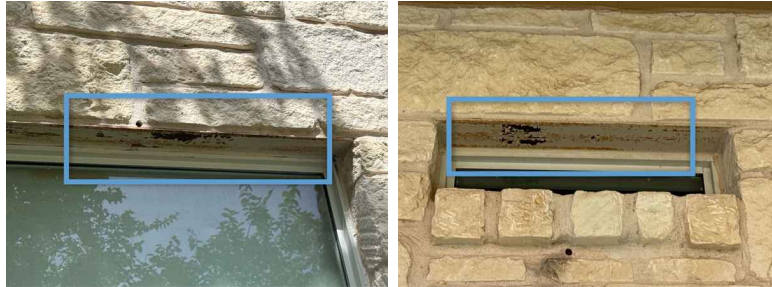
**3: Rusted Lintels**

Rusted/exposed lintels were present. Recommend ensuring that the lintels are properly painted to prevent to rust.

Recommendation: Contact a handyman or DIY project

Pyka: Contractor,  
Joe Gonzales, painted  
lintels on  
7-6-2026.

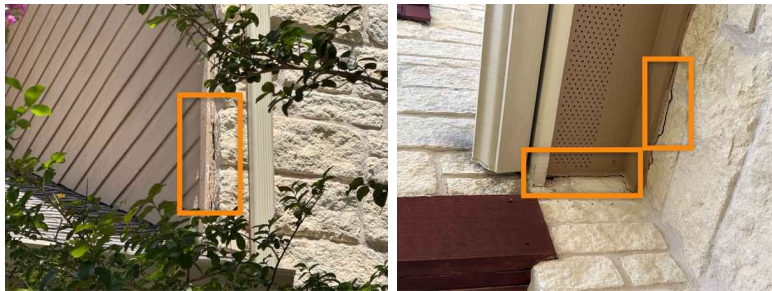
**4: Trim / Mortar Joint Cracks**

Multiple gaps were observed between trim materials and mortar joints at multiple locations. These joints should be sealed between all exterior siding materials to prevent water/pest intrusion.

Recommendation: Contact a qualified siding specialist.

Pyka: Contractor,  
Joe Gonzales, added  
sealant on 7-6-2026.

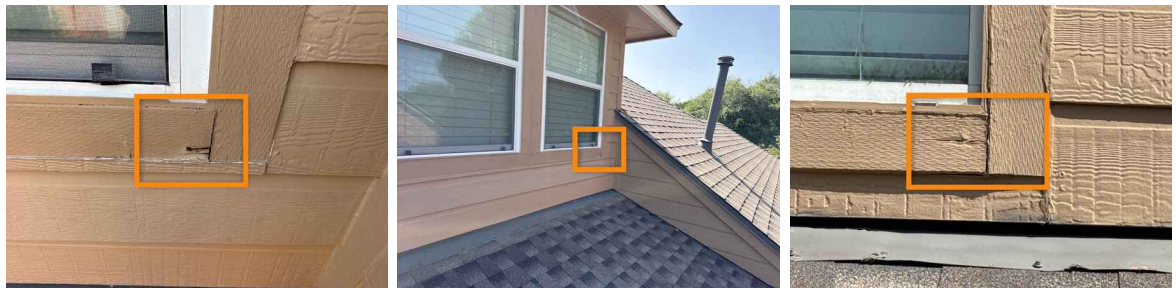
**5: Wood Rot / Water Damage**

Wood deterioration/rot was observed at siding/trim at multiple locations at the second story windows

Recommendation: Contact a qualified professional.

Pyka: Contractor,  
Joe Gonzales,  
replaced trim and  
painted trim on  
7-6-2026.

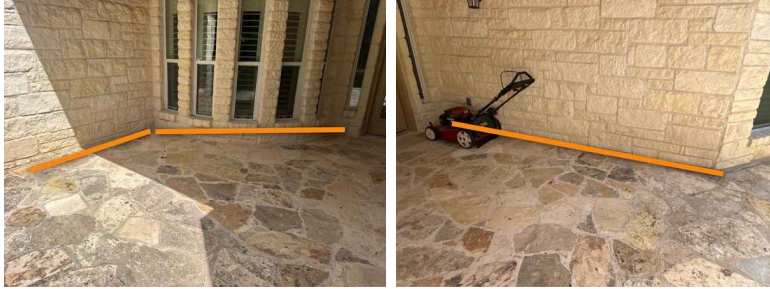
**6: Missing Weep Holes****🔧 Recommendation**

Missing/blocked weep holes for the exterior masonry siding materials observed at the back patio. The drying potential for non-structural brick is limited. Weep holes should be present no more than 33" apart on-center around the perimeter of the residence.

Pyka: After careful consideration, property owner elects to not proceed with recommendation.

Recommendation: Contact a qualified siding specialist.

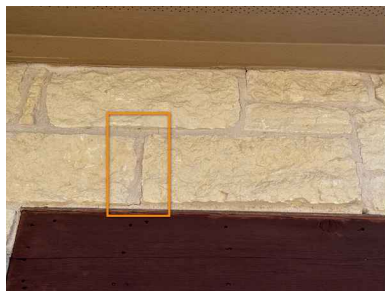
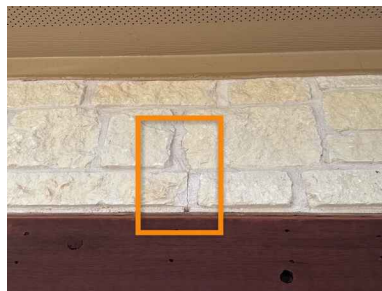
**10: Cracks above garage****➔Recommendation**

Cracks/gaps were observed in the mortar joints of the brick/stone siding at multiple locations at the front of the home above the garage. Recommend further evaluation by a professional mason to repoint the mortar joints

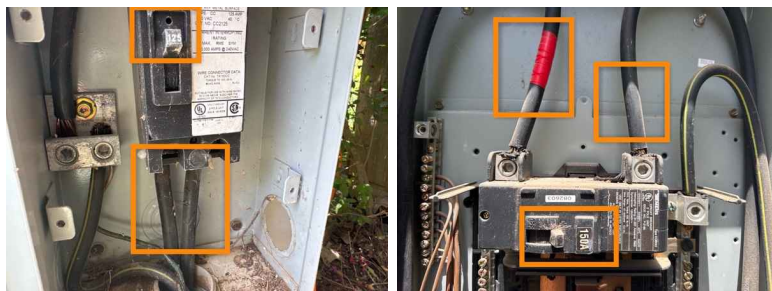
## 4: Breaker and wire gauge are not matched

The breakers were undersized/oversized for the gauge of wire used at the breakers in the backyard main service panel and left side exterior electrical panel. The main service feed is 125 Amps while the breaker to the exterior electrical panel is 150 Amps. This configuration may cause the breakers to overheat. Recommend replacement of the breaker by a licensed electrician.

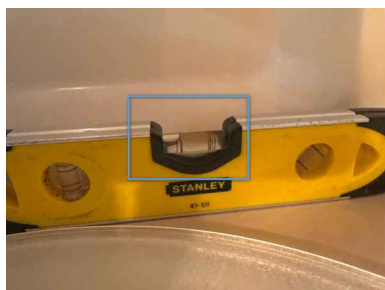
*Comments:***1: Level** **Maintenance Item**

The microwave was not level or not mounted properly. The microwave door closes by itself. Recommend adjustment to prevent damage or personal injury

Pyka: After careful consideration, property owner elects to not proceed with recommendation.

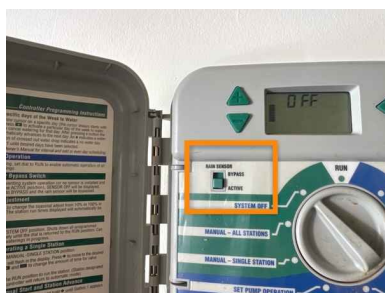
### 4: No Rain Gauge

Unable to locate the required rain gauge sensor for the irrigation system. Recommend further evaluation to ensure this device is installed and functioning properly
