INSPECTION REPORT

1309 SCOLLARD DRIVE
PETERBOROUGH, ON K9H 7K7

Inspection Date: Friday, October 3, 2025

RE: Report No. 5471
1309 Scollard Drive
Peterborough, ON
K9H 7K7

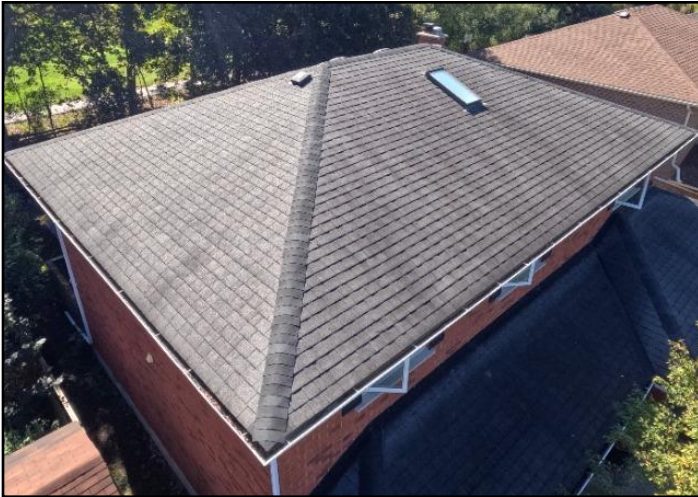
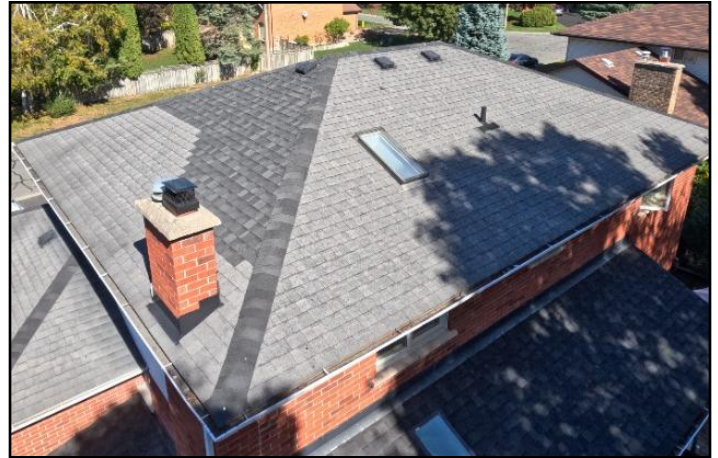
1. *Asphalt shingles*

1. **Condition:** • Aging

Task: Monitor

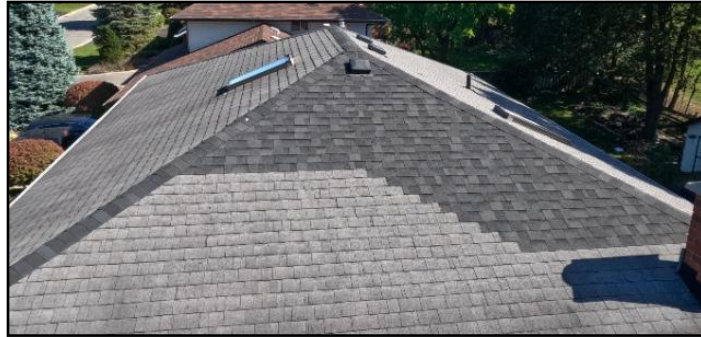
2. **Condition:** • Patched/repaired

Implication(s): Possible shortened life expectancy

Location: Right hip

3. Patched/repared

Task: Monitor

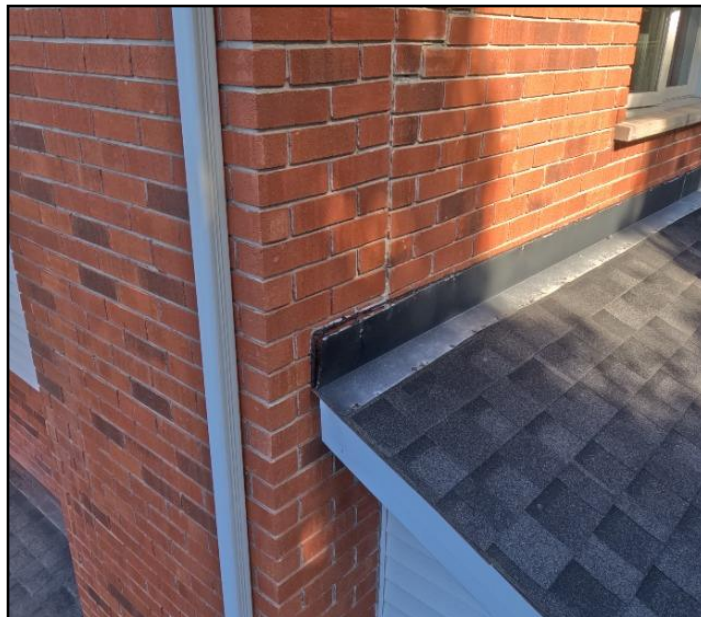
3. Condition: • Open at top

Implication(s): Chance of water damage to structure, finishes and contents

Location: Rear elevation

4. Open at top

Task: Repair

Time: As soon as is practicable

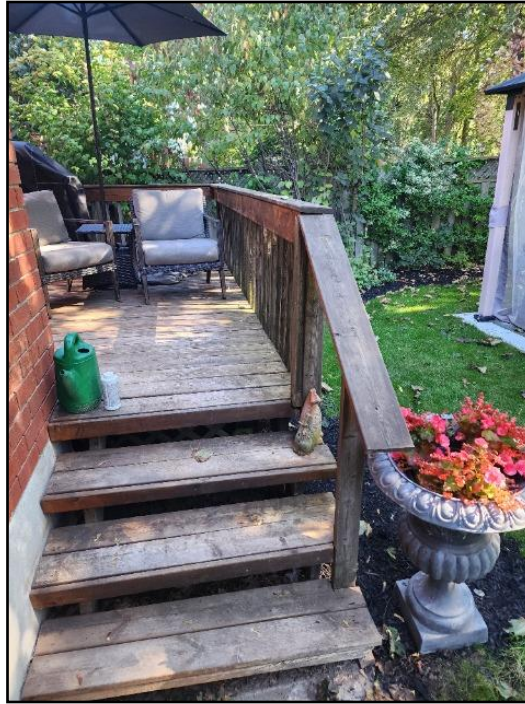
4. Condition: • Movement

Implication(s): Weakened structure | Chance of continued movement

Location: Rear decking

5. Movement

Task: Improve

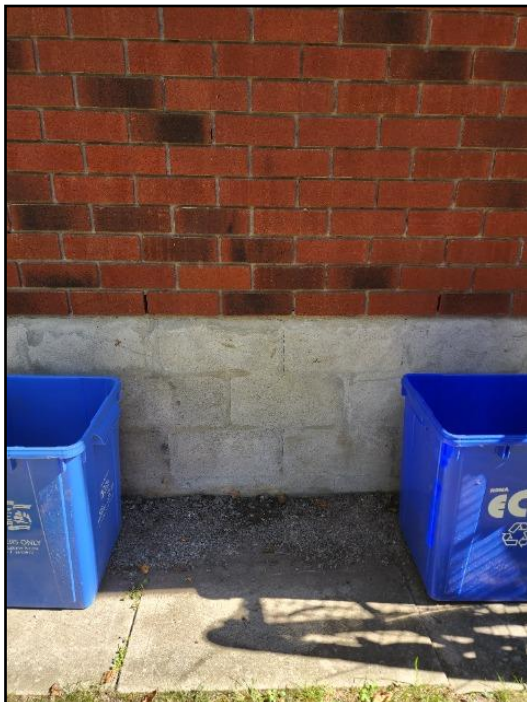
5. Condition: • Typical minor cracks

Implication(s): Material deterioration

Location: Various locations

6. Typical minor cracks

Task: Repair

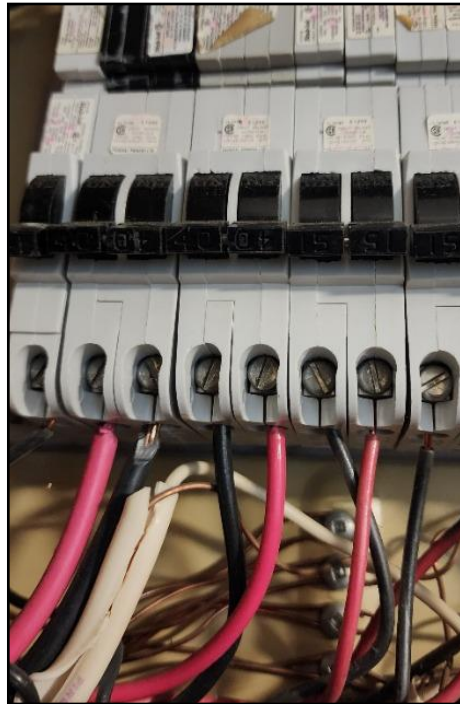
7. Condition: • Breakers too big

40 Amp breakers on a 10 gauge branch circuit wire. Although not a deficiency in a panel of this age, safety may be improved by replacing this breaker.

Implication(s): Equipment overheating | Fire hazard

13. Breakers too big

Task: Improve

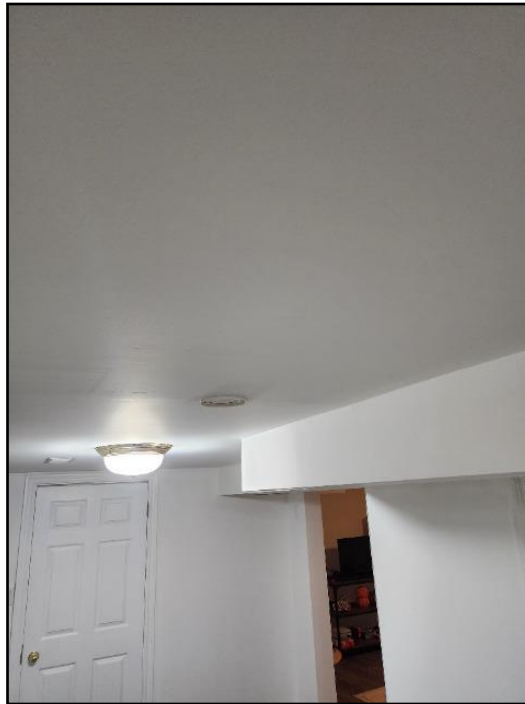
8. Condition: • Missing

Implication(s): Safety issue

Location: Basement

14. *Missing*

Task: Replace

Time: Immediate

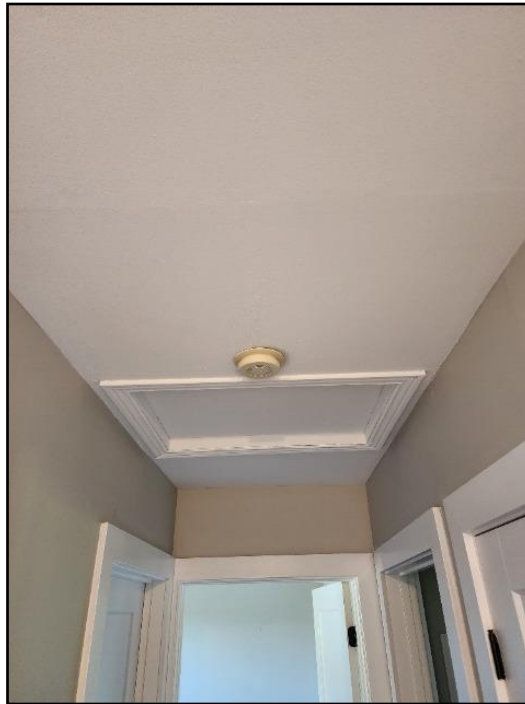
9. Condition: • More than 10 years old

Implication(s): Life safety hazard

Location: Second floor

15. More than 10 years old

Task: Replace

Time: Immediate

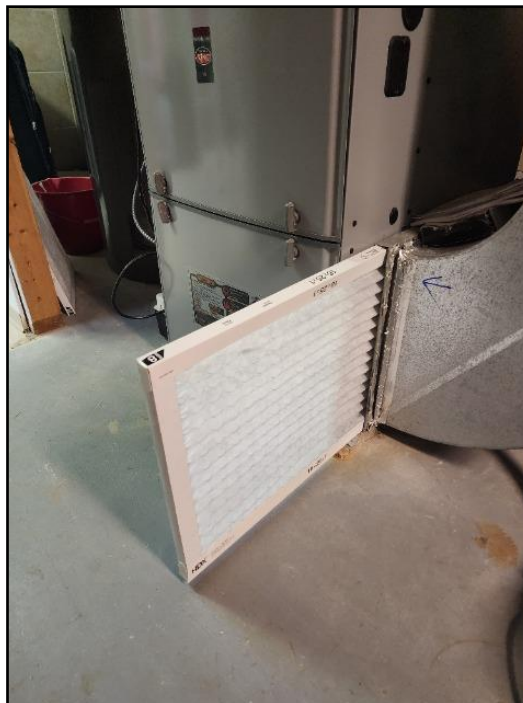
11. Condition: • Replace - regular maintenance

22. *Replace - regular maintenance*

Task: Replace - regular maintenance

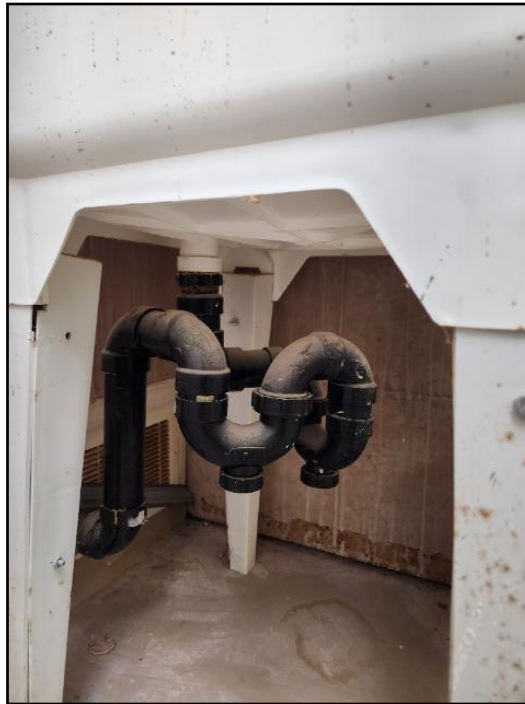
14. Condition: • Double trapping

29. Double trapping

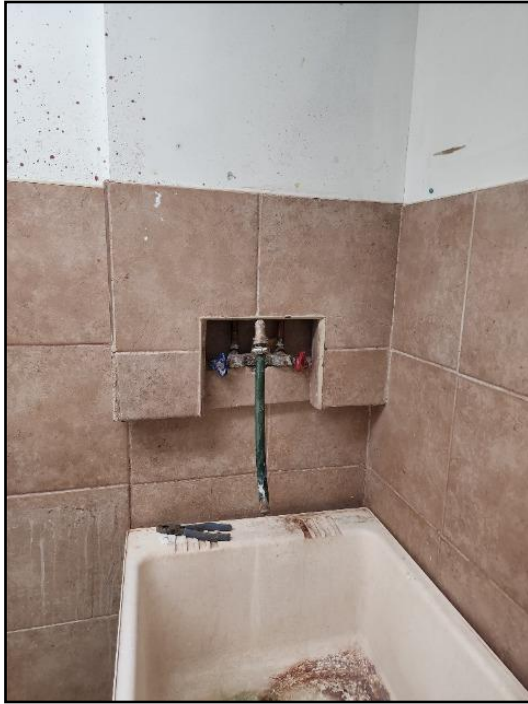
15. Condition: • Hot and cold reversed

30. Hot and cold reversed

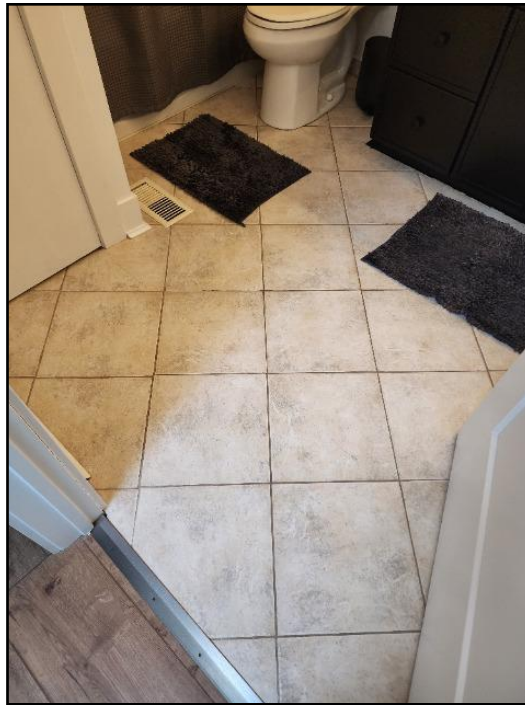
16. Condition: • Tiles cracked, loose or damaged

Implication(s): Continued material deterioration. Physical injury

32. *Tiles cracked, loose or damaged*

Task: Replace

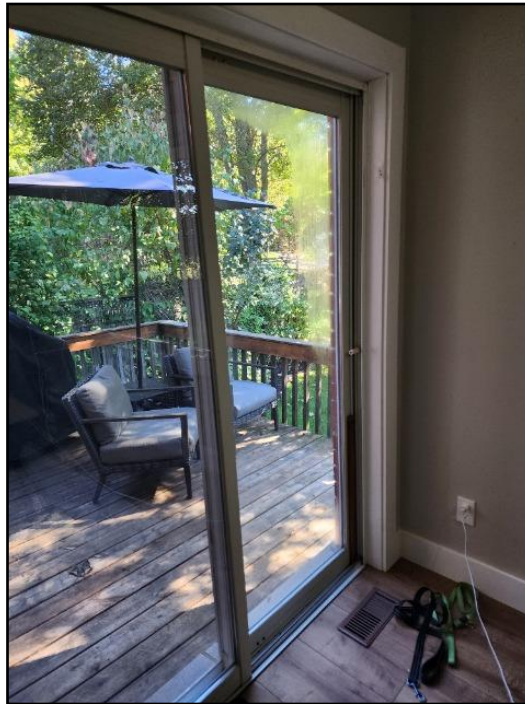
17. Condition: • Lost seal on double glazing

33. *Lost seal on double glazing*

Task: Repair or replace

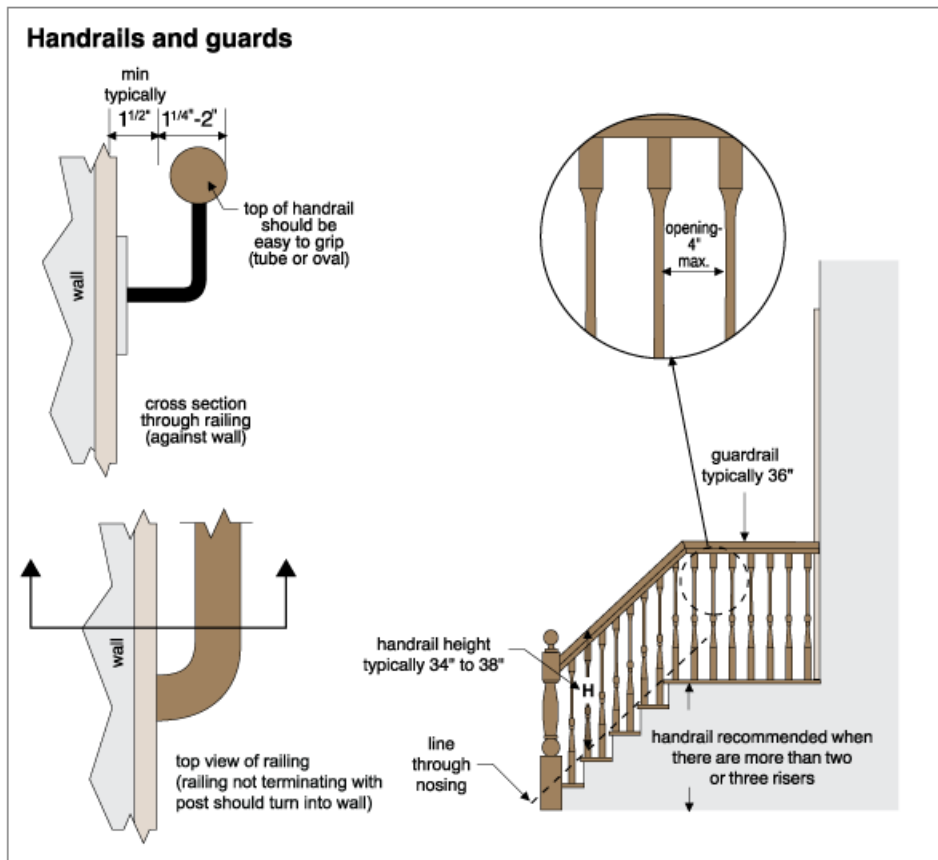
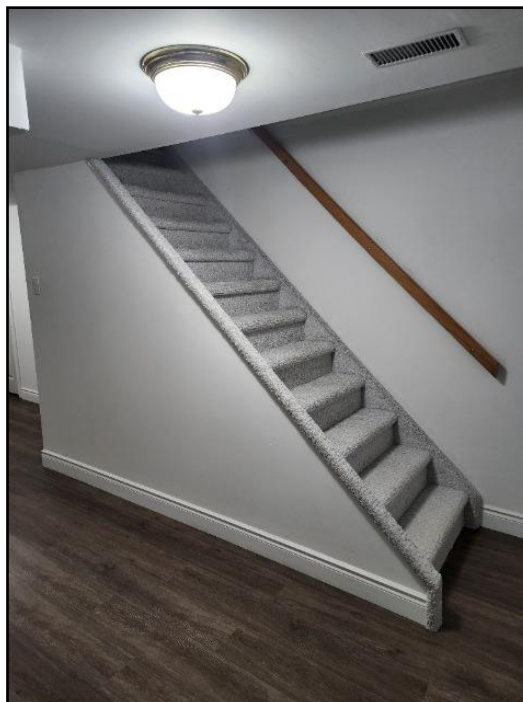
18. Condition: • Missing

Implication(s): Fall hazard

34. Missing
