SELLER'S DISCLOSURE NOTICE

CONCERNING THE PROPERTY AT 1006 Shelley Avenue, Austin, Texas 78703

1006 Shelley – Engineering Foundation Evaluation Provided by Seller

1006 Shelley – Foundation Inspection Pages Provided by Buyer 1

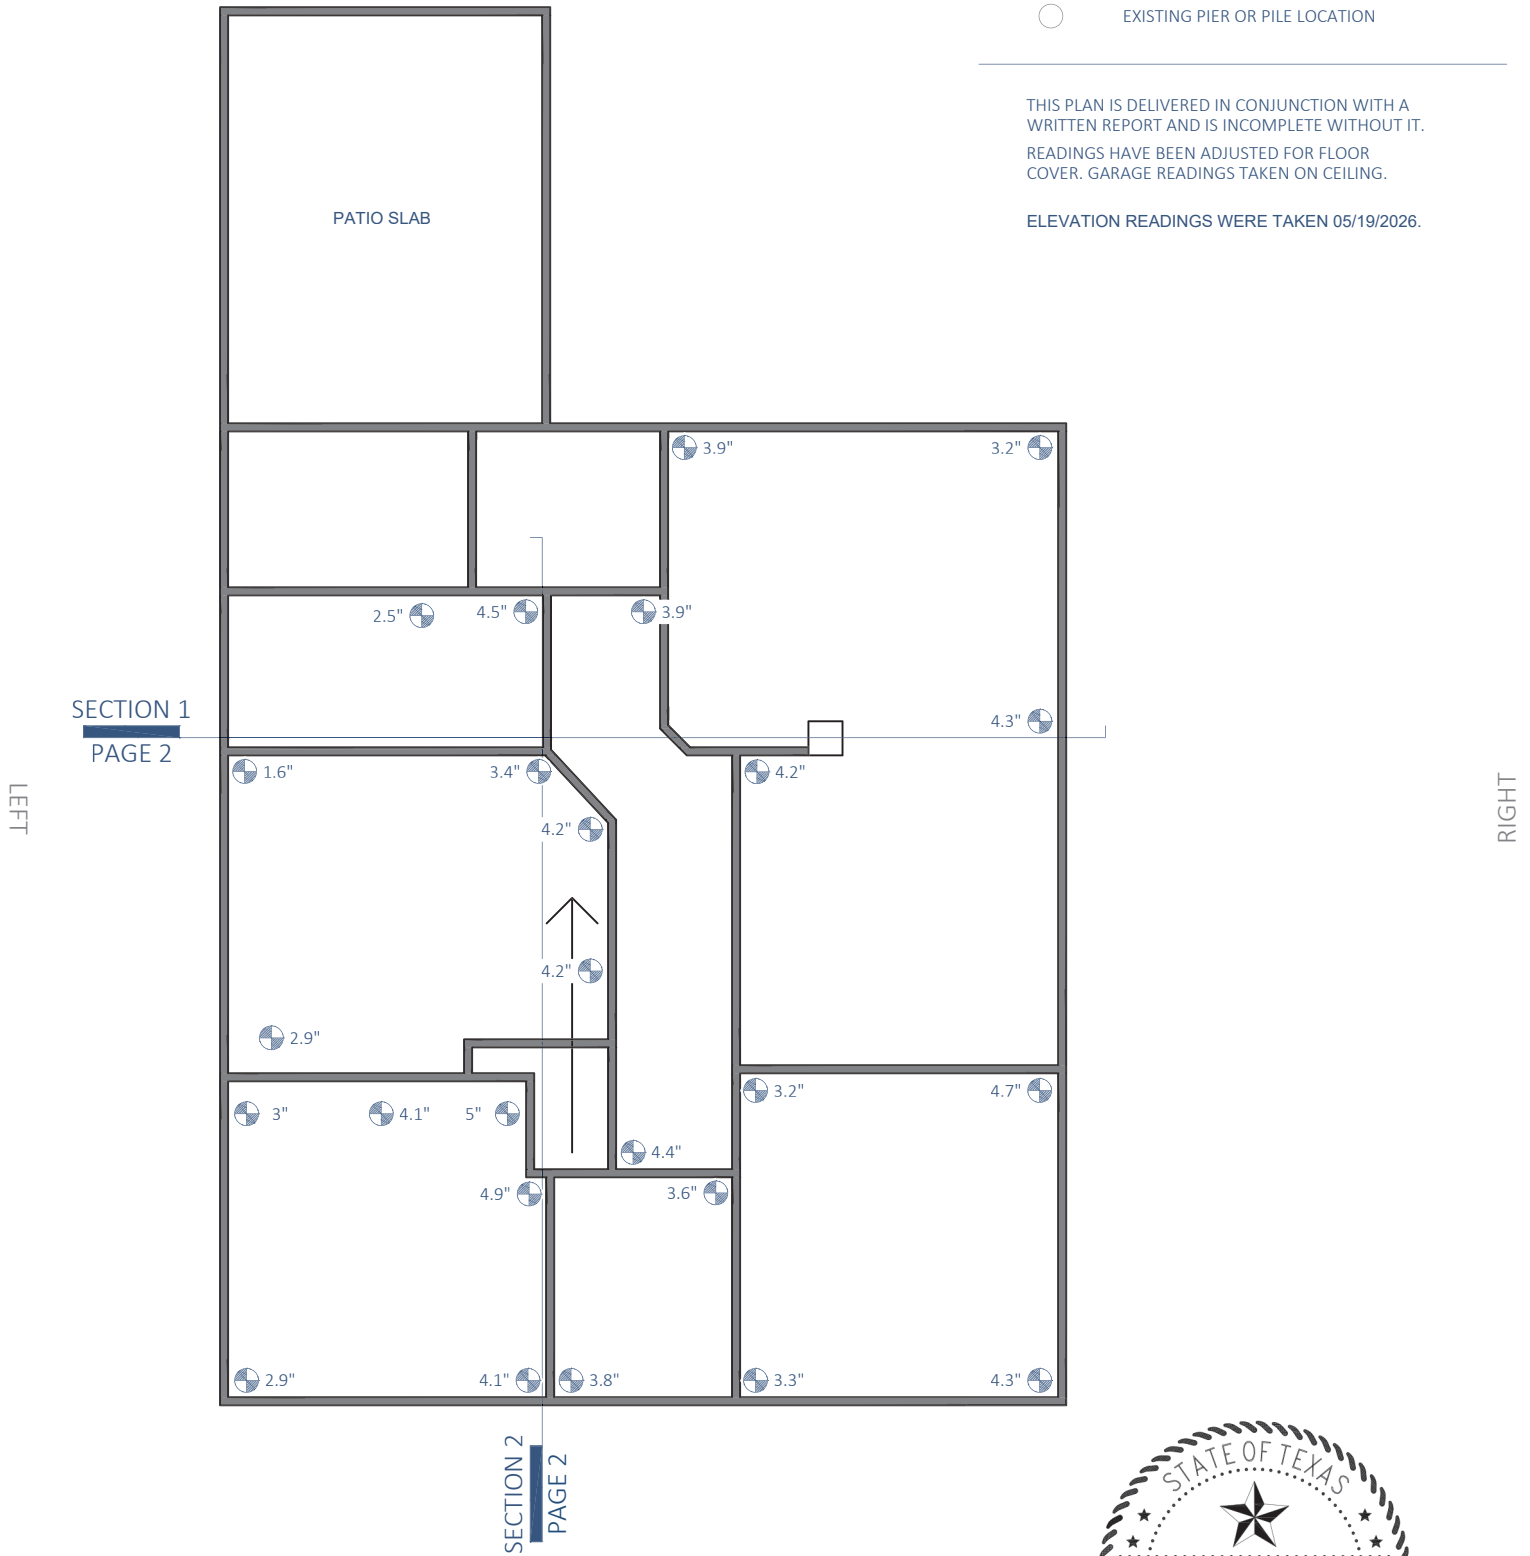
Measurements were taken inside the house as shown in the enclosed diagram. It was determined that the foundation had significant humps and dips throughout. Cross sections of the foundation were analyzed as shown in the enclosed diagrams. The utility was originally constructed as exterior space with a slope built into the floor and was excluded from the elevation readings.

ELEVATION READINGS WERE TAKEN 05/19/2026.

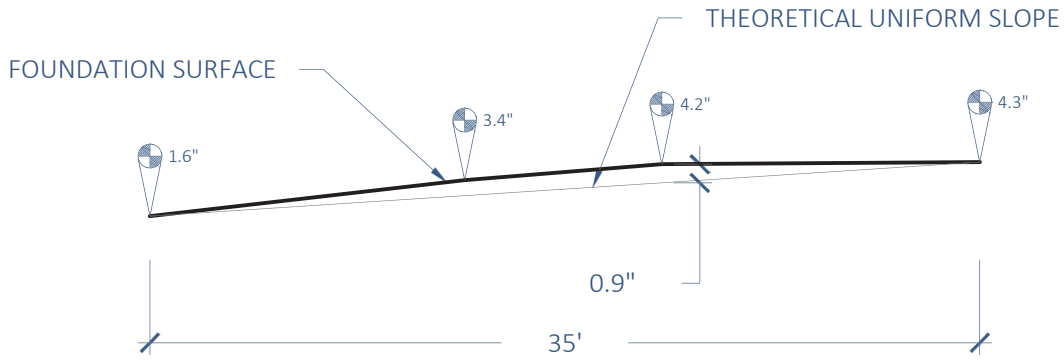
# 1 FOUNDATION CROSS SECTION

SCALE: 1/8" = 1'-0"  
 NOTES: MEASURED UNIFORM SLOPE: 2.7"  
 ALLOWABLE UNIFORM SLOPE (1%): 4.2"  
 MEASURED BENDING DEFLECTION: 0.9"  
 ALLOWABLE BENDING DEFLECTION (L/360): 1.2"

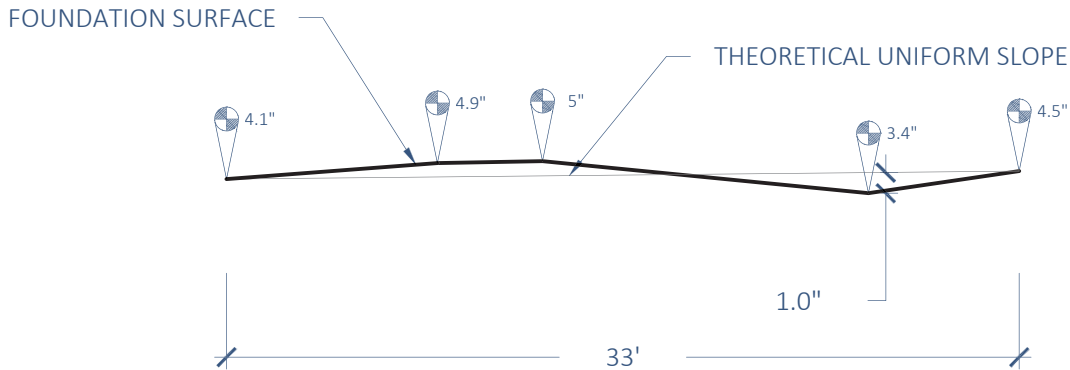
# 2 FOUNDATION CROSS SECTION

SCALE: 1/8" = 1'-0"  
 NOTES: MEASURED UNIFORM SLOPE: 0.4"  
 ALLOWABLE UNIFORM SLOPE (1%): 4.0"  
 MEASURED BENDING DEFLECTION: 1.0"  
 ALLOWABLE BENDING DEFLECTION (L/360): 1.1"

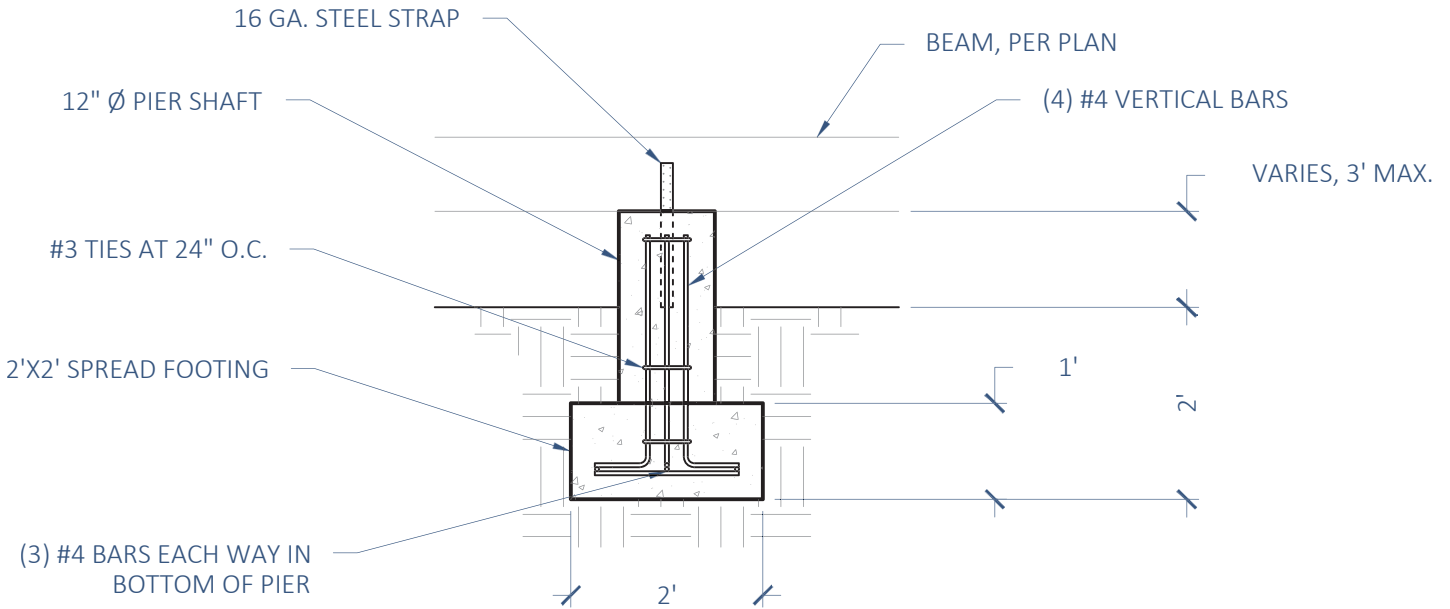
# 1 SPREAD FOOTING / PIER DETAIL

NOTES: THESE PIERS IN CLAY SOIL MAY EXPERIENCE MOVEMENT DUE TO MOISTURE CHANGES RESULTING IN CRACKS AND STICKING DOORS. ADJUSTMENTS MAY NEED TO BE MADE PERIODICALLY.

I recommend that the dry-stacked cinderblock pier be replaced with a new spread footing constructed as shown in the enclosed details. I also recommend that the beams be positively anchored to the grouted cinderblock piers as shown in the enclosed details.

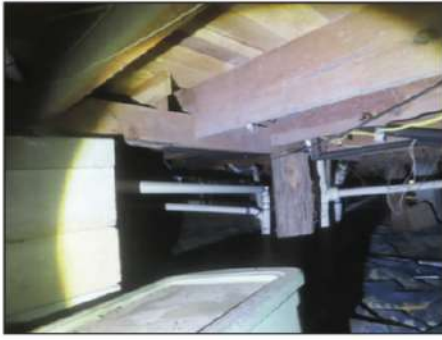
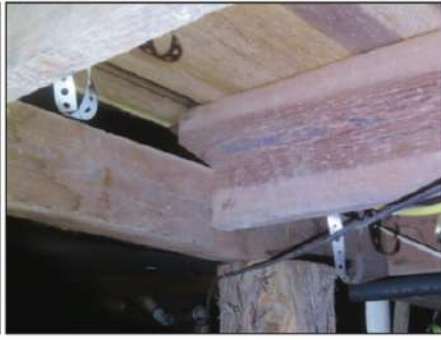
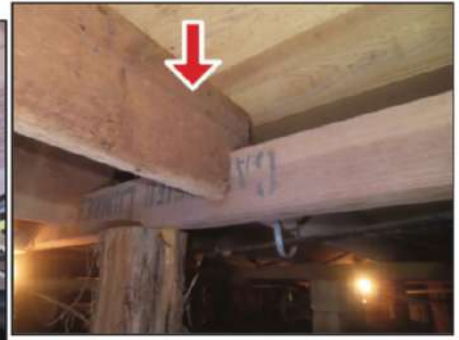
Damage to joist observed

There are piers not in contact with beams. This may be corrected with metal levelling shims. Consult with qualified foundation contractor for completing work.

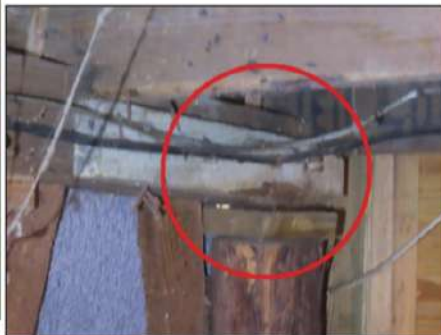
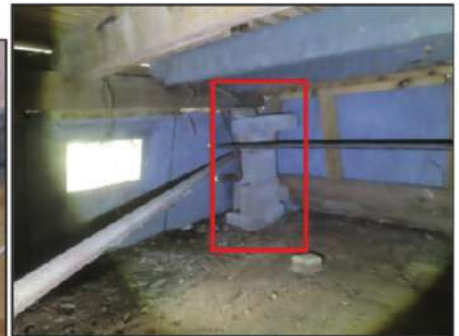
Poorly supported beam(front right corner)

There are multiple areas observed in the crawlspace on the foundation structure with varying degrees of damage from water and/or wood destroying insects. These may affect foundation performance. Further evaluation for repairs is needed by a licensed engineer or foundation contractor.

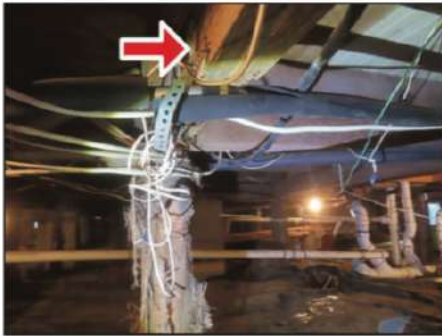
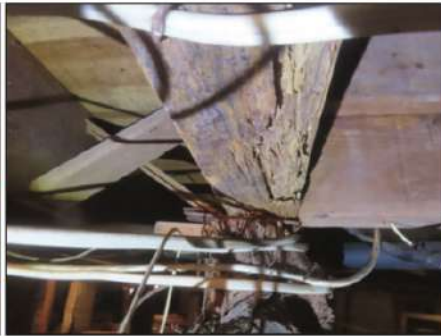
It appears a beam has been added for additional support-beam may have been positioned incorrectly(layed flat- 4" dimension supporting joist). Have a foundation contractor review for any recommended repair or improvement.
