**Dubuqueland Home Inspection**  
18186 Williamsburg Ct. Durango IA, 52039  
(563) 556-4663

2164 Comanche Dr.  
Asbury, IA 52002

10/01/2024 07:56 AM GMT-05:00

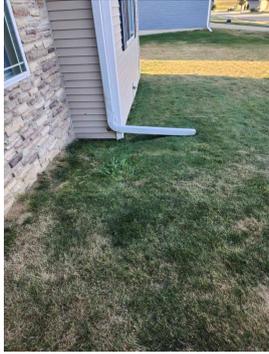
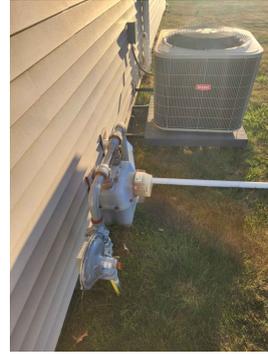
Negative grade

South side

West side

Recommend changing grade to maintain a positive slope away from the foundation for proper drainage

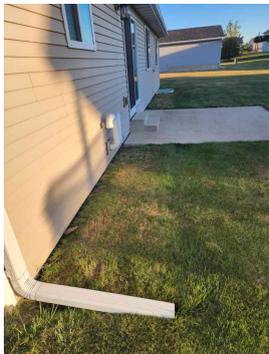
East side

Negative grade

Recommend changing grade to maintain a positive slope away from the foundation for proper drainage

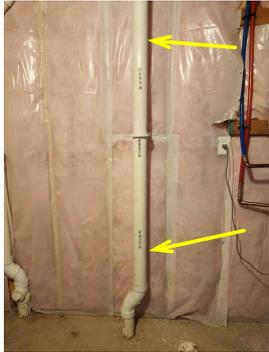
3" PVC passive radon pipe installed from lower level utility room through roof
