# INSPECTION REPORT

**114 OAKWOOD CRESCENT**  
PETERBOROUGH, ON K9J 1N3

RE: Report No. 5453  
114 Oakwood Crescent  
Peterborough, ON  
K9J 1N3

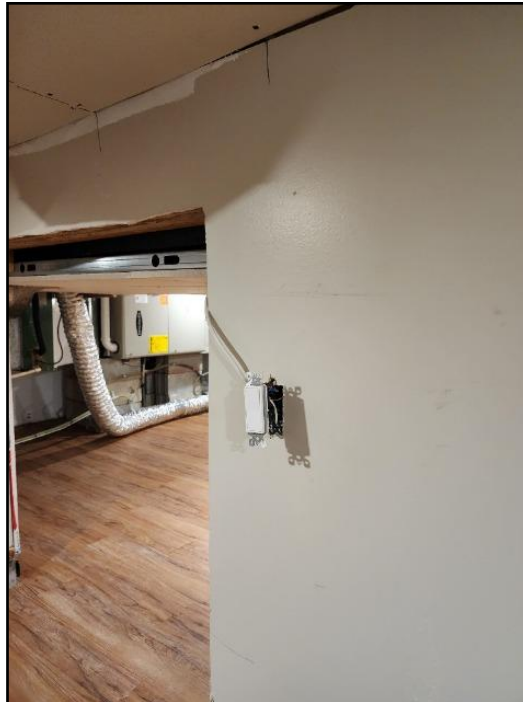
7. Condition: • Loose

Implication(s): Electric shock

**Location:** Crawlspace

12. Loose

**Task:** Repair

Realtor Note: A switch plate has been installed and switch has been secured

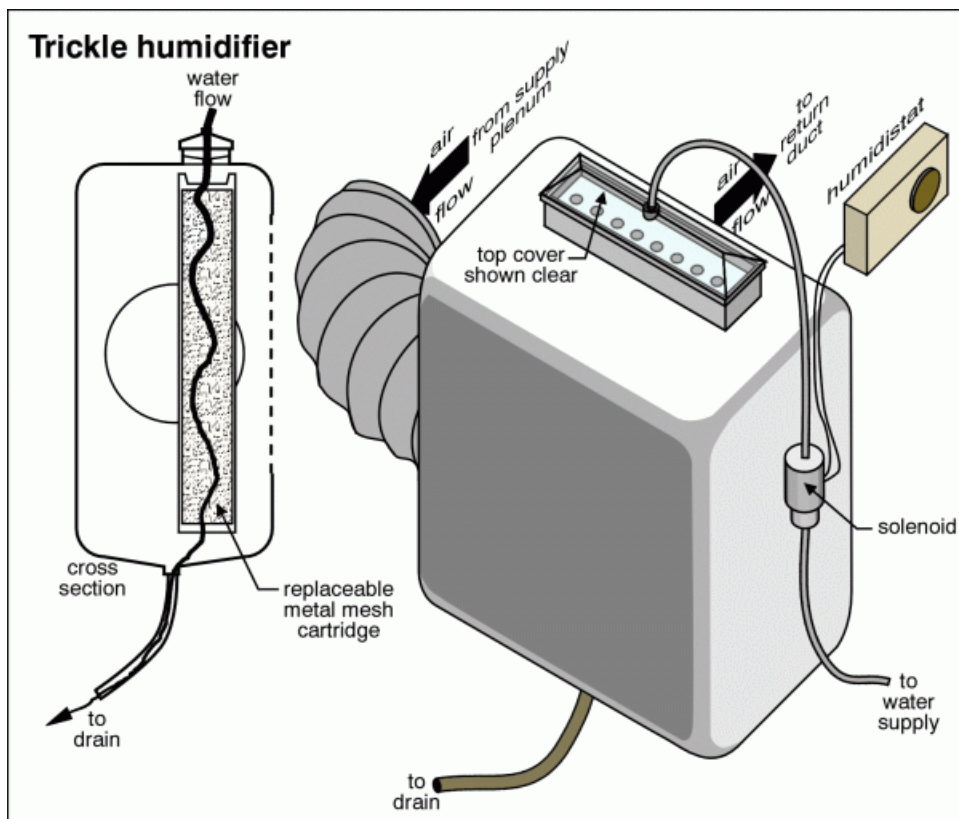
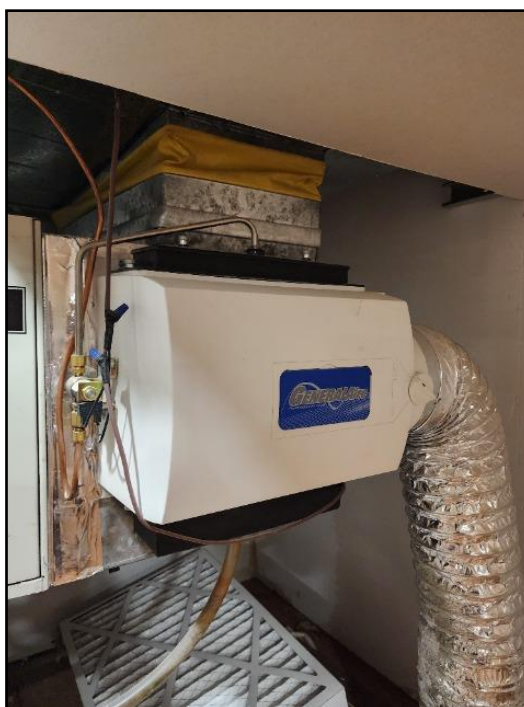
19. Trickle/cascade type humidifier

Realtor Note: New mesh installed

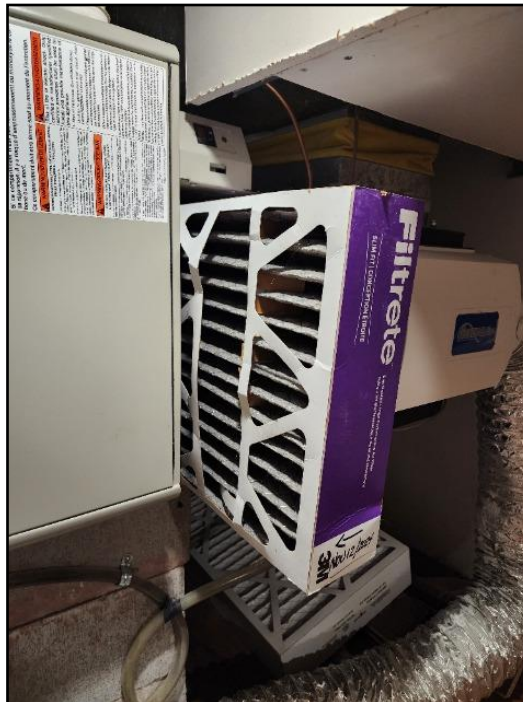
**8. Condition:** • Replace - regular maintenance

20. Replace - regular maintenance

Realtor Note: Furnace filter has been replaced.

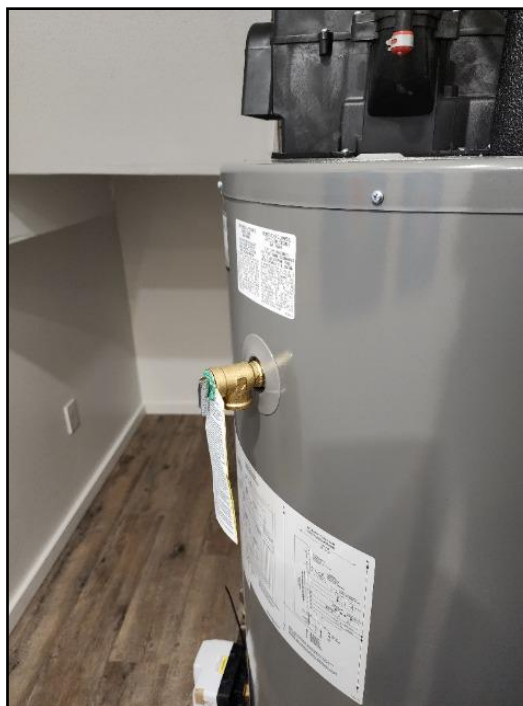
**12. Condition:** • Discharge tube missing

**Implication(s):** Scalding. Possible water damage to finishes, storage and structure

32. Discharge tube missing

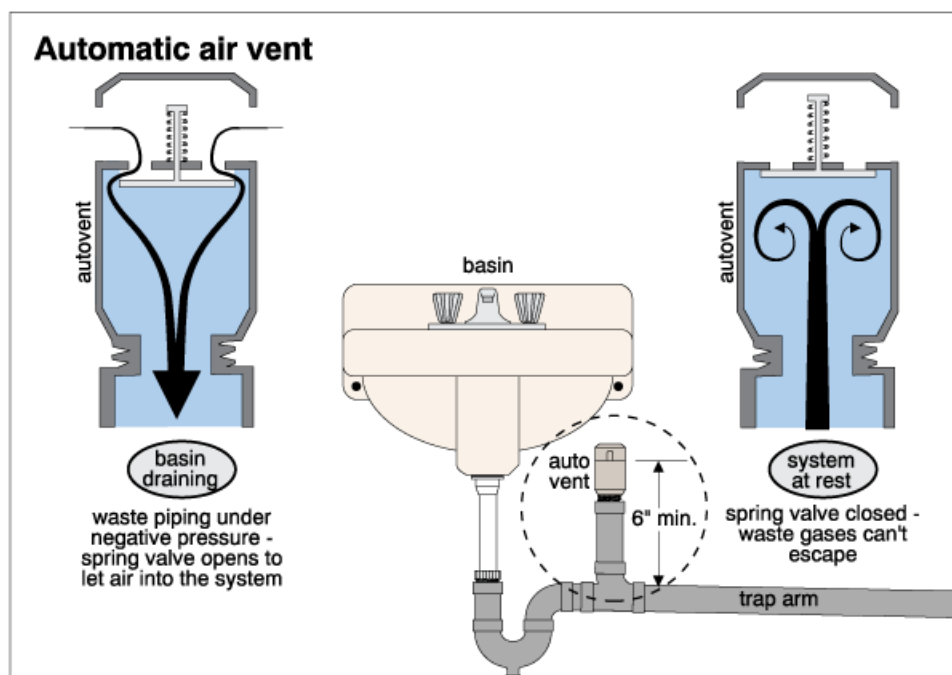
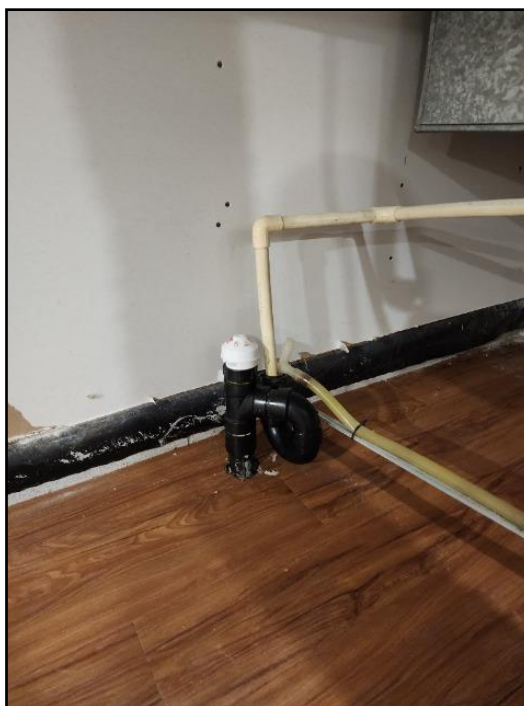
13. Condition: • Automatic air vents

**Implication(s):** Failure may allow sewer gasses to enter building

33. Automatic air vents

**Task:** Monitor

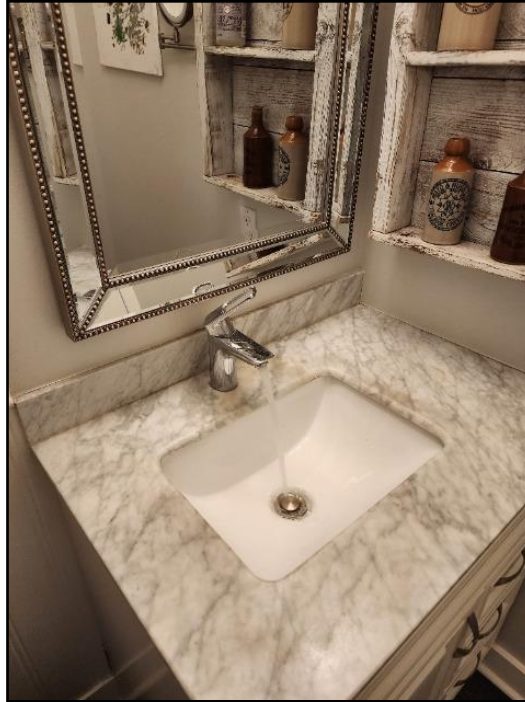
**14. Condition:** • Hot and cold reversed

**34.** *Hot and cold reversed*

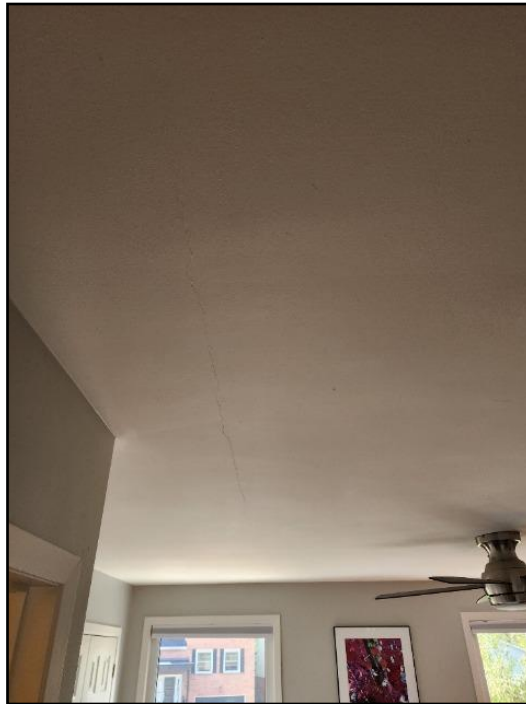
**15. Condition:** • Minor cracking

**Implication(s):** Material deterioration

35. Minor cracking

**Task:** Repair

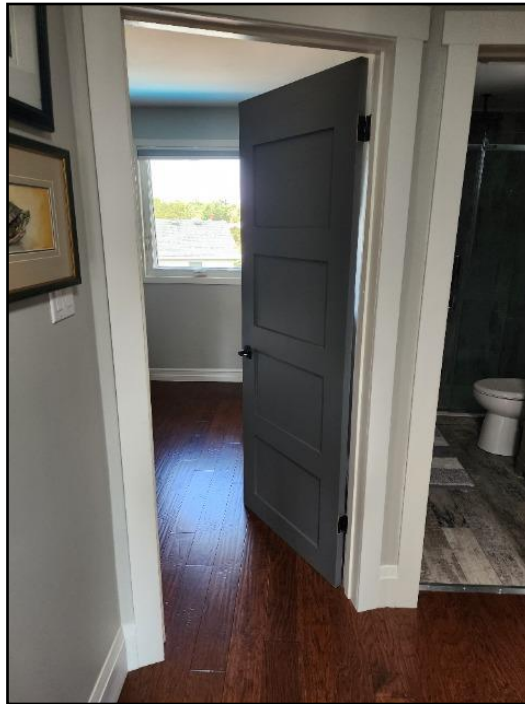
**16. Condition:** • Binds

**Implication(s):** Wear and/or damage to flooring and/or door

38. Binds

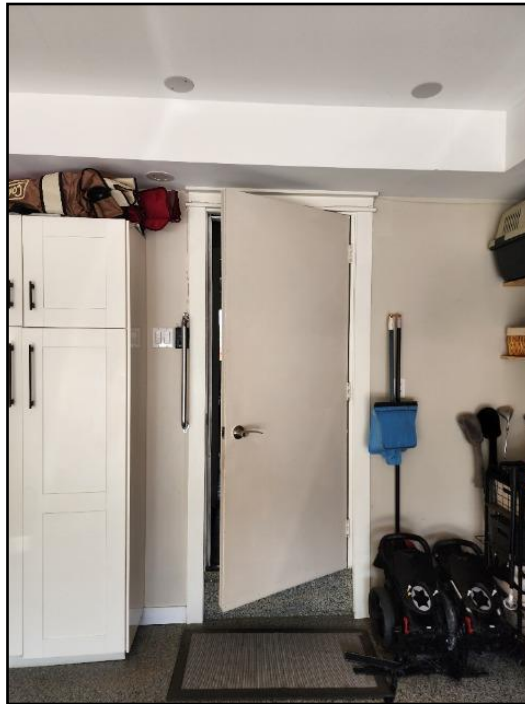
**17. Condition:** • Self closer missing, damaged or disconnected

**Implication(s):** Hazardous combustion products entering home

39. Self closer missing, damaged or disconnected
