5 POINT HOME INSPECTIONS

RESIDENTIAL INSPECTION

12935 Brigham Dr
Austin, TX 78732

PROPERTY INSPECTION REPORT FORM

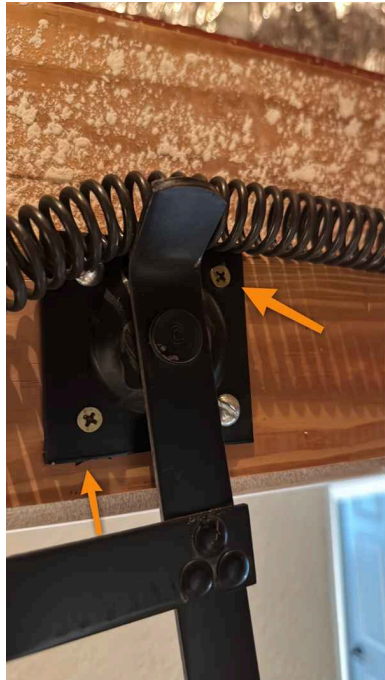
1: Attic Stairs Improperly Secured with Screws

Implication: Screws can loosen over time under the weight and movement of regular use, potentially compromising the structural attachment of the stairs. This can create a safety hazard due to the risk of detachment or collapse.

Priority: Moderate (Address to reduce risk of failure and improve safety).

Recommendation: I recommend evaluation and correction by a qualified contractor. Fasteners should be replaced with appropriate nails or lag bolts as specified by the attic stair manufacturer to ensure safe and secure installation.

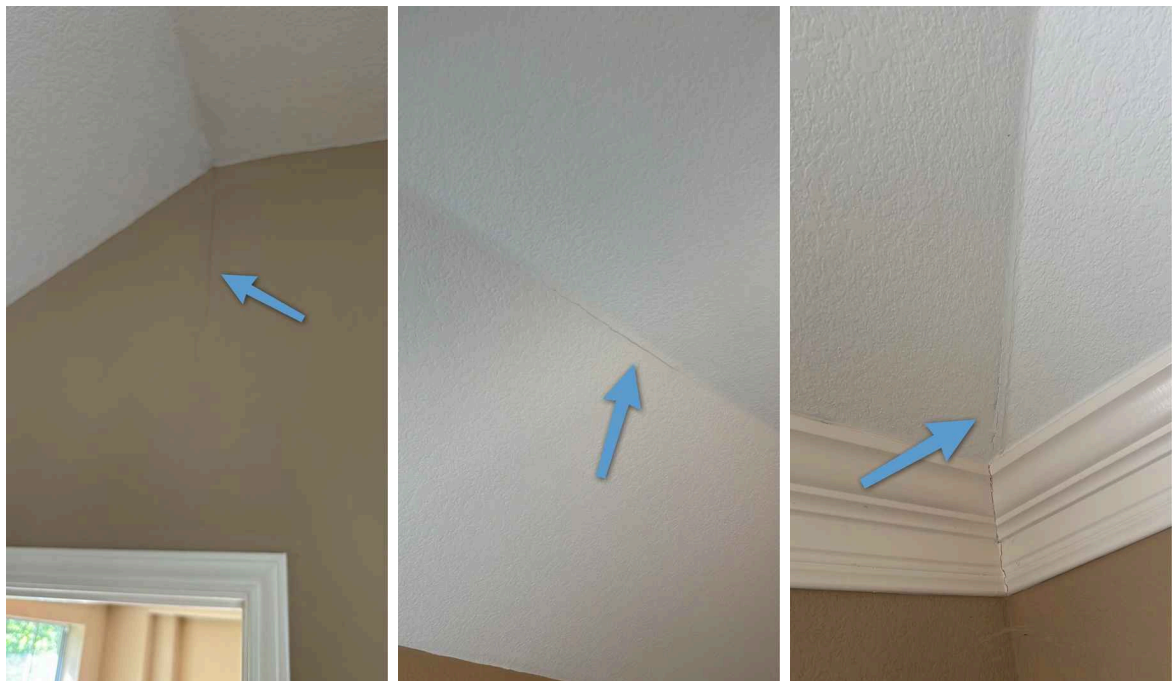
1: Common Wall Drywall Deficiencies

Common drywall defects were observed including cracks, loose joint tape, or nail pops. As homes settle over time, these defects may become visible. We recommend repairing these items to improve ascetics.

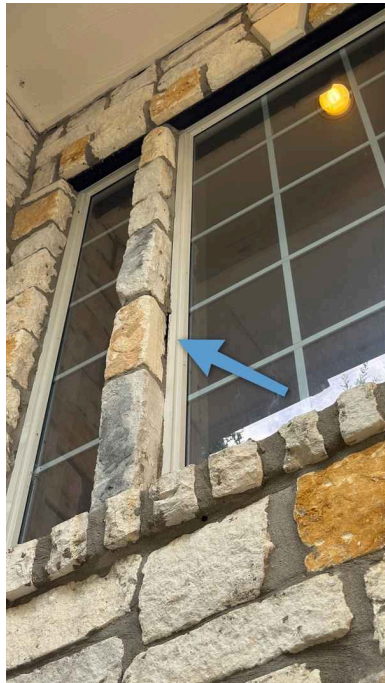
Above Front Door

Observation: Areas around the home were observed to require caulking to prevent moisture intrusion.

Implication: Lack of adequate caulking can allow moisture to enter the structure, potentially leading to water damage and deterioration of materials.

Priority: Low

Recommendation: It is recommended to identify and apply caulking to these areas to create a moisture barrier. Regular inspection and maintenance of the caulking will help ensure its effectiveness in protecting the structure.

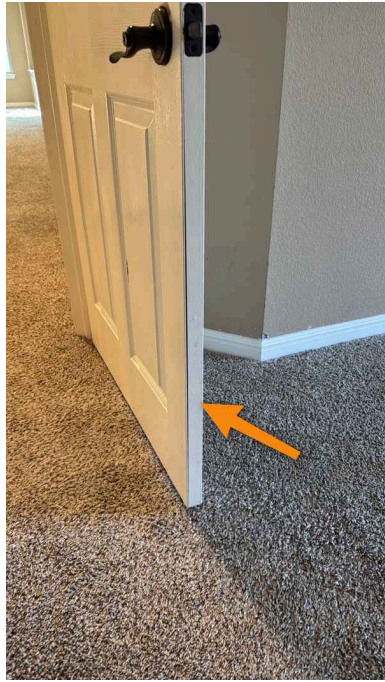
Primary Bedroom Door

1: Door Damaged

One or more doors exhibited damage. We recommend repairing or replacing the doors in the noted locations.

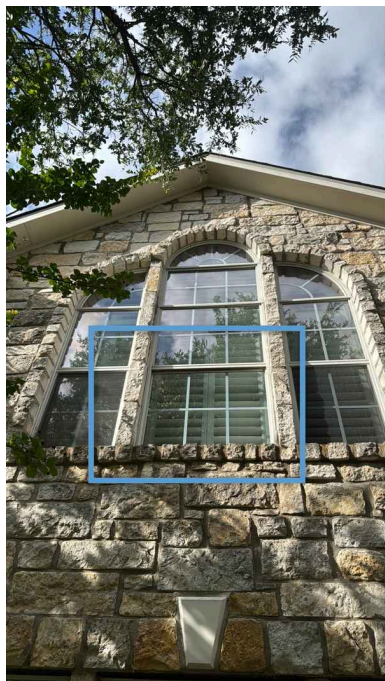
1: Window Missing Screen

One or more windows are missing a screen. Recommend replacement.

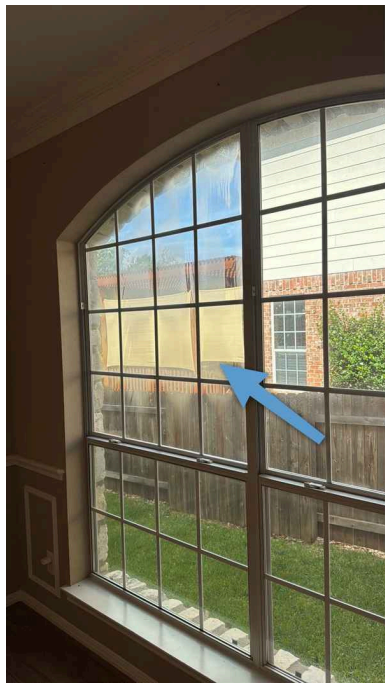
Dining Room

Implication: A failed window seal compromises the insulating properties of the window, reducing energy efficiency and obstructing visibility. Over time, it may also lead to further deterioration of the window unit.

Priority: Low to Moderate (Cosmetic and energy efficiency concern).

Recommendation: I recommend further evaluation and repair or replacement by a qualified window contractor. In many cases, the glass panes can be replaced without needing to replace the entire window frame.

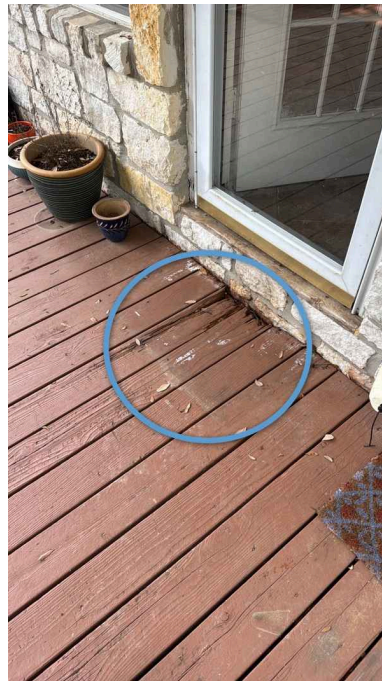
Back Door

Deck boards were observed to be bouncy. This could be due to deterioration or being over spanned. Recommend evaluation and repair as needed.

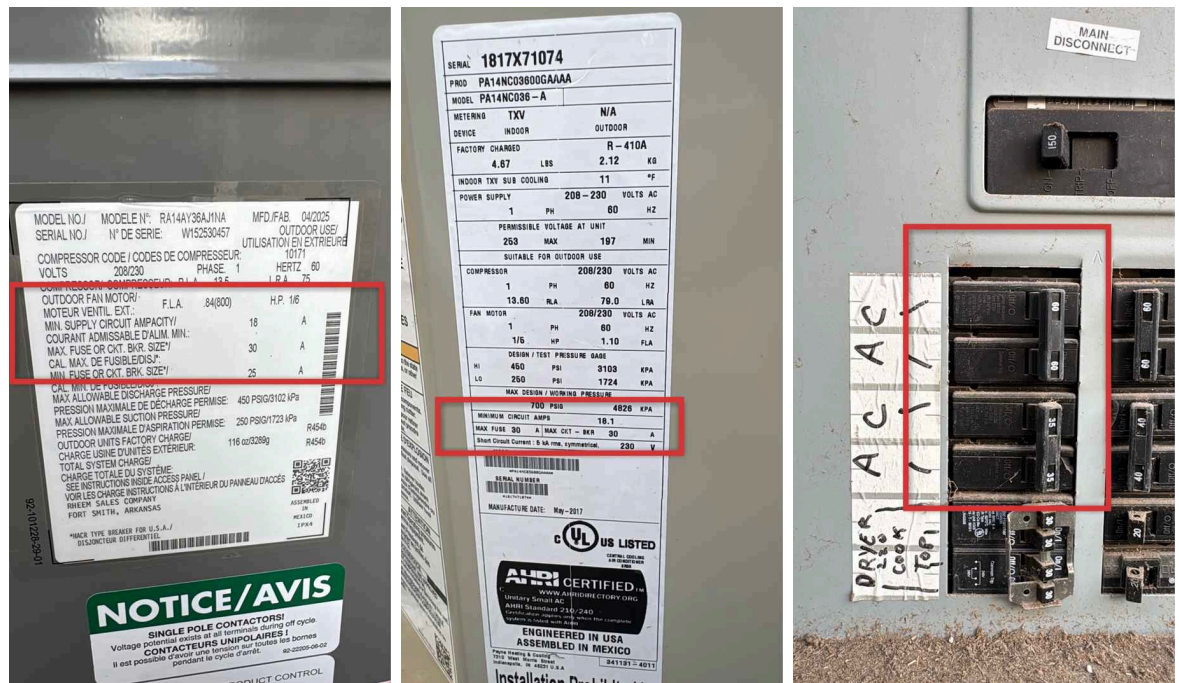
Implication: Using an incorrectly sized breaker can pose a risk of overloading or underpowering the HVAC unit, potentially leading to equipment failure or safety hazards.

Priority: High

Recommendation: Recommend consulting a licensed electrician to replace the breaker with the appropriate size as indicated on the data plate to ensure proper operation and safety.

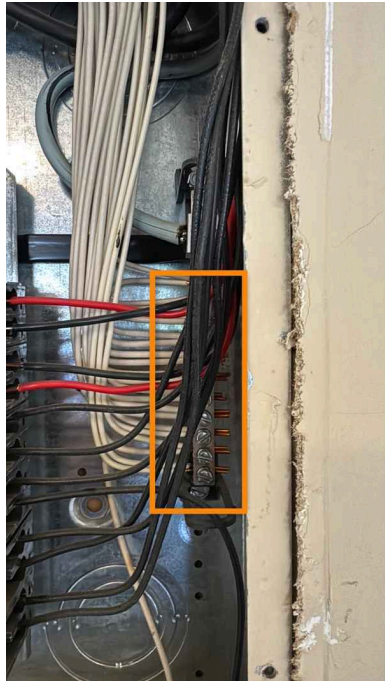
Sub Panel Garage

2: Double Tapped Neutrals

Observation: During the inspection, I observed that multiple neutral conductors were terminated under a single lug at the neutral bus bar inside the electrical panel.

Implication: Double-tapped neutrals are not permitted by most panel manufacturers and can create loose connections, increasing the risk of overheating, arcing, and potential fire hazards. Additionally, a loose neutral connection can cause voltage fluctuations that may damage electrical devices.

Priority: Moderate (Address promptly to reduce the risk of electrical hazards).

Recommendation: I recommend having a licensed electrician evaluate and correct the wiring by relocating each neutral conductor to its own dedicated terminal, as required by electrical safety standards. If additional neutral bus terminals are needed, an approved expansion kit or sub-panel may be necessary.

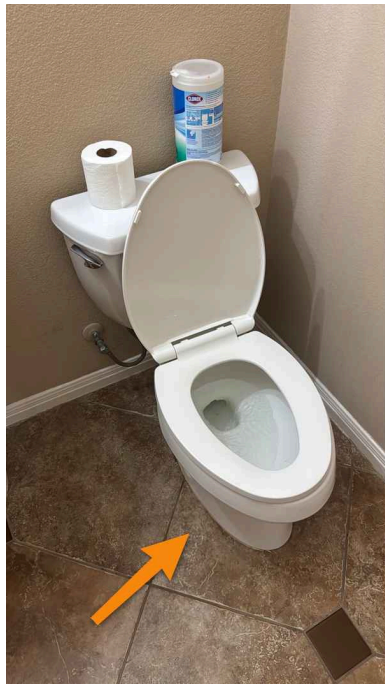
Downstairs Hallway Bathroom

1: Toilet Loose At Floor

During the inspection, I observed that the toilet in one or more bathrooms was loose at the floor.

Implication: A loose toilet can lead to instability, potential water leaks around the base, and damage to the flooring or subfloor. Proper attachment is necessary to ensure a secure and watertight seal.

Priority: Moderate (Address soon to prevent further issues and ensure proper function).

Recommendation: I recommend that a qualified plumbing contractor re-attach the loose toilet to the floor to restore stability and prevent potential water damage. This repair will ensure the toilet functions properly and maintains its seal.

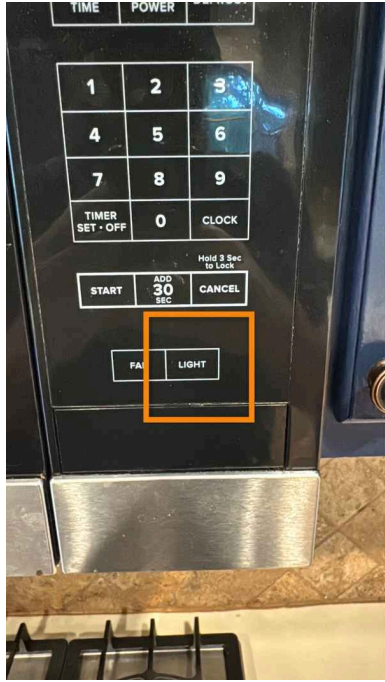
The light on the microwave was not functioning at the time of inspection. This may be a bulb or a loose connection. Recommend further evaluation from a qualified professional.
