RESIDENTIAL INSPECTION

3700 Clawson Rd 401 Austin, TX 78704

Jaret Kanarek	03/18/2024 2:00 pm
Name of Client	Date of Inspection
3700 Clawson Rd 401, Austin, TX 78704	
Address of Inspected Property	
Chris Walsh	25159
Name of Inspector	TREC License #
Name of Sponsor (if applicable)	TREC License #

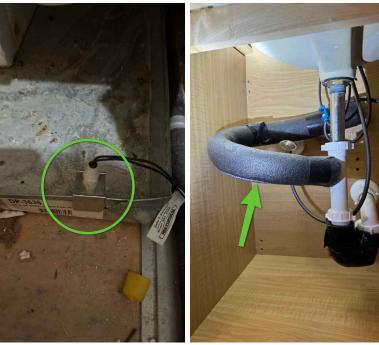
Float Switch Attic Pan

Primary Condensate Drain Primary Bathroom Sink
