5 POINT HOME INSPECTIONS 512-429-1091 cwalsh@5pointinspections.com https://5pointinspections.com

RESIDENTIAL INSPECTION

12935 Brigham Dr Austin, TX 78732

Jackie Hickithier	04/15/2024 9:00 am
Name of Client	Date of Inspection
12935 Brigham Dr, Austin, TX 78732	
Address of Inspected Property	
Chris Walsh	25159
Name of Inspector	TREC License #
Name of Sponsor (if applicable)	TREC License #

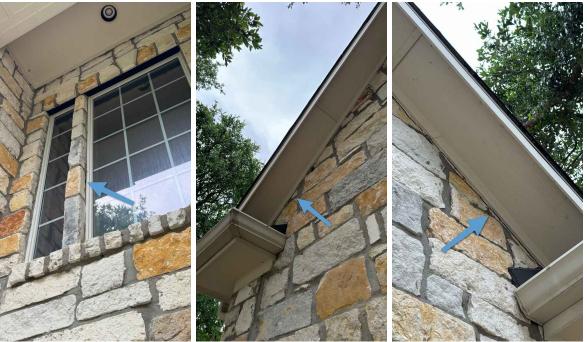
Above Front Door

Areas around the home that require caulking to prevent moisture intrusion. It is recommended to identify these areas and apply caulking to them as soon as possible. This will help to create a barrier against moisture and ultimately protect the structure of the home. It is important to regularly inspect and maintain the caulking to ensure it remains effective in preventing moisture intrusion.

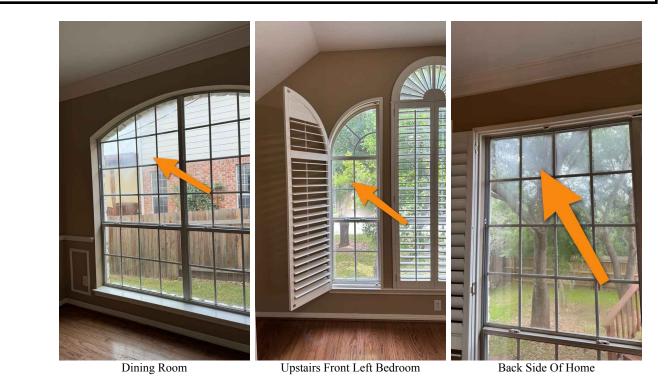
3: Window Weatherstrip Loose ✤Recommendation

The weather strip on of the referenced window(s) was loose. Repair recommended.

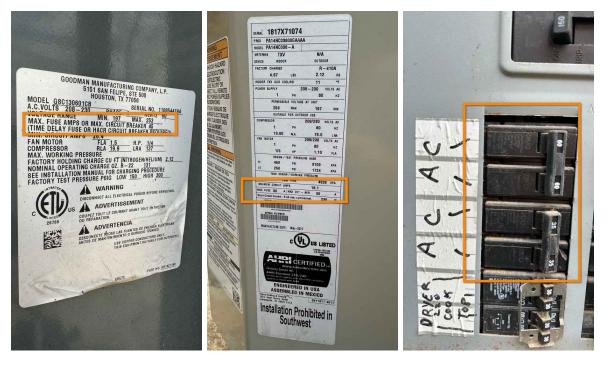
The breaker that supplies the HVAC Condenser was not the correct size as required by the data plate on the exterior condenser. Mismatched electrical components may affect performance or damage the HVAC equipment and potentially void any warranties. The HVAC equipment electrical connections should be further evaluated and repaired/replaced as needed by a licensed electrician.

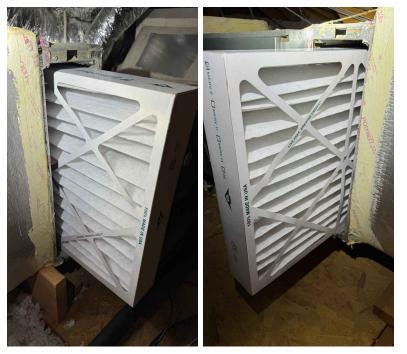
1: Plenum Not Fully Sealed Deficiencies

At the air handler, unsealed openings in the cabinet enclosing the evaporator coils will reduce system efficiency. The inspector recommends that any such openings be sealed by a qualified HVAC contractor.
