# **Inspection Report**

# **G2** Home Inspections

Property Address 1824 W 28th Ave Kennewick Wa

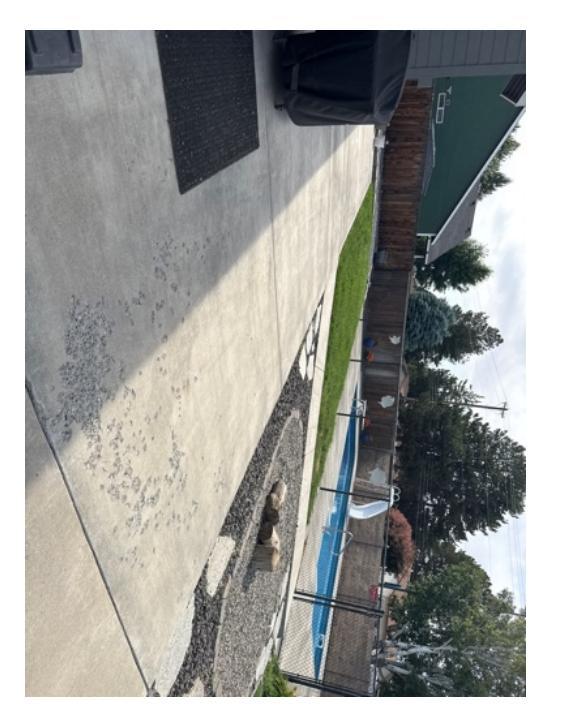
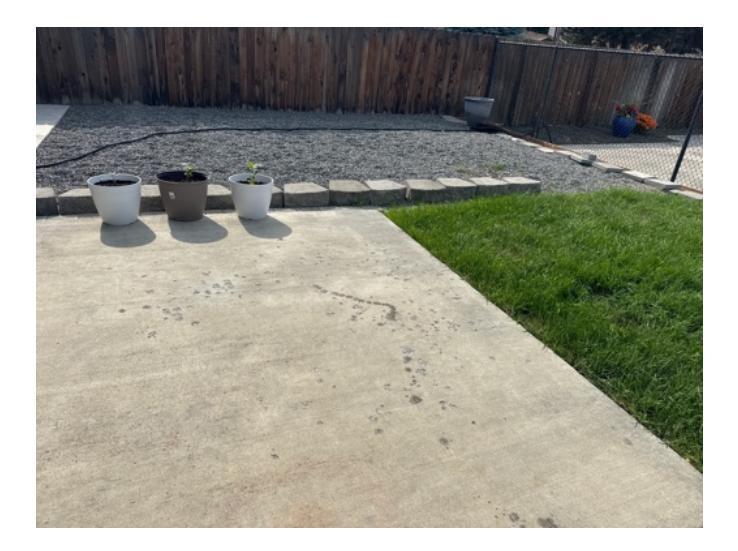
#### 1.3) Sidewalk Conditions

There were common cracks and areas of minor surface deterioration observed at the back patio area.

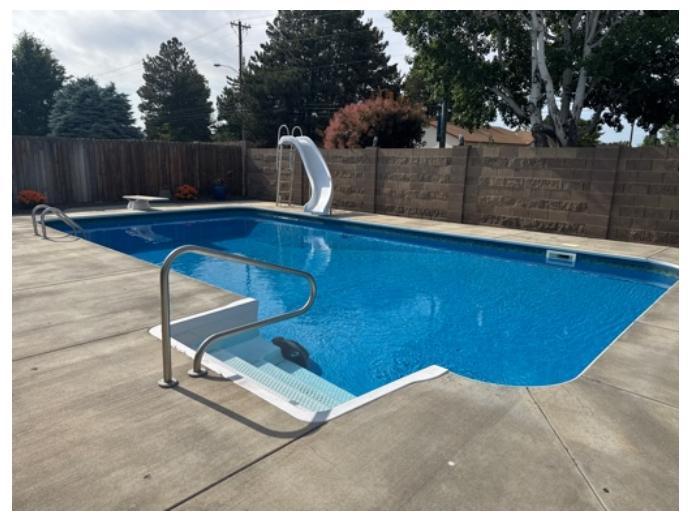
### 1.4) Pool

There was evidence of moisture exposure and damage observed at the wall, sheathing and framing components below the window windows at the south wall of the pool house. Recommend further evaluation and repair by a qualified contractor.

The weatherstripping at the exterior door to the pool house was damaged. Recommend repair.

There were cracks and minor surface deterioration observed at the concrete pool deck. Recommend monitoring condition and repair as needed.

There was a damaged blank cover at an exterior junction box at the pool house. Recommend replacing cover.

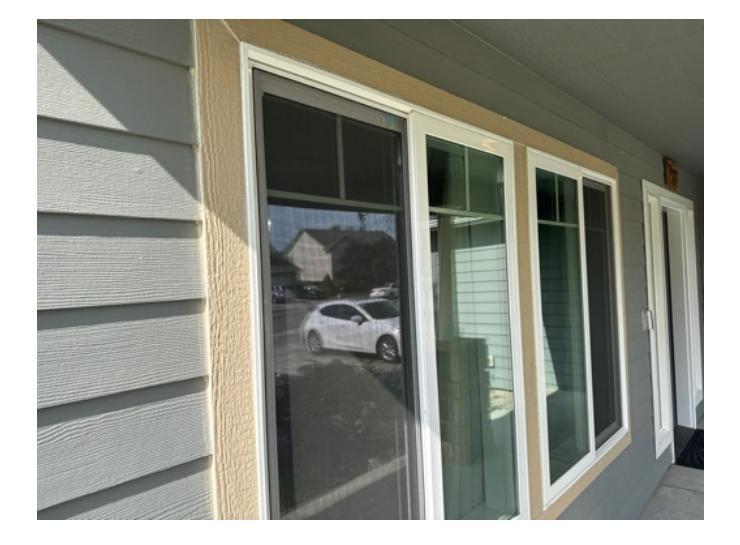
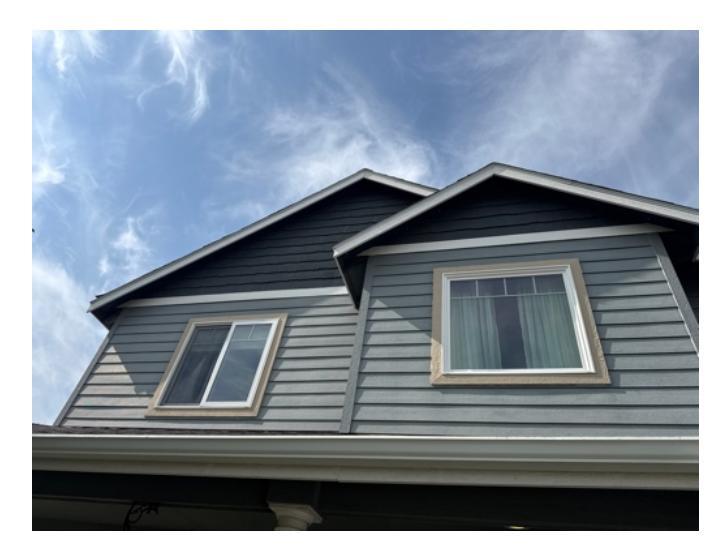
2.1) Exterior Wall Conditions

The trim around the exterior windows was unpainted. Recommend painting trim.

The mortar at the stone front pillars was slightly cracking. Recommend maintenance and repair as needed.

there were cracks at the stone at the front of the garage and some of the stone at the east side of the front of the garage appeared to be slightly loose. Recommend maintenance and repair.

The exterior paint at the trim around the garage doors was slightly weathered at the top piece of trim. Recommend maintenance as needed.

There was an area of peeling paint observed behind the fence at the east side of the home. Recommend maintenance/repainting.

There was an area of peeling paint at the siding below the vent for the furnace at the north side of the home. This exhaust does contain some moisture and may need periodic maintenance at this area.

The caulk at the siding joints was cracking. Recommend caulking as needed.

The paint at the exterior trim and facia boards was slightly weathered in some areas. Recommend repainting as needed.

The paint at the west exterior wall is slightly weathered. Recommend repainting as needed.

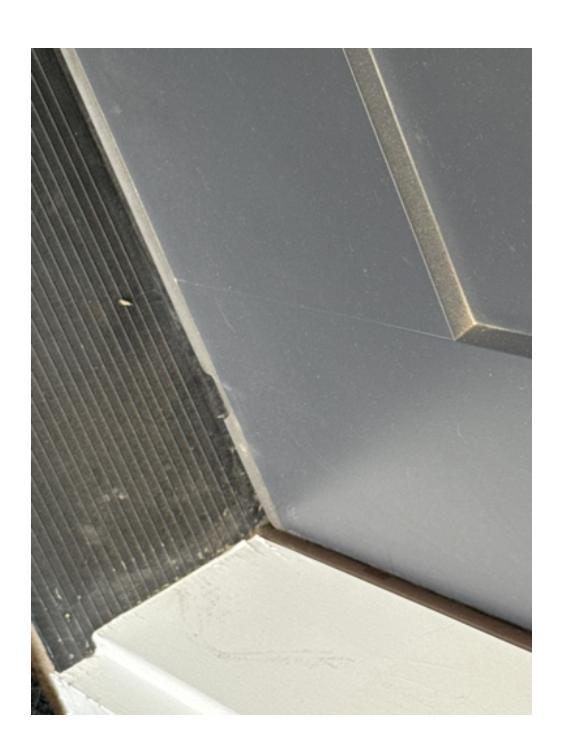
## 2.3) Exterior Door Conditions

The weatherstripping at the bottom of the front exterior door was slightly damaged. Recommend replacement.

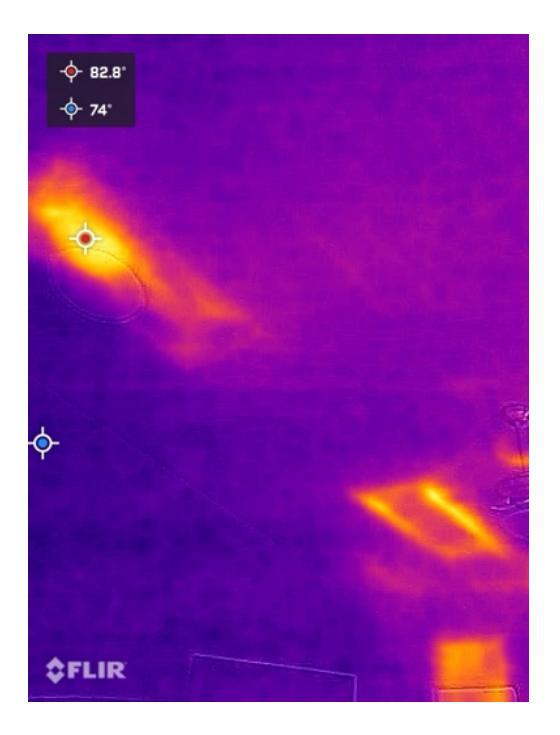
| Attic Ventilation Type | Ridge Vents.Soffit vents. |
|---|--|
| 3.5) Attic Insulation Condition | ns R |

When scanned with a thermal imaging camera, it appears that the insulation does not have as much coverage in the areas in the upstairs living room that have had large skylights removed. Recommend adding insulation at these areas.

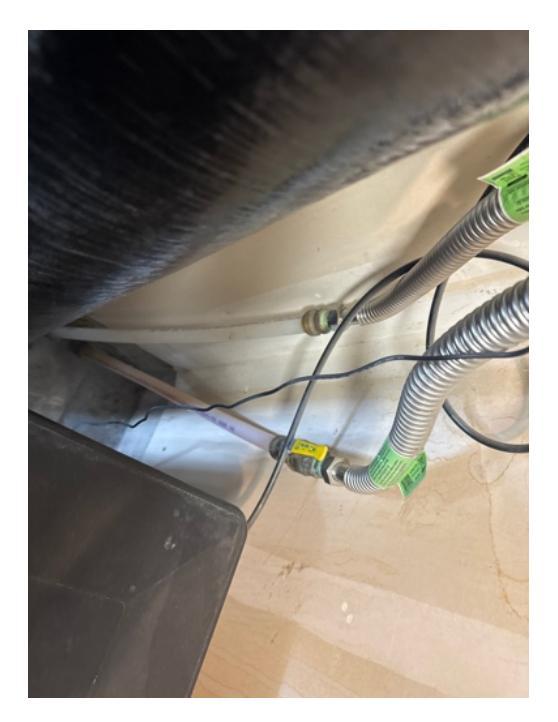
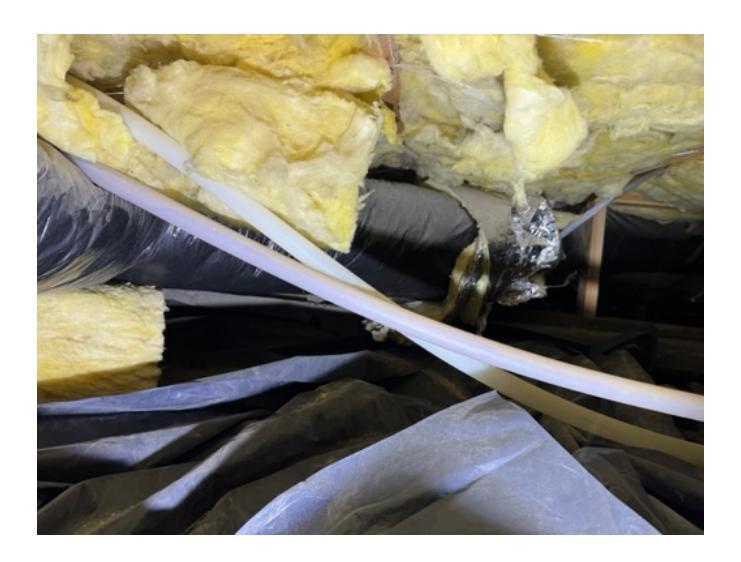
6.1) Main Line & Valve Conditions

It would be recommended to install insulation at the waterlines from the water softener in the garage to their connection to the main line in the crawlspace to prevent freezing.

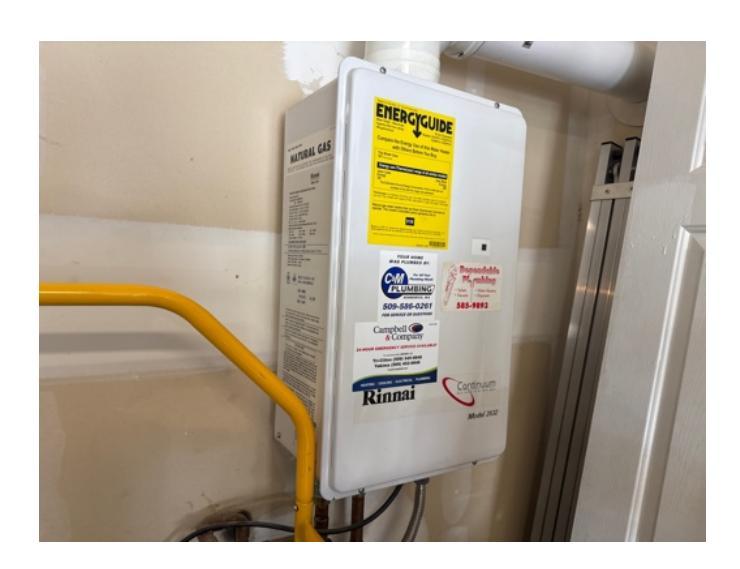
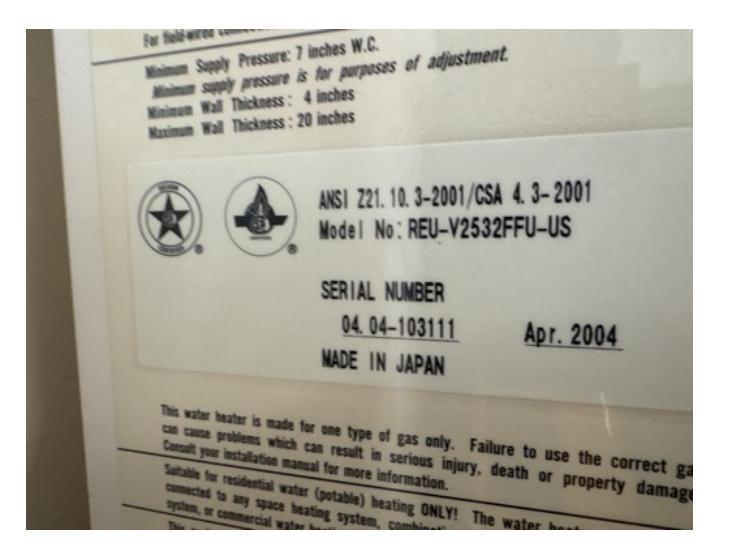
6.4) Water Heater Conditions

The water heater was manufactured in 2004 and maybe nearing the end of its expected lifespan. Recommend monitoring condition.

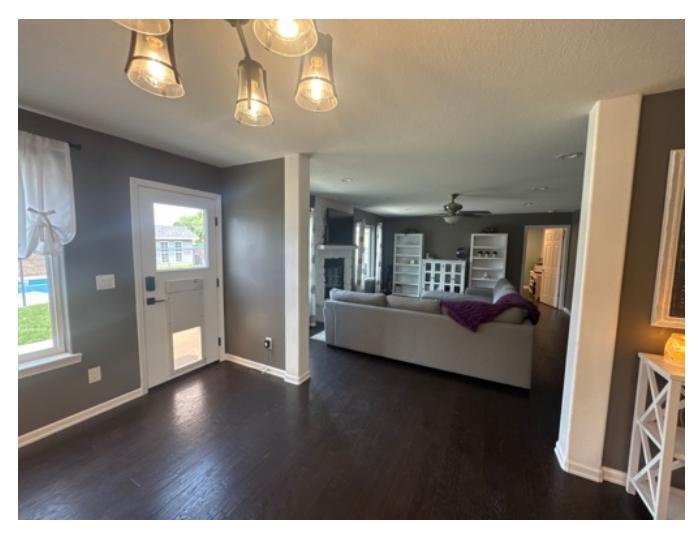
### 7.1) Wall Conditions

There were small cosmetic imperfections observed at the interior walls and trim. Recommend touchup/minor repairs as needed.

There were small partially finished drywall repair repairs at the back wall in the laundry area. Recommend repair as needed/desire.

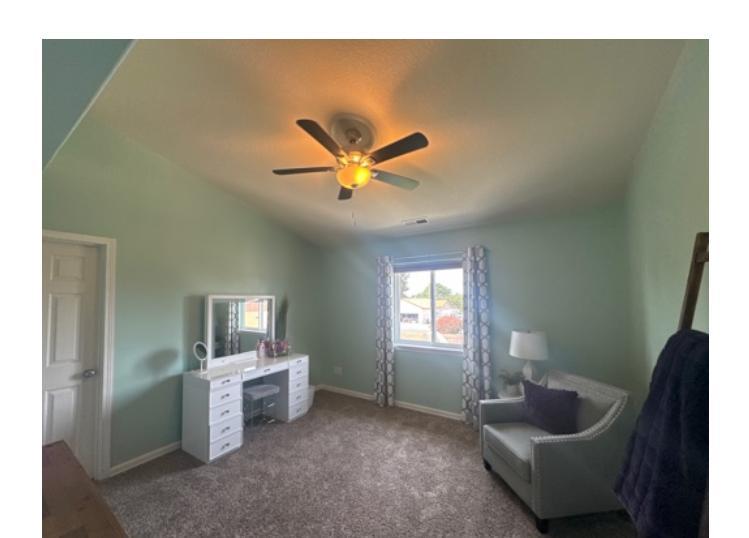
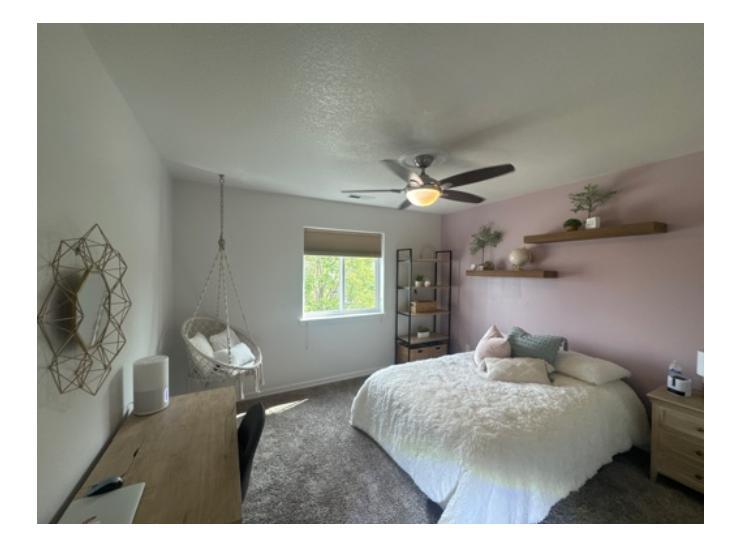
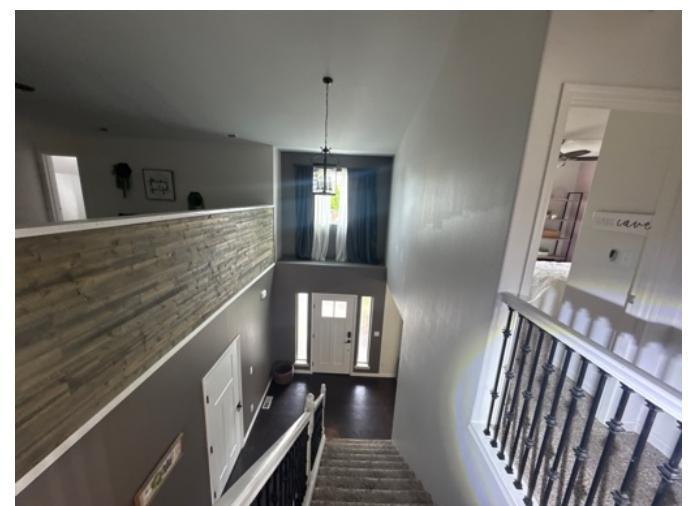
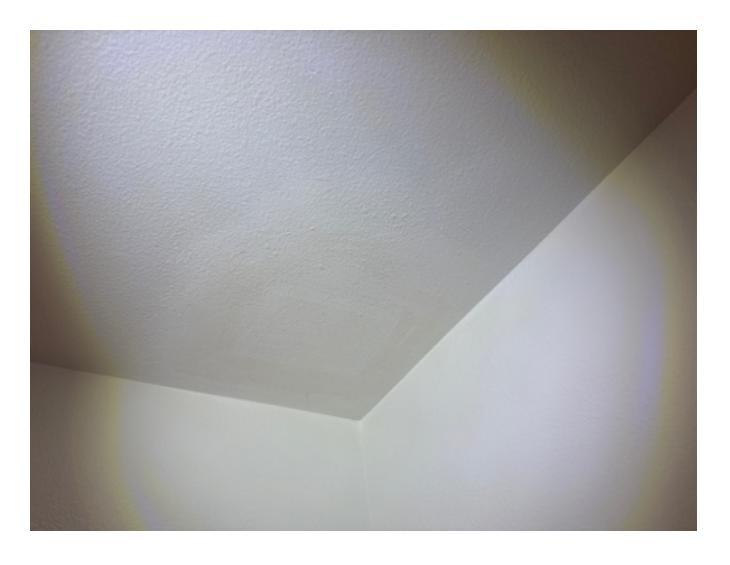
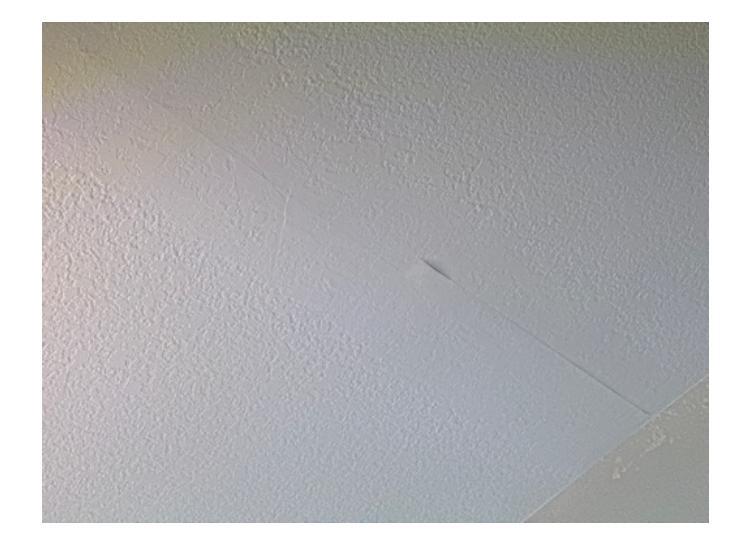
A drywall seam at the master bedroom ceiling appears to have been repaired, and the tape line has slightly cracked against the back wall. Recommend repair.

There were areas of drywall repair observed at the Ceilings in several areas around the home

including the powder room, ceiling, and upstairs living area ceilings. Recommend asking seller why these repairs were made.

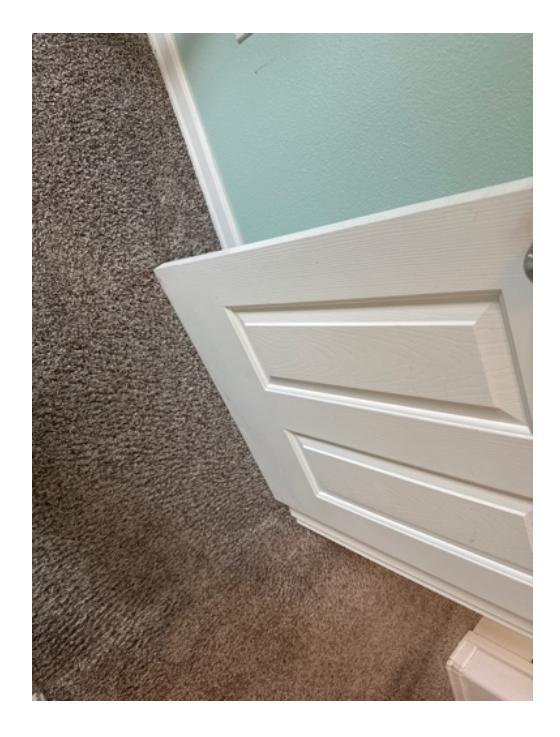
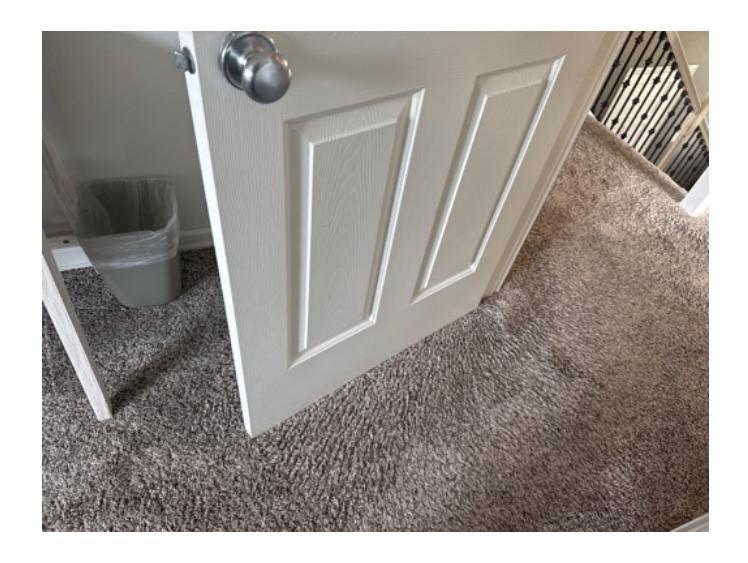
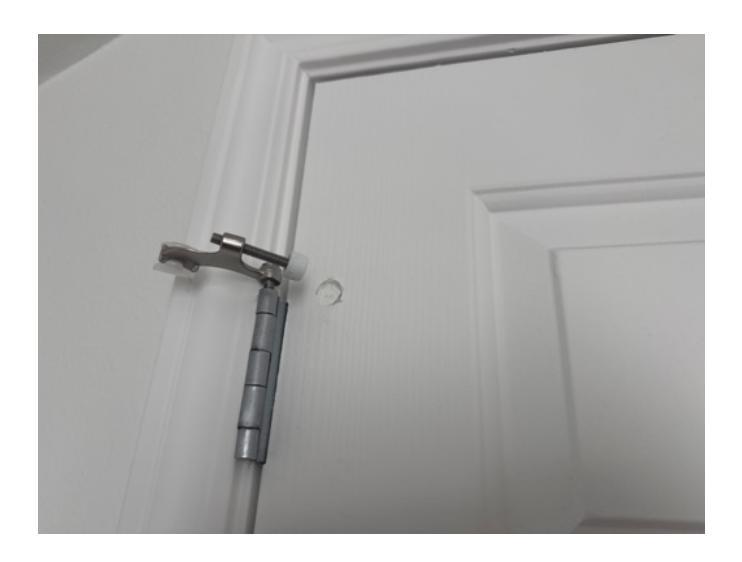
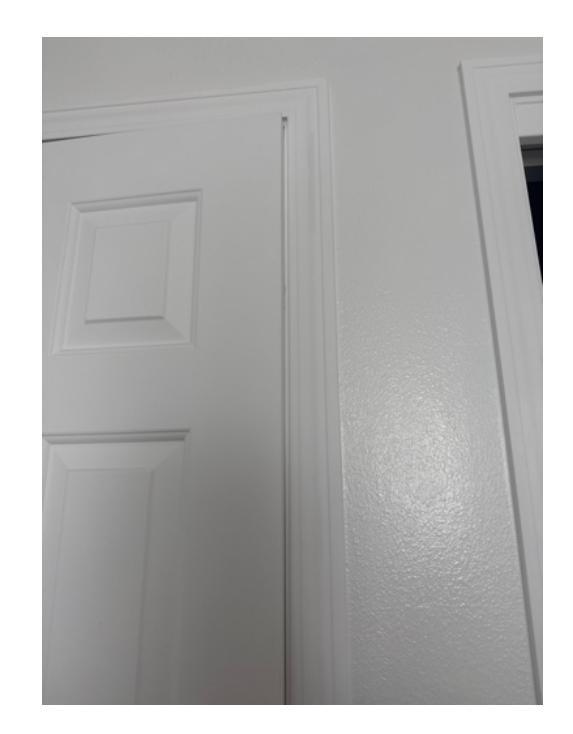
7.5) Interior Door Conditions

Several of the bedroom doors in the upstairs level of the home drag on the carpet. Recommend Adjustment

There was damage at the interior side of the small bonus room door where the doorstop is installed. Recommend repair or replacement of door as needed/desired.

The door to the small bonus room at the upper level of the home was slightly out of adjustment Making the door difficult to close. Recommend adjustment/repair.

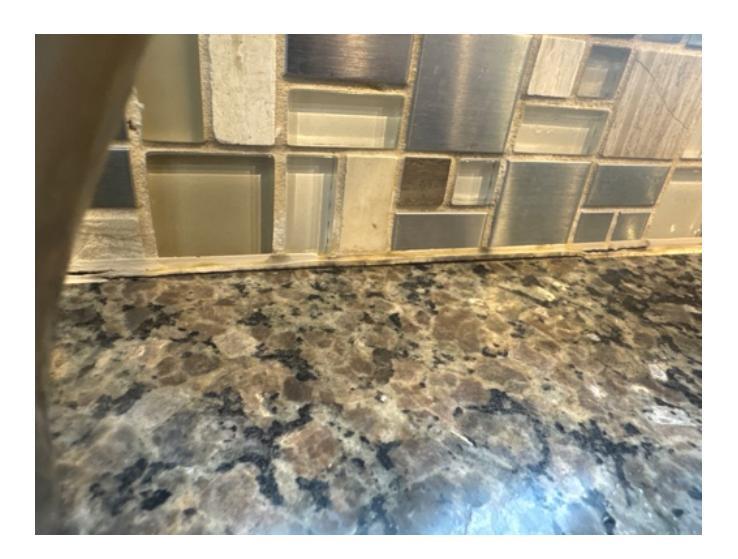
#### 8.1) Counter Conditions

The caulk was cracked at the backsplash behind the kitchen sink. Recommend recaulking

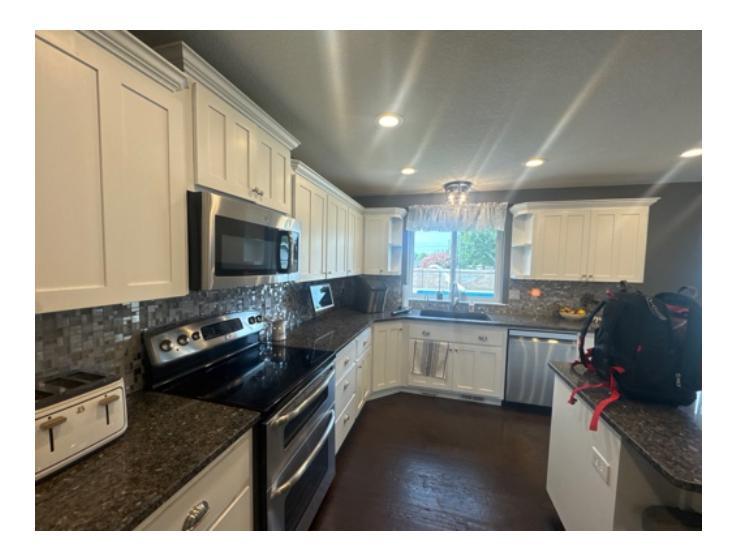
### 8.2) Cabinet Conditions

several of the lower kitchen cabinet doors were slightly loose. Recommend tightening hardware.

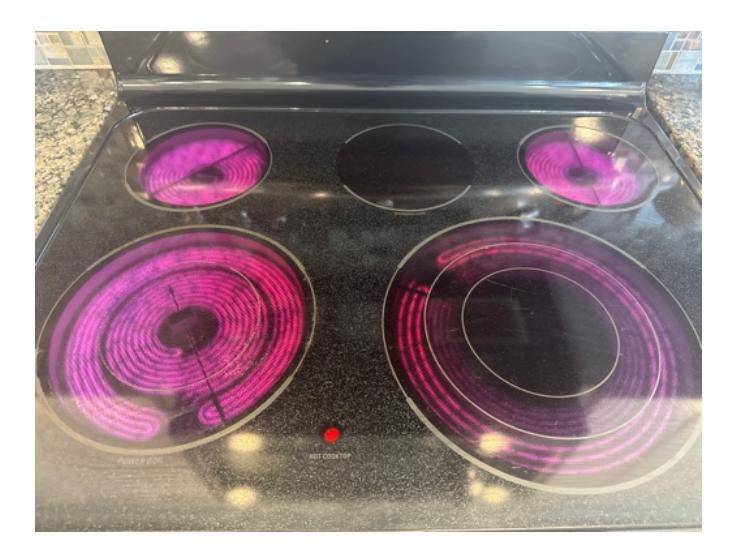
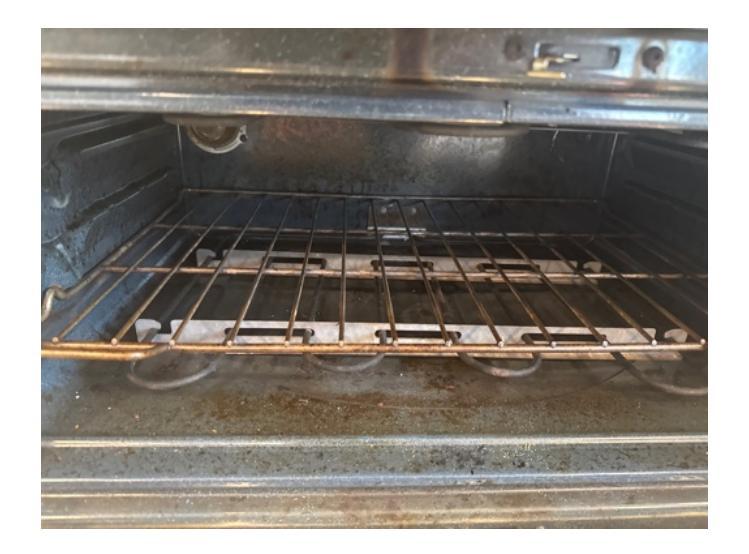
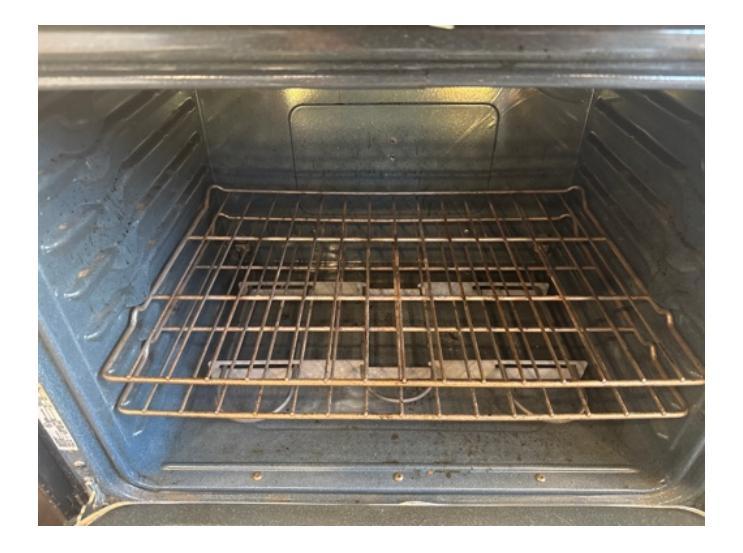
8.5) Stove - Range Condition

The middle portion of the front right burner at the kitchen stove did not operate. Recommend repair.

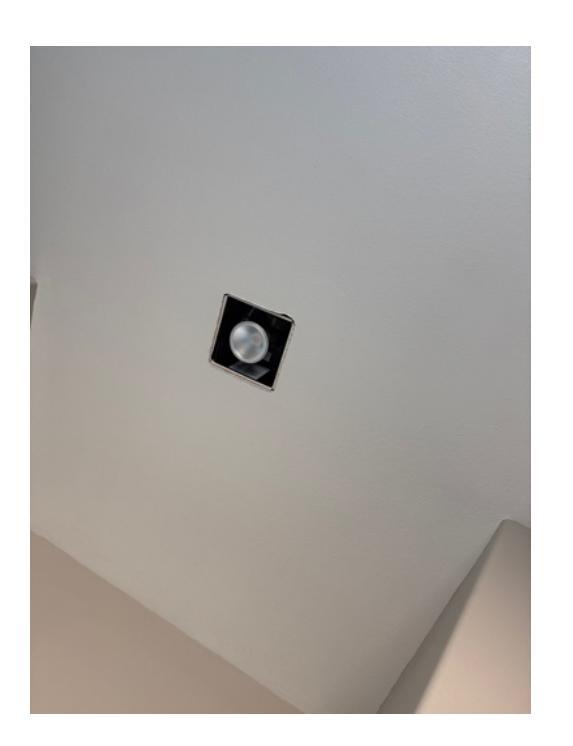
The cover was missing at the master bathroom exhaust fan. Recommended installing cover.

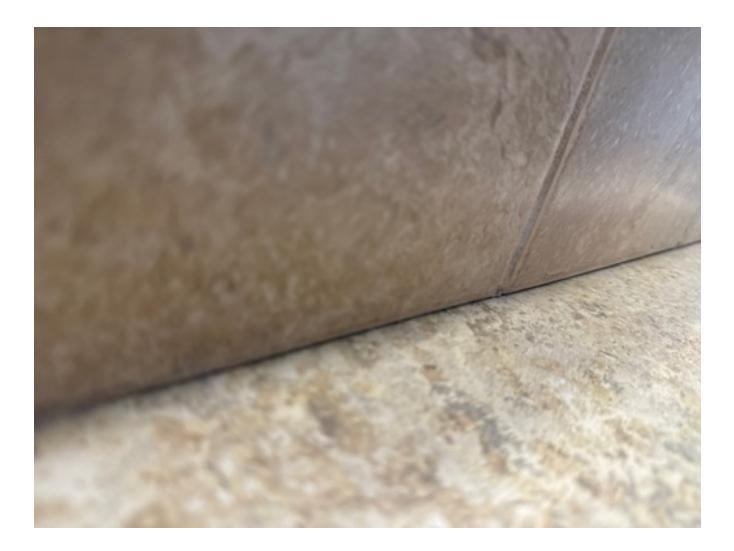
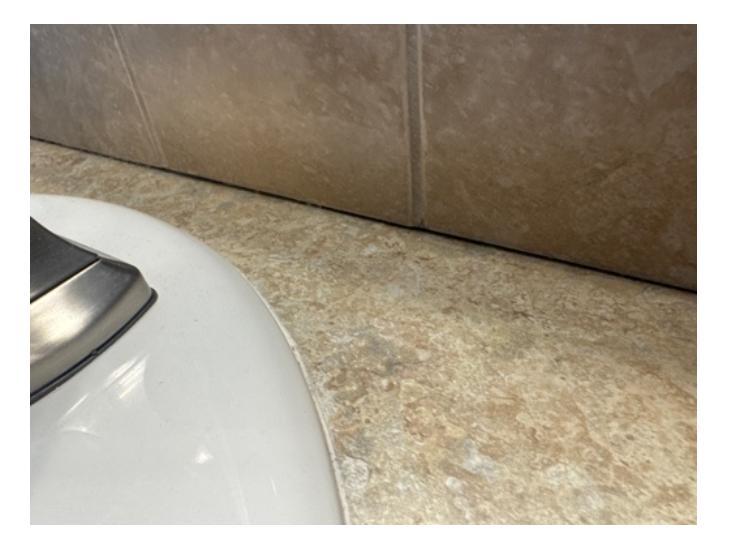
9.4) Counter - Cabinet Conditions

Recommend recaulking at the backsplash at the master bathroom vanity countertops.

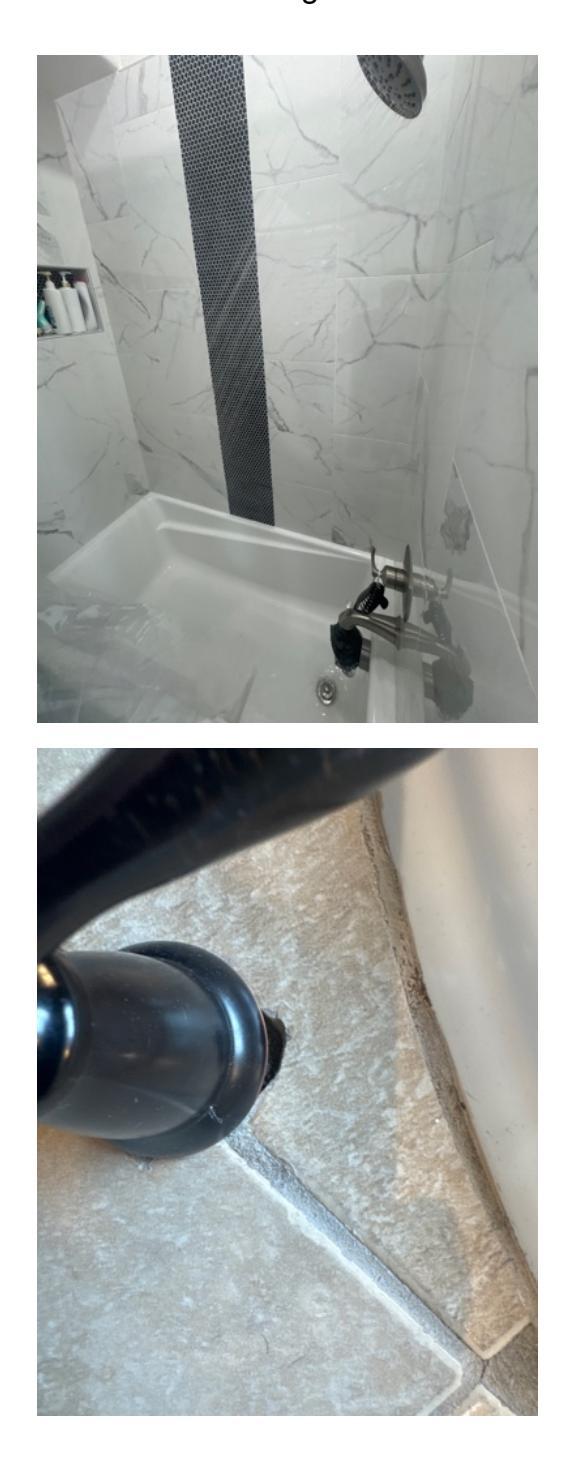
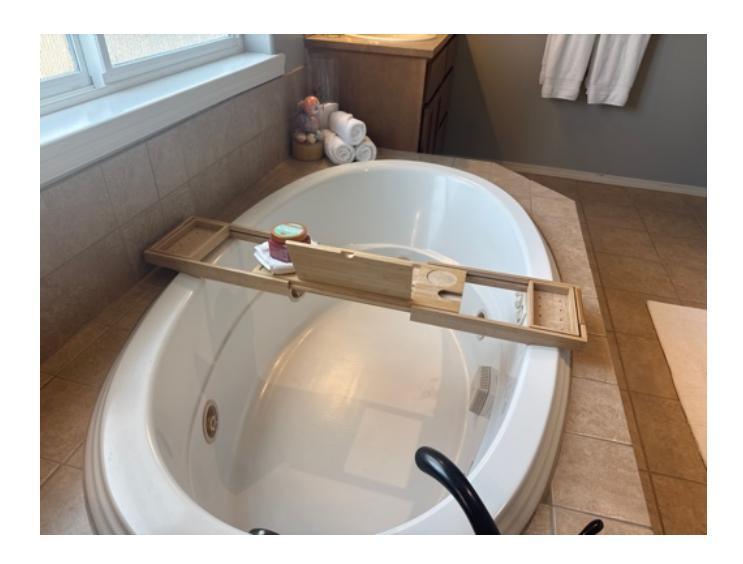
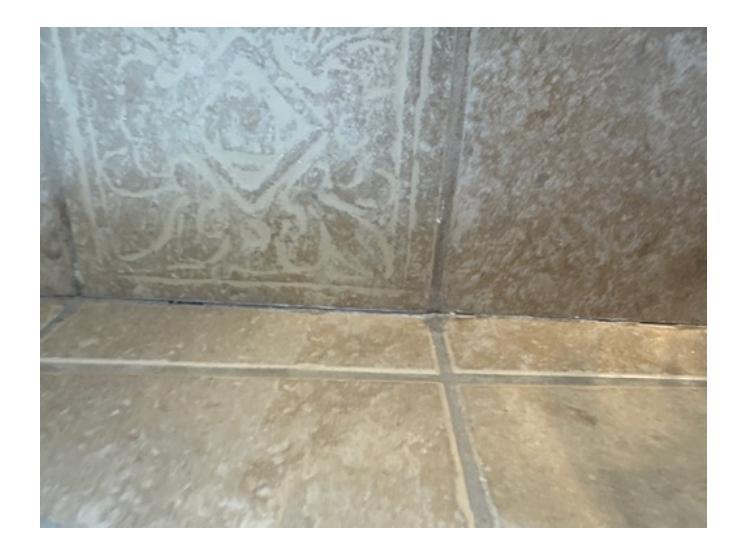
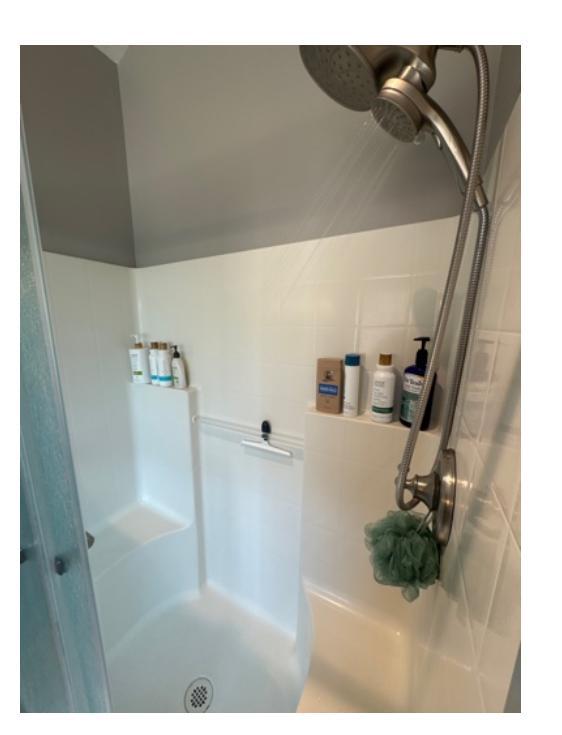
9.6) Shower - Tub Conditions

There was a small gap at the tile around the hot water valve for the master bath bathtub. Recommend sealing this gap.

Recommend re-caulking at the tile behind the master bathtub.

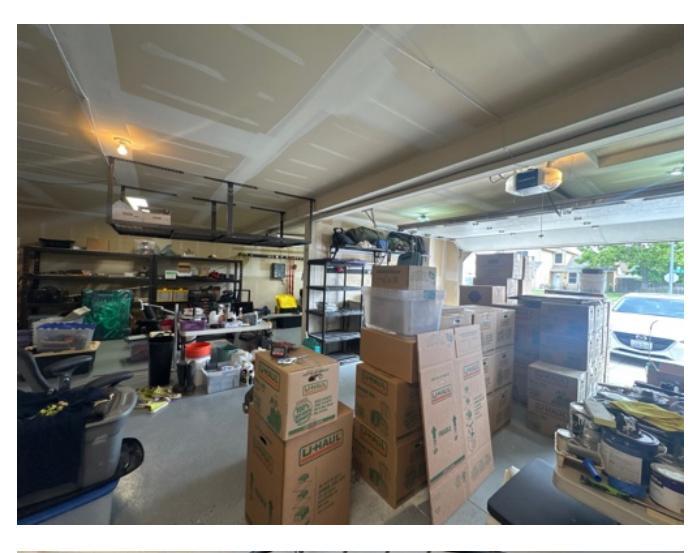
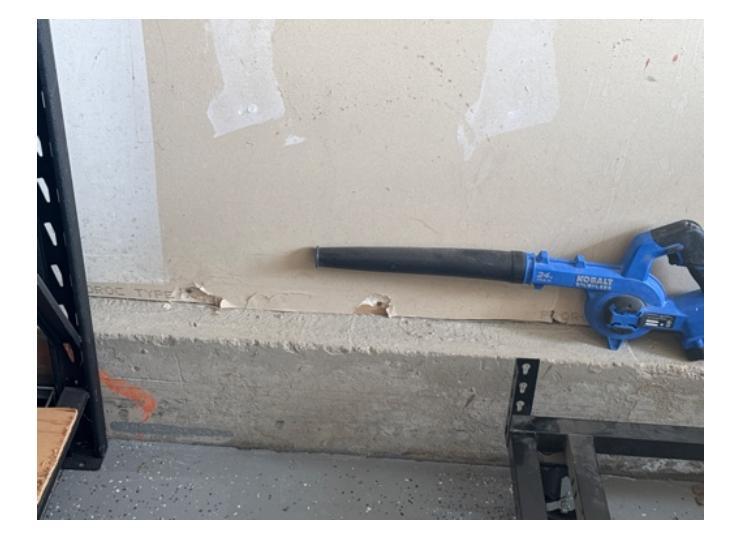
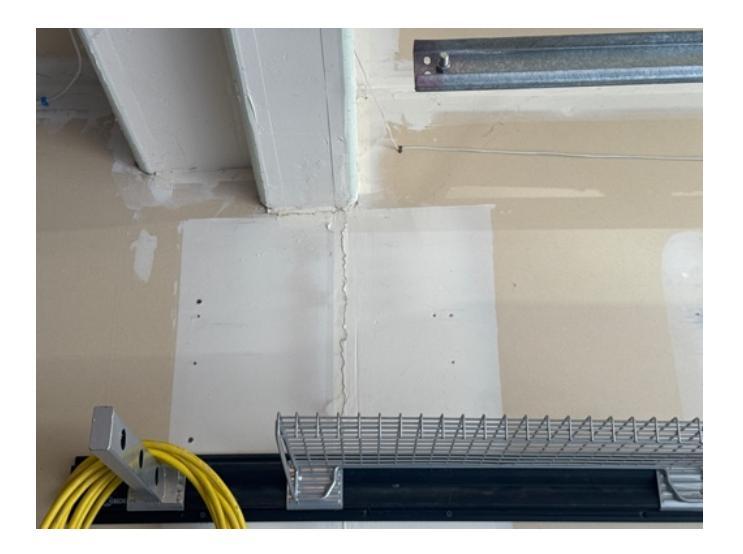
10.1) Wall Conditions

There were common drywall cracks in areas of minor damage, observed at the interior walls of the garage. Recommend maintenance and repair as needed. There were no immediate concerns observed at the time of inspection.

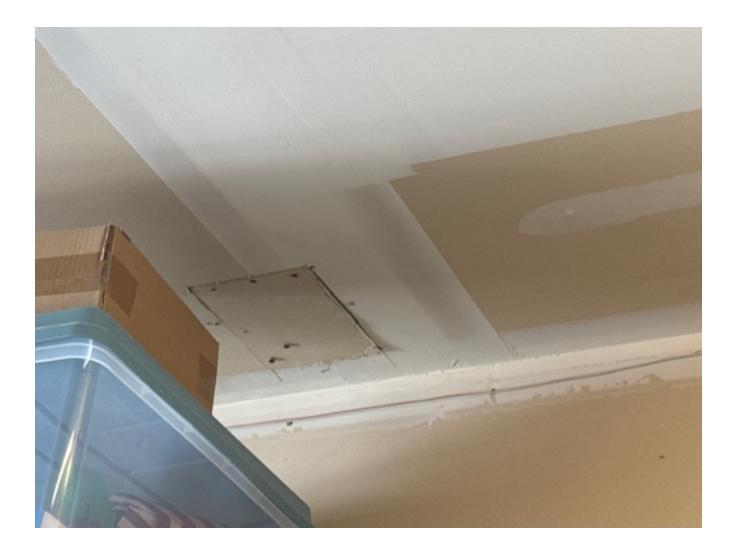
10.2) Ceiling Conditions

There was a small square of drywall that had been cut out and reinstalled at the garage ceiling near the door into the home. Recommend fire taping this drywall patch.

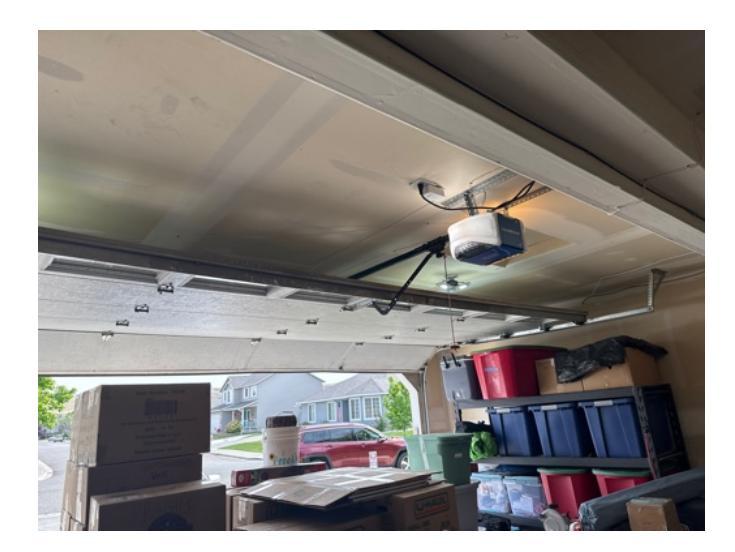
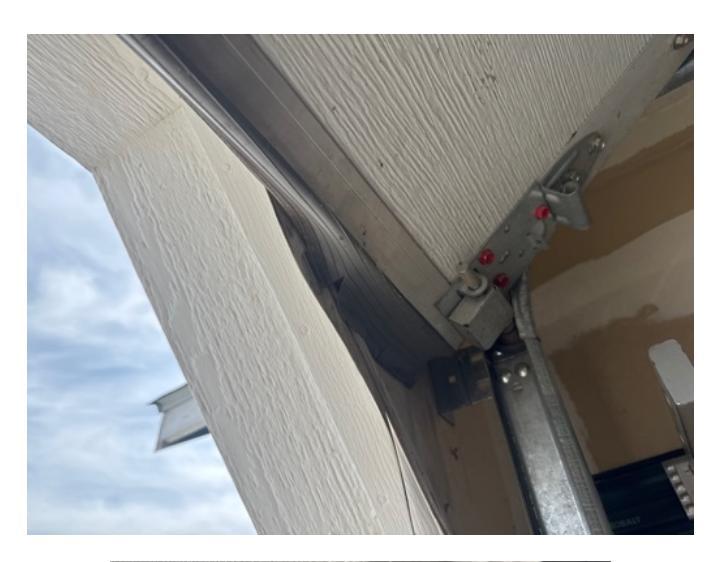
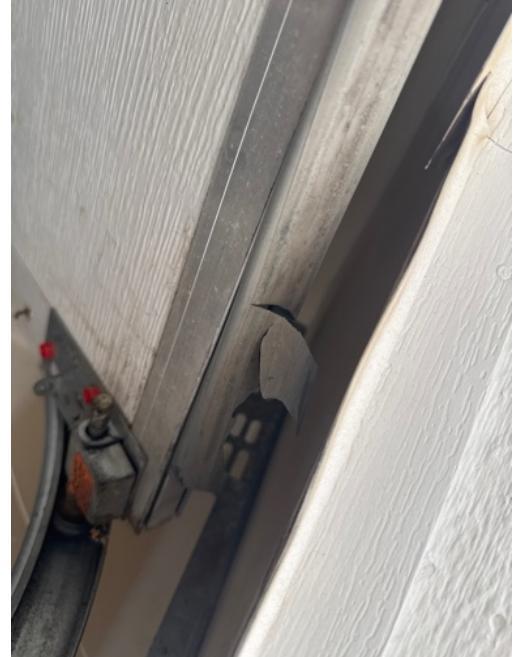
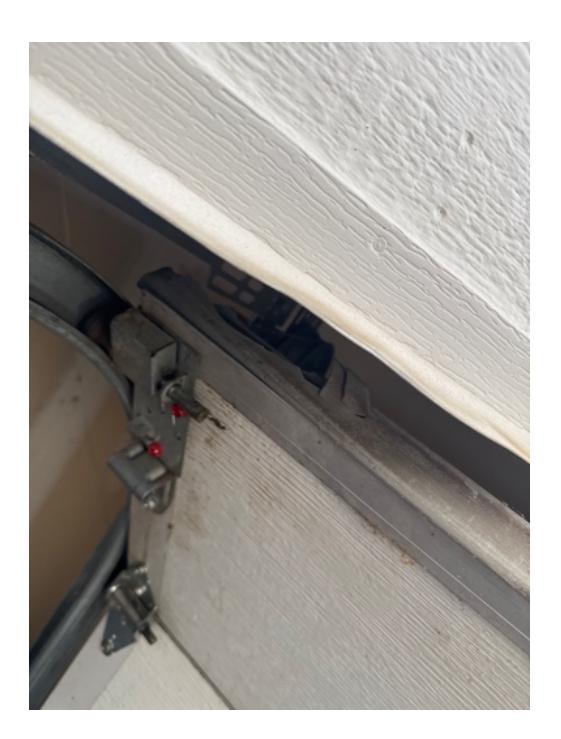
#### 10.5) Vehicle Door Conditions

The weatherstripping at the bottom of the garage door was slightly damaged at the corners. It

appears that the weatherstripping rubs on the door frame when the door is fully opened. Recommend repair as needed.

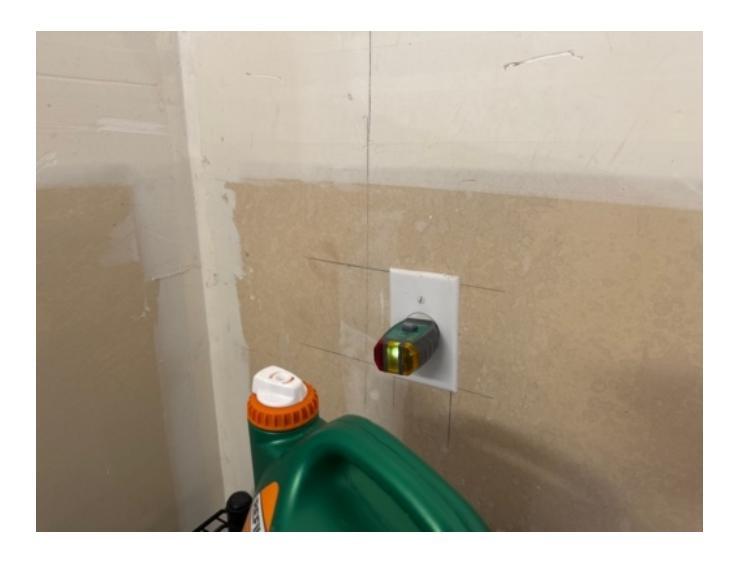
**10.6) Electrical Conditions**

Some of the receptacles in the garage are not GFCI protected. This is common for the age of the home. Current codes require all receptacles in garages to be GFCI protected. Recommend consulting with a qualified electrician to install GFCI protection for unprotected outlets.

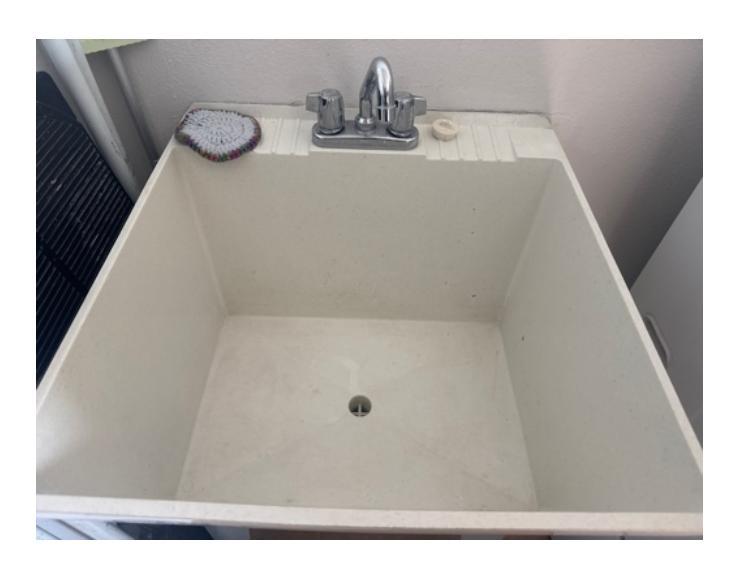
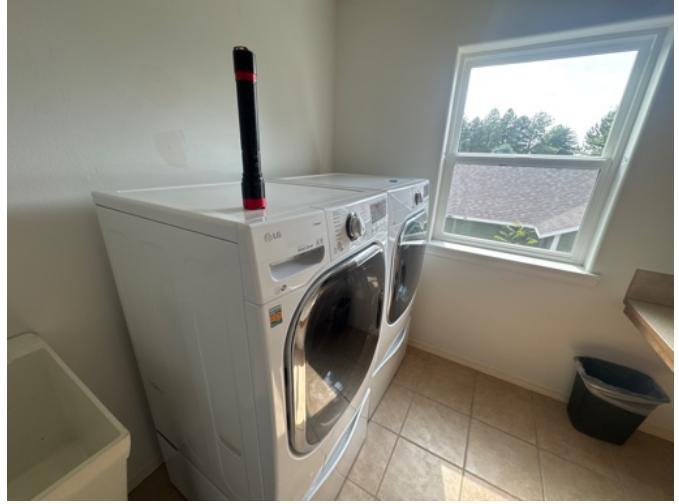
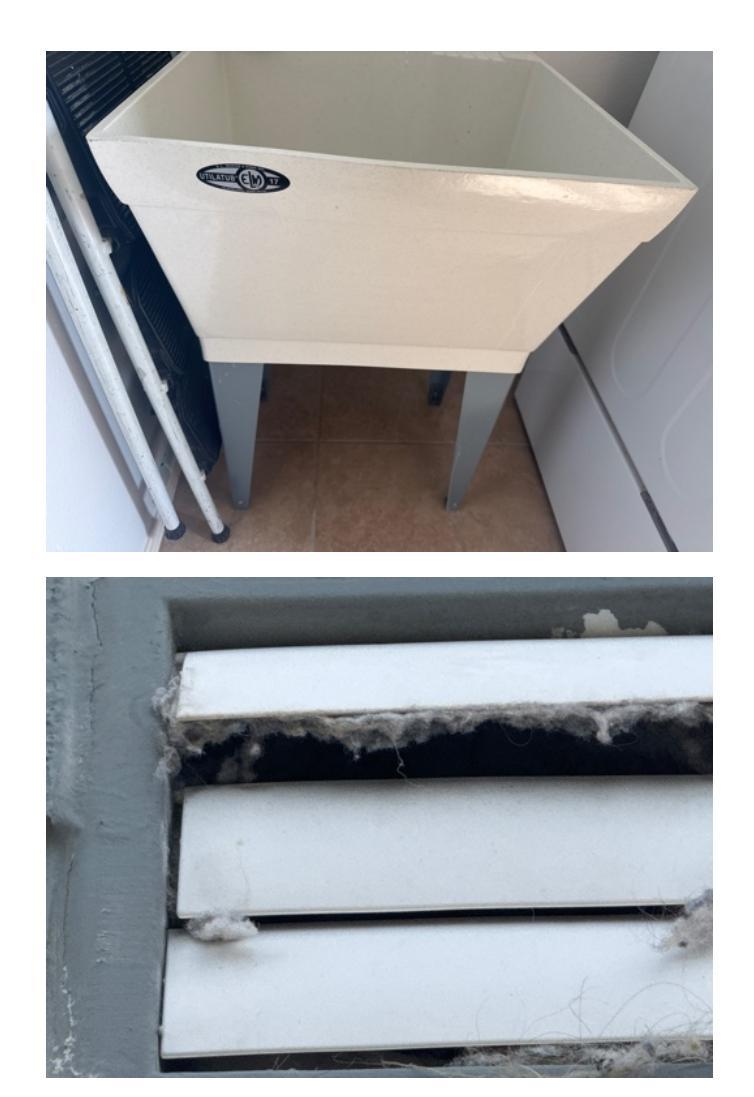
## 10.8) Laundry Room Conditions

The laundry room sink was not securely fastened in place. Recommend repair.

Recommend cleaning dryer vent as an accumulation of lint can be a fire hazard.
