-Level I Tree, Soil, and Vegetation Protection Plan-

Matthew Solomon Property

1511 Fairview St. SE
Olympia WA 98510

Date: December 15, 2017

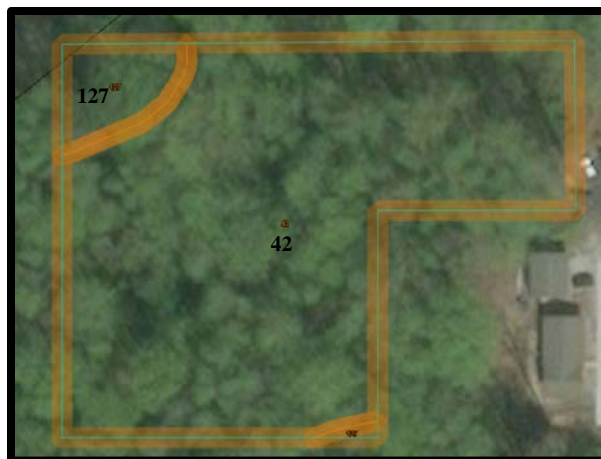
42 – Grove very gravelly sandy loam: 93%
127 – Yelm fine sandy loam: 7%

The predominant soil type is the Grove very gravelly sandy loam. It is a very deep, somewhat excessively drained soil found on outwash plains. It formed in glacial outwash. Permeability is rapid. Plant available water capacity is low. The effective rooting depth is 60 inches or more and the hazard of runoff and erosion is slight. The potential for windthrow of trees is slight under normal conditions. Seedling mortality is severe and new trees require irrigation to establish.

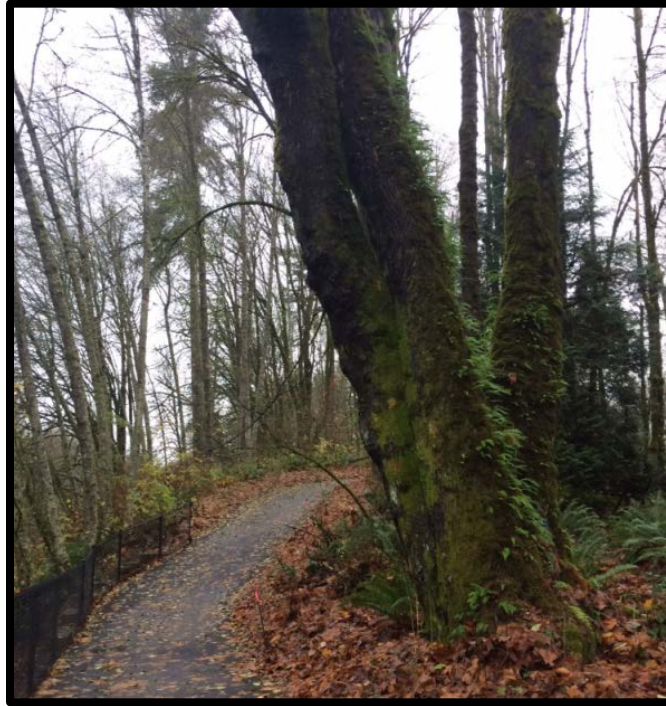
There are 7 trees that appear to be growing on City of Olympia property along the pedestrian path to the north of the project area. These trees will require protection if they are to be retained. Tree protection fences should be placed 5 ft. outside of the dripline of these trees.

Photo 1: Two bigleaf maple trees growing in City rights-of-way near the project area.

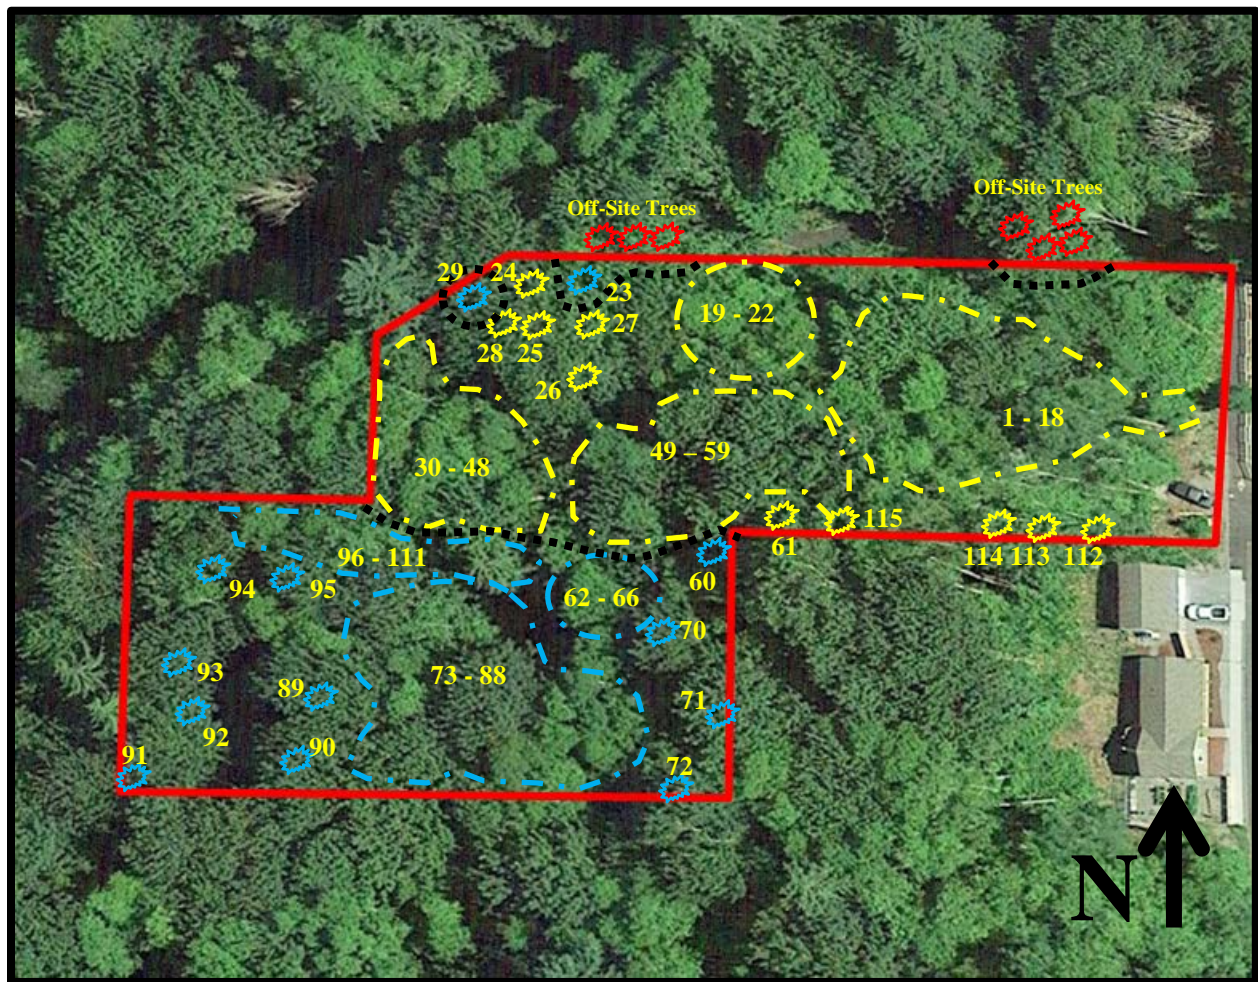
Attachment #2. Site Plan/Tree Map – Approximate tree locations.

By retaining all of the trees in the lower (southern) portion of the property, this tree protection plan retains 190.7 more tree units than required by the City of Olympia. All of the deciduous trees and most of the conifers in the vicinity of the proposed home are either in the footprint of proposed improvements or unsuitable for retention as landscape trees and should be removed during land clearing. Three conifers near the proposed construction site are suitable for retention and could be retained if protection measures are provided.

Trees to be saved must be protected during construction by temporary chain-link fencing on driven posts (Attachment 3), located at the edge of the critical root zone (CRZ). The individual CRZ are a radius 5 ft. outside the dripline of the tree, unless otherwise delineated by WFCI.

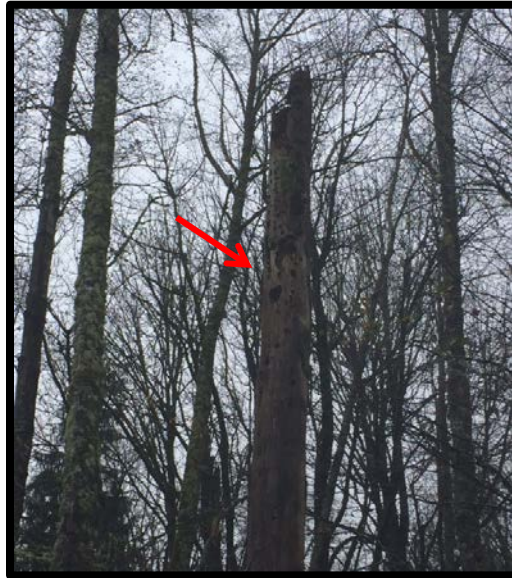
Photo 2: Trees in poor condition can provide habitat for wildlife if retained away from buildings and other developments

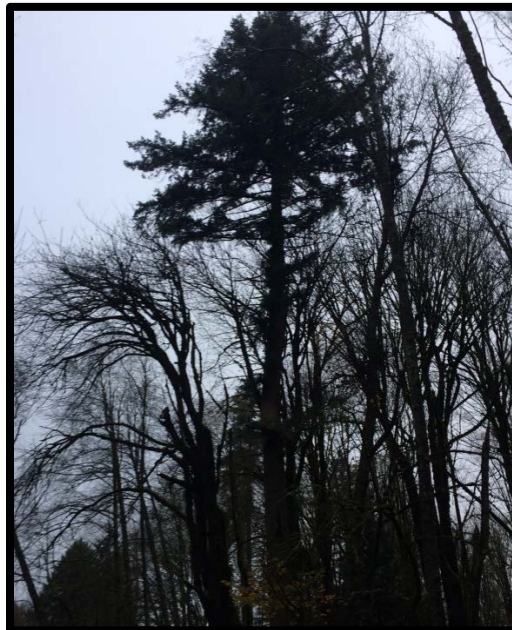
Photo 3: One Douglas-fir tree (#29) currently grows on site and could be retained.
