PROPERTY INSPECTION REPORT

FOUR POINT
HOME INSPECTION INC.

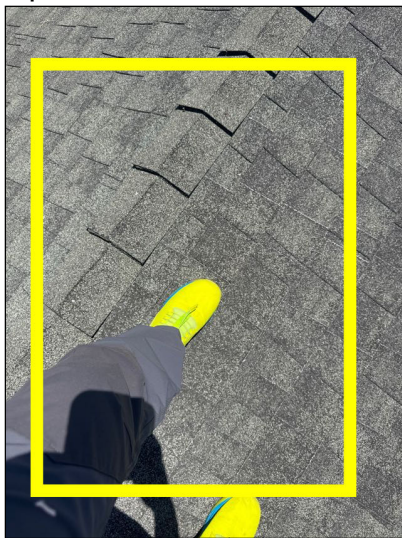
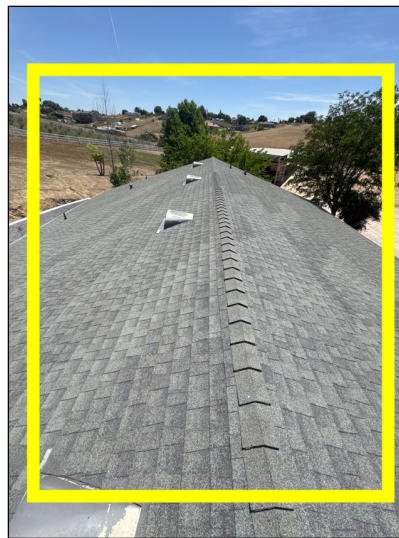
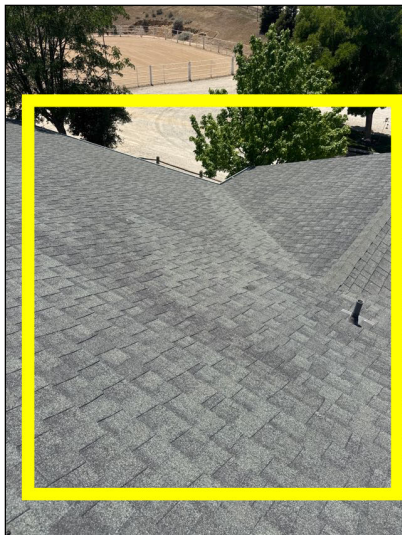
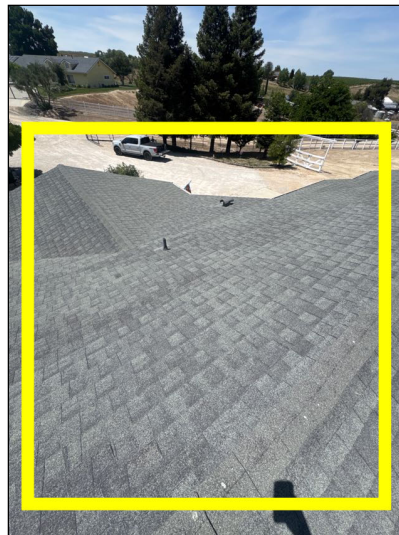
The inspector observed no deficiencies in the condition of the roof structure exterior.

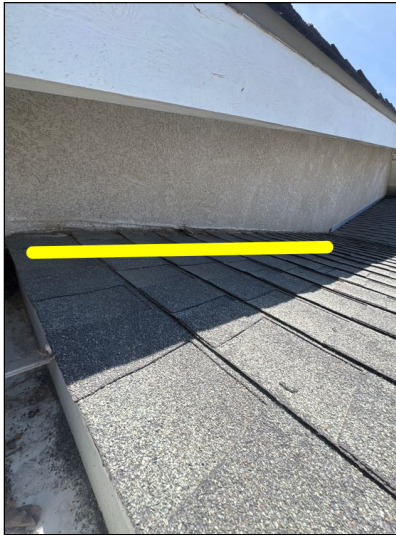
Sidewall flashing over the back patio with the spa was protected against moisture entry by sealant only.

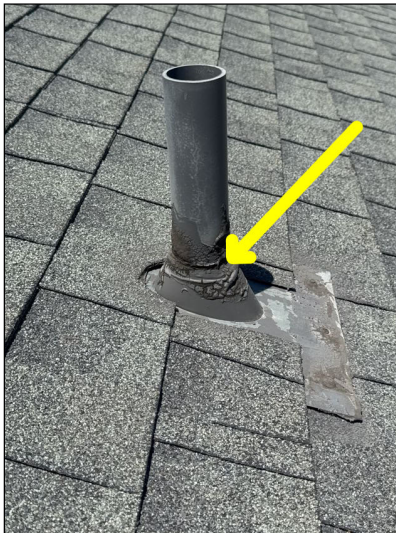
Maintenance Needed: Plumbing vent flashings are mastic covered and some are *showing signs of cracked mastic/mastic deterioration* from sun exposure. Recommend re-sealing all through the roof vents and projections as a part of routine maintenance to prevent unwanted moisture intrusion.

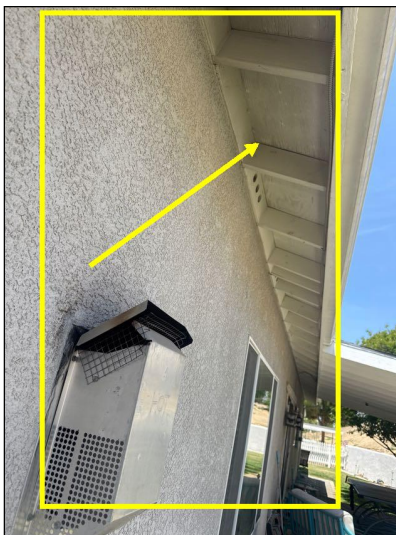
Black stains above the direct vent for the gas fireplace were visible at the time of inspection. This usually indicates a dirty or clogged burner that can lead to incomplete combustion of the gas causing soot to form. The Inspector recommends that before the expiration of your Inspection Objection Deadline you consult with a qualified contractor to gain an idea of options and costs for repairs.

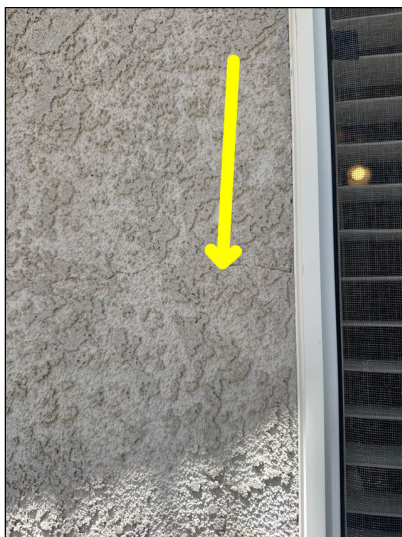
Monitor: Normal cracking was visible in stucco covering exterior walls of the home at the time of the inspection.

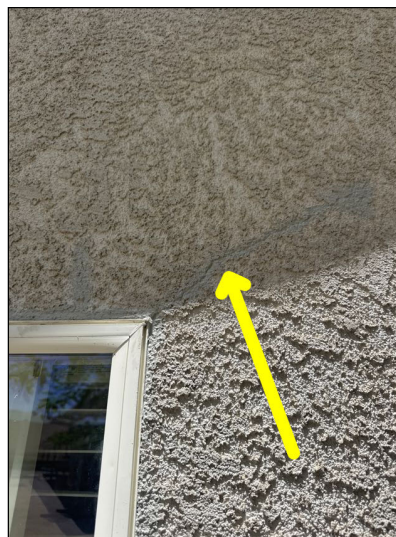
Monitor: Normal cracking was visible in stucco covering exterior walls of the home at the time of the inspection.

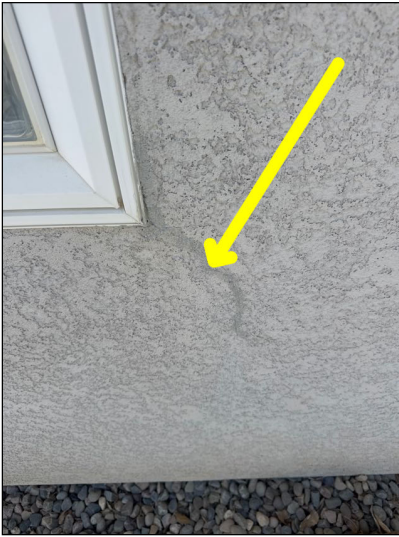
Monitor: Normal cracking was visible in stucco covering exterior walls of the home at the time of the inspection.

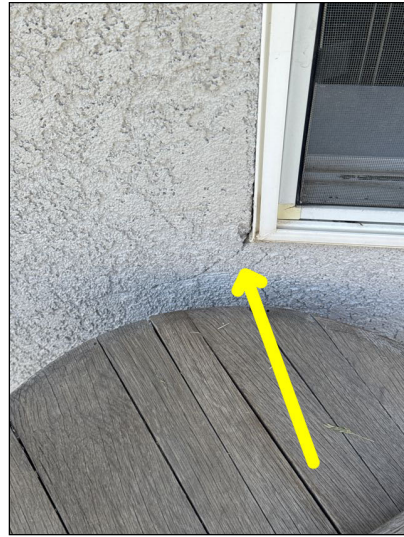
Monitor: Normal cracking was visible in stucco covering exterior walls of the home at the time of the inspection.

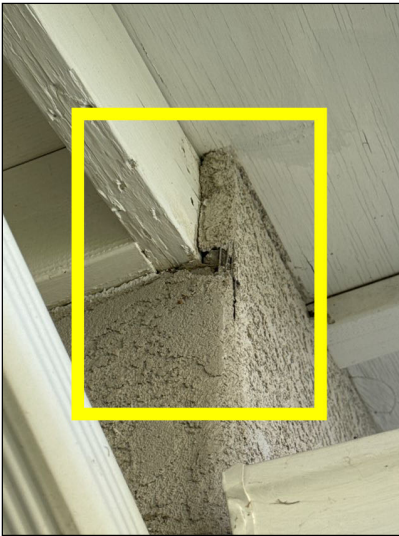
Maintenance: All gaps and holes in the stucco surface should be sealed to keep unwanted moisture out.

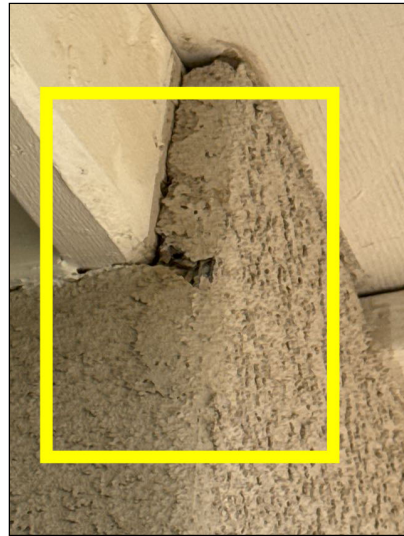
Maintenance: All gaps and holes in the stucco surface should be sealed to keep unwanted moisture out.

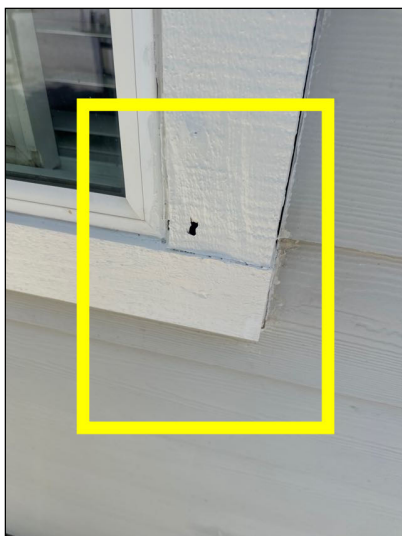
Moisture damage, wood rot, observed.

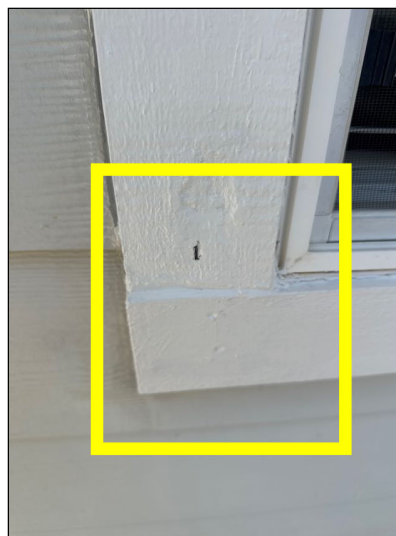
Moisture damage, wood rot, observed.

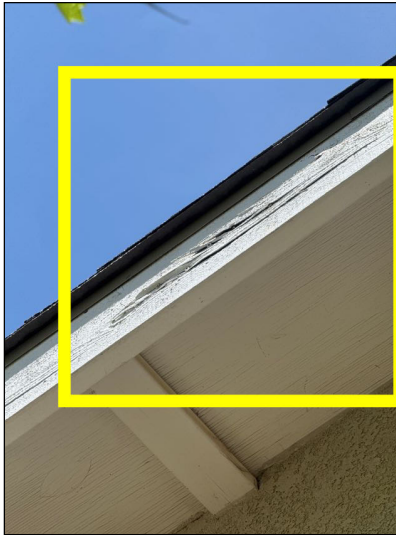
Monitor: Minor moisture damage, wood rot, observed.

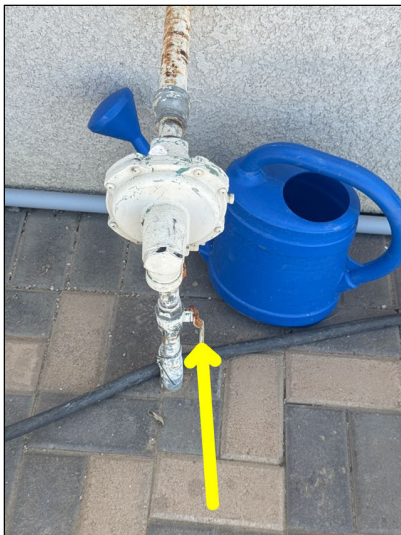
Main gas shut off to the home.

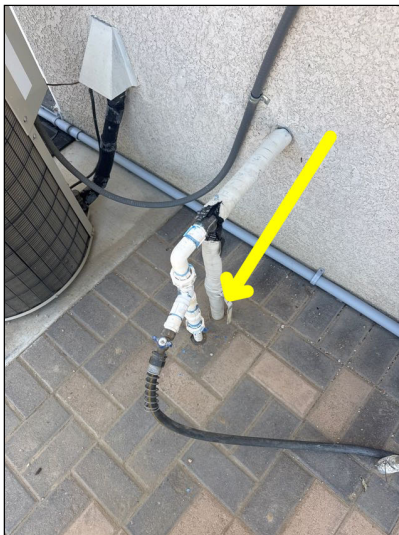
Main water shut off to the home where the main water line enters the home.

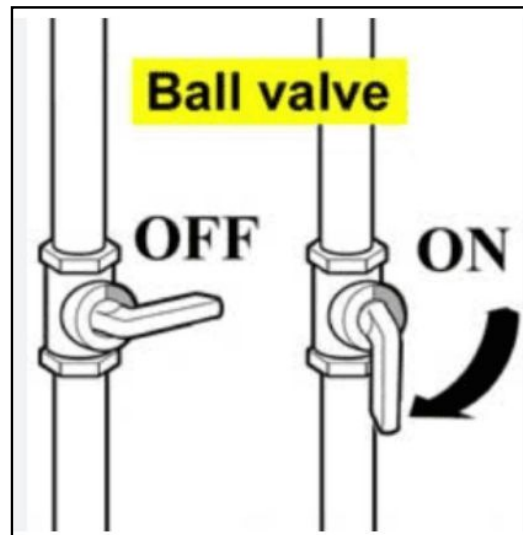
The basic operation for a ball valve shut off is pictured above.

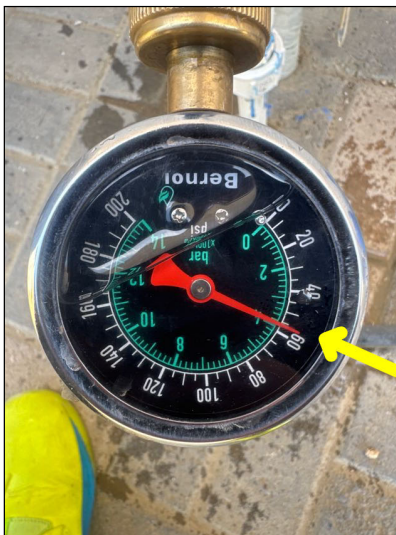
5. Pressure Regulator

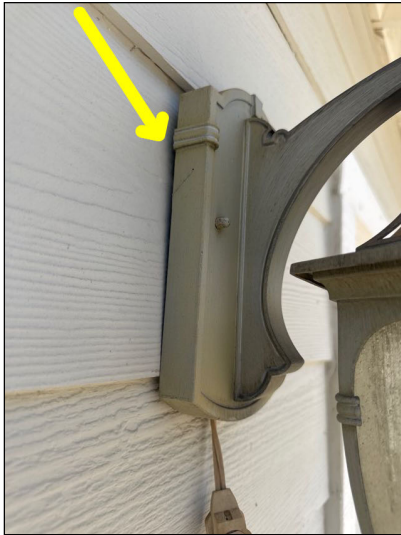
Exterior lighting was loose/not flush to the wall and could expose electrical components to moisture intrusion. front of garage

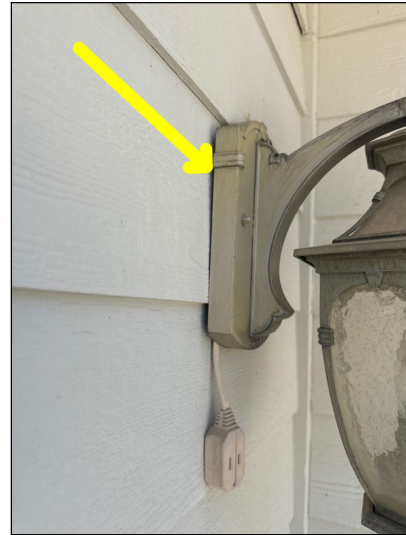
Exterior lighting was loose/not flush to the wall and could expose electrical components to moisture intrusion. front of garage

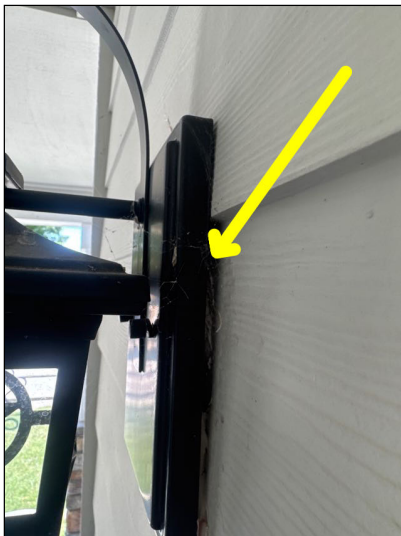
Exterior lighting was loose/not flush to the wall and could expose electrical components to moisture intrusion. front door

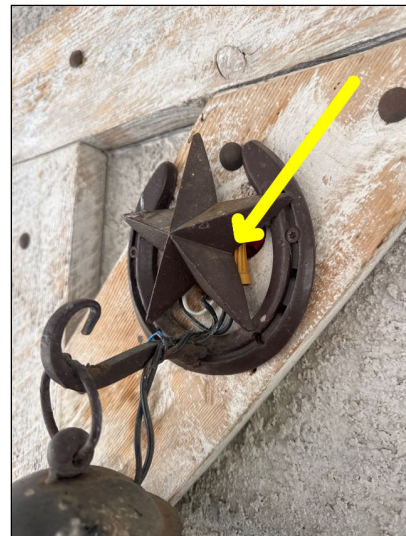
Exterior lighting was installed in a manner that left energized electrical components exposed to moisture intrusion.

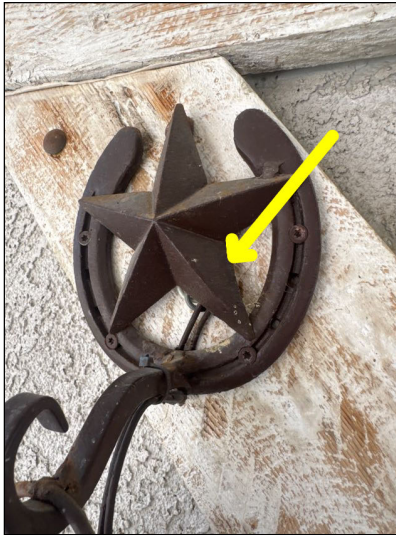
Exterior lighting was installed in a manner that left energized electrical components exposed to moisture intrusion.

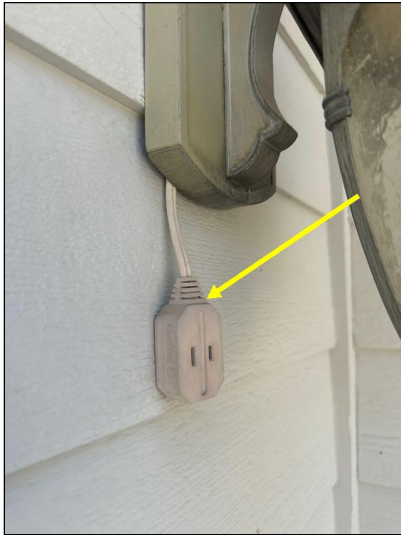
Extension cord used as permanent wiring was visible at the front of the garage.

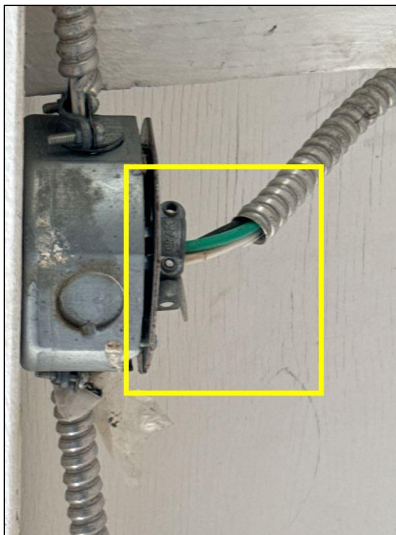
The electrical conduit is separated and/or damaged.

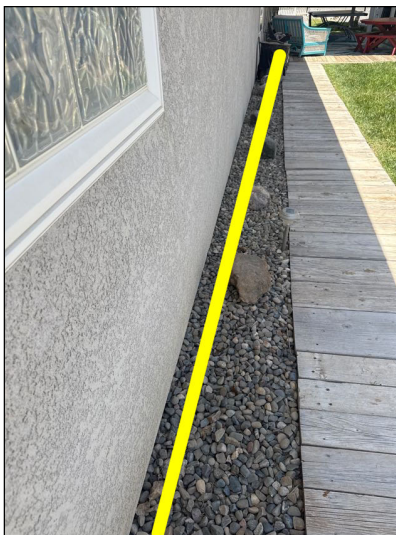
Maintenance Needed: Earth to stucco contact at exterior walls.

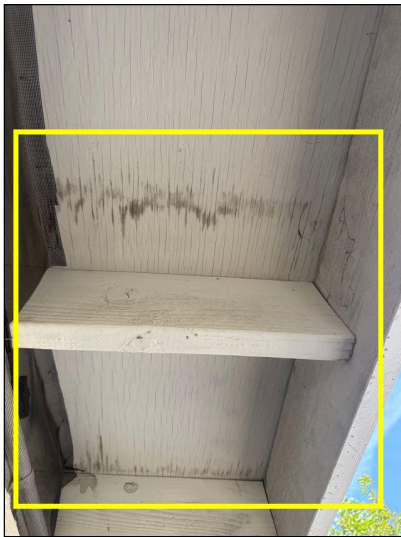
Monitor: The soffit was not sealed above the covered patio area(s) at the time of the inspection.

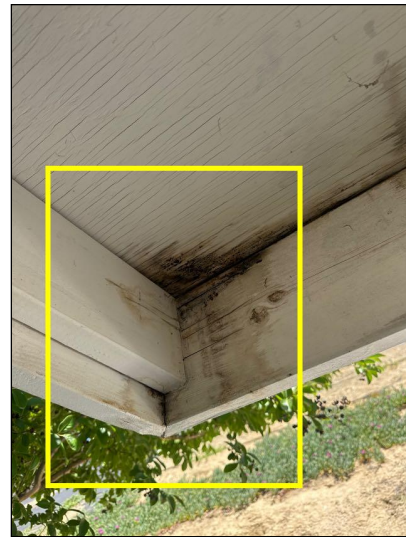
Moisture damage, wood rot, observed.

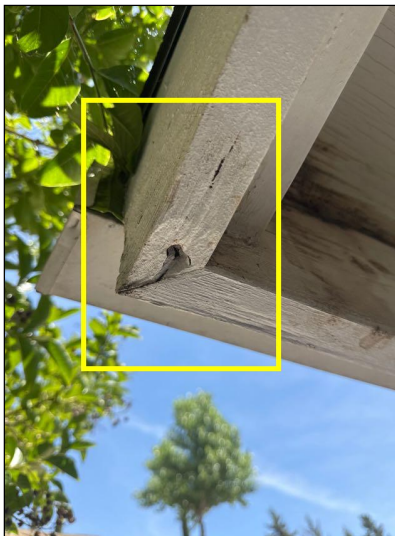
Moisture damage, wood rot, observed.

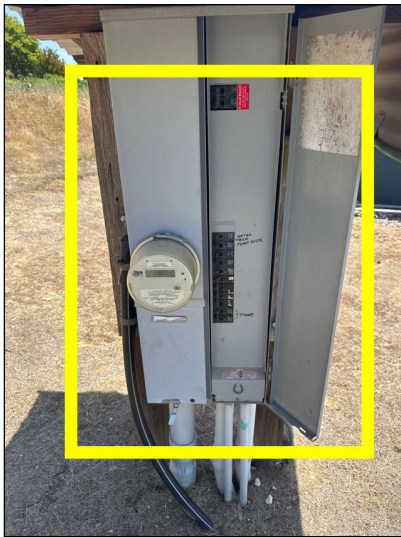
Main electrical service panel to the property

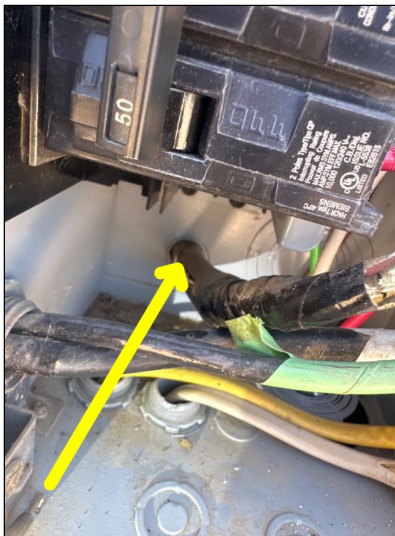
Non-metallic conductors had no clamps installed where they passed through knock-outs

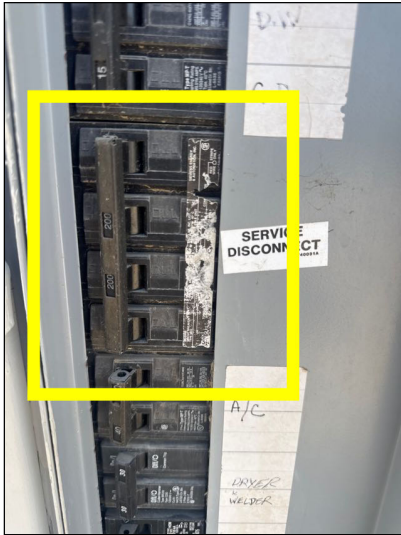
Main electrical shut off to the home

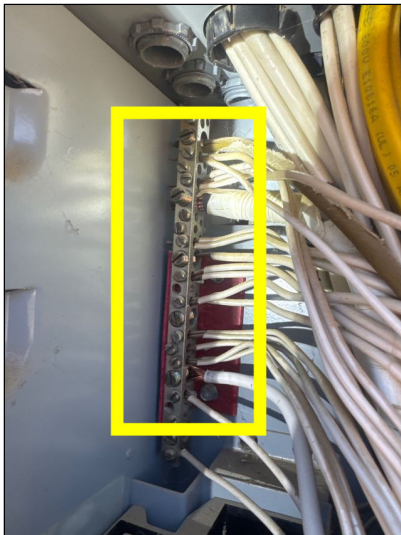
Multiple neutral conductors (white wire) from separate branch or separate feeder circuits cannot be installed in the same neutral terminal (lug screw)

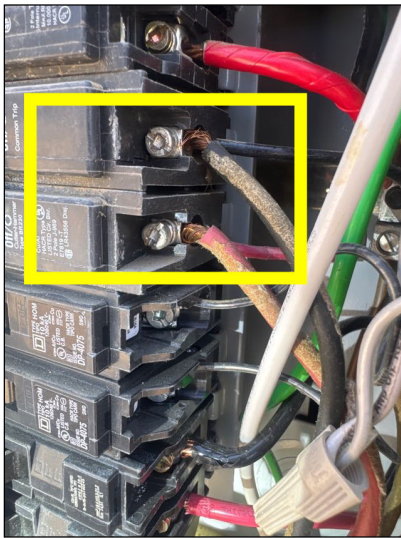
Double tapping observed. Double tapping (i.e. 2 wires on a single pole breaker) can add to the load of the affected circuit causing a possible overload and tripping breakers

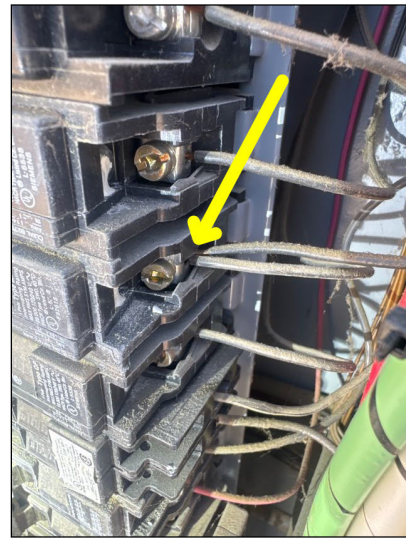
Double tapping observed. Double tapping (i.e. 2 wires on a single pole breaker) can add to the load of the affected circuit causing a possible overload and tripping breakers

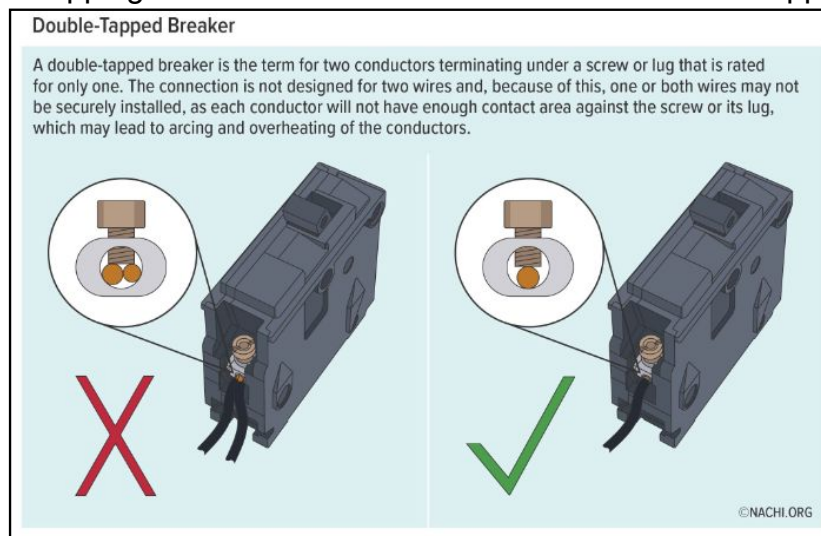
Electrical (continued)

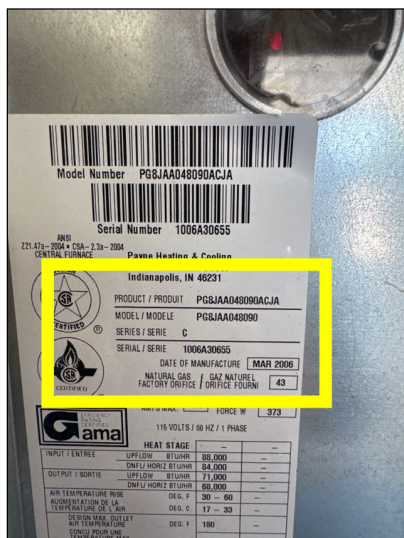
Heater model and serial number

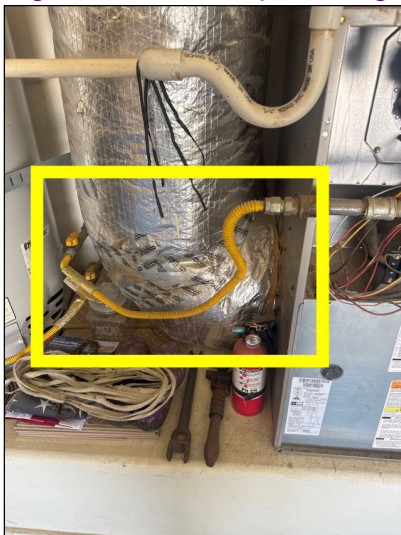
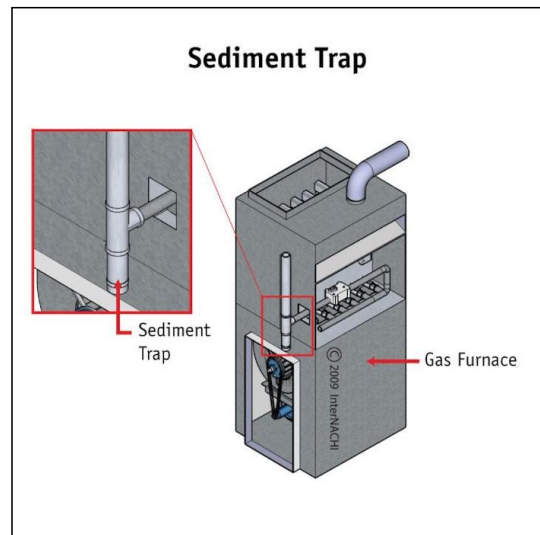
Improvement: The gas supply pipe contained no sediment trap.

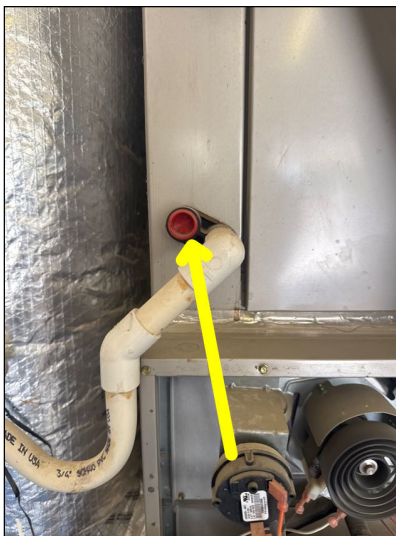
Monitor: No secondary condensation tube was installed. Instead, the outlet was left plugged. The secondary line is a backup line, so if the primary line gets clogged, the condensate water will then go through the secondary line. The Inspector recommends installation of a secondary condensate drain pipe by a qualified HVAC contractor.

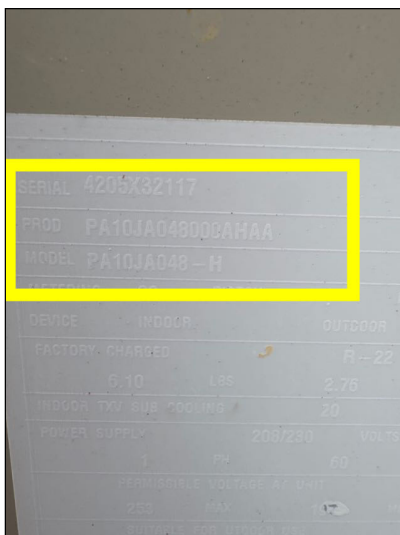
AC model and serial number

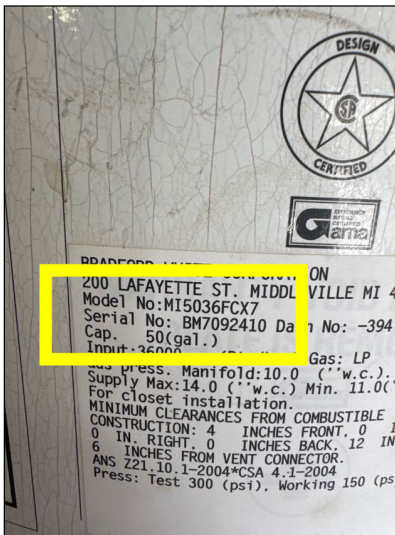
Water heater model and serial number

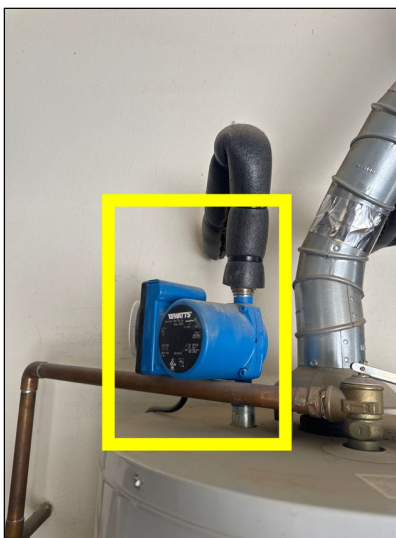
Note: The home had a hot water re-circulation system installed.

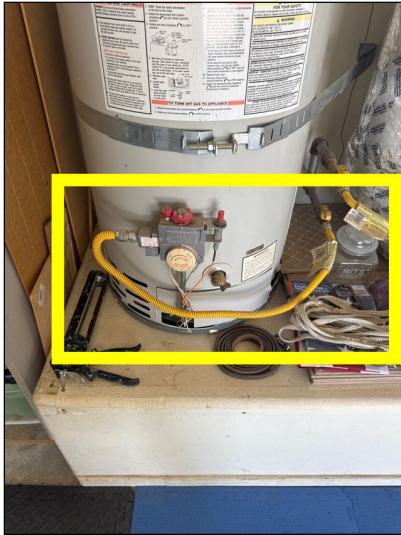
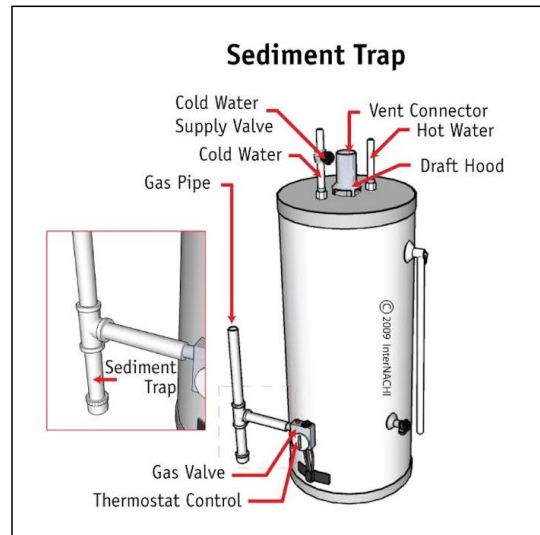
Improvement: The gas supply pipe contained no sediment trap.

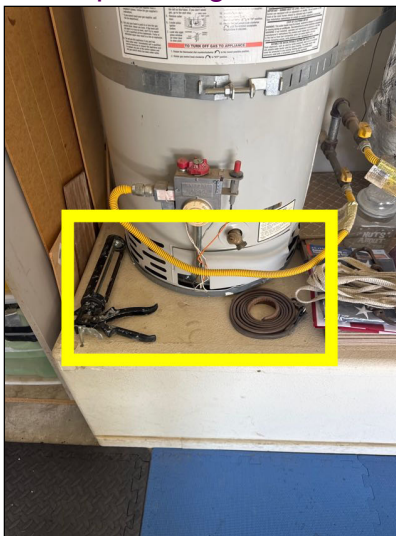
Improvement: no drip pan was installed.

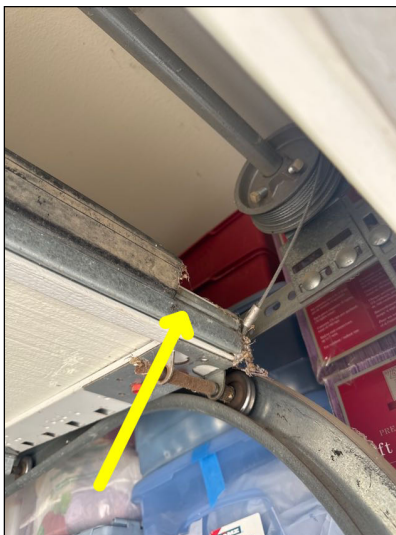
The bottom weather stripping on the overhead door is showing signs of deterioration or missing in areas.

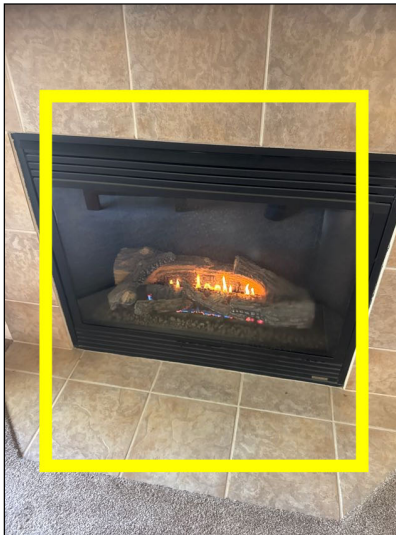
Find a CSIA-certified inspector near you at <http://www.csia.org/search>

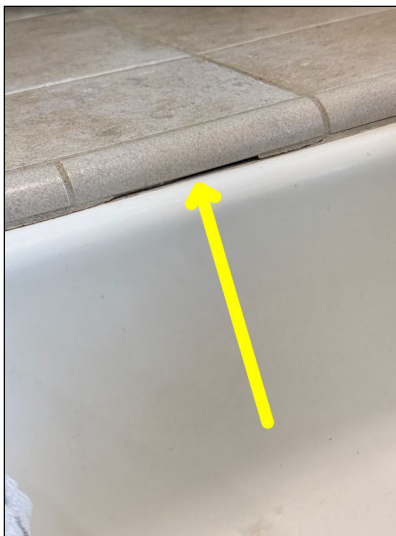
Maintenance Needed: Sealant at the kitchen countertop and backsplash behind the kitchen sink exhibited moderate deterioration. The Inspector recommends maintenance be performed by a qualified contractor to prevent any moisture intrusion behind the wall.

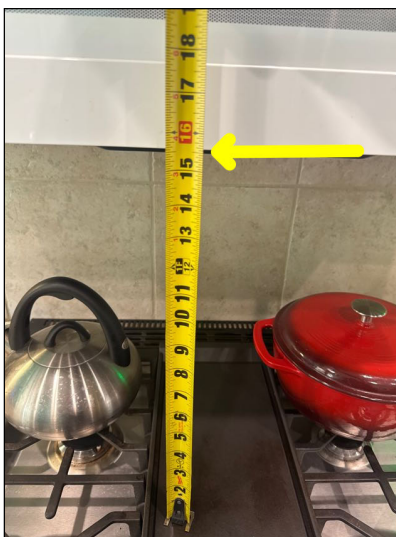
Safety: Any range hood, including microwaves, installed above the stove must be a minimum of 24 inches

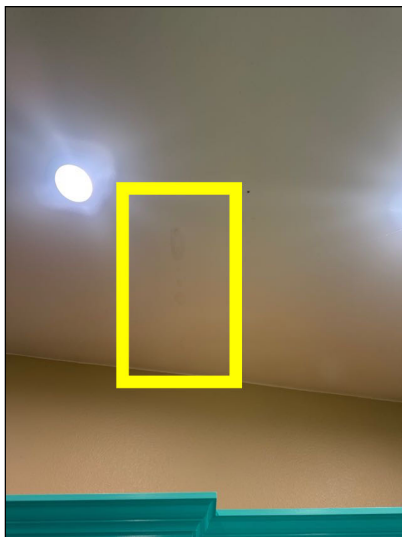
Monitor: Stains on the ceiling visible at the time of the inspection appeared to be the result of moisture intrusion.

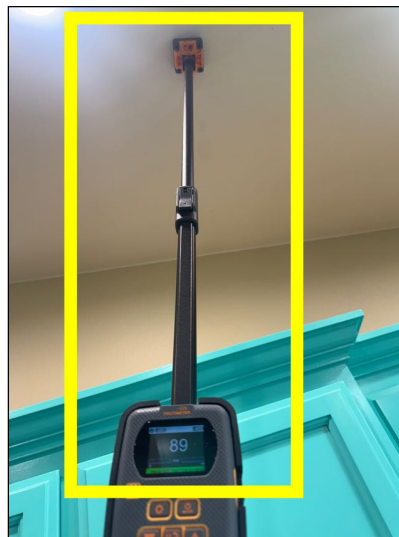
The moisture meter showed no elevated levels of moisture present in the stained areas at the time of the inspection (Normal moisture is considered between 5-12%)

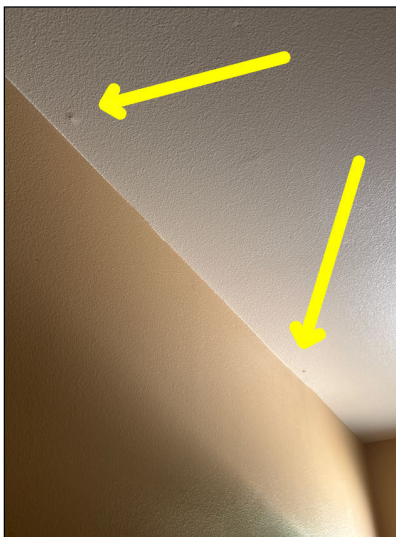
Monitor: Normal settlement nail pops were visible in interior ceiling of the bathroom at the time of the inspection. The nail pops appeared to be consistent with that caused by normal settlement. Settlement typically takes place in the first few years after original construction, and then stops. Nail pops can be repaired and sealed, but may reappear over time with temperature and humidity levels.

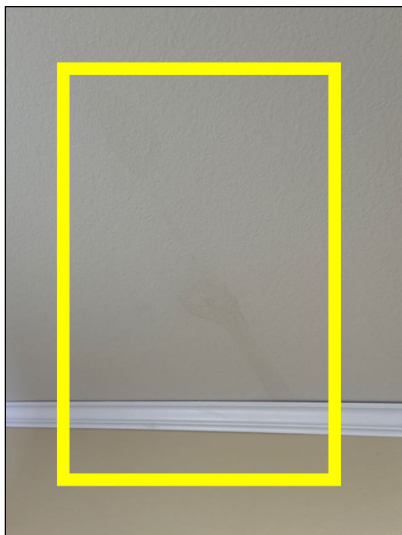
Monitor: Stains on the ceiling visible at the time of the inspection appeared to be the result of moisture intrusion.

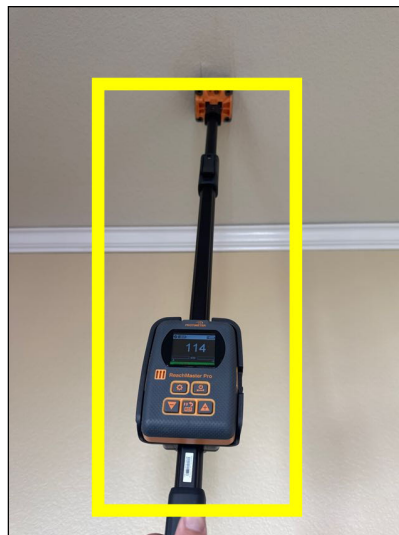
The moisture meter showed no elevated levels of moisture present in the stained areas at the time of the inspection (Normal moisture is considered between 5-12%)

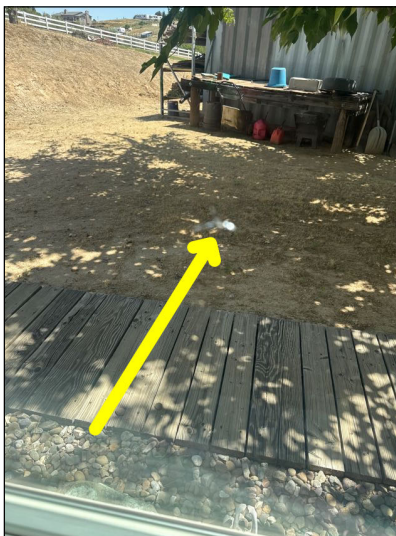
A window had a cracked or broken pane.
