PIER & BEAM FOUNDATION REPAIR AGREEMENT

**RE: 4608 Windy Brook
Austin, Texas**

Job #20103155

ADDENDUM UPDATING SELLER'S DISCLOSURE NOTICE

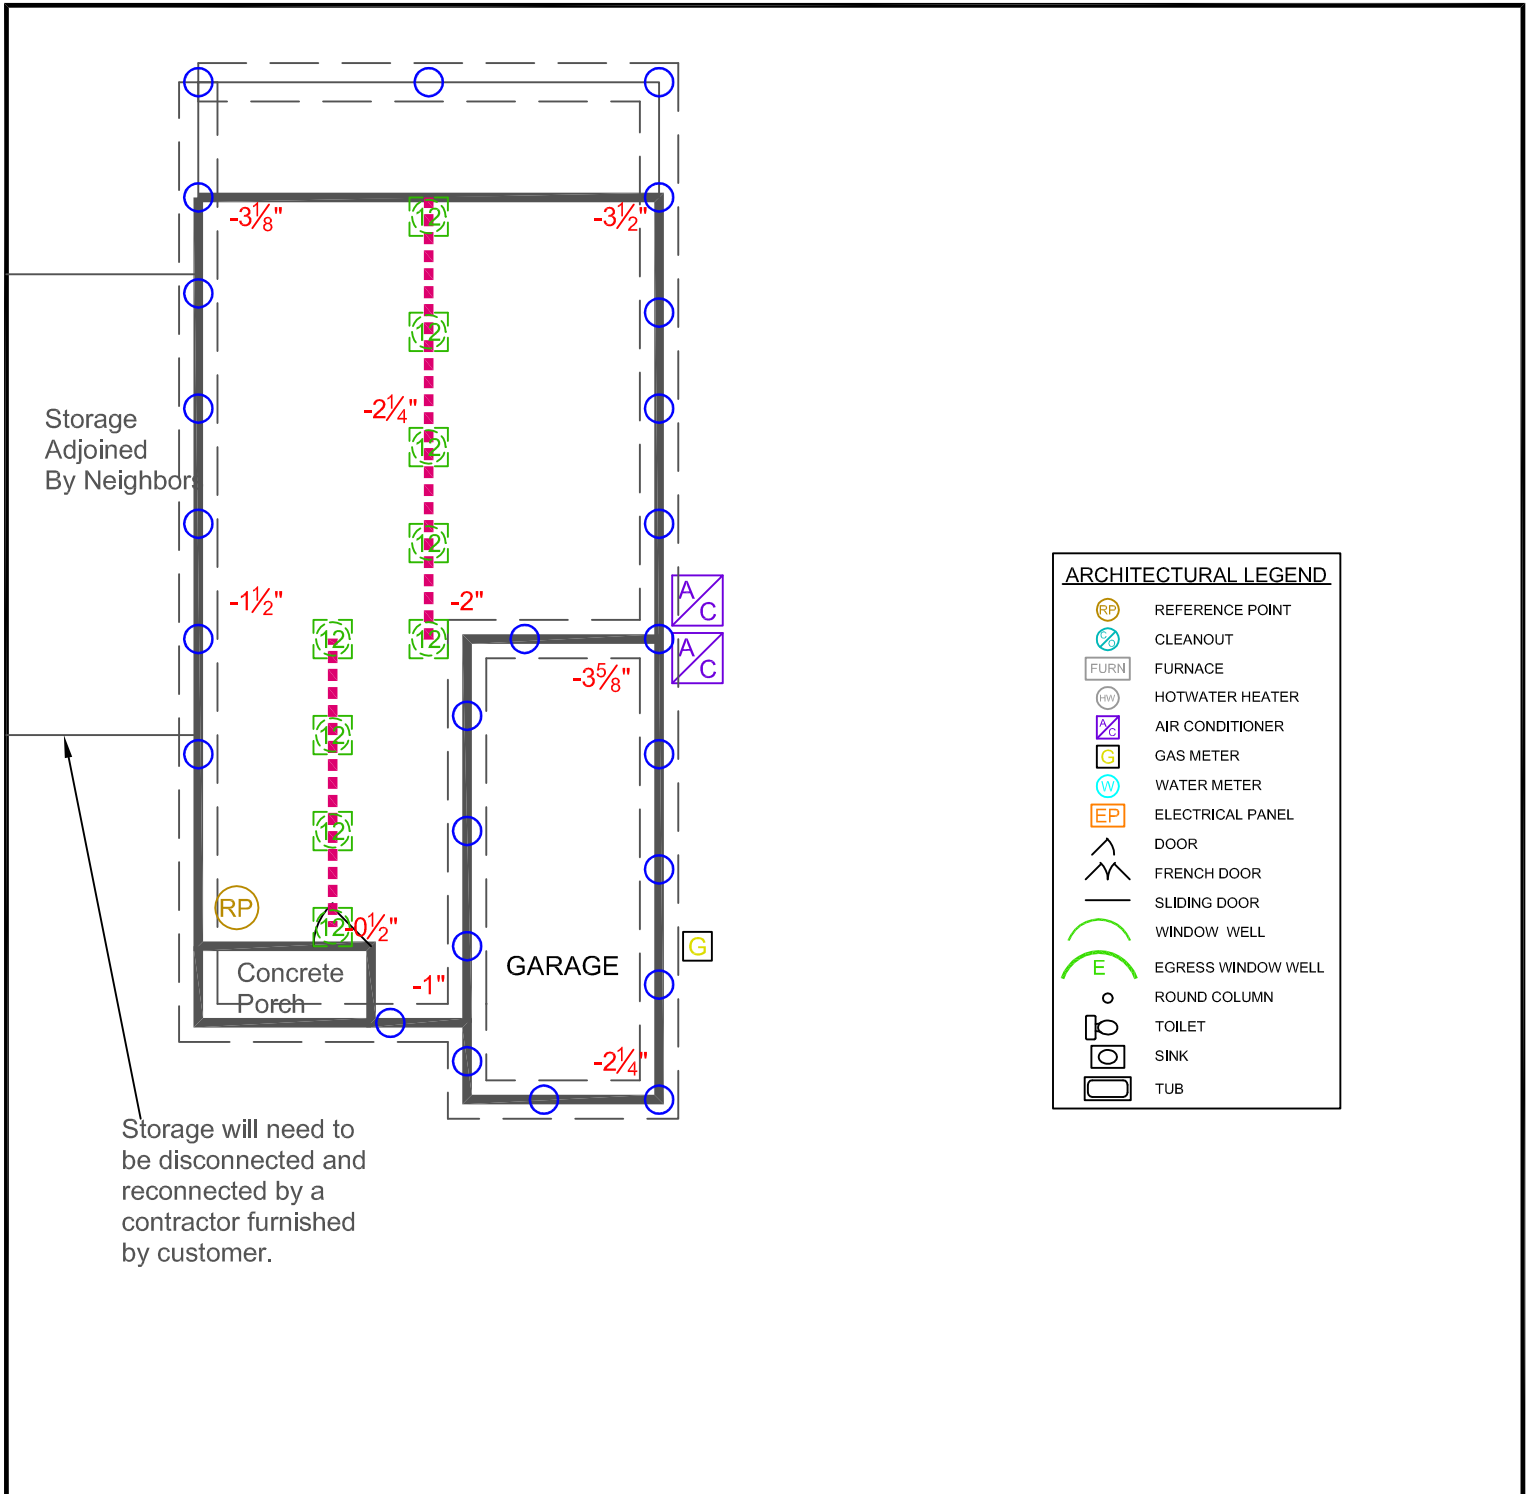
Contractor to install or replace approximately 43 ft. of 4X6 sill beam below structure for support. Contractor will install 9 spread footing piers with 10" sonotube. New piers to be installed with 2'X2' footing 2' deep, or less if sitting on rock. Contractor will install approximately ft. of joist. After installation, Contractor to raise structure to as near as possible to level to the limits of the structure, unless otherwise stated. Newly installed piers to be shimmed as necessary to retain newly attained height. Existing piers to be shimmed as necessary. All shim material to be steel plates. It is understood and agreed that in order to perform the above mentioned work: it is possible that sheetrock, wallpaper, or other rigid materials may crack. Therefore the below figures do not include any redecorating, painting, repairing, plumbing or electrical work, or replacing any materials not called for in this agreement.

Additional Work To Be Performed: Use 12" Piers

Install 25 Exterior Piers under Stemwall and garage

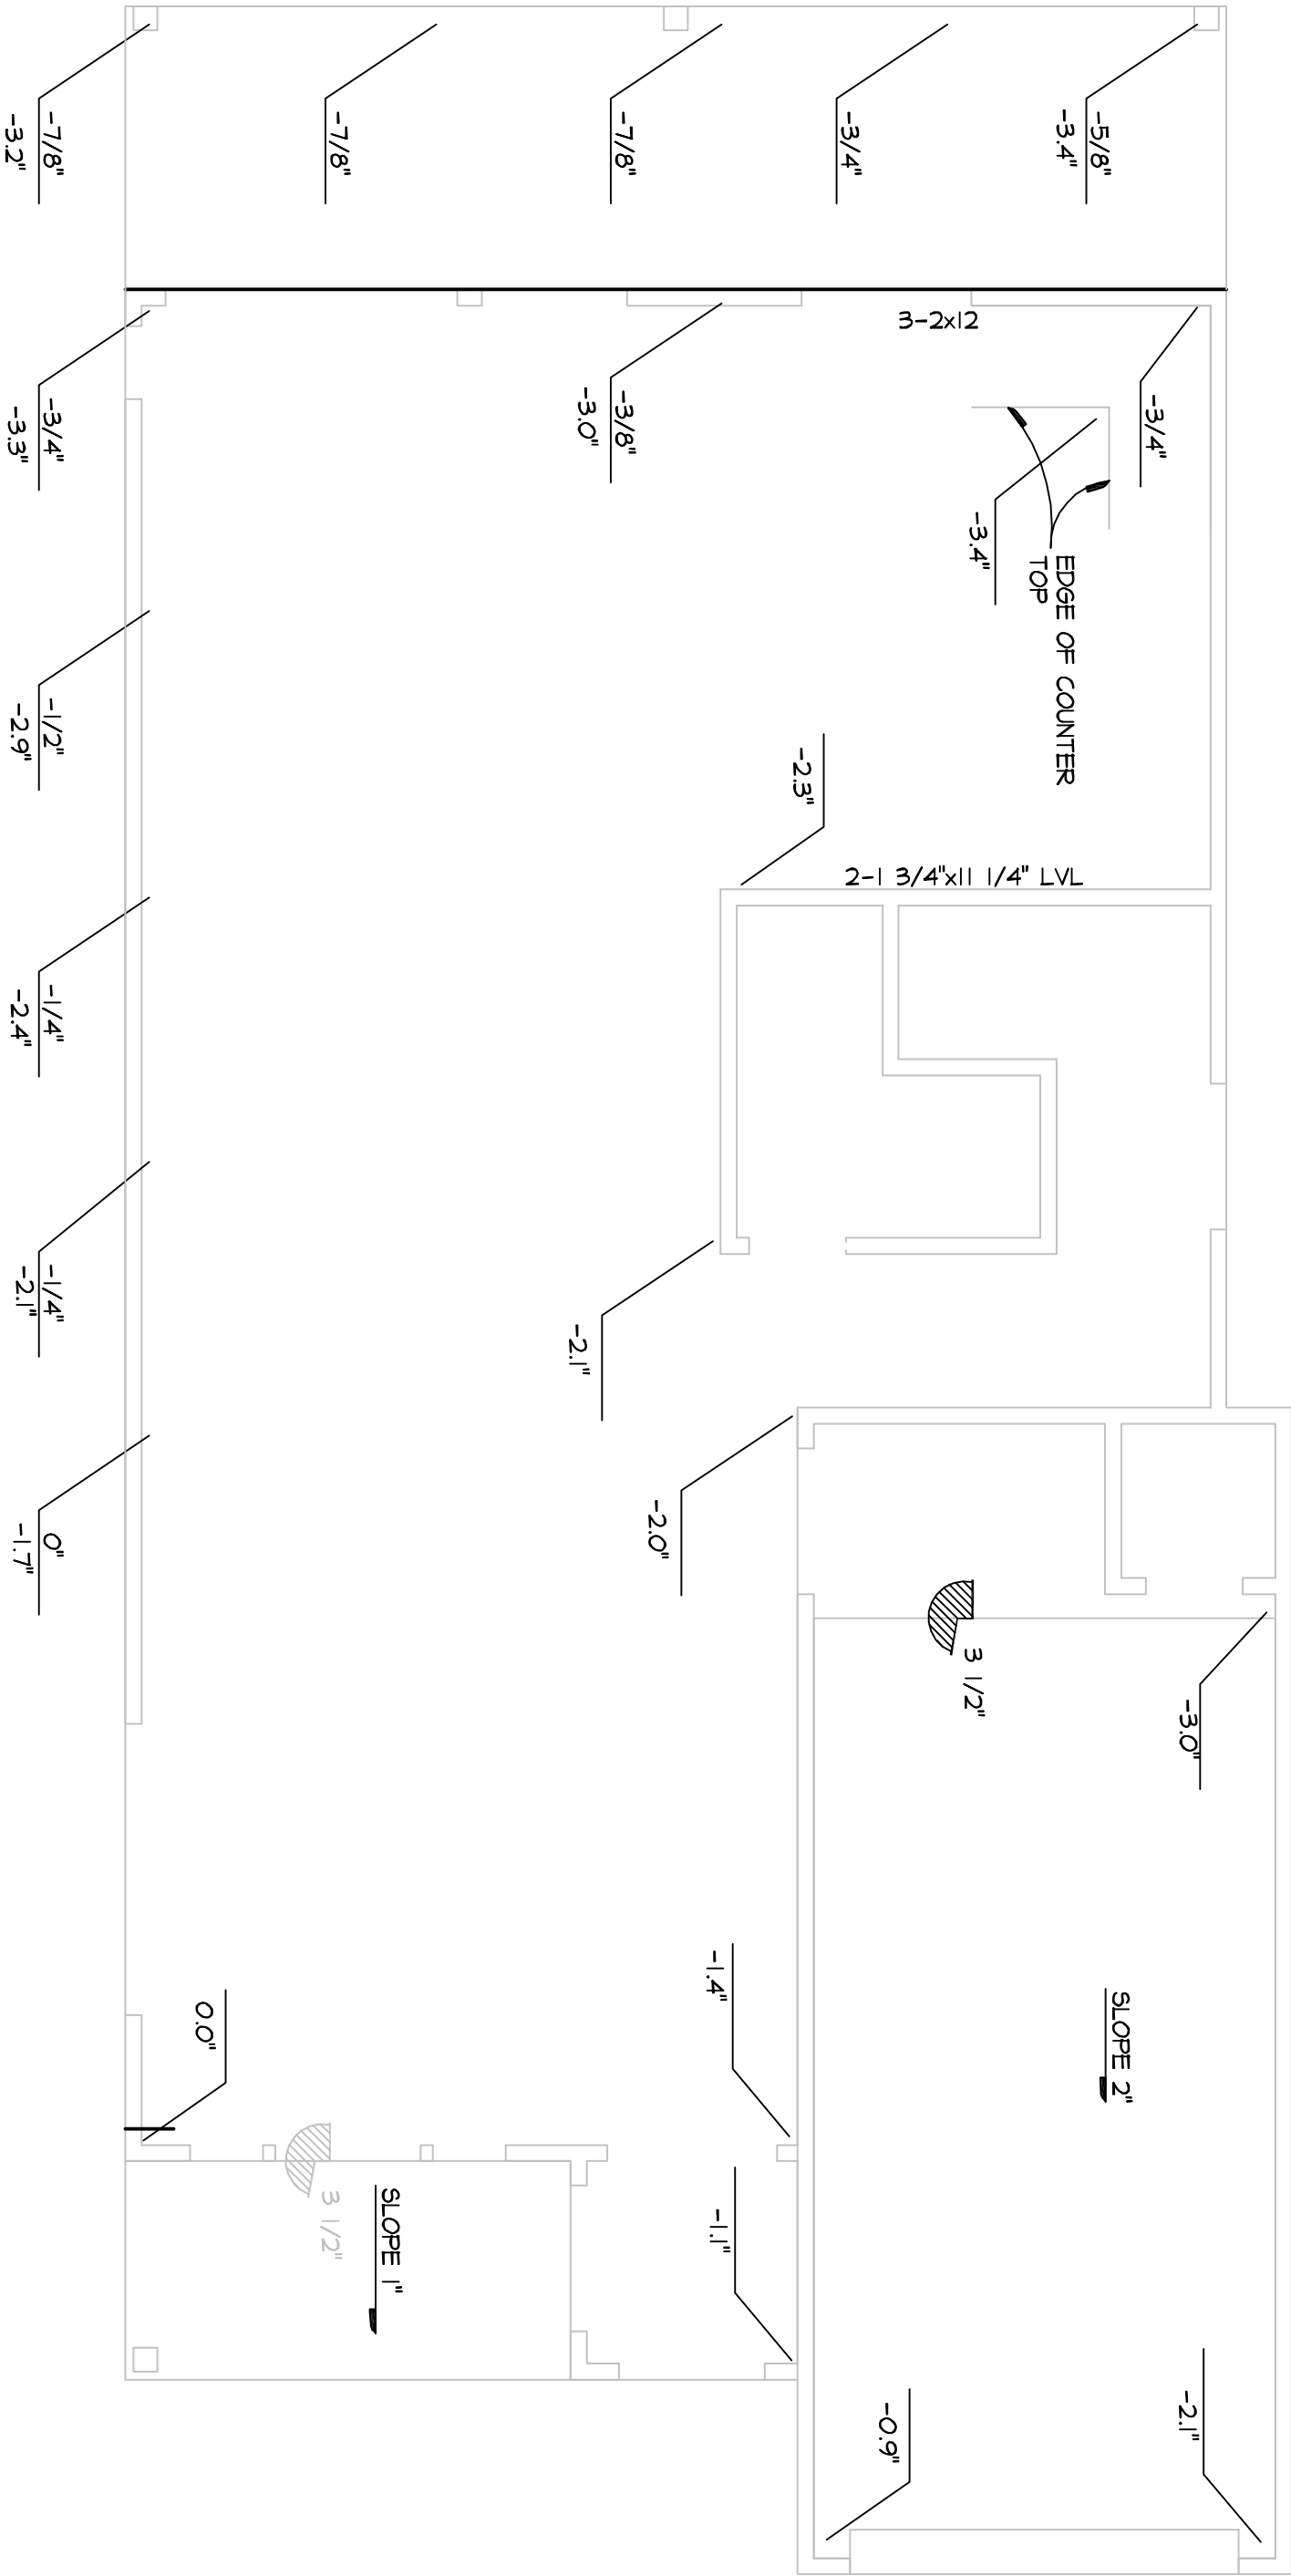
In 2012 the measurements we took indicated a difference in elevation from the front of the house to the back deck of approximately 7/8" downward. The measurements were taken with a water level. At the time we attributed the drop to normal pier movement that that could be expected and settling of the wood frame structure.

On July, 16 we measured a maximum difference from the front of the house to the back deck of 3.4". These measurements were taken with an electronic Zip level. Part of the difference of recent measurements to previous measurements can be attributed to differences in the accuracy in the types of equipment used. We do not have base measurements taken after the concrete structure was poured, nor when the house was completed. Therefore we don't know if the house was constructed somewhat out of level or if some of the movement occurred during construction.

UPPER READINGS WERE TAKEN IN 2012
LOWER READINGS WERE TAKEN IN 2015

Without observed severe distress in the house or the foundation I do not feel that it would be prudent at this time to try and level the structure. It is possible that moving the structure as much as 3 inches would do more harm than good at this point considering that the house appears by observation and by owner comments to be functioning well.

Areas of the structure that should be addressed are at the front of the house. The front of the lot slopes toward the street side of the foundation. It appears that the front of the house does not drain well, and it is possible that water could be saturating the soil at the front of the foundation. Therefore we recommend that a drainage system similar to the one that was added at the north side of the lot be added to assure water is draining away properly. In addition, we would recommend that a thorough observation of the crawl space be done to assure that there is still a void below front and side of the foundation grade beams and that the beam earth retainers are still in good working condition. Void below the grade beams is critical in assuring the proper function of the foundation. No other modifications to the structure in my opinion are need at this time.
