# Inspection Report

**Property Address:**  
2254 Assumption Road

**Paul Galvin Residential Home Inspections**

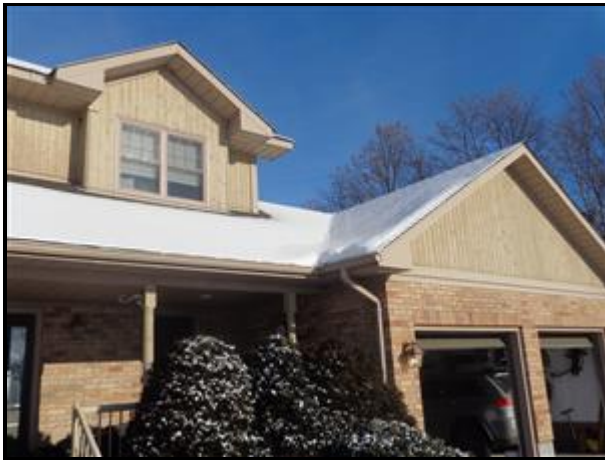
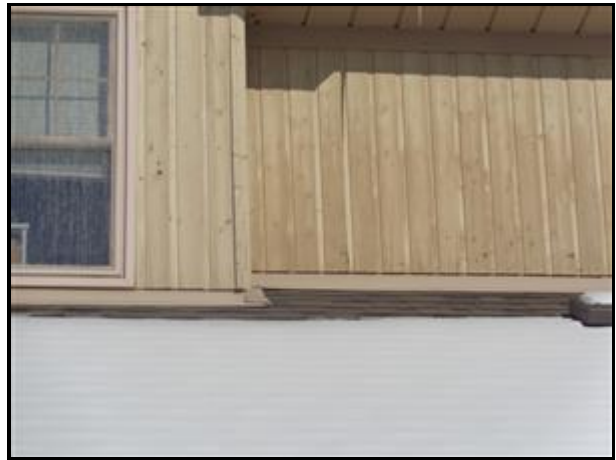
1.0 Picture 1

The entire roof surface appears to be asphalt shingles. The roof was snow covered at the time of the inspection. Therefore no exact comment can be made on it's condition or life expectancy. However the very small area of shingles that could be seen appear to be newer.

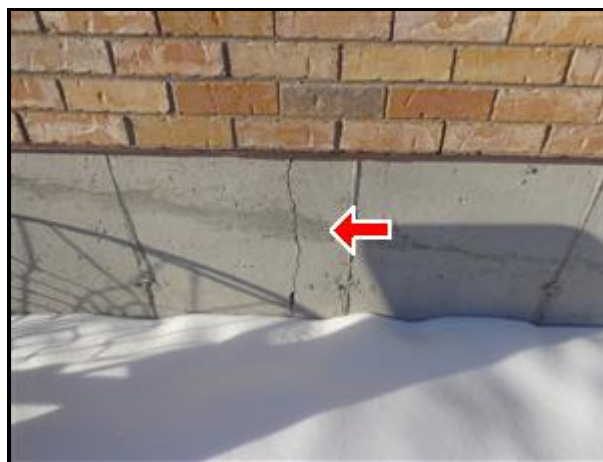
2.1 Picture 1

There is a very minor exterior foundation crack at the right side of the garage. This is quite typical and not a structural concern.

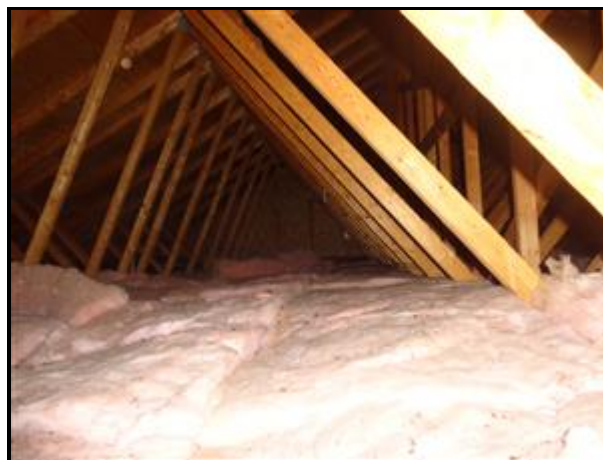
4.0 Picture 1

The attic contains fiberglass batt insulation. This insulation appears to be well placed and installed in adequate amounts.

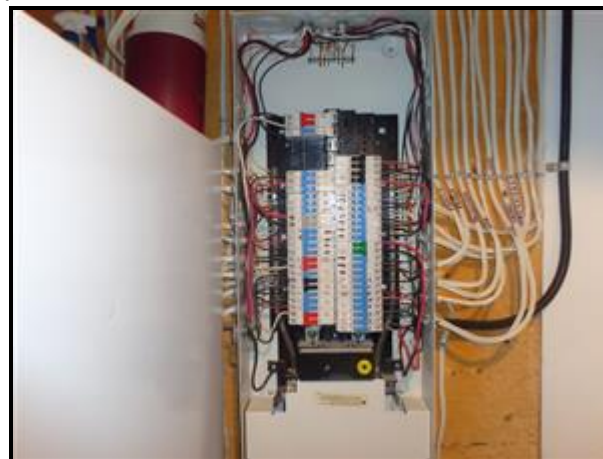
5.2 Picture 1

(1) The main electrical panel was inspected and found to be installed properly and wired correctly. All of the proper sized breakers were present.

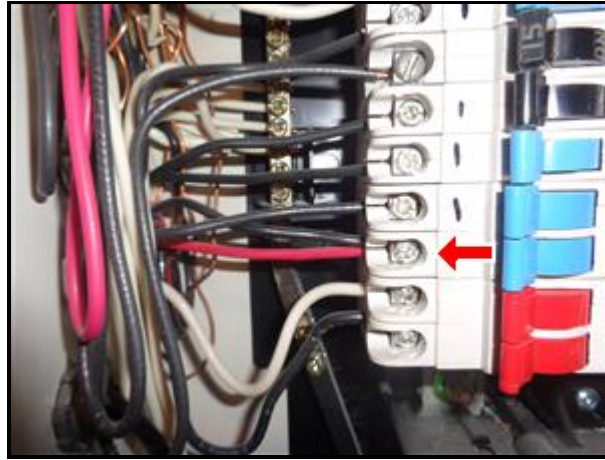
5.2 Picture 2

(2) There appeared to be one double tap in the panel. This is a minor concern. This can easily be corrected by adding a breaker if needed.

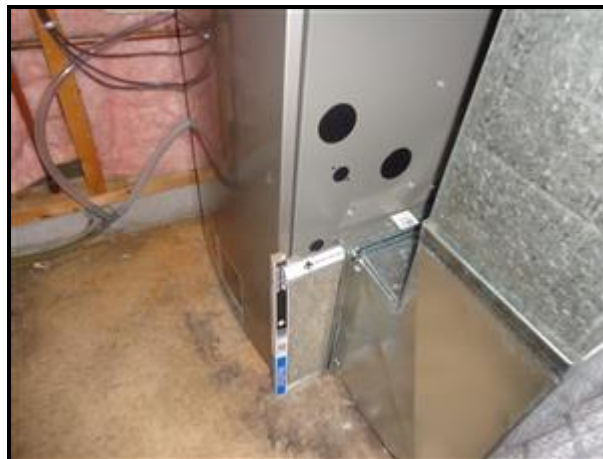
6.0 Picture 1

- (1) The furnace was tested and inspected and found to be installed properly and working well. All the necessary safety features were present.
- (2) The furnace filter should be changed on a regular basis.

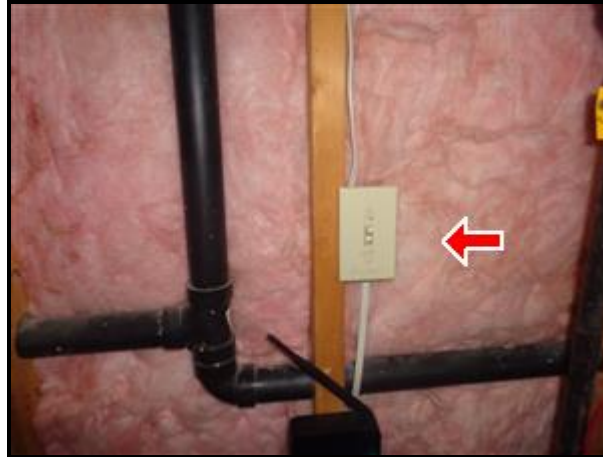
6.7 Picture 1

In the basement beside the furnace.

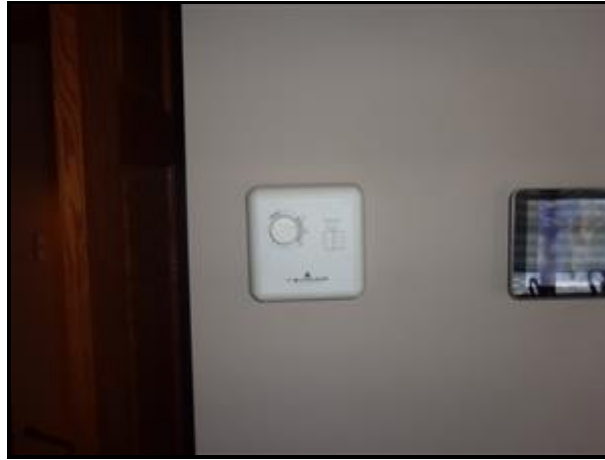
6.12 Picture 1

(1) The heat recovery ventilator located in the basement is a mechanical device that exchanges stale indoor air with fresh outdoor air. Heat is transferred from the outgoing air to incoming air by passing the two air streams through a heat exchange core. Stale air is removed from the cold air return and then fresh air from outside is delivered to the cold air return closer to the furnace. This fresh air is then delivered to the house through the furnace ductwork. This device controls air quality and condensation levels in a well sealed house. This is controlled by a humidistat located beside the thermostat.

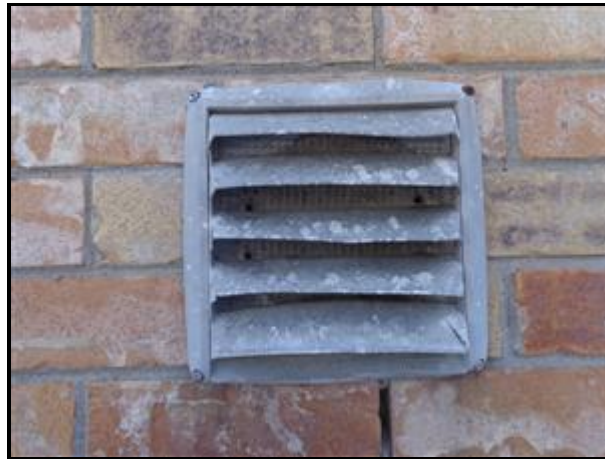
6.12 Picture 2

(2) The heat recovery ventilator filters including the outside fresh air intake screen will require cleaning on a regular basis (see manufacturers recommendations). The outside fresh air intake appeared to be dirty. This can be cleaned for better efficiency.

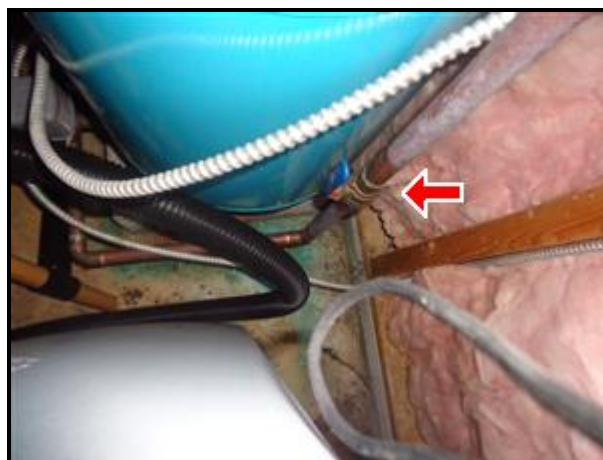
7.4 Picture 1

At pressure tank.

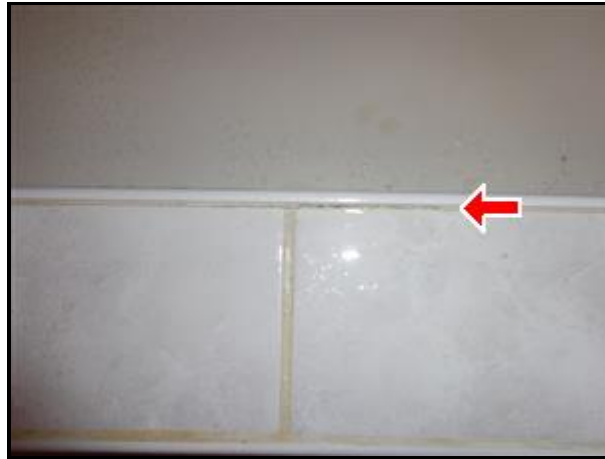
7.11 Picture 1

The basement shower curb could use for some more grout or caulking to ensure a water tight seal.

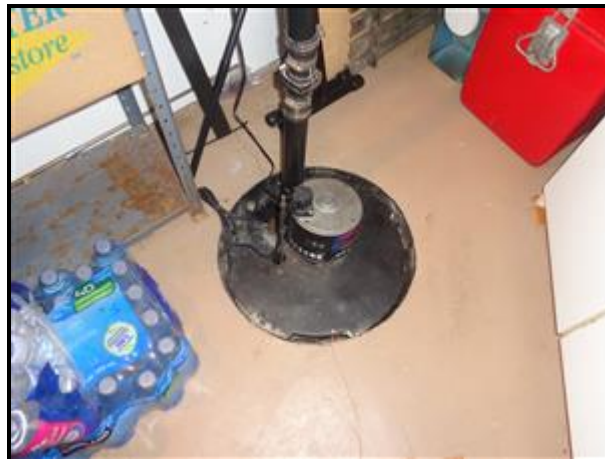
7.12 Picture 1

The sump pump should be tested on a regular basis to ensure its proper operation.

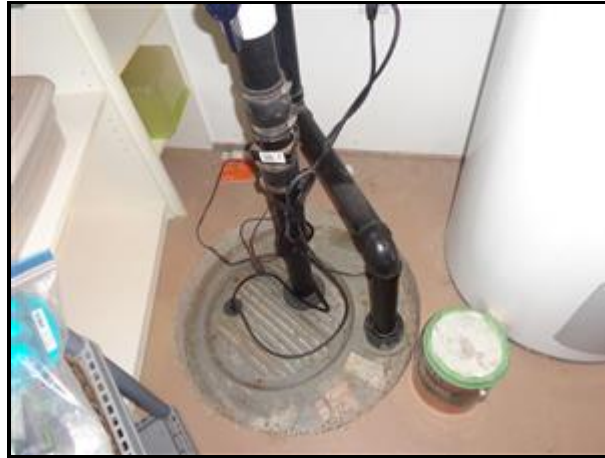
7.13 Picture 1

There is a sewage ejector in the basement bathroom. This is used to pump the sewage/grey water from the lower bathroom and bar sink up to the septic outlet.

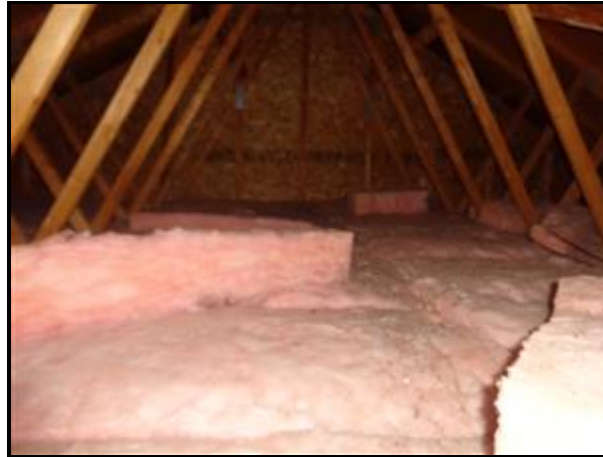
9.0 Picture 1

There appeared to be some fiberglass batt in the garage attic.

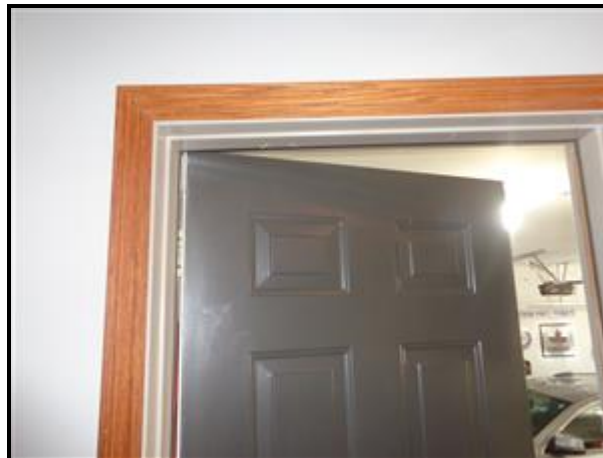
9.5 Picture 1

Technically there should be a self-closing device on the door from the garage to the house.

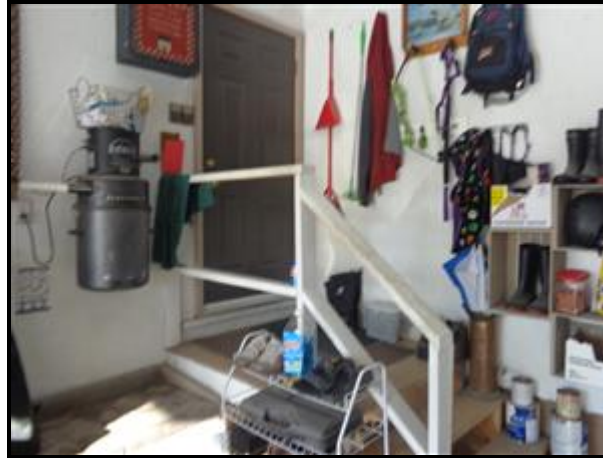
9.8 Picture 1

The garage railing does not meet the present code for safety. This could pose a safety / fall hazard. Care should be taken particularly with children or a proper railing should be installed.
